Back Creek Stream and Wetland Restoration

Project No. 17

2006 Monitoring Report: Year 1 of 5

March 2007

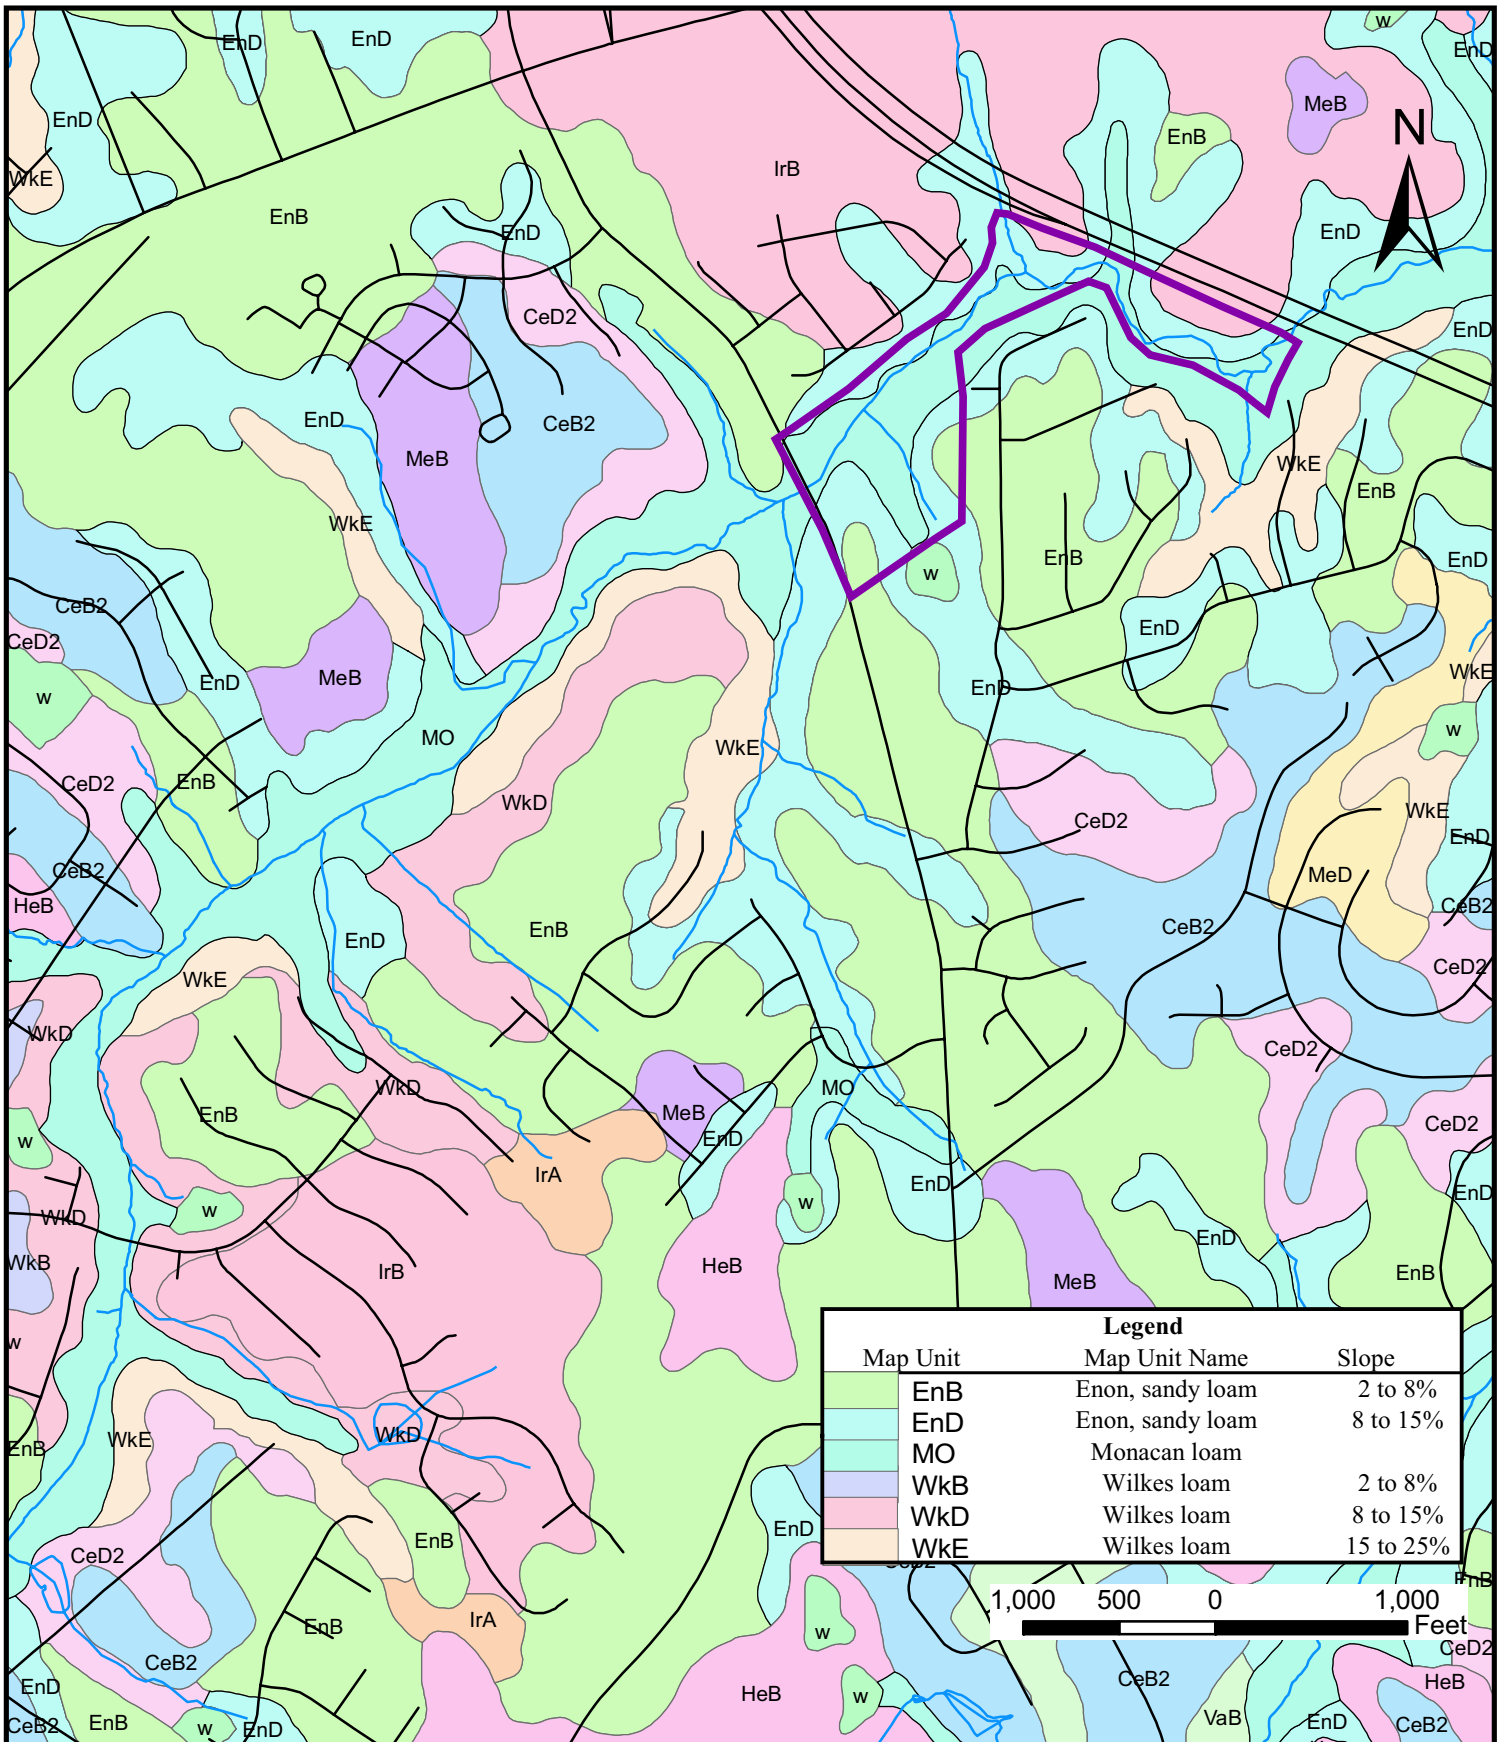
Figure III. SOIL MAP
 Back Creek Stream Restoration
 Mecklenburg County, NC
 Monitoring Report Year 1 of 5

Review of the *Soil Survey of Mecklenburg County, North Carolina* indicates that three soil series are found within the project limits. These soil series consist of Monacan, Enon, and Wilkes (Figure III). Monacan soils are very deep, well-drained to somewhat poorly drained soils found along stream corridors. These soils are formed in recent alluvium sediments of the Piedmont and Coastal Plain. Slopes are generally less than 2 percent. Enon soils are very deep, well-drained soils on ridges and side slopes of the Piedmont uplands. The soils are formed in clayey residuum weathered from mafic or intermediate igneous and metamorphic rocks such as diorite, gabbro, gneiss, and schist of the Piedmont uplands. Slopes range from 2 to 15 percent for the Enon series. Wilkes soils are shallow, well-drained soils adjacent to drainageways. They are formed in residuum weathered from intermediate and mafic crystalline rocks on the Piedmont uplands. Slopes range from 15 to 25 percent for the Wilkes series. Please refer to Table V for descriptions of the soil series within the project area.

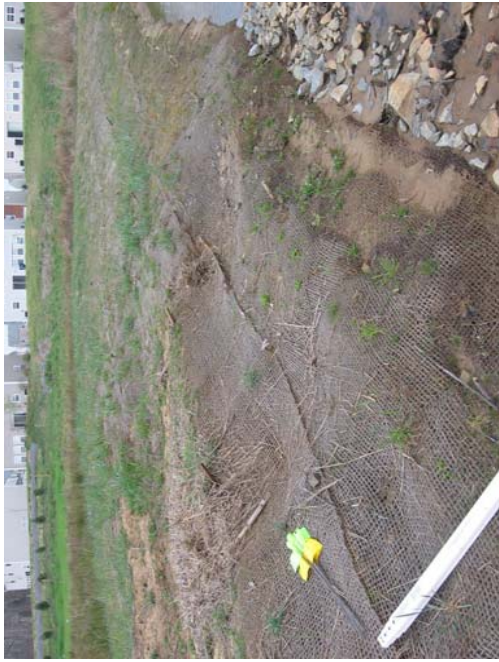
Feature Issue	Station Numbers	Probable Cause	Photo #
Bank erosion - moderate	3+05 - 3+20	Flood event	A2 - 1
	12+60 - 12+75	Flood event	
	14+70 - 15+20	Flood event	
Loose matting	14+55	Flood event	A2 - 2
Stream bank cover - moderate	4+30 - 4+50	Flood event	A2 - 3
Stream bank cover - poor	35+00-35+50	Flood event	
Mortality rate is 46% in Vegetation Monitoring Plots	All Plots	Saplings appear to be not rooting due to shallow planting depth, soil compaction, or nutrient poor soil conditions	A2 - 4

1. Bank Erosion: Moderate – Flood Event

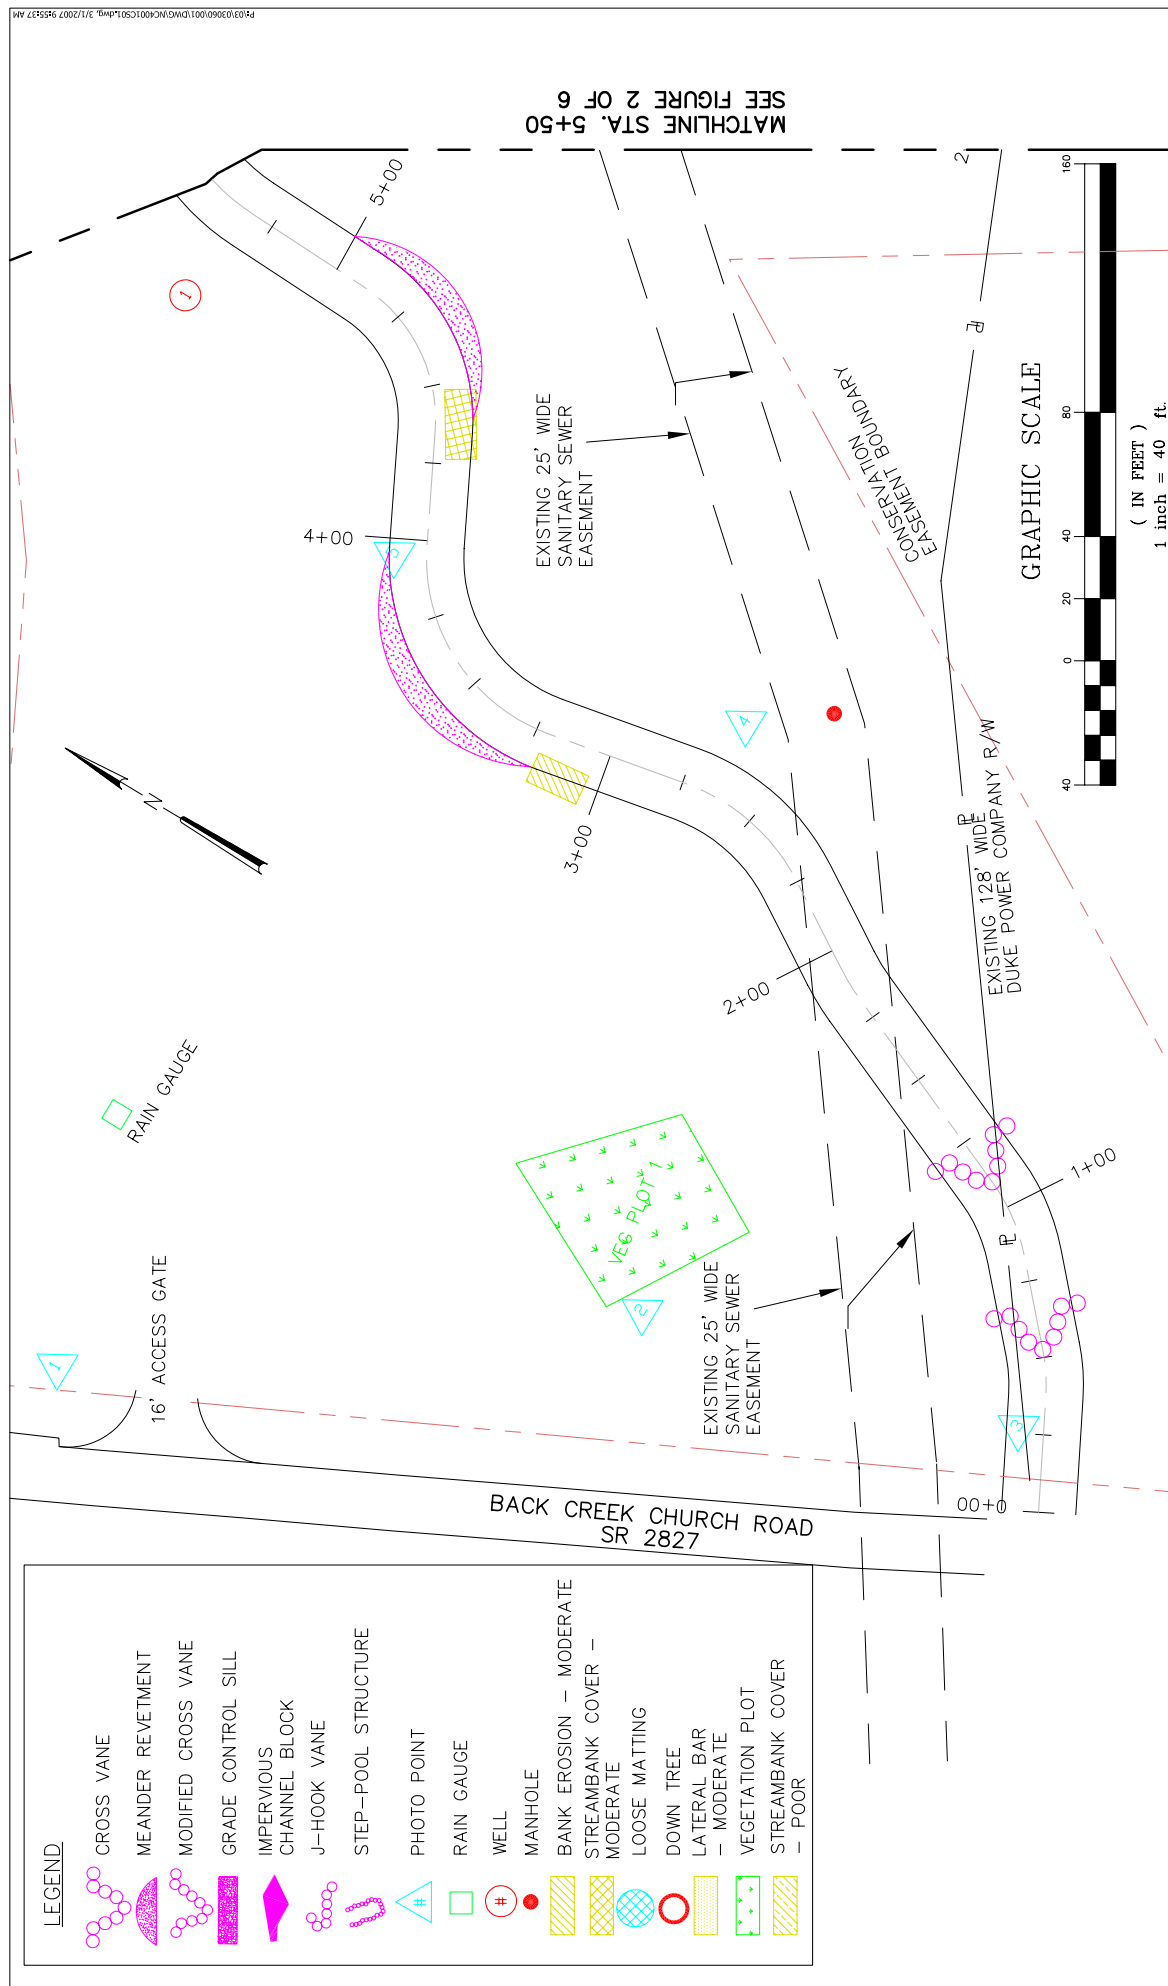
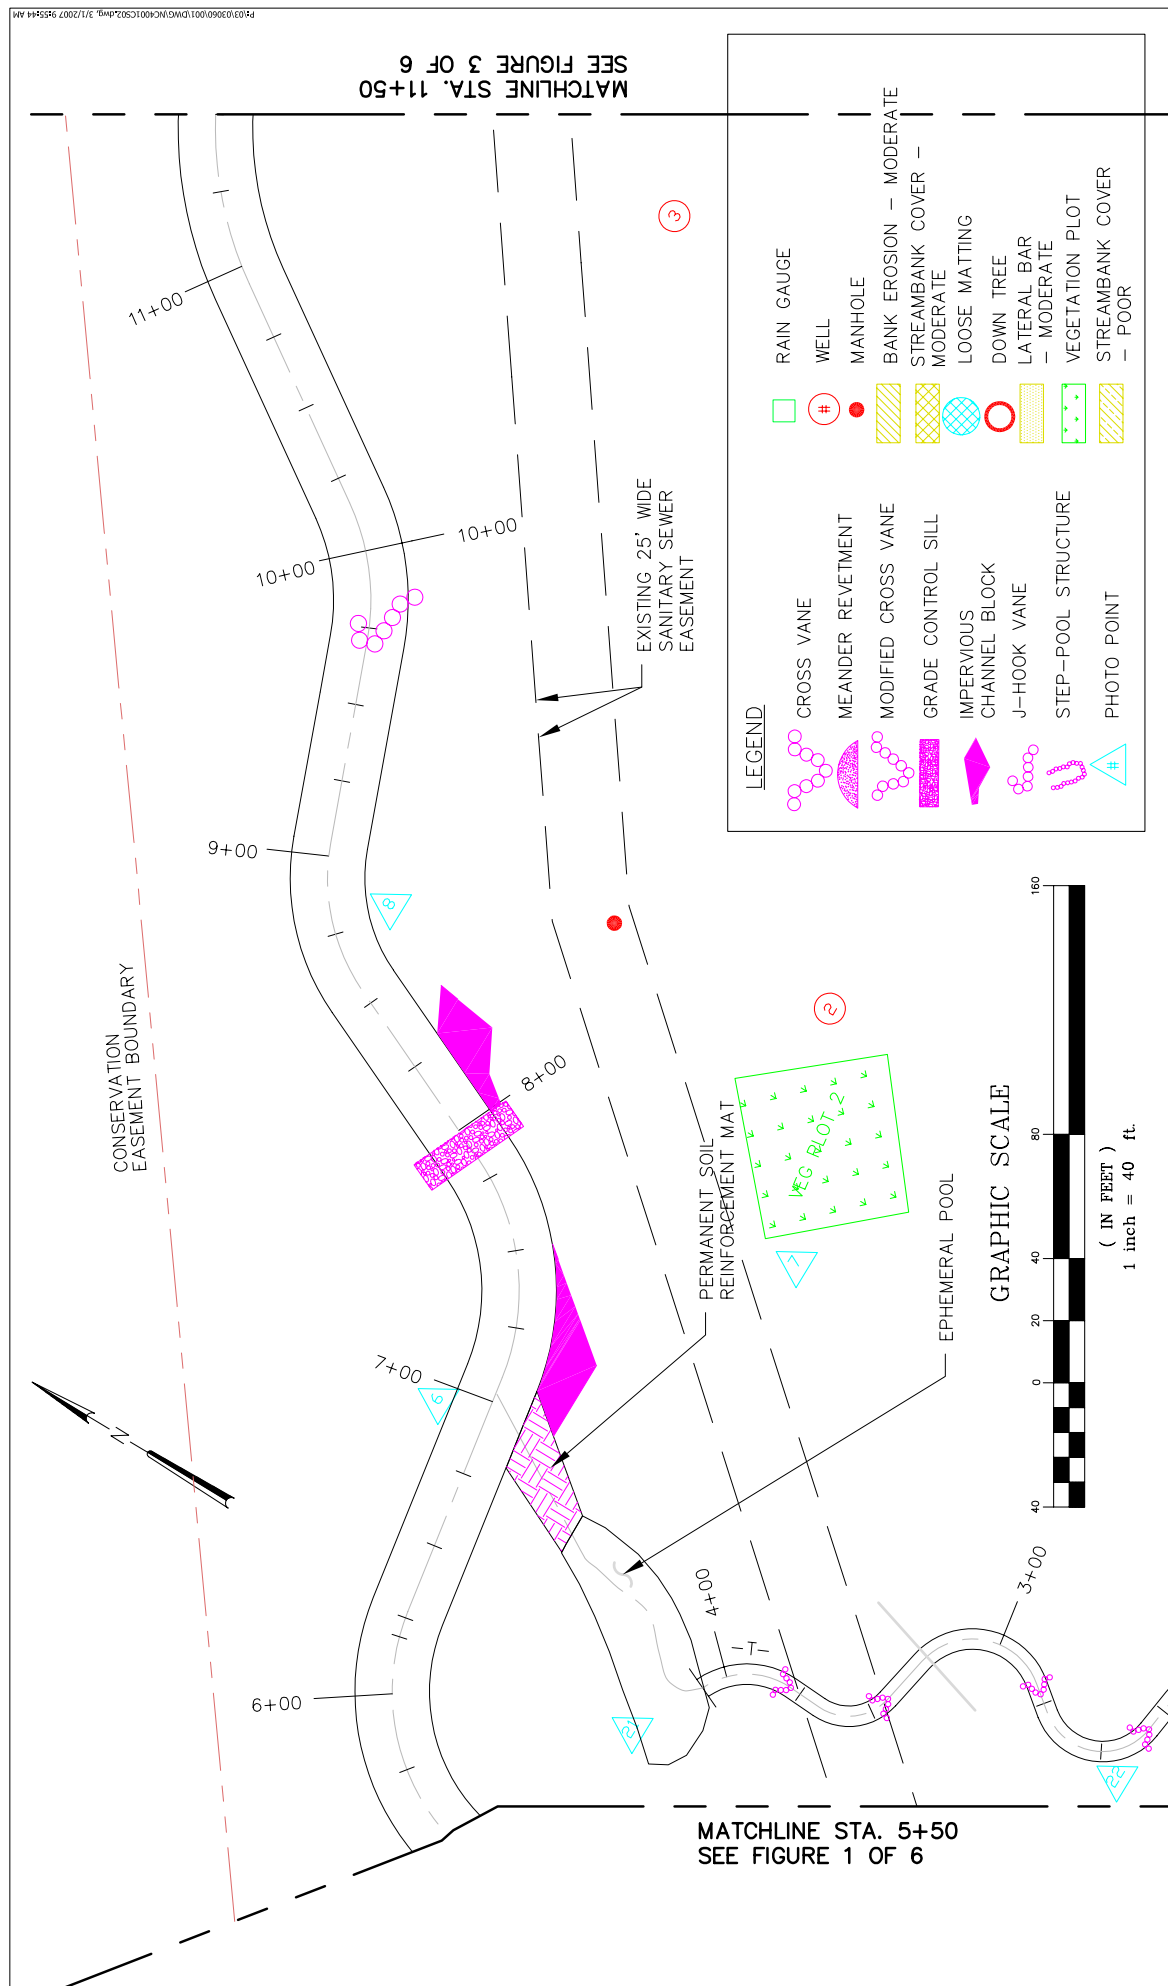
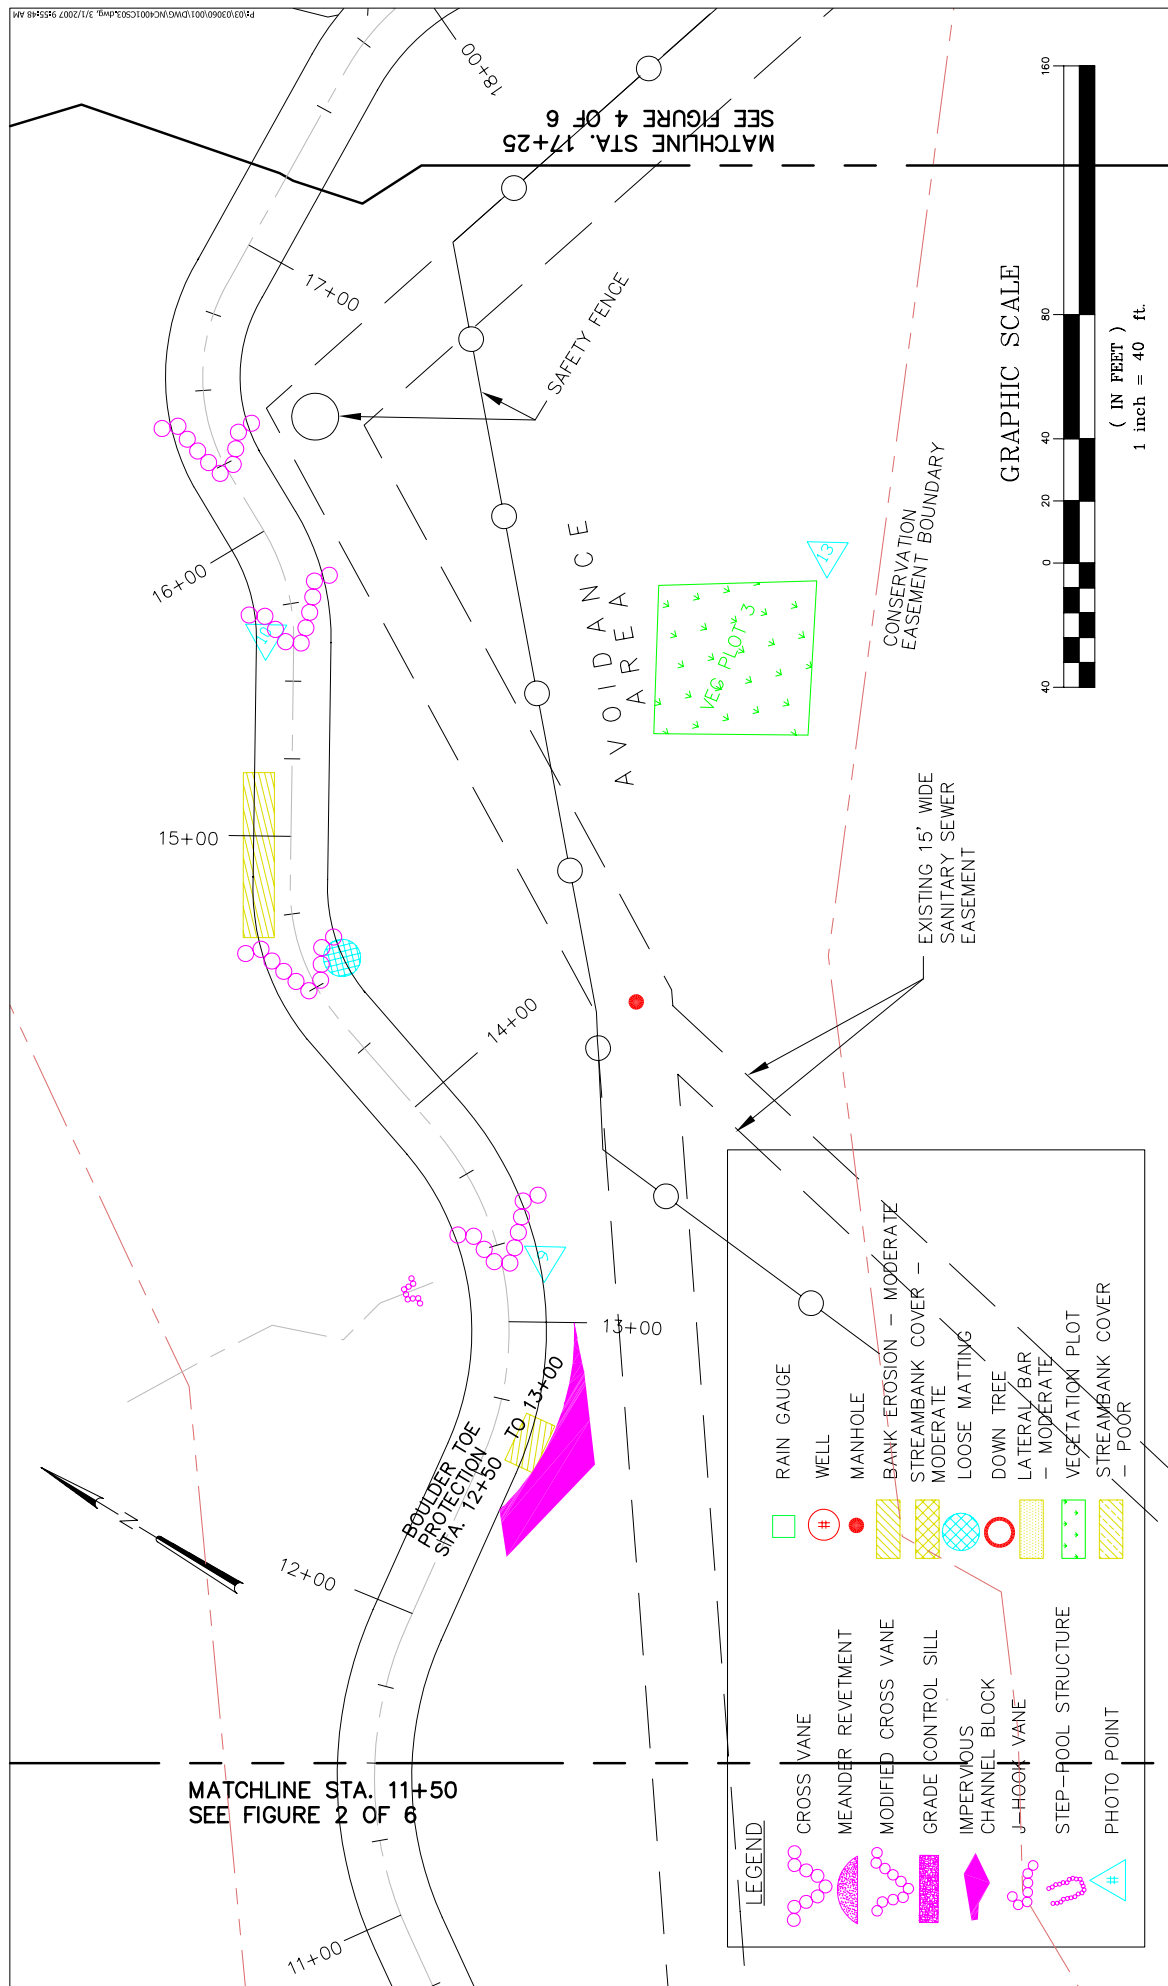
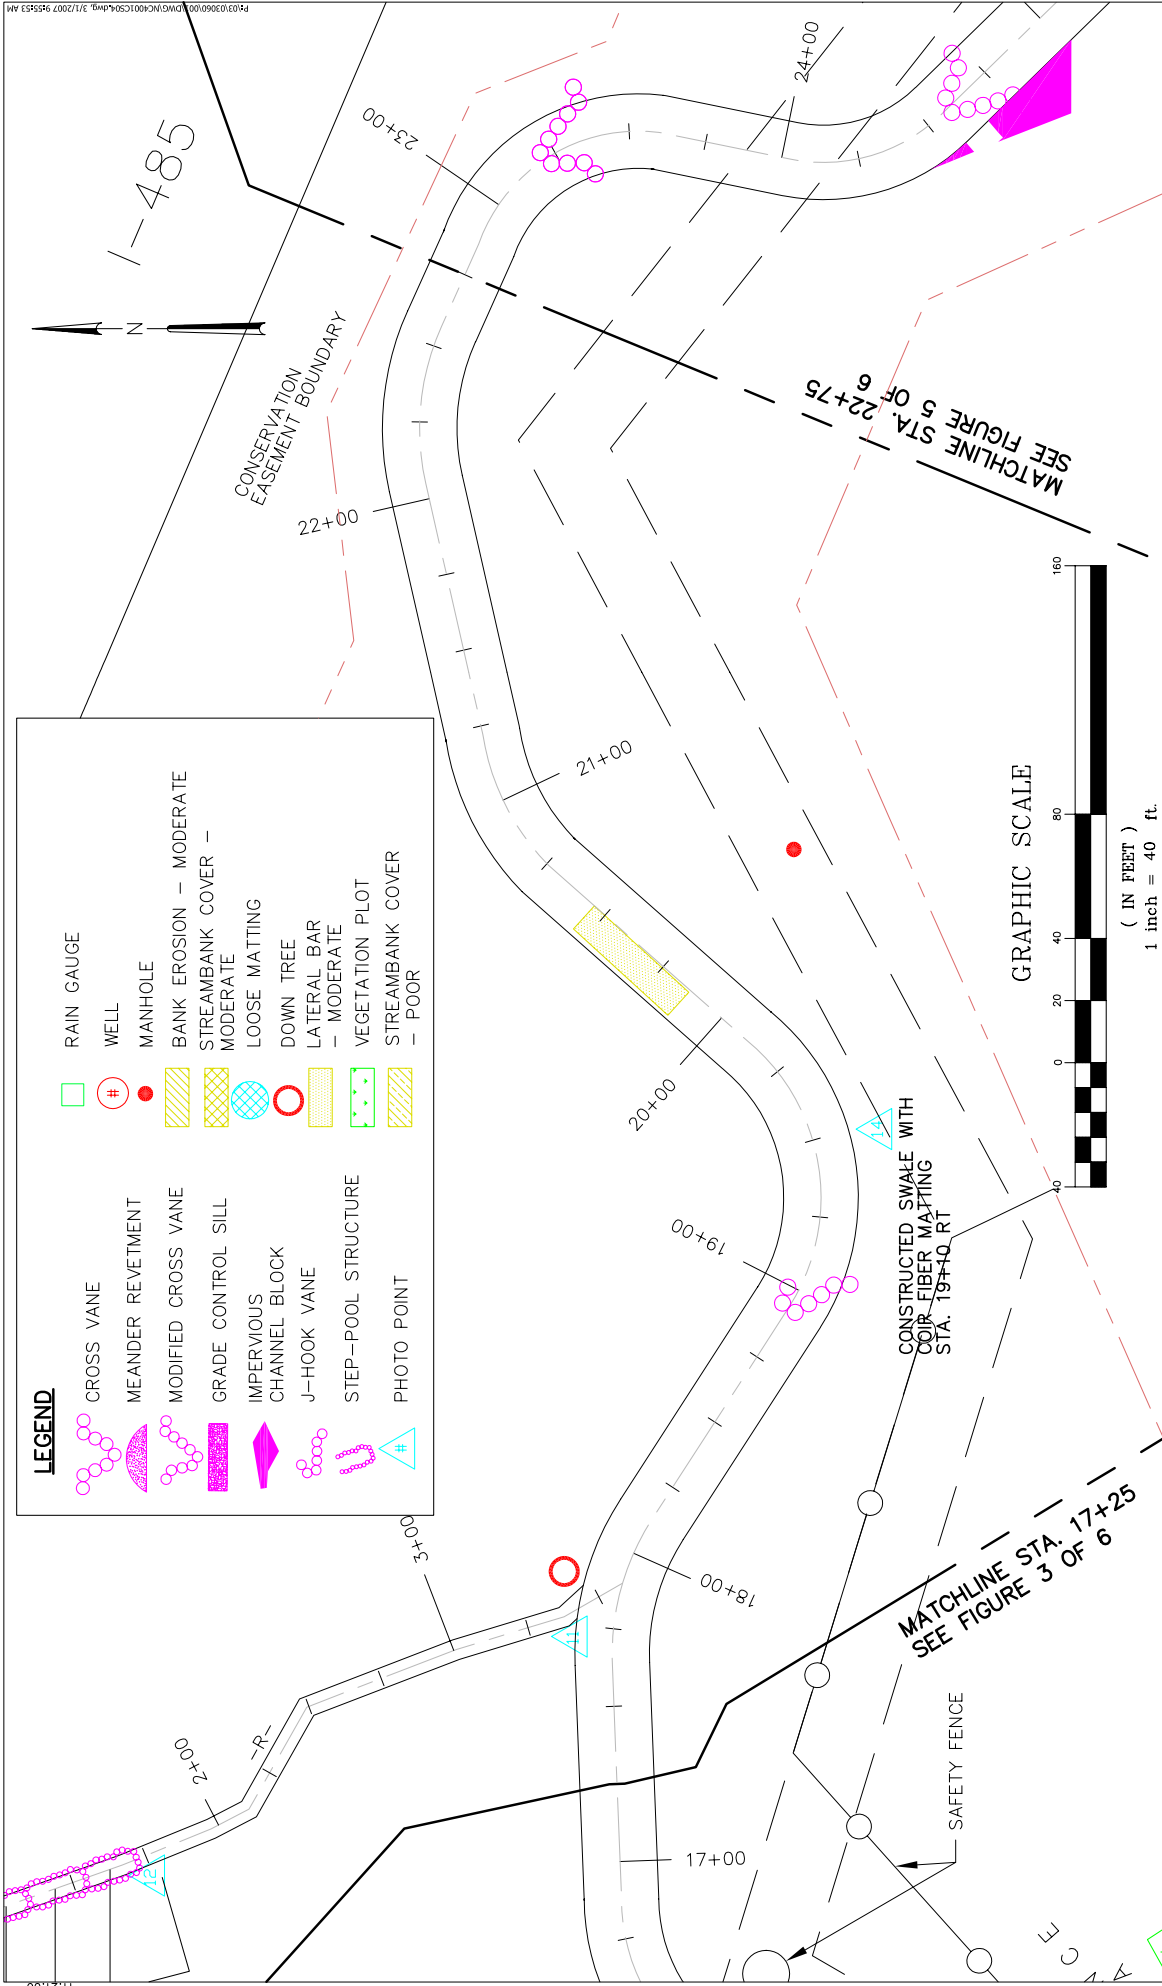
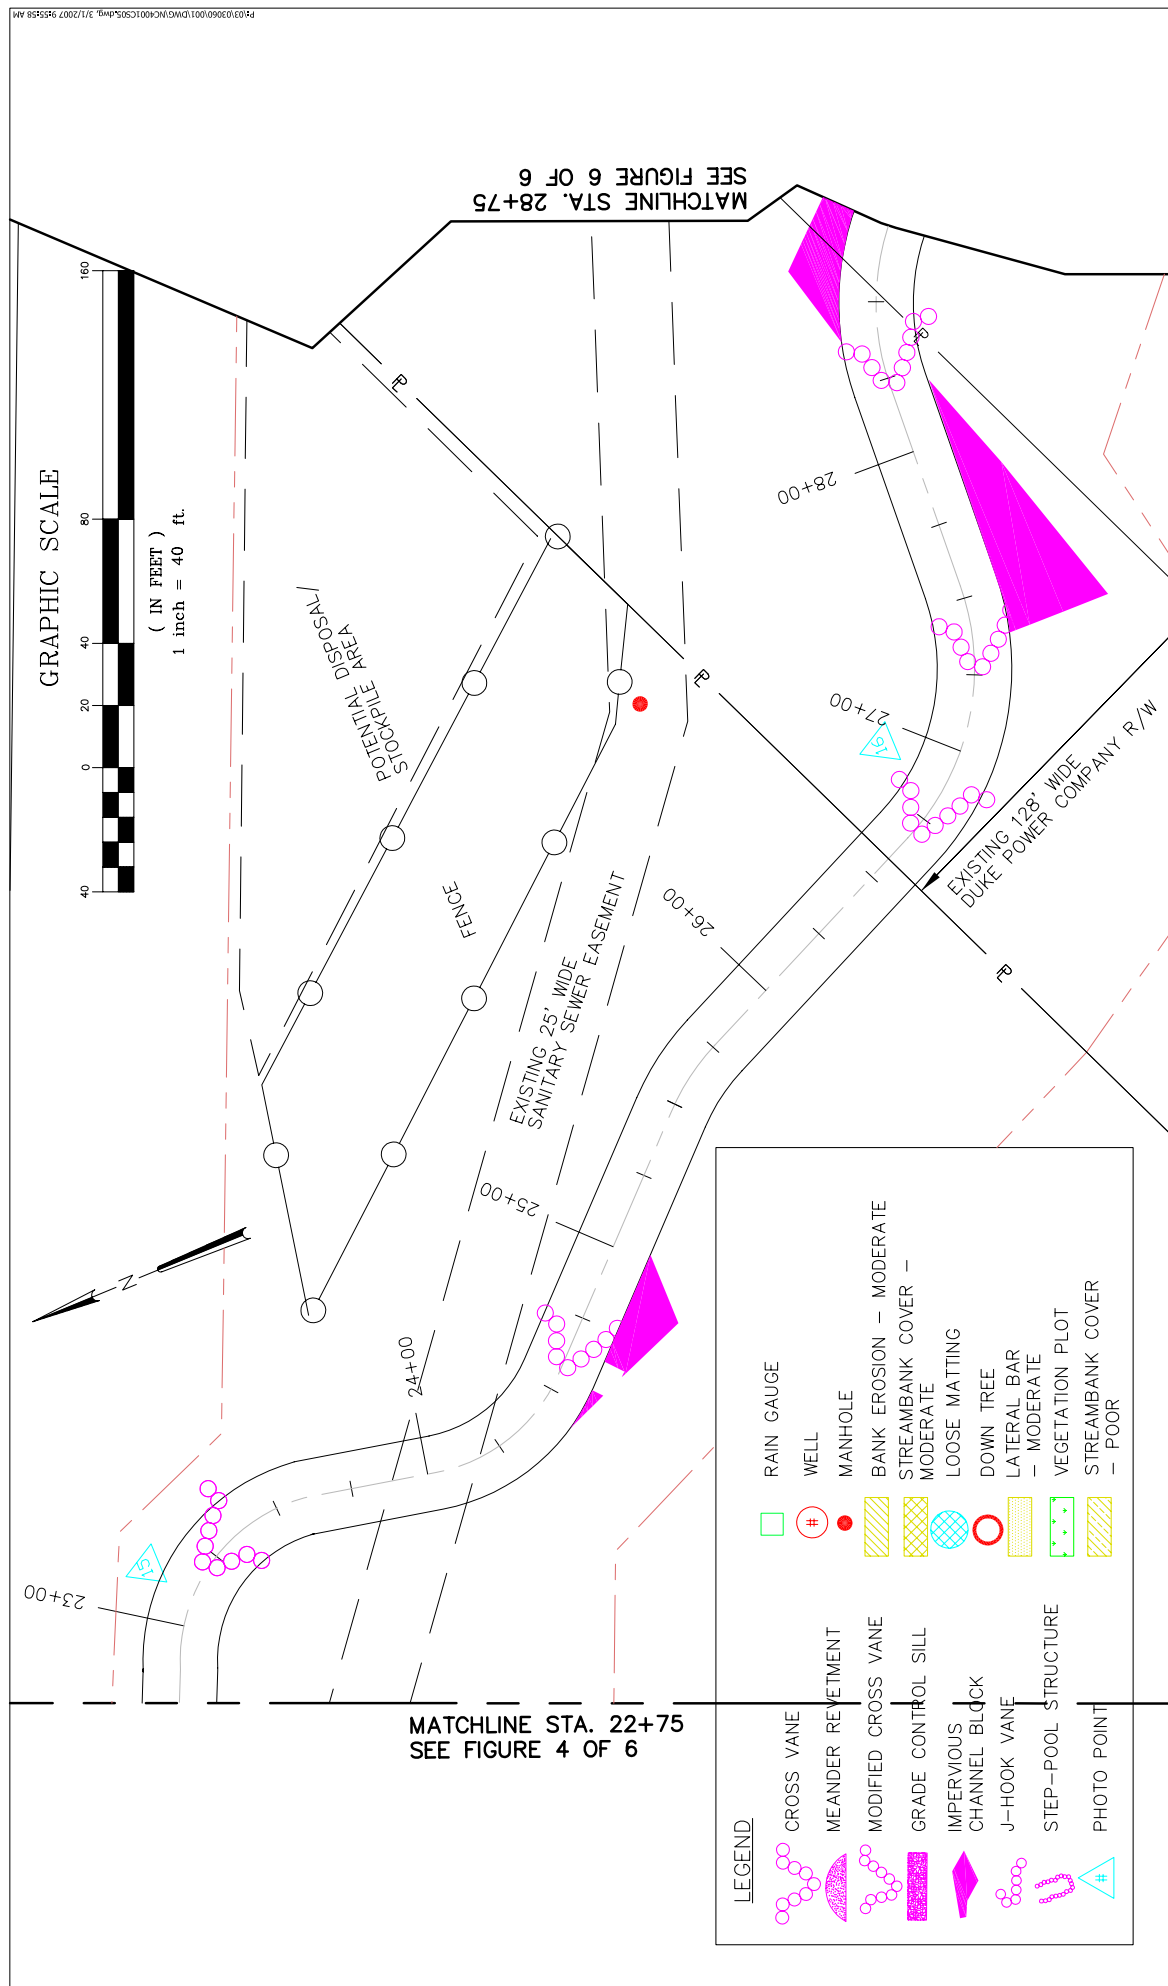
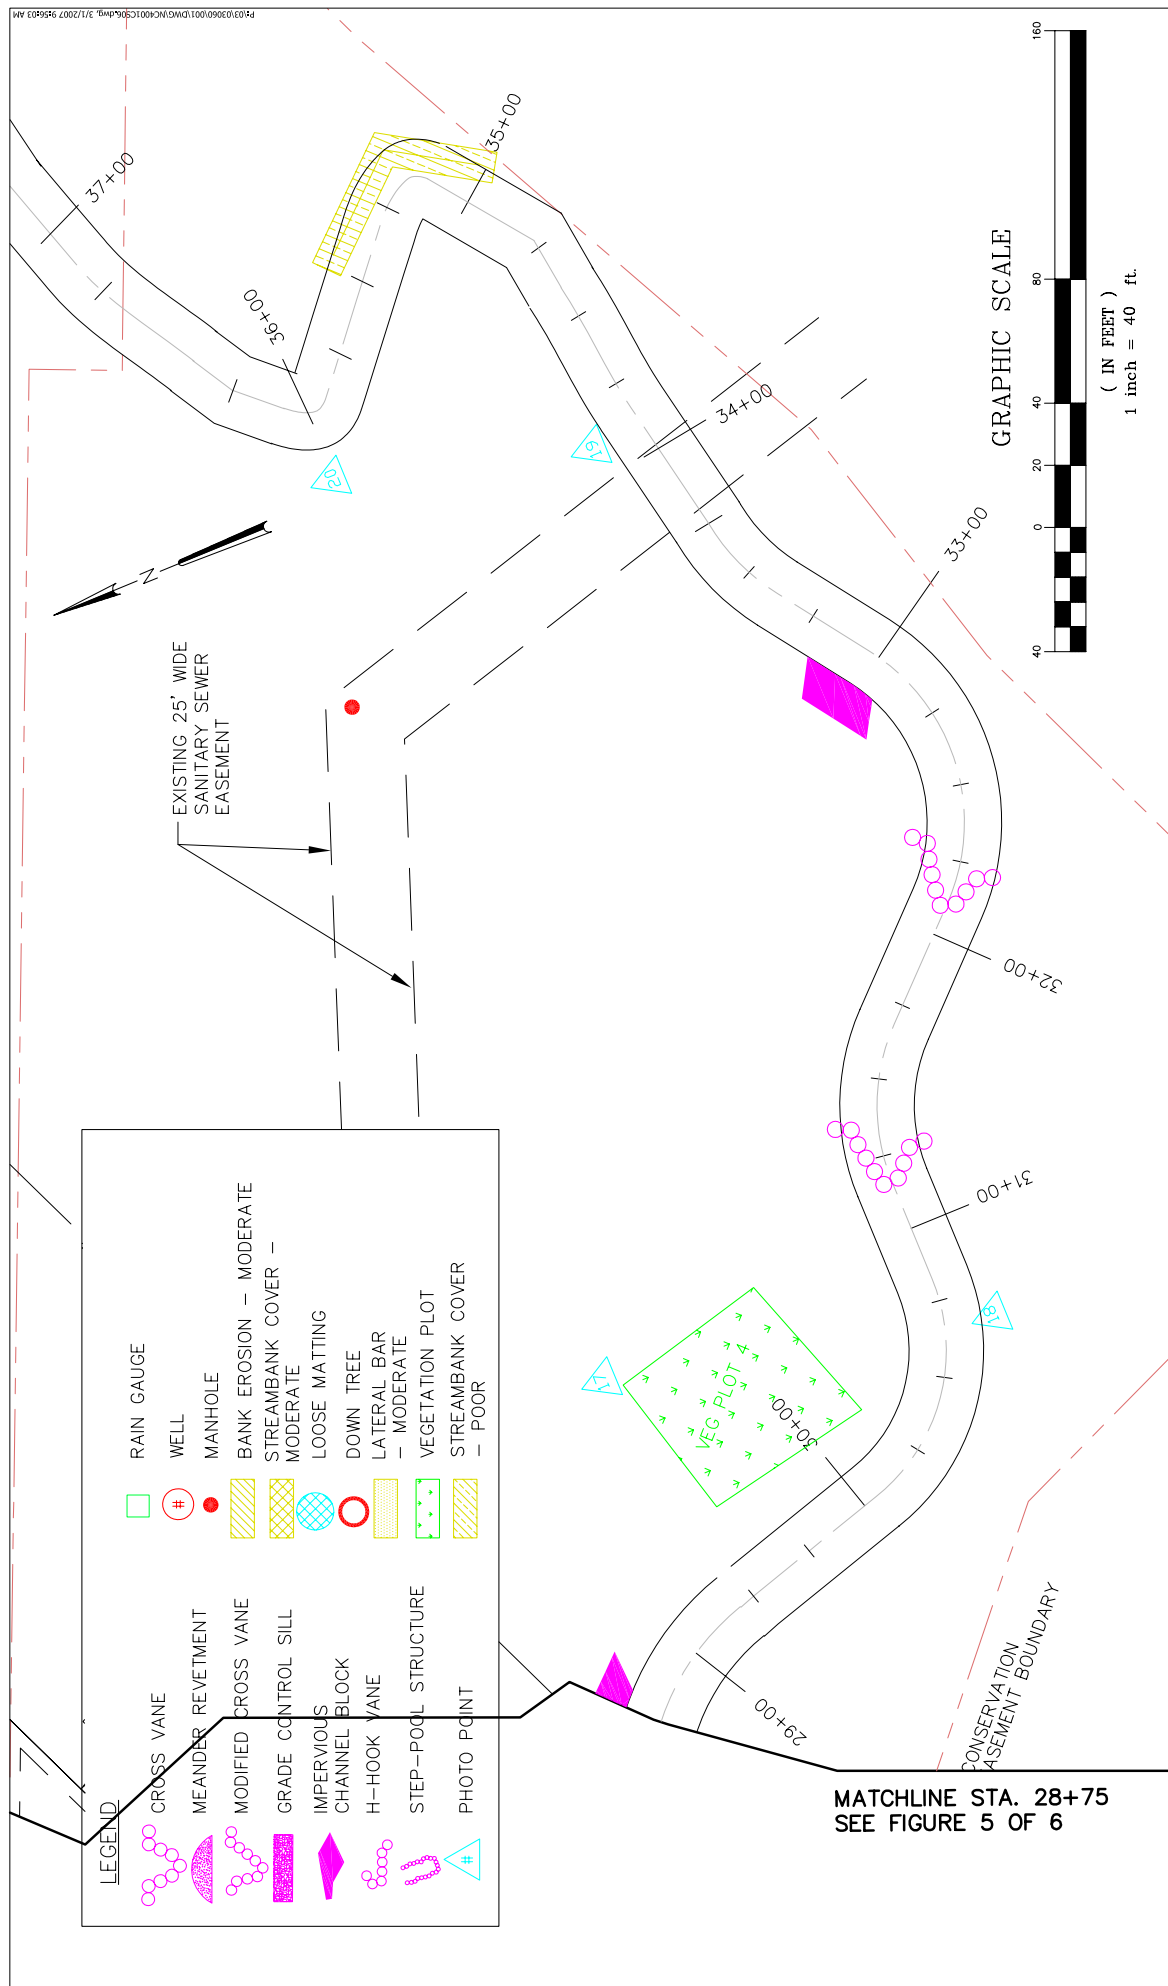
DATE : MARCH 2007
SCALE : 1"=40'
JOB NO.: 03060-001
APPENDIX B1
PROBLEM AREAS PLAN VIEW
FIGURE 1 OF 6

Back Creek/Project No.17				
Feature Issue	Reach	Station Numbers	Suspected Cause	Photo ID
Bank erosion - moderate	Main	3+05 - 3+20	Eroding under matting - LB	1
	Main	12+60 - 12+75	Toe protection slightly undermined - TOB/RB	
	Main	14+70 - 15+20	Eroding under matting - LB	
Down Tree	Main	17+85	Down tree from stream bank - potential for debris jam	2
Lateral bar	Main	20+20 - 20+60	Overwidened channel - lateral bar forming - LB	3
Loose matting	Main	14+55	Stakes protruding causing loose matting	4
Stream bank cover - moderate	Main	4+30 - 4+50	Stream bank near waters edge needs matting/staking - RB	5
Stream bank cover - poor	Main	35+00 - 35+50	Bare bank needs coverage - RB	
Mortality rate approx. 50% in Vegetation Plots	Main	NA	Saplings appear to be not rooting due to shallow planting depth	N/A

- There are a few areas of moderate erosion under the stream bank matting. However, once vegetation is established, these areas may be less noticeable and will likely not result in instability. If possible, these areas should be stabilized with riparian vegetation.
- Since completion of construction, one medium-sized cedar tree has fallen into the stream below the convergence of the tributary that was restored as a B-channel. Over time, this tree will likely catch debris.
- One area of bare bank was observed at the downstream end of the project. Access may have prevented completion of matting in this area.

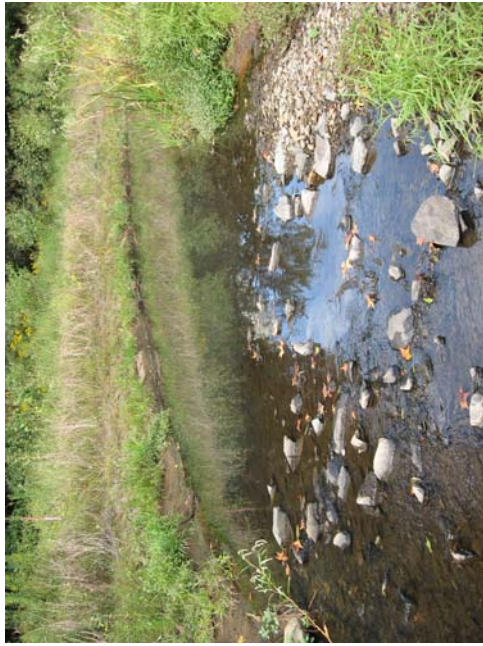
Cross-Section #7 Riffle: Upstream

Photos taken during the stream assessment conducted in September 2006

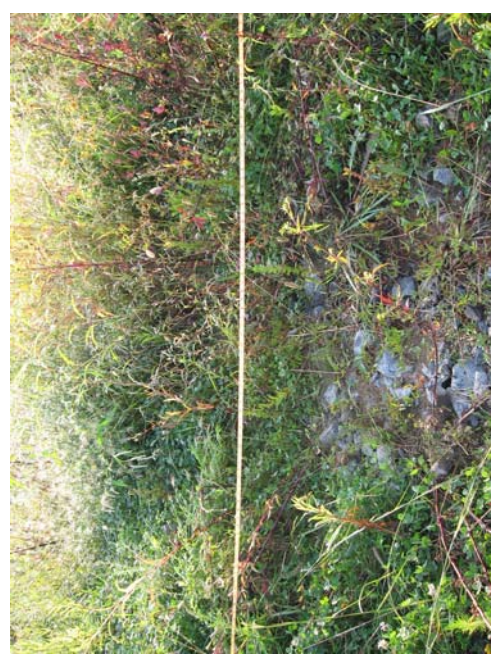
Cross-Section #8 Riffle: Upstream

Photos taken during the stream assessment conducted in September 2006
