Back Creek Stream and Wetland Restoration

Project No. 17

2007 Monitoring Report (Final): Year 2 of 5

March 2008

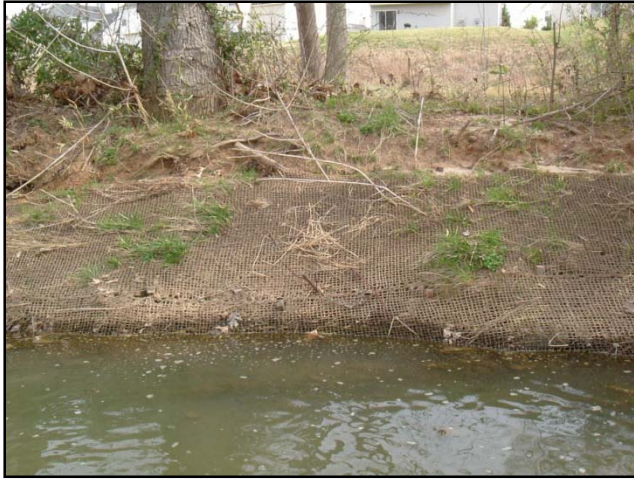
*Photos 1 and 2 illustrate poor vegetation associated with bank erosion

1. Bank Erosion: Moderate
3/22/2007

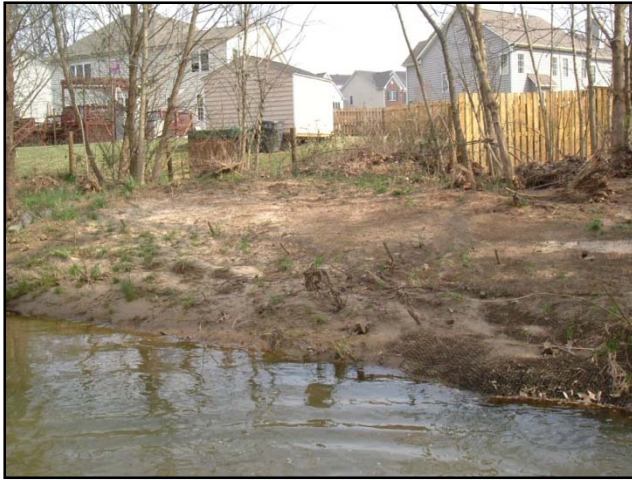
7. Stream Bank Cover Poor
3/22/2007
