Back Creek Stream and Wetland Restoration

Project No. 17

2008 Monitoring Report (Final): Year 3 of 5

March 2009

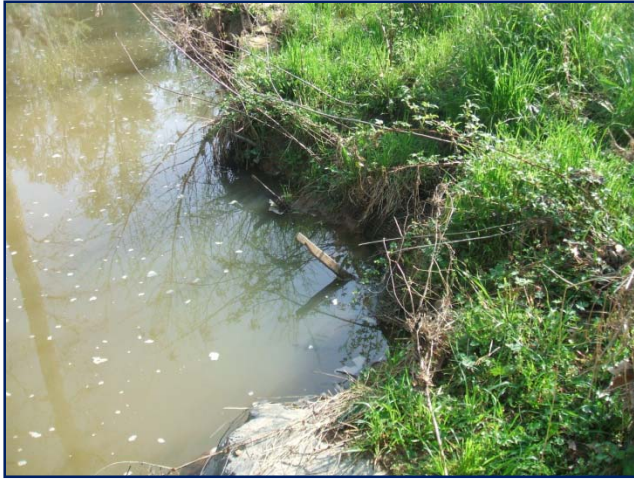
1. Bank Erosion: Moderate (4/2008)
