**Back Creek Stream and Wetland Restoration
EEP Project No. 17
2010 Monitoring Report: Year 5 of 5**

**Construction Completed: December 2005
Submission Date: February 2011**

Jordan, Jones and Goulding
309 East Morehead Street, Suite 110
Charlotte, NC 28202

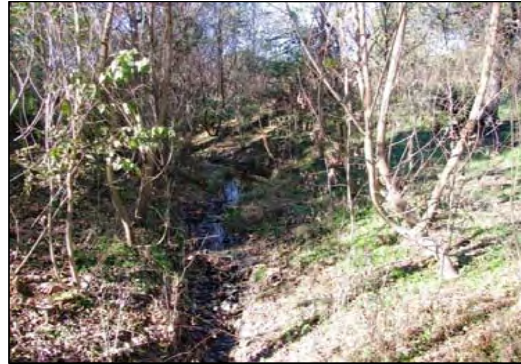
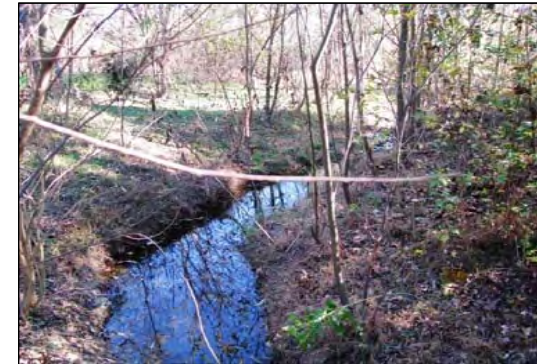
XS-9: View Upstream

The tributary appears to be maintaining its proposed function as a B-type storm drain channel. There are some areas with minor bank erosion, but no structural failure is occurring along this reach. Cross-section 9, which is located midway along the tributary has remained vertically and laterally stable. Minor sediment deposition occurred in 2010, which resulted in a decrease in the cross-sections mean depth (1.04 ft) from previous monitoring year ranges (1.24-1.32 ft). The d50 and d84 particle size has decreased from 0.33 mm to 0.2 mm and 3.43 to 1.67, respectively. Most likely, these fine particles will be flushed with future rain events.

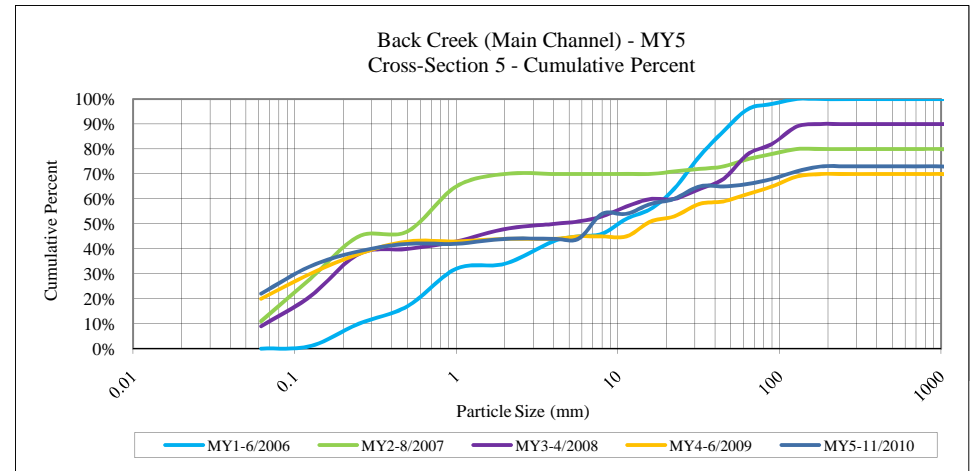
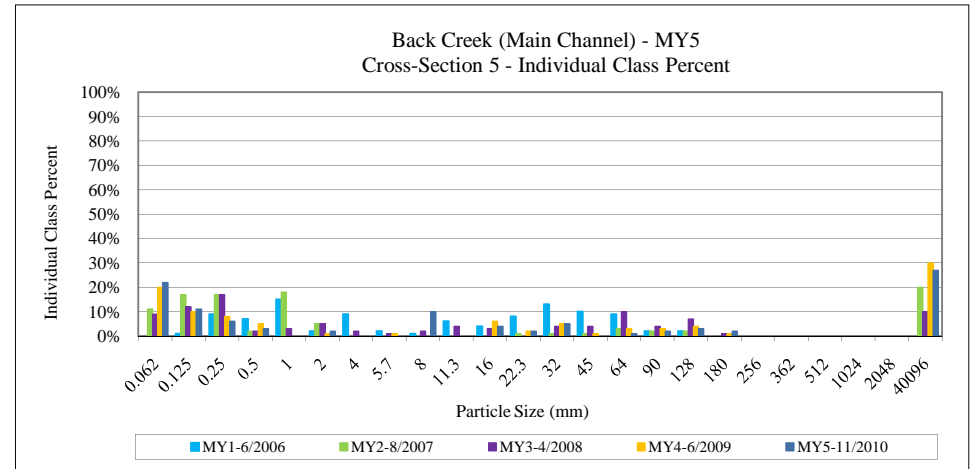
Project Name	Back Creek
EEP Project Number	17
Cross-Section ID	XS-5, Riffle, 19+73
Survey Date	11/2010

Description	Material	Size (mm)	Total #	Item %	Cum %
Silt/Clay	silt/clay	0.062	22	22%	22%
Sand	very fine sand	0.125	11	11%	11%
	fine sand	0.250	6	6%	6%
	medium sand	0.50	3	3%	3%
	coarse sand	1.00	0	0%	0%
	very coarse sand	2.0	2	2%	2%
Gravel	very fine gravel	4.0	0	0%	0%
	fine gravel	5.7	0	0%	0%
	fine gravel	8.0	10	10%	10%
	medium gravel	11.3	0	0%	0%
	medium gravel	16.0	4	4%	4%
	course gravel	22.3	2	2%	2%
	course gravel	32.0	5	5%	5%
	very coarse gravel	45	0	0%	0%
	very coarse gravel	64	1	1%	1%
Cobble	small cobble	90	2	2%	2%
	medium cobble	128	3	3%	3%
	large cobble	180	2	2%	2%
	very large cobble	256	0	0%	0%
Boulder	small boulder	362	0	0%	0%
	small boulder	512	0	0%	0%
	medium boulder	1024	0	0%	0%
	large boulder	2048	0	0%	0%
Bedrock	bedrock	40096	27	27%	27%
TOTAL % of whole count			100	100%	100%

Summary Data	
D50	7.08
D84	Bedrock
D95	Bedrock

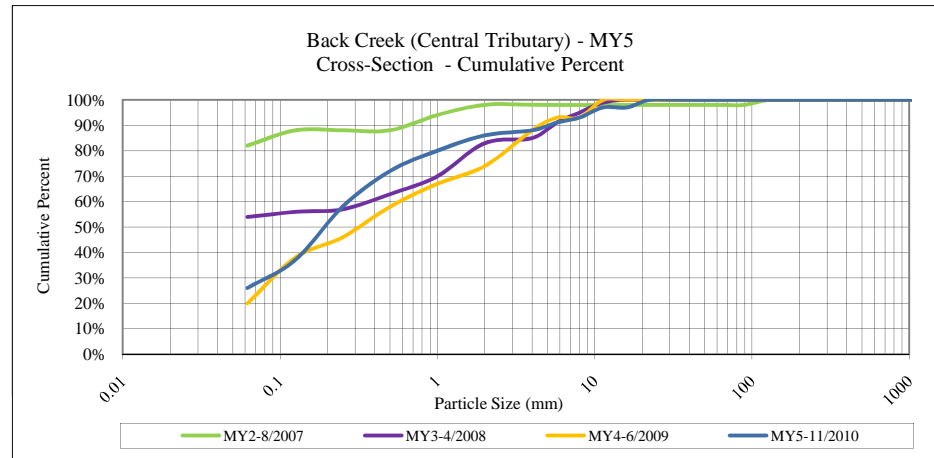
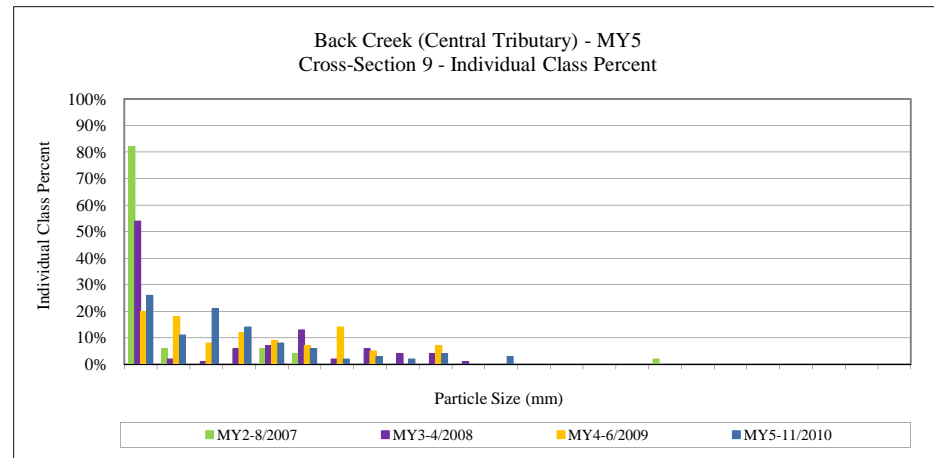
Project Name	Back Creek MY5
EEP Project Number	17
Cross-Section ID	XS-9, Riffle
Survey Date	11/2010

Description	Material	Size (mm)	Total #	Item %	Cum %
Silt/Clay	silt/clay	0.062	22	22%	22%
Sand	very fine sand	0.125	15	15%	15%
	fine sand	0.250	11	11%	11%
	medium sand	0.50	10	10%	10%
	coarse sand	1.00	8	8%	8%
	very coarse sand	2.0	10	10%	10%
Gravel	very fine gravel	4.0	12	12%	12%
	fine gravel	5.7	3	3%	3%
	fine gravel	8.0	2	2%	2%
	medium gravel	11.3	4	4%	4%
	medium gravel	16.0	0	0%	0%
	course gravel	22.3	3	3%	3%
	course gravel	32.0	0	0%	0%
	very coarse gravel	45	0	0%	0%
	very coarse gravel	64	0	0%	0%
Cobble	small cobble	90	0	0%	0%
	medium cobble	128	0	0%	0%
	large cobble	180	0	0%	0%
	very large cobble	256	0	0%	0%
Boulder	small boulder	362	0	0%	0%
	small boulder	512	0	0%	0%
	medium boulder	1024	0	0%	0%
	large boulder	2048	0	0%	0%
Bedrock	bedrock	40096	0	0%	0%
TOTAL % of whole count			100	100%	100%

Summary Data	
D50	0.2
D84	1.67
D95	9.65

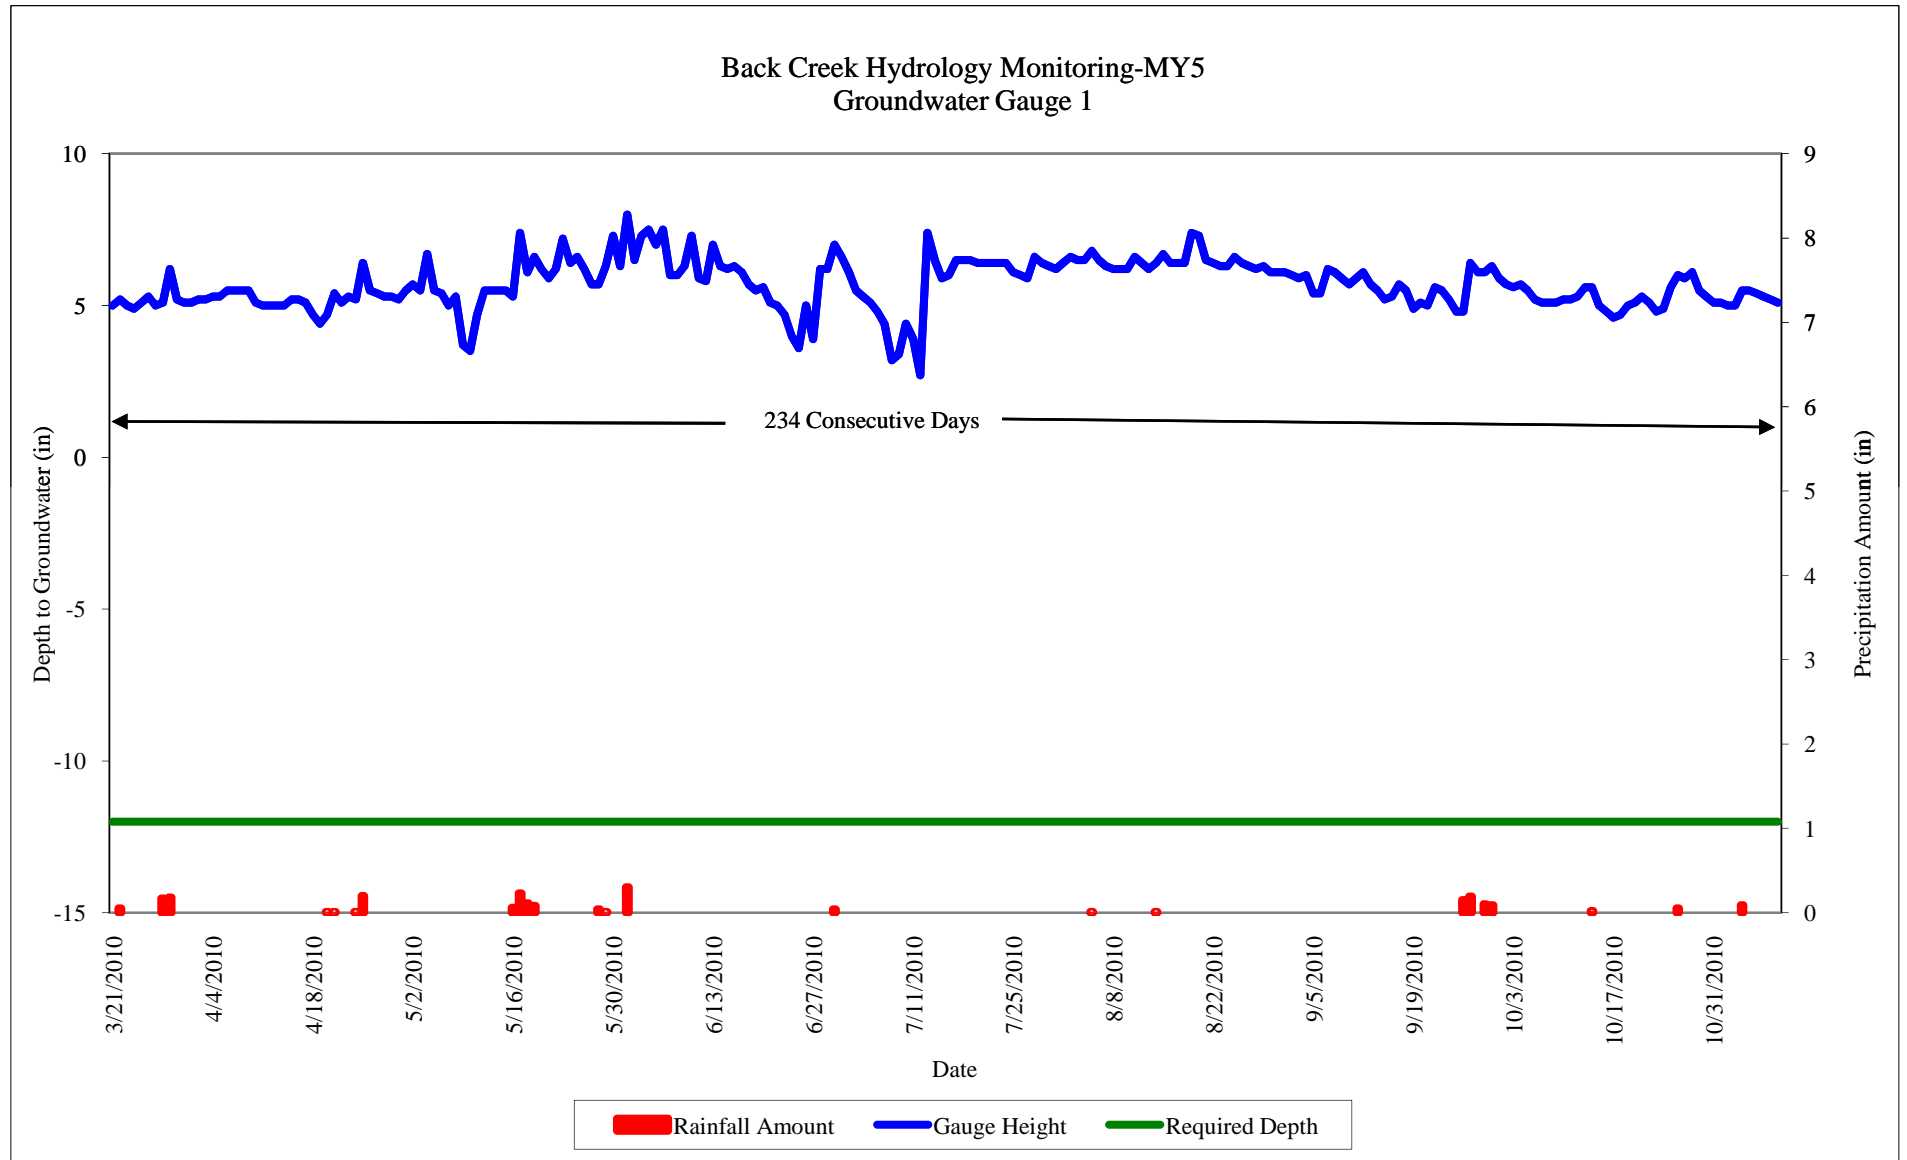
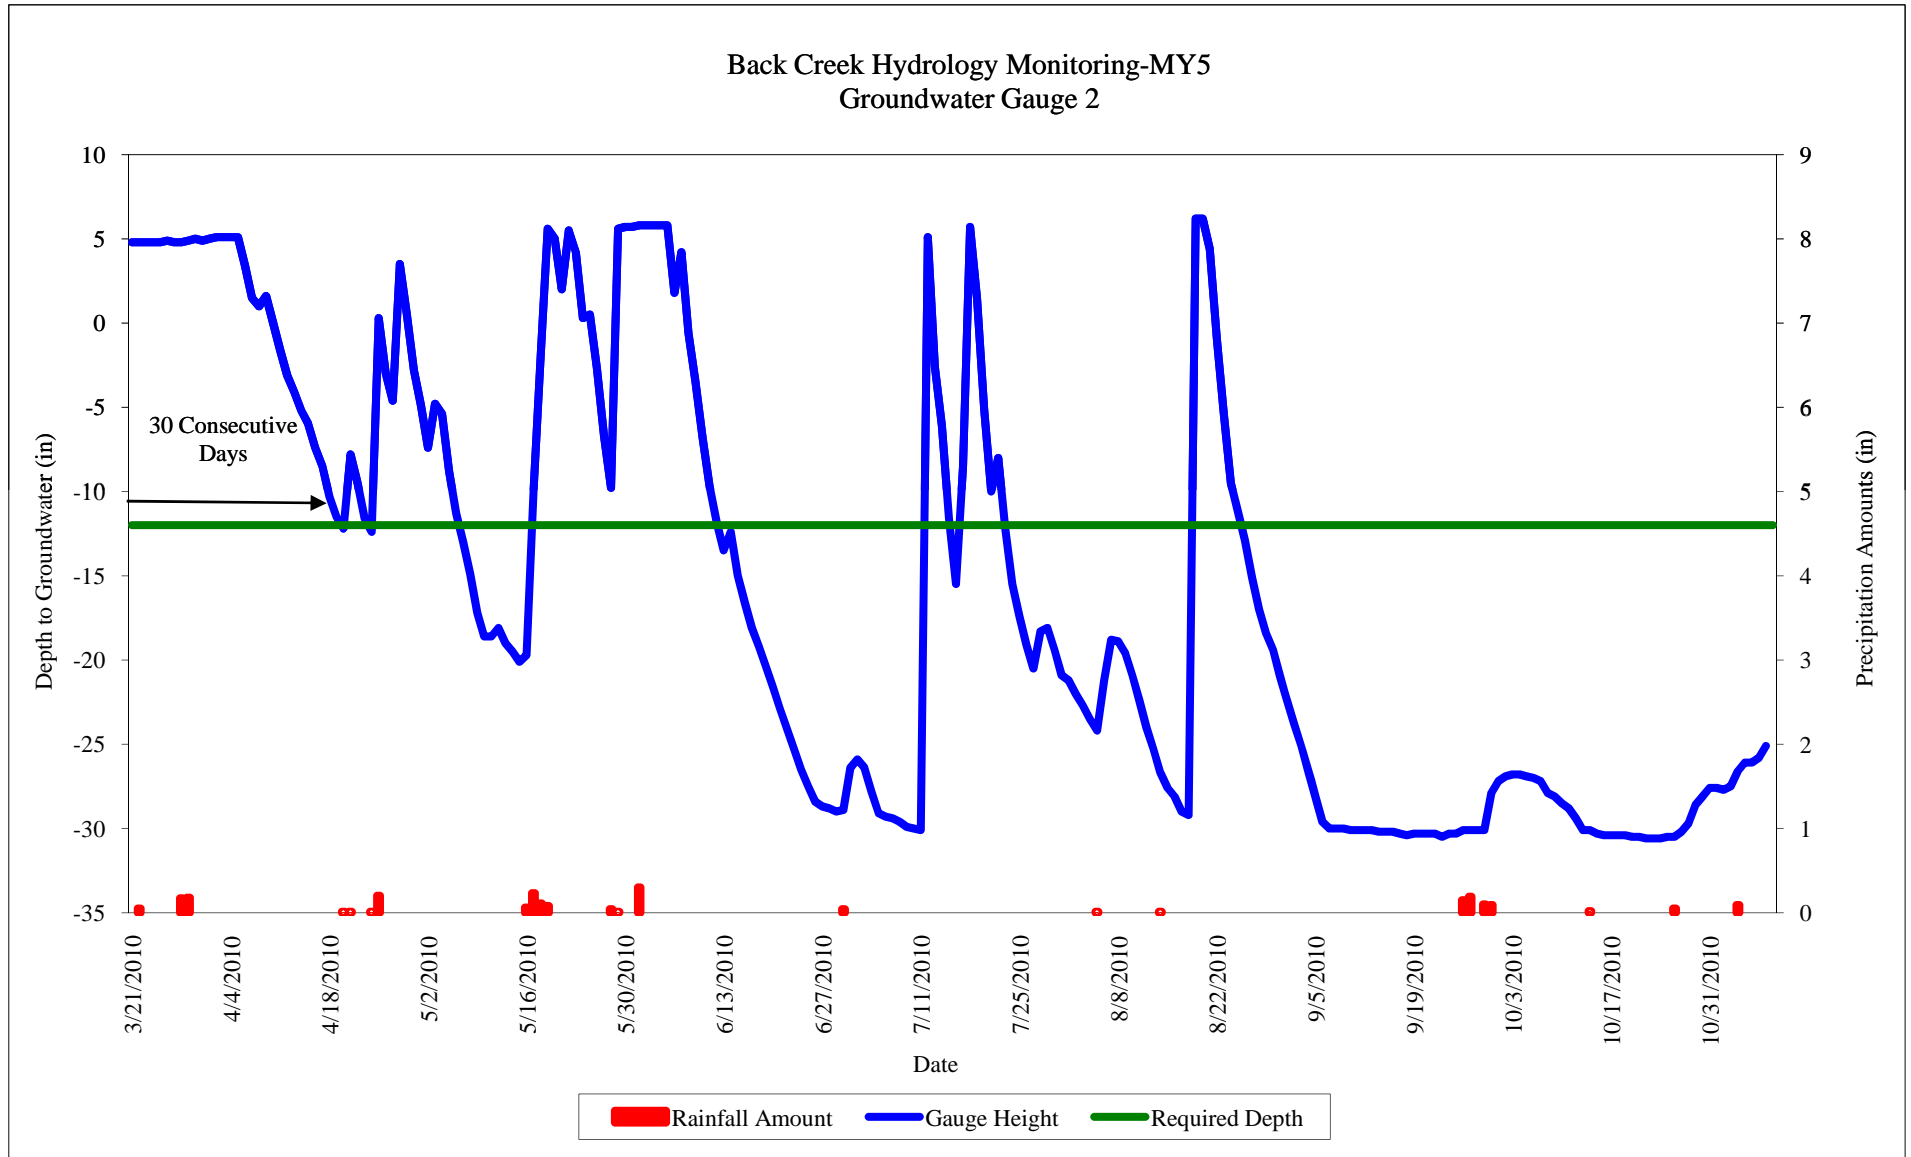
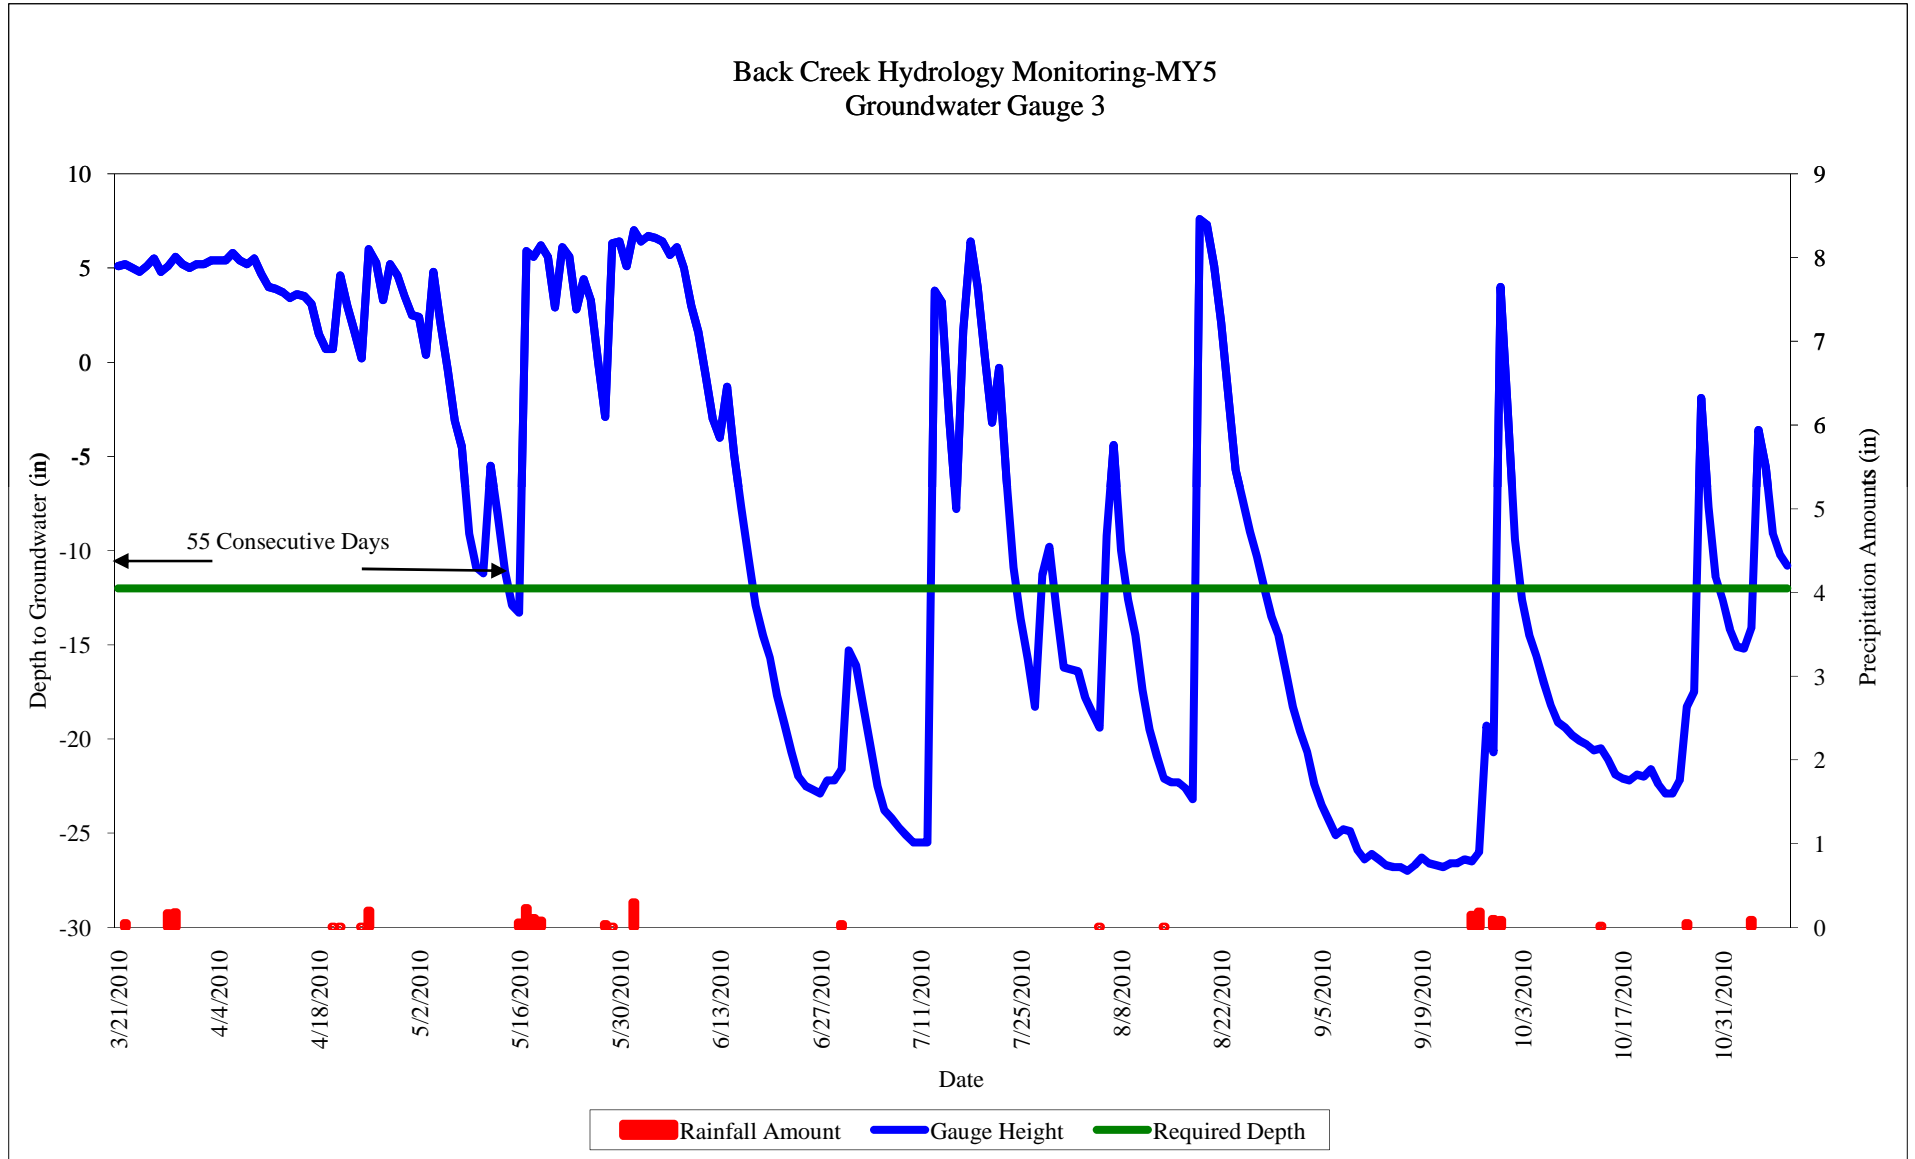
Appendix 5.1 Precipitation - Water Level Plots for Gauges
Back Creek Stream and Wetland Restoration/EEP Project No. 17
Monitoring Year 5 of 5

All gauges on-site achieved the wetland success criterion of soil saturation within the upper 12 inches for 30 consecutive days during the growing season. There were no problem areas observed within the wetland restoration zones for the Site. Within the wetland zones, hydrophytic vegetation and hydrology indicators have developed. In some areas, the appropriate soil chroma has also developed. It is suspected that these areas may have already had hydric conditions present. Hydrophytic vegetation consists of a thick herbaceous layer of sedge species (*Carex* spp.), rush species (*Juncus* spp.), bulrush species (*Scirpus* spp.), spotted touch-me-not (*Impatiens capensis*), and smartweed species (*Polygonum* spp.). The general success of hydrology within the wetland restoration zones is adequate to meet success requirements. Surface inundation to ground saturation was observed throughout the site; therefore, appropriate hydrological condition for the wetland zones appears to be present. Please refer to Appendix 5 for wetland plots and a summary of the wetland criteria attainment.

Summary of Groundwater Gauge Results for Years 1 through 5					
Gauge	Success Criteria Achieved/Max Consecutive Days During Growing Season (Percentage %)				
	Year 1 (2006)	Year 2 (2007)	Year 3 (2008)	Year 4 (2009)	Year 5 (2010)
GW1	Yes/241 Days (100%)	Yes/142 Days (59%)	Yes/241 Days (100%)	Yes/241 Days (100%)	Yes/234 Days (100%)
GW2	Yes/40 Days (17%)	Yes/58 Days (24%)	Yes/67 Days (28%)	Yes/96 Days (40%)	Yes/30 Days (38%)
GW3	Yes/103 Days (43%)	Yes/64 Days (27%)	Yes/83 Days (34%)	Yes/100 Days (42%)	Yes/55 Days (53%)
