**Badin Inn  
Stream Restoration  
Stanly County, North Carolina  
Year 1 Monitoring Report**

Monitoring Year: 2010  
Measurement Year 1  
As-Built Date 2009  
NCEEP Project Number 92666

**May 2010**

**BADIN INN STREAM RESTORATION  
YEAR 1 MONITORING REPORT**

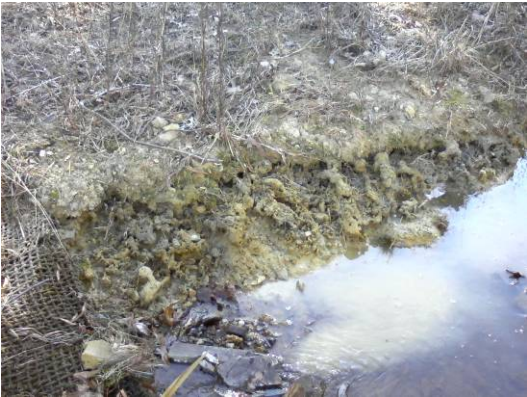
The stream remains in excellent condition. Only one small area of scour was observed during the Year 1 monitoring. Floodplain scour was noted in several locations and the possibility of a few overflow channels that were in the early stages of formation were the only problems observed along the stream and these problems were minor. Overall, the stream is remaining close to as-built morphology.

SPA 2. Bank scour.
