**Badin Inn
Stream Restoration
Stanly County, North Carolina
Year 2 Monitoring Report**

Monitoring Year: 2011
Measurement Year 2
As-Built Date 2009
NCEEP Project Number 92666

March 2011

**BADIN INN STREAM RESTORATION
YEAR 2 MONITORING REPORT**

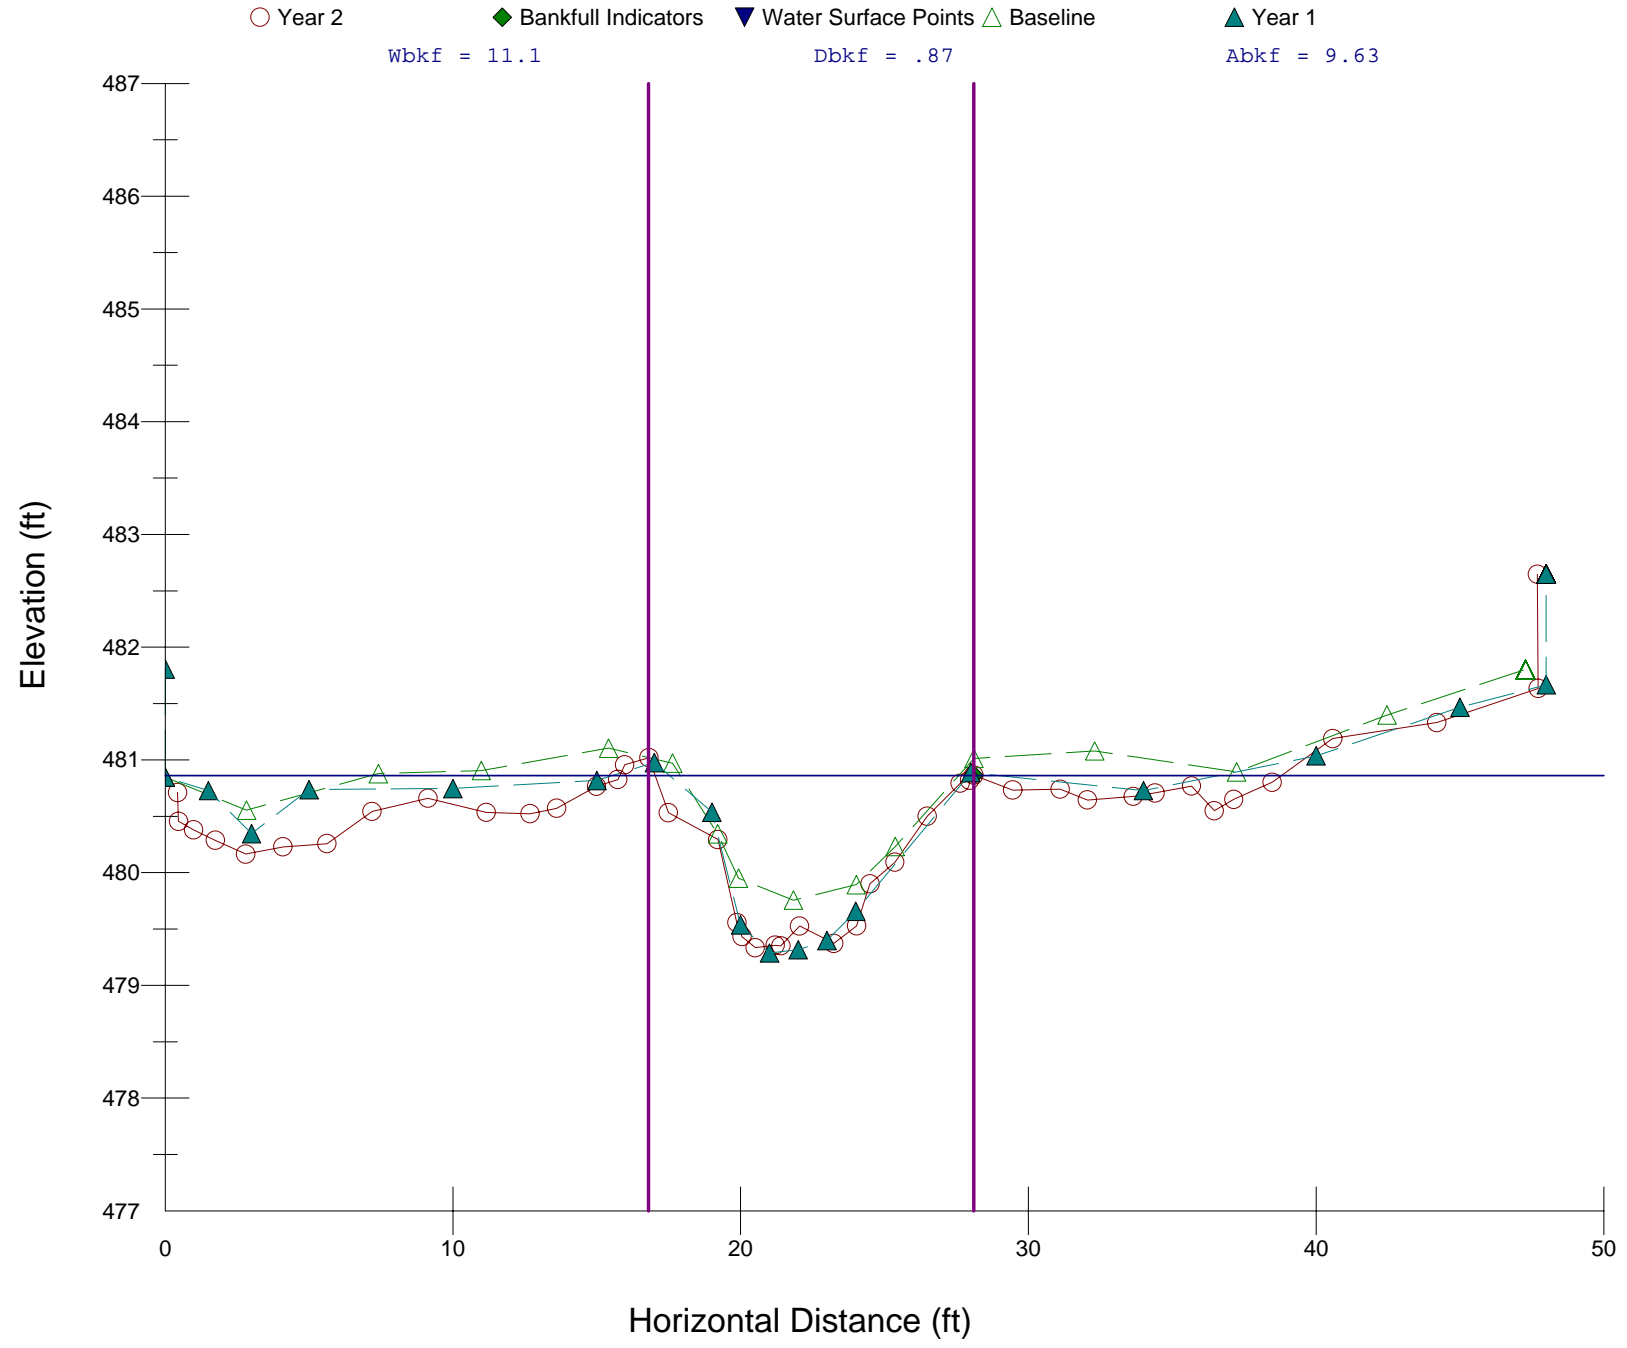
Cross Section 9 - Riffle

The stream remains in excellent condition. No problem areas were noted this year. Overall, the stream is remaining close to as-built morphology and no signs of bank or structure instability were noted. Slight degradation is occurring in the left floodplain of the riffle at Cross Section 9 but it is not a problem and slight changes are to be expected.
