# BAILEY FORK WETLAND AND STREAM RESTORATION PROJECT

## ANNUAL MONITORING REPORT FOR 2006 (YEAR 1)

Project Number D04006-3

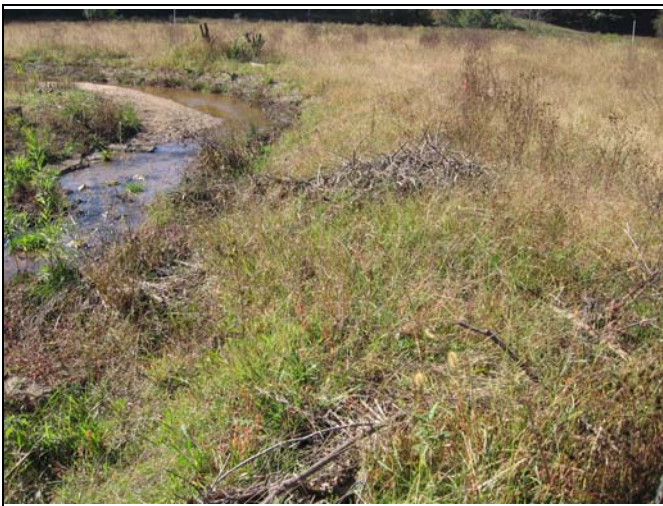
Photo 53 – Bankfull Evidence Near CR8

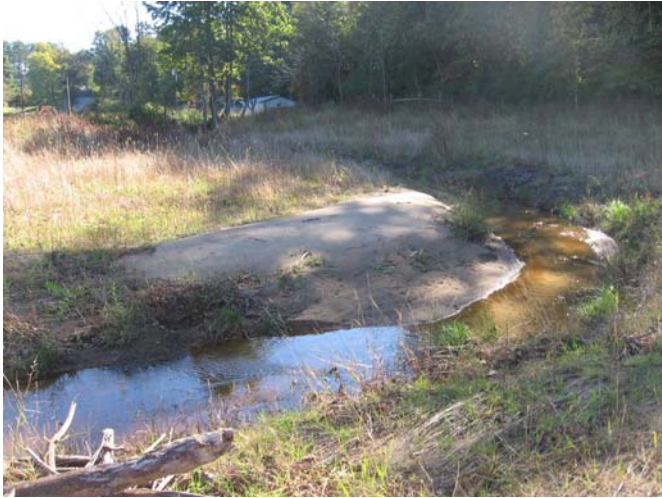
Photo 87 – Bar Deposition near Beginning of UT3

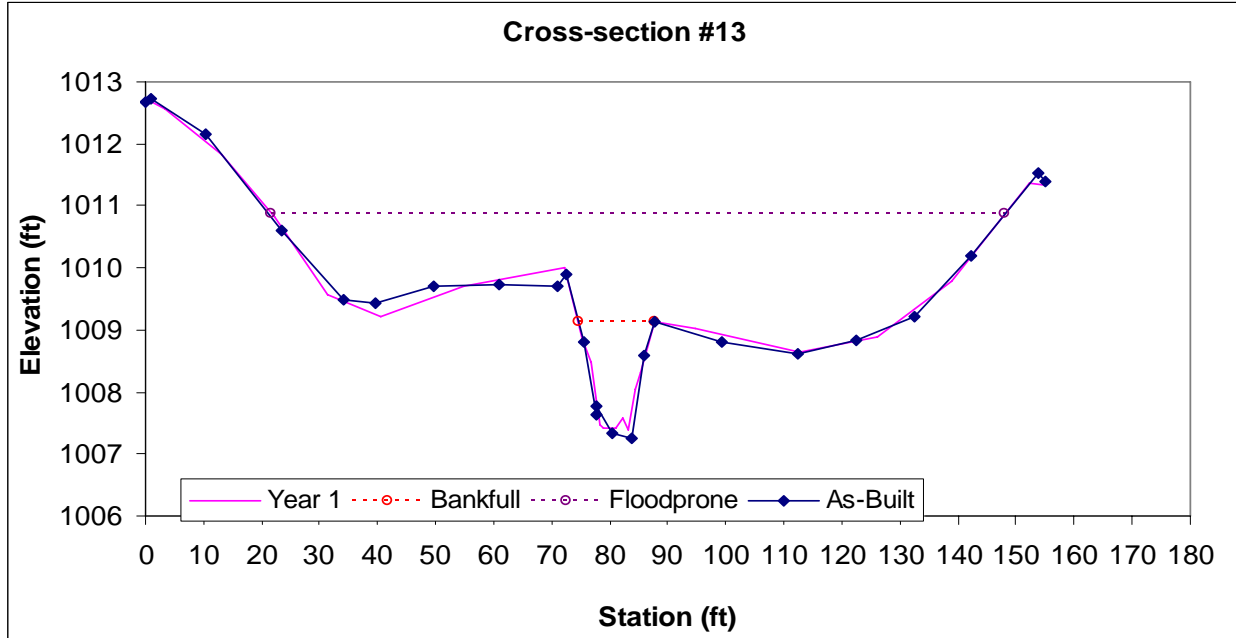
**Bailey Fork Site**  
**Profile Chart - Year 1 - Reach UT1**  
(data collected April, 2006)

Feature	Stream Type	BKF Area	BKF Width	BKF Depth	Max BKF Depth	W/D	BH Ratio	ER	BKF Elev	TOB Elev
Riffle	C	14.3	13.09	1.09	1.74	12	1	9.7	1009.14	1009.14
