BAILEY FORK WETLAND AND STREAM RESTORATION PROJECT (DRAFT)

ANNUAL MONITORING REPORT FOR 2007 (YEAR 2)

Project Number D04006-3

December 2007

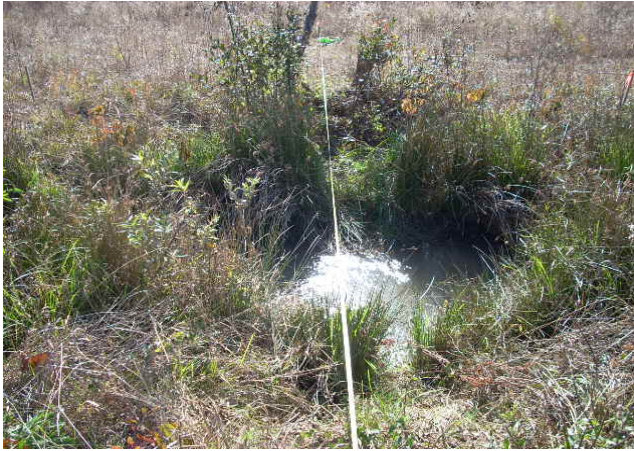
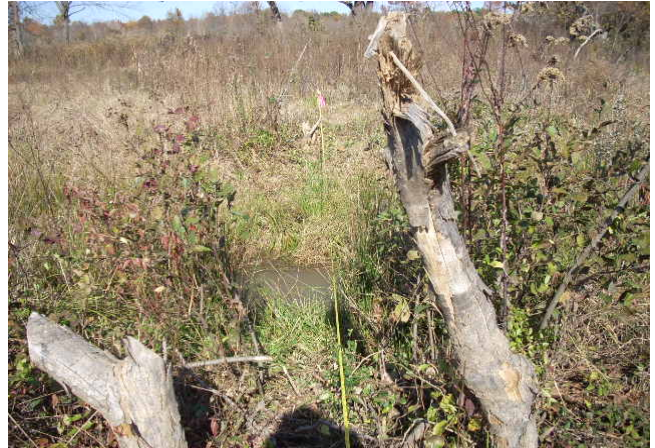
Permanent Cross-section #3
(Year 2 Data - Collected Nov. 2007)

Feature	Stream Type	BKF Area	BKF Width	BKF Depth	Max BKF Depth	W/D	BH Ratio	ER	BKF Elev	TOB Elev
Riffle	C	40.1	23.88	1.68	3.66	14.24	0.9	3	1013.5	1013.14

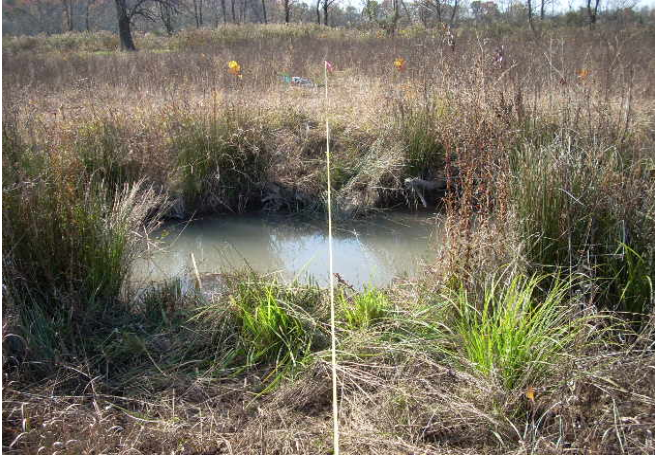
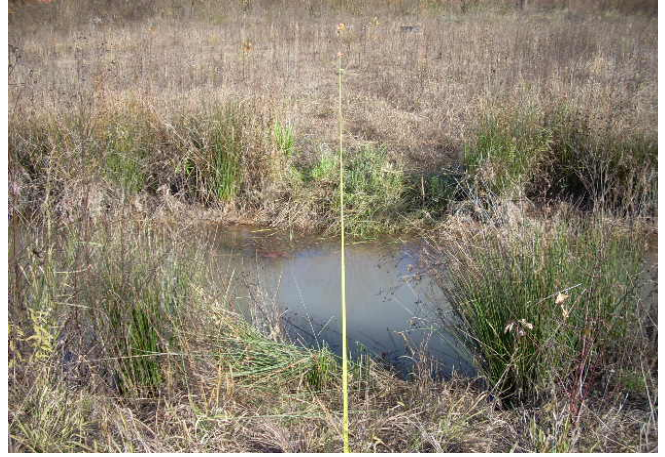
Permanent Cross-section #4
(Year 2 Data - Collected Nov. 2007)

Feature	Stream Type	BKF Area	BKF Width	BKF Depth	Max BKF Depth	W/D	BH Ratio	ER	BKF Elev	TOB Elev
Pool		28.5	22.84	1.25	2.57	18.27	1	3.9	1011.7	1011.69

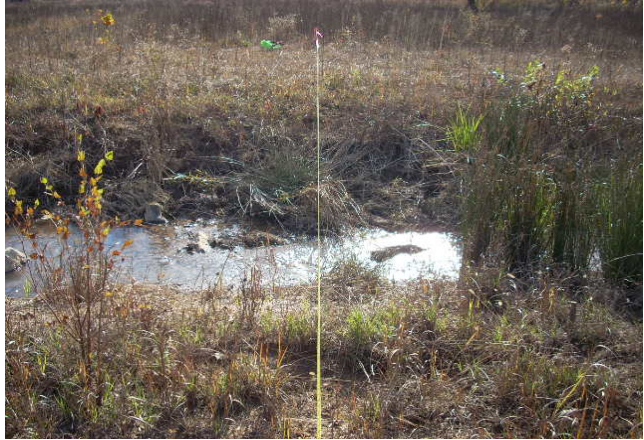
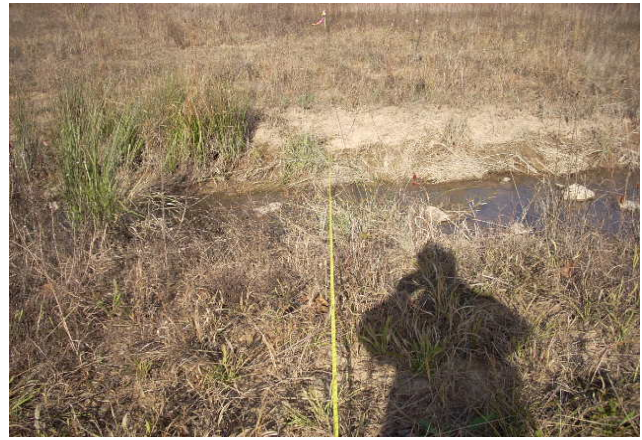
Permanent Cross-section #5
 (Year 2 Data - Collected Nov. 2007)

Feature	Stream Type	BKF Area	BKF Width	BKF Depth	Max BKF Depth	W/D	BH Ratio	ER	BKF Elev	TOB Elev
Riffle	C	19	17.59	1.08	2.07	16.28	1	4.8	1011.5	1011.55

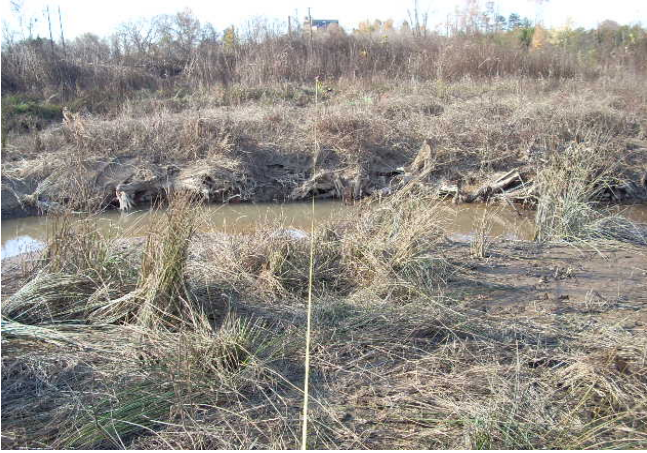
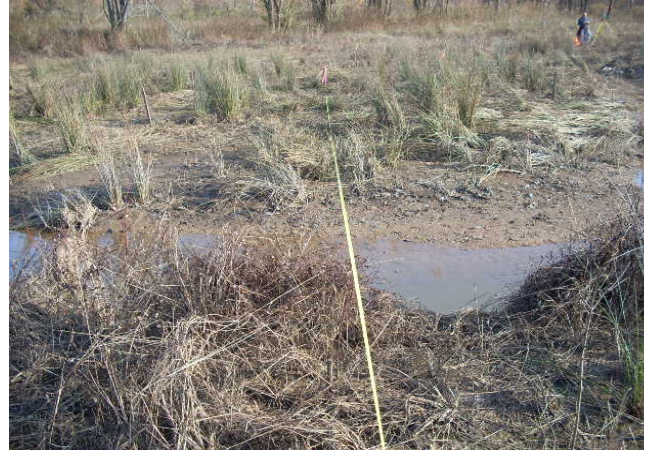
Permanent Cross-section #6
 (Year 2 Data - Collected Nov. 2007)

Feature	Stream Type	BKF Area	BKF Width	BKF Depth	Max BKF Depth	W/D	BH Ratio	ER	BKF Elev	TOB Elev
Pool		22.3	20.57	1.09	2.24	18.95	1.1	3.2	1009.46	1009.58

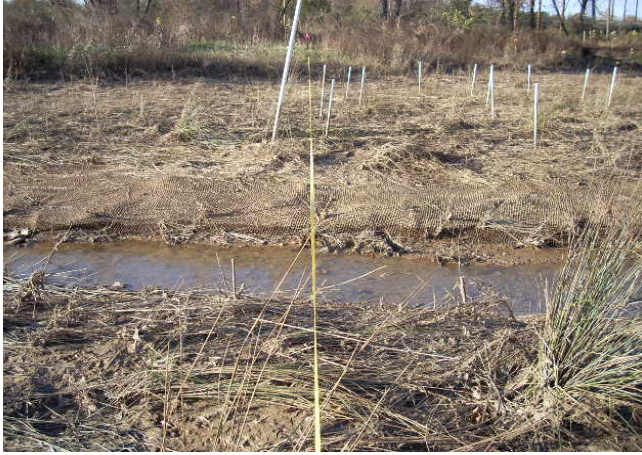
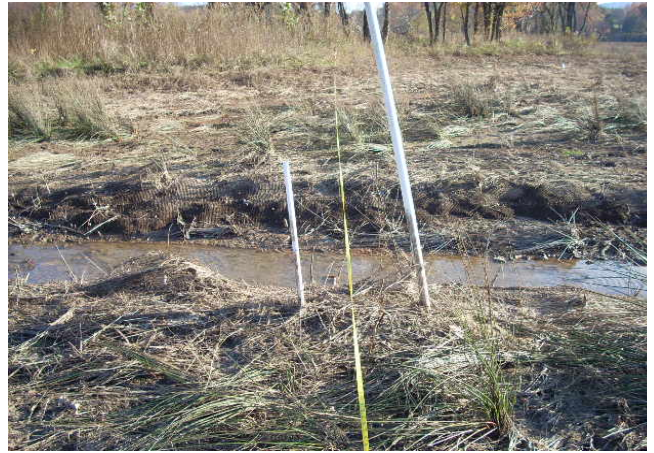
Permanent Cross-section #7
 (Year 2 Data - Collected Nov. 2007)

Feature	Stream Type	BKF Area	BKF Width	BKF Depth	Max BKF Depth	W/D	BH Ratio	ER	BKF Elev	TOB Elev
Riffle	C	13	11.25	1.16	1.73	9.72	1.1	11	1009.14	1009.3

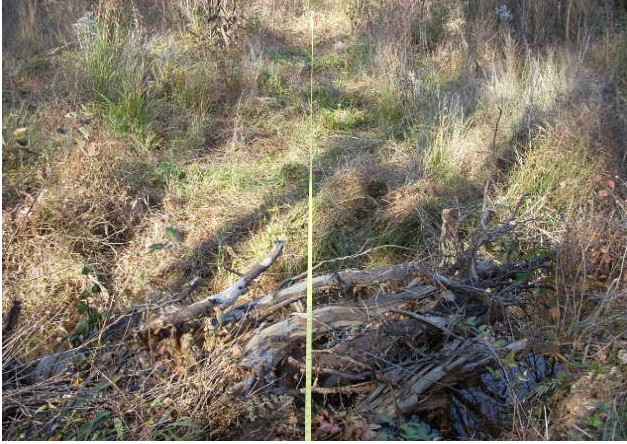
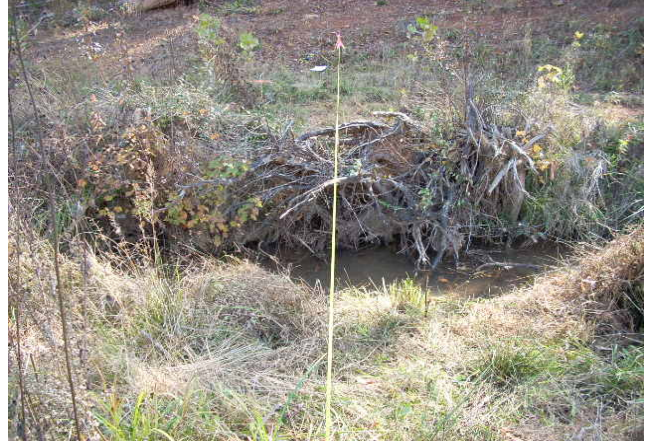
Permanent Cross-section #8
 (Year 2 Data - Collected Nov. 2007)

Feature	Stream Type	BKF Area	BKF Width	BKF Depth	Max BKF Depth	W/D	BH Ratio	ER	BKF Elev	TOB Elev
Pool		25.7	17.55	1.47	2.94	11.97	1	3.3	1029.79	1029.77

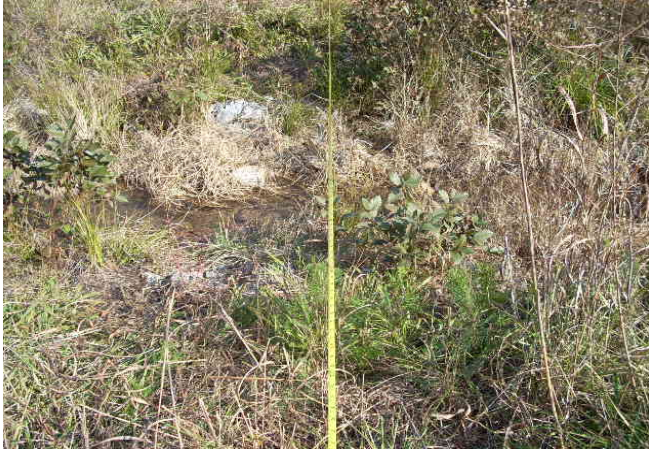
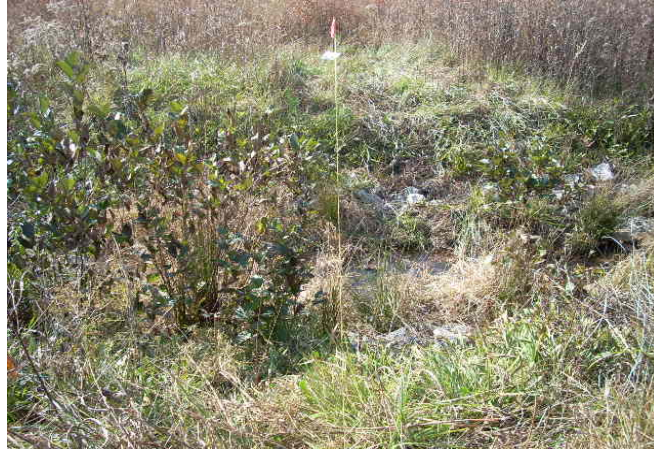
Permanent Cross-section #9

Feature	Stream Type	BKF Area	BKF Width	BKF Depth	Max BKF Depth	W/D	BH Ratio	ER	BKF Elev	TOB Elev
Riffle	C	29.5	20.2	1.46	2.87	13.83	1	2.4	1025.18	1025.04

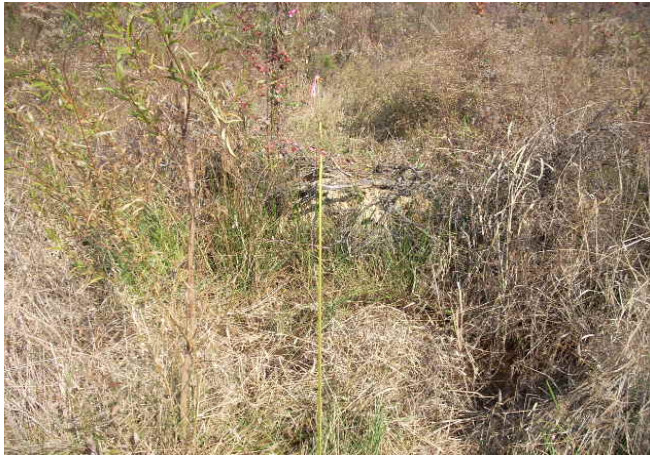
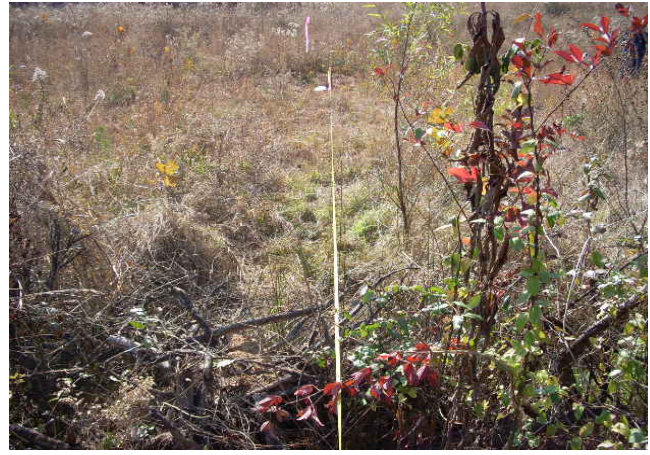
Permanent Cross-section #10
(Year 2 Data - Collected Nov. 2007)

Feature	Stream Type	BKF Area	BKF Width	BKF Depth	Max BKF Depth	W/D	BH Ratio	ER	BKF Elev	TOB Elev
Pool		21.3	28.26	0.75	1.74	37.57	0.9	2.2	1025.96	1025.86

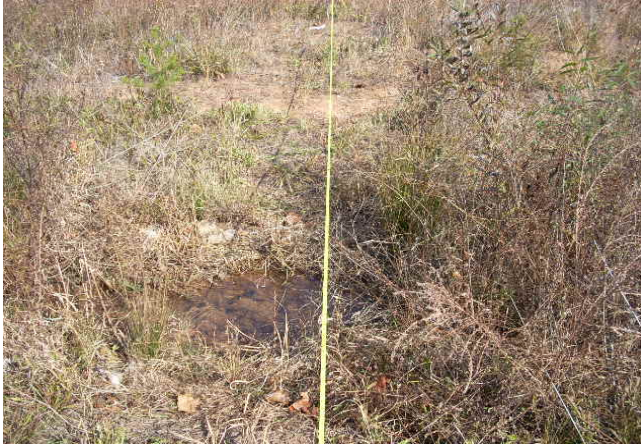
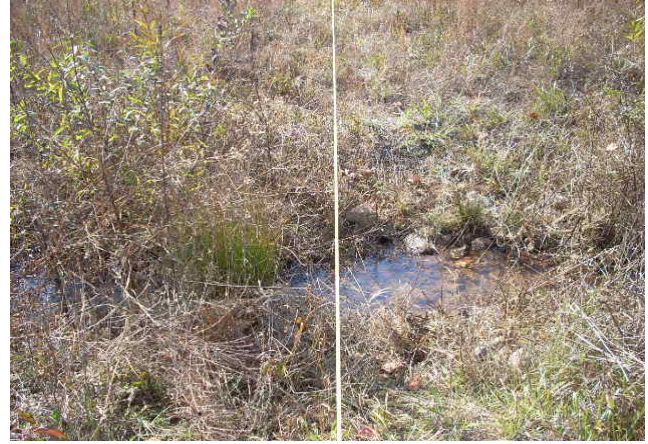
Permanent Cross-section #11

Feature	Stream Type	BKF Area	BKF Width	BKF Depth	Max BKF Depth	W/D	BH Ratio	ER	BKF Elev	TOB Elev
Riffle	C	9.00	11.69	0.77	1.4	15.13	1	4.6	1022.55	1022.61

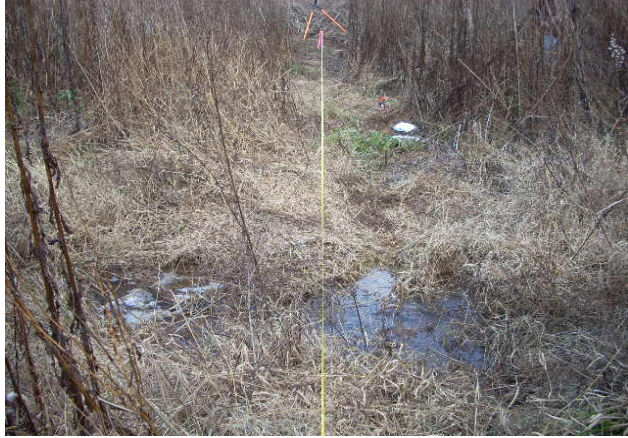
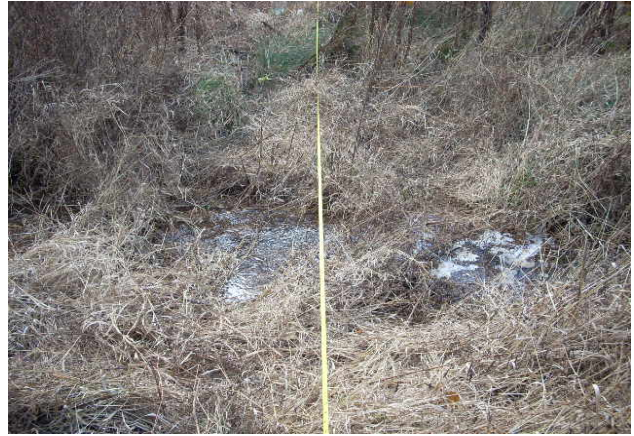
Permanent Cross-section #12

Feature	Stream Type	BKF Area	BKF Width	BKF Depth	Max BKF Depth	W/D	BH Ratio	ER	BKF Elev	TOB Elev
Riffle	C	8.5	13.9	0.61	1.24	22.81	1	5.7	1031.84	1031.84

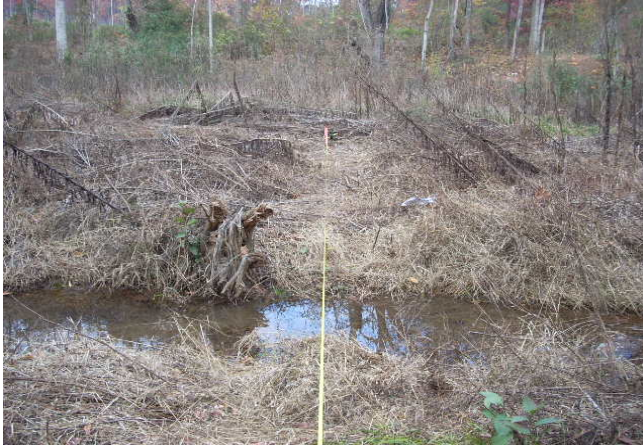
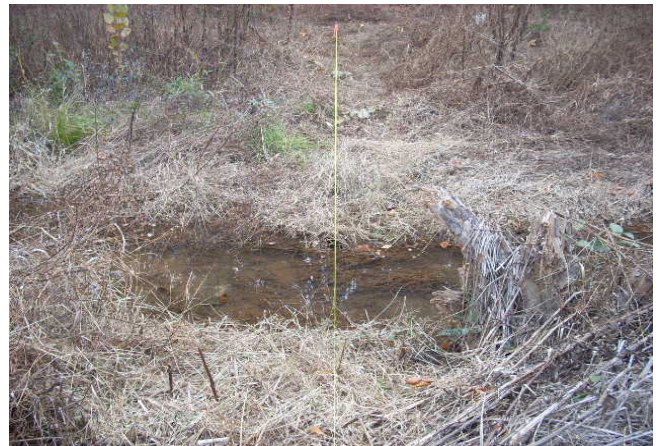
Permanent Cross-section #13

Feature	Stream Type	BKF Area	BKF Width	BKF Depth	Max BKF Depth	W/D	BH Ratio	ER	BKF Elev	TOB Elev
Pool		16.2	18.07	0.9	1.84	20.15	1	3.8	1036.23	1036.26
