BAILEY FORK WETLAND AND STREAM RESTORATION PROJECT (DRAFT)

ANNUAL MONITORING REPORT FOR 2008 (YEAR 3)

Project Number D04006-3

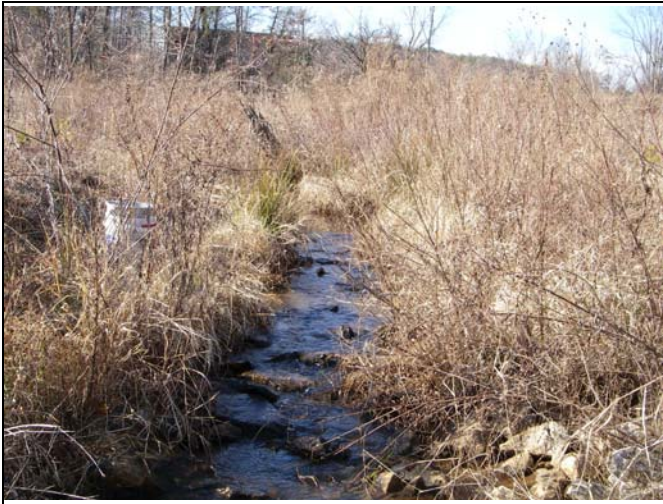
P1 Site 1 – Facing upstream

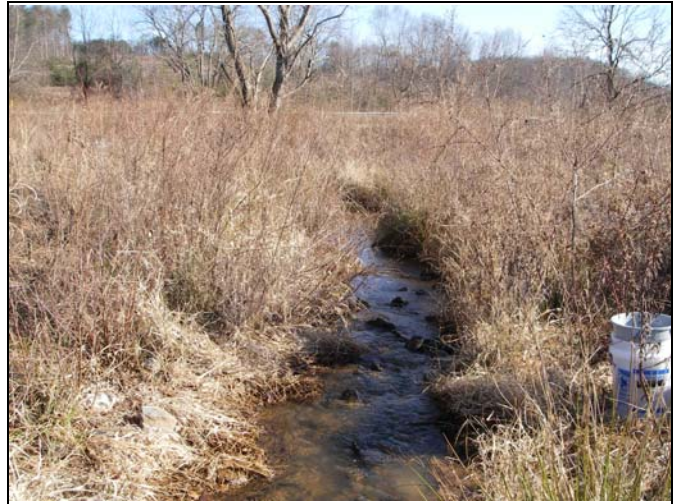
P2 Site 1 – Facing downstream

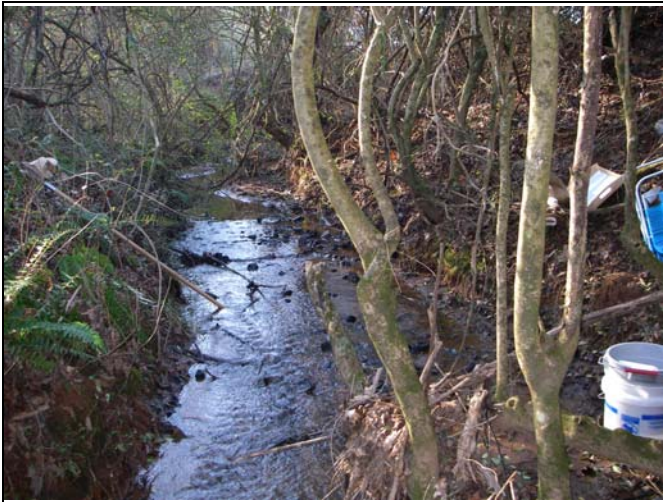
P3 Site 2 – Facing upstream

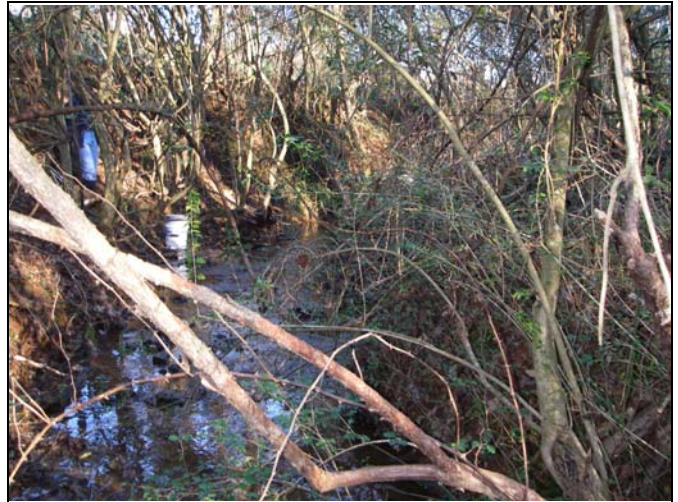
P4 Site 2 – Facing downstream

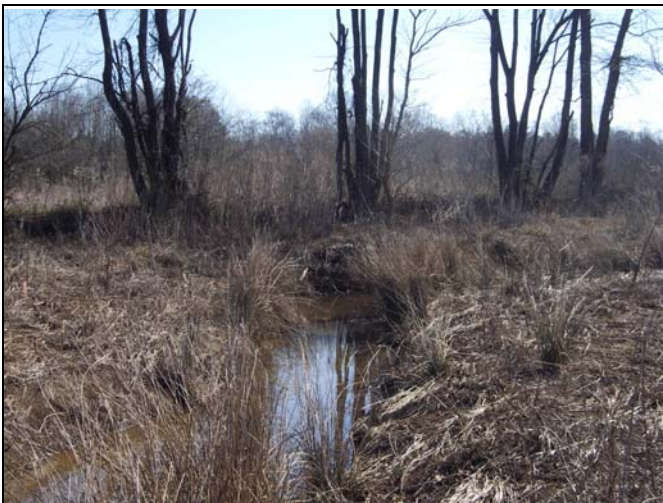
P5 Site 3 – Facing upstream

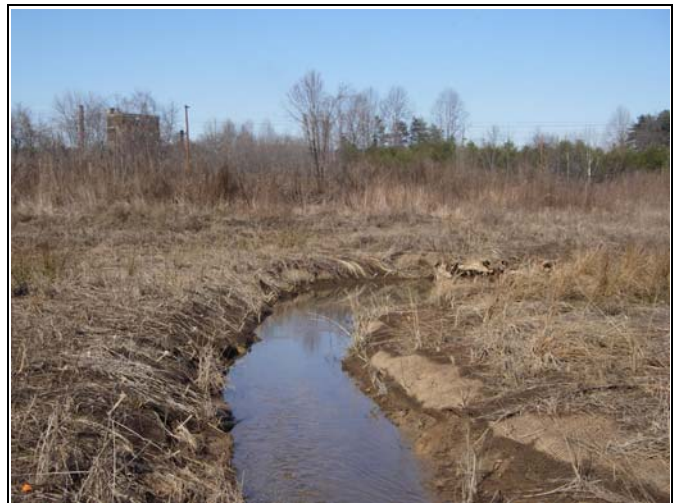
P6 Site 3 – Facing downstream

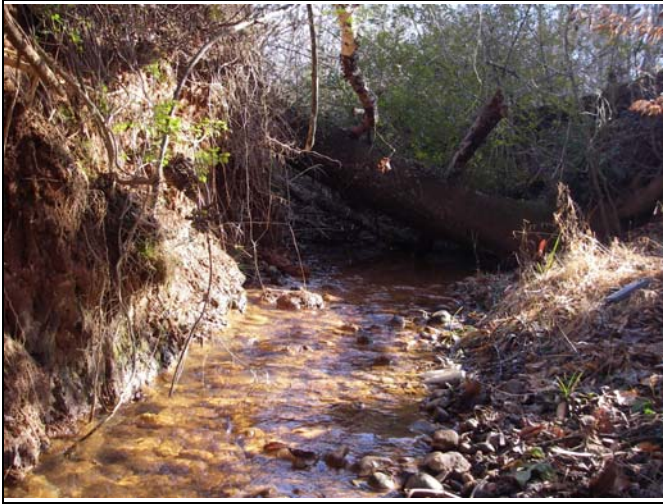
P7 Site 4 – Facing upstream

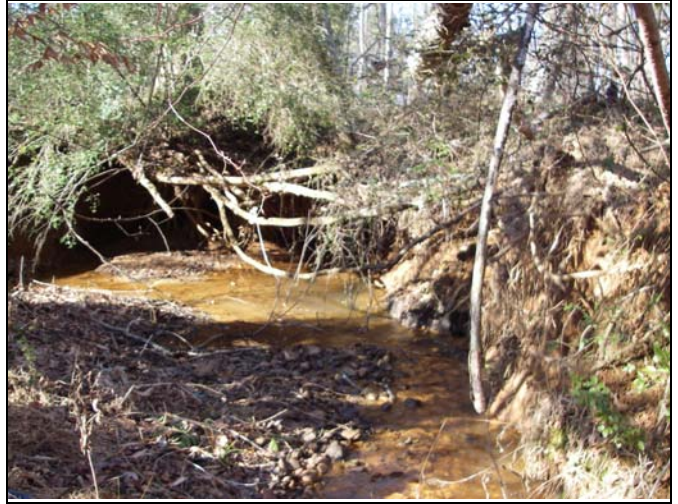
P8 Site 4 – Facing downstream
