BAILEY FORK WETLAND AND STREAM RESTORATION PROJECT (DRAFT)

ANNUAL MONITORING REPORT FOR 2009 (YEAR 4)

Project Number D04006-3

December 2009

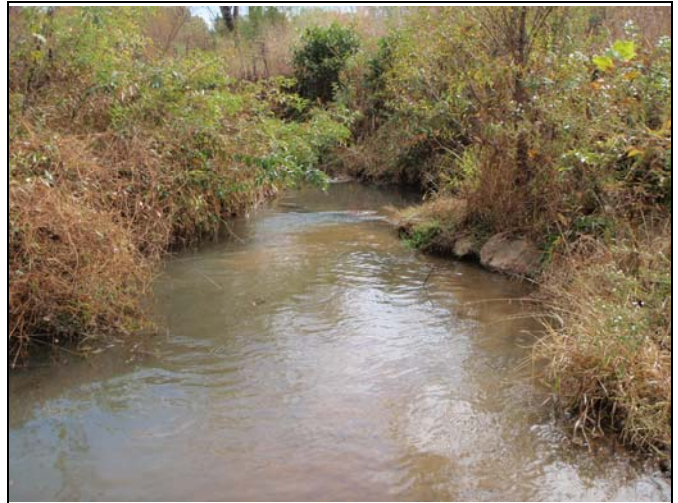
Bailey Fork Cross Vane 1

It was also noted that two rock cross vanes on Bailey Fork Creek at approximate stations 17+00 and 28+50 have been impacted by beaver activity. During a site visit in early November 2008 (Year 3), two beaver dams were observed across the rock invert on top of the cross vanes. These beaver dams were not present in October 2009. The area will continue to be observed for further beaver activity.

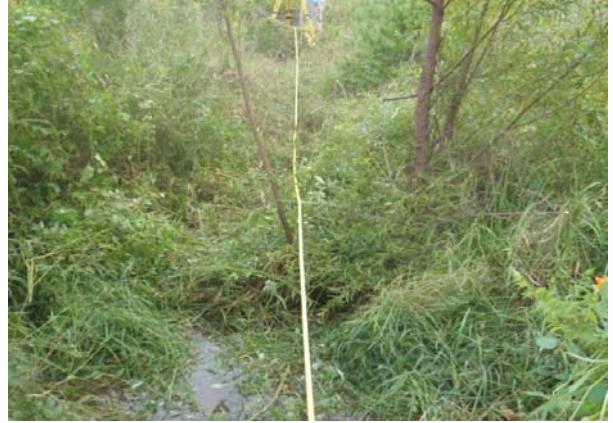
Looking at the Right Bank

Feature	Stream Type	BKF Area	BKF Width	BKF Depth	Max BKF Depth	W/D	BH Ratio	ER	BKF Elev	TOB Elev
Pool		22.7	28.96	0.78	1.93	37	1.1	1.9	1025.96	1026.14

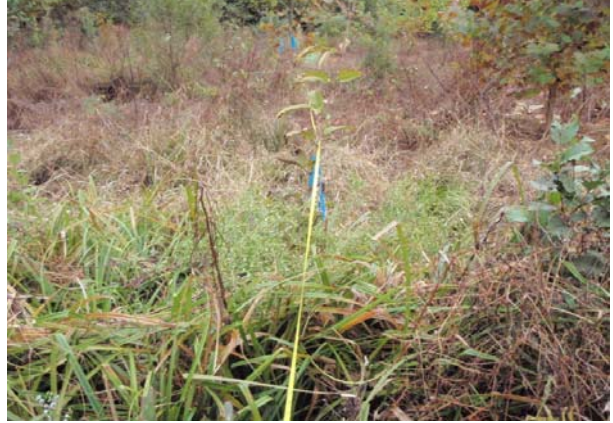
Looking at the Right Bank

Feature	Stream Type	BKF Area	BKF Width	BKF Depth	Max BKF Depth	W/D	BH Ratio	ER	BKF Elev	TOB Elev
Riffle	C	7.6	13.25	0.57	1.1	23.08	1.2	6	1031.74	1031.98

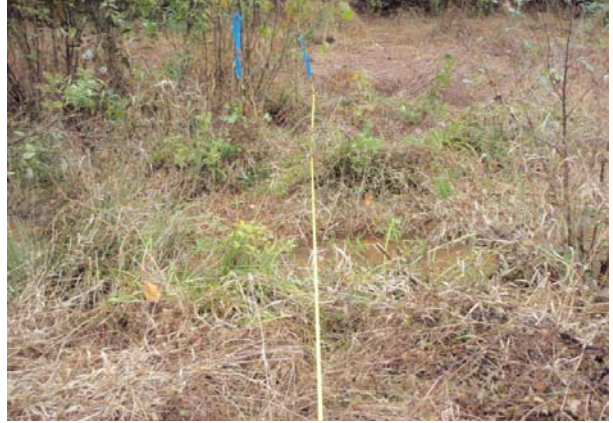
Looking at the Right Bank

Feature	Stream Type	BKF Area	BKF Width	BKF Depth	Max BKF Depth	W/D	BH Ratio	ER	BKF Elev	TOB Elev
Pool		12.4	21.95	0.56	1.35	38.91	0.7	3.1	1036.23	1035.84
