Year 1 Monitoring Report for Stream Restoration of Bailey Fork

Burke County, NC
SCO # D04006-02

Submitted: January 2008

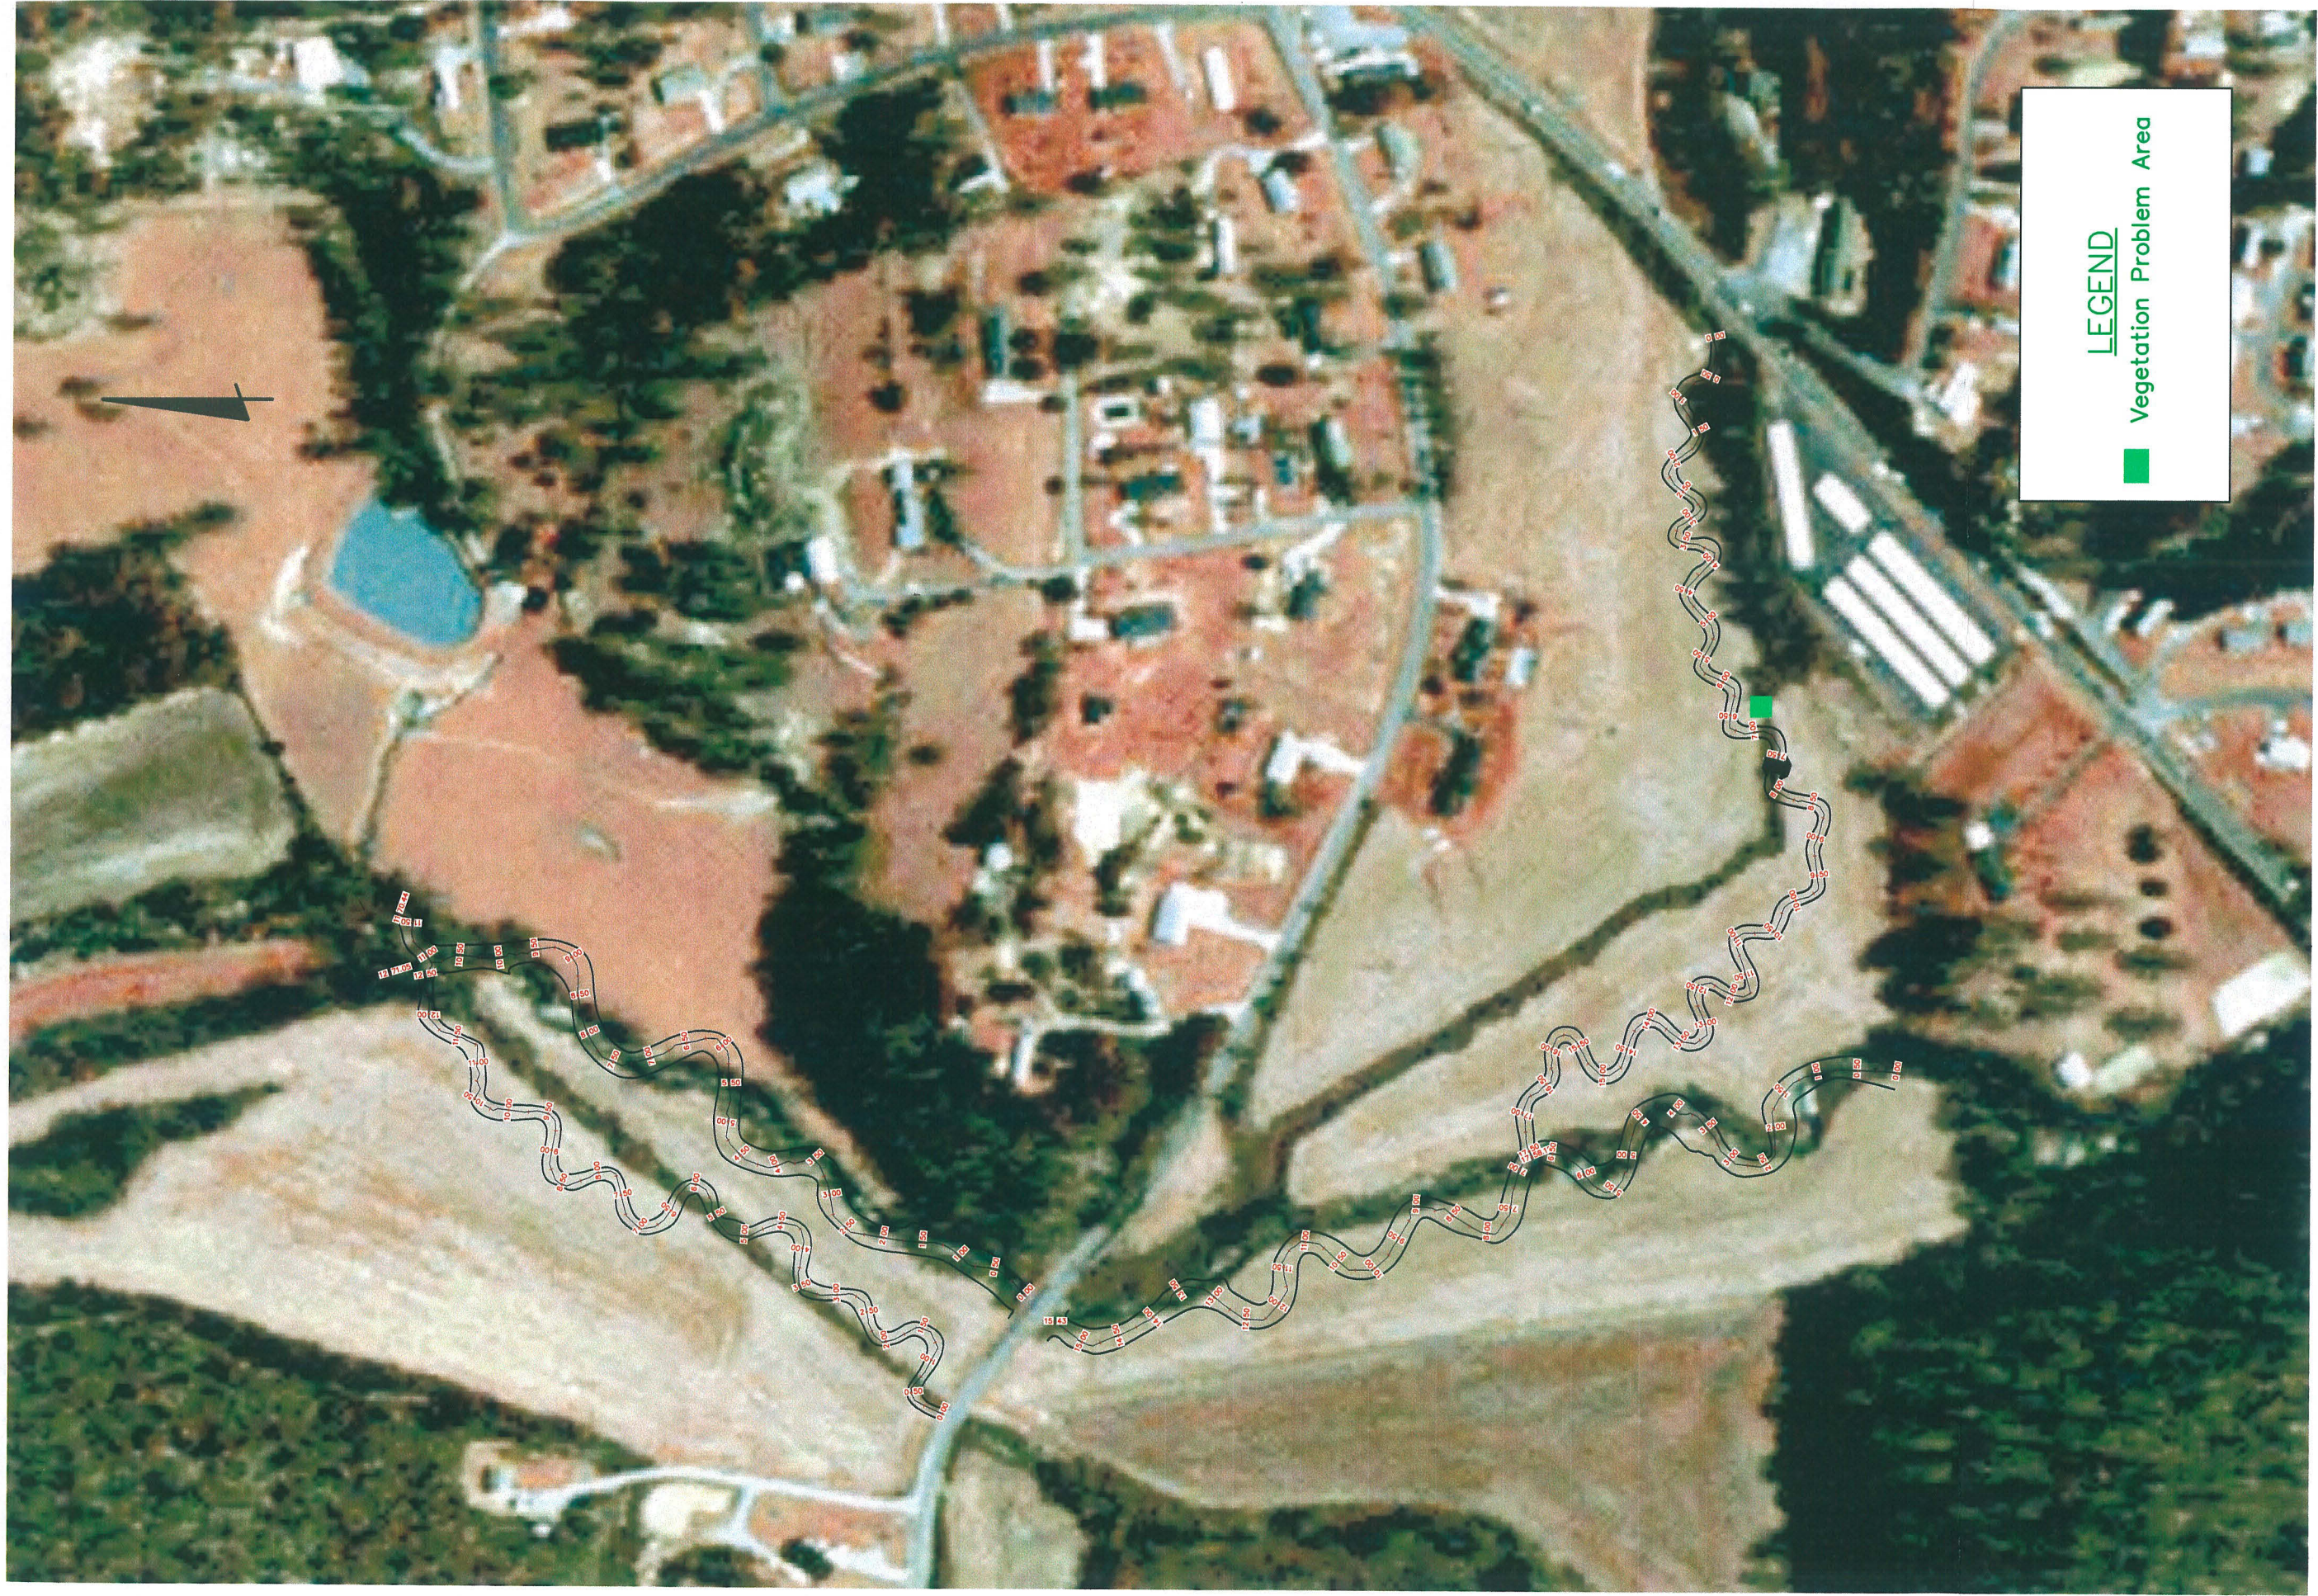
COUNTY, NORTH CAROLINA
BAILEY FORK
 MONITORING
 APPENDIX A
 VEGETATION PROBLEM AREA PLAN VIEW

The only vegetation problem area was a section near Vegetation Plot #5 where mowing of the adjacent pasture land for hay had infringed upon the riparian buffer. This mowing appeared to have damaged and killed some of the woody vegetation planted in this area.

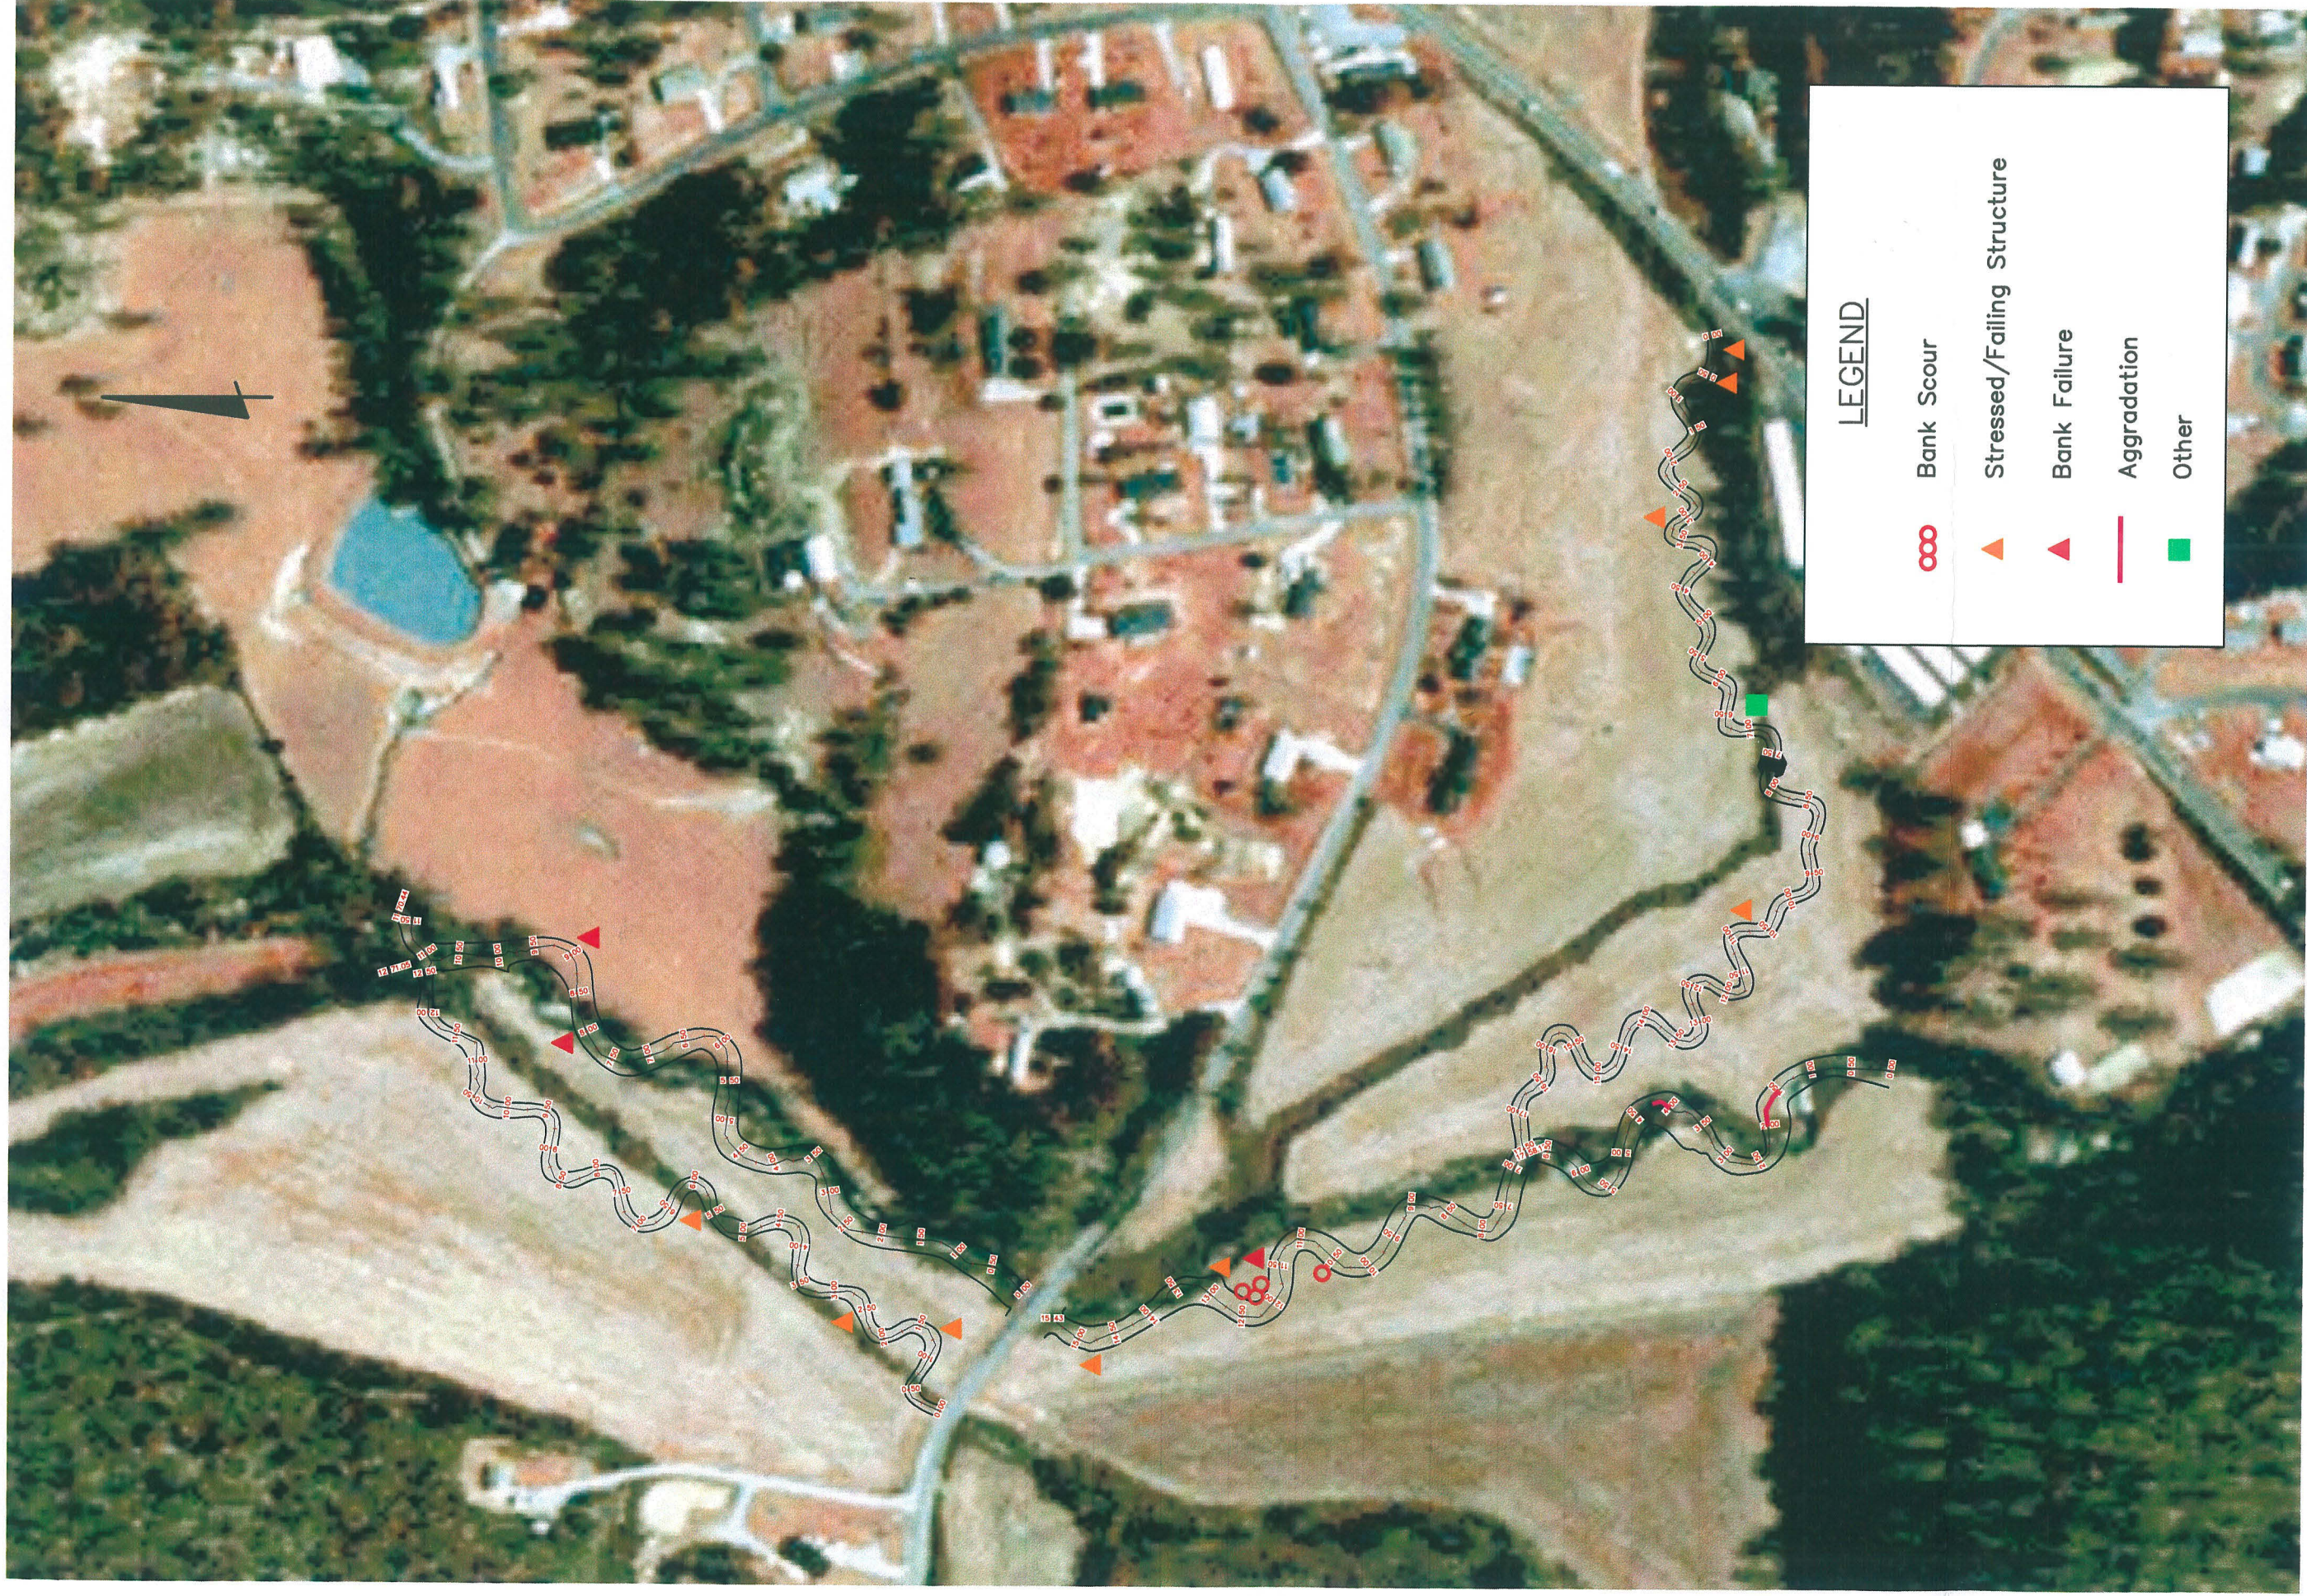
A number of unstable areas were found along the upper and lower reaches of the Bailey Fork mainstem, including areas of aggradation, bank scour, and bank failure. Several structures along Upper Bailey Fork and Tributaries UT1 and UT2 have become impacted by channel aggradation at these structures. As sand is dominant in the watershed, the sediment over the embedded structures may partially result from the natural sand supply in the watershed. However, in each area where a structure is embedded, the channel is stable, with no bank failure or bar formation.

^All of the meanders in an unstable state had pronounced erosion along the outer bends. Streambank maintenance has already occurred to reestablish stability; this will be documented in the Year 2 results. Identified problematic structures on Upper Bailey and on Tributaries UT1 and UT2 were vanes/J-hooks. Each of the affected structures has become embedded in fine sediment. However, the channel is stable at each location where aggradation has covered a structure. Deposition was also deemed the likely cause for those pools and riffles that differed in profile from the as-built. Some of the pools have become quite shallow, a few to the point of losing pool functions. The unstable riffles were typically areas where a structure had become covered by sediment. Despite the deposition, the channel appears to be stable, and no maintenance is planned for these features.
