Year 2 Monitoring Report for Stream Restoration of Bailey Fork

Burke County, NC
SCO # D04006-02

Submitted: January 2008

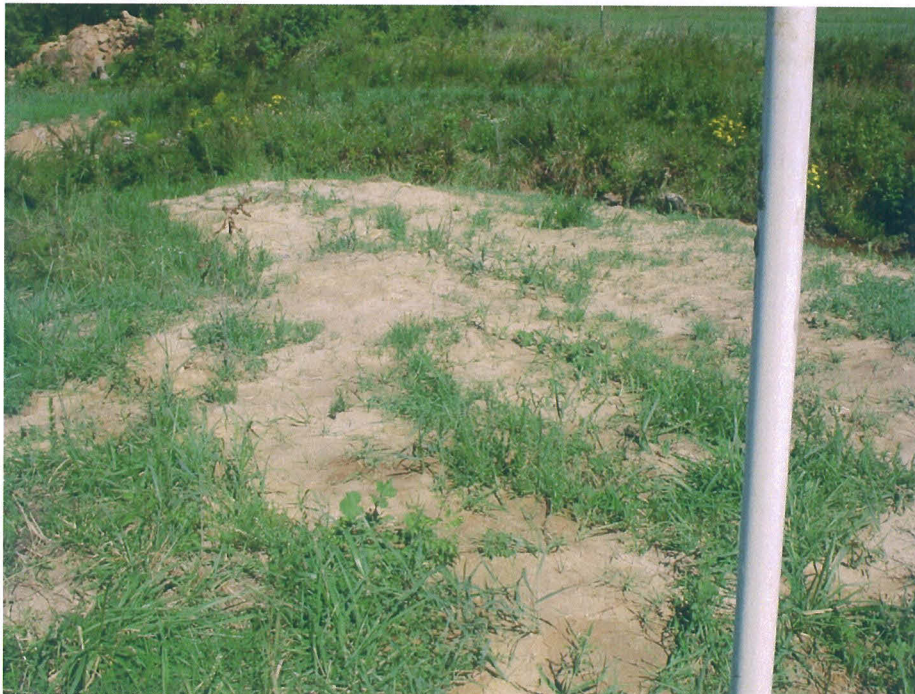
Vegetation Plot 6
Monitoring Year 2
(EMH&T, Inc. 9/18/07)

Feature/Issue	Station # / Range	Probable Cause	Photo #
Invasive Population	Throughout: See VPA Plan View	<i>Sericea lespedeza</i> : encroachment from pasture	VPA 1, VPA 2
Bare Bank	Vegetation Plot 6	Plot has been partially removed during streambank maintenance; woody vegetation was lost	VPA 3

The remaining vegetation problem area was a section along Upper Bailey Fork where remedial maintenance activities along the stream banks impacted Vegetation Plot #6. These activities were represented by a plan sent by email to EEP on August 3, 2007 and subsequently discussed in the field with the EEP following completion. The focus of the efforts to repair the degraded reaches of the channel was to improve channel bank stability by creating a more stable bank slope that also provided a more stable width to depth relationship within the bankfull channel. In order to accomplish this, the existing banks were cut back to decrease the slope, which disturbed half of Vegetation Plot #6. The vegetation in the remainder of the plot, along with much of the buffer vegetation along the top of the slope at this location was damaged or destroyed by the construction activities. The streambanks were reseeded upon completion of maintenance activities, and new trees will be planted in the spring of 2008.

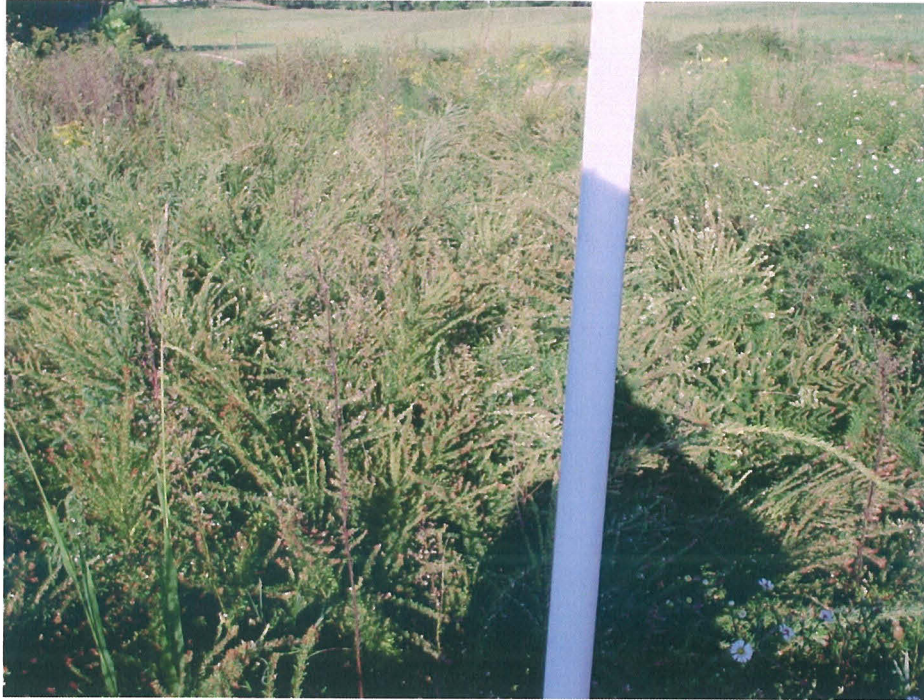
Vegetation Plot 9
Monitoring Year 2
(EMH&T, Inc. 9/18/07)

The average stem density for the site exceeds the minimum criteria of 320 stems per acre after three years. Four individual plots have stem densities below the minimum; however, four seedlings have recruited in Plot #1, which would increase the stem count to exceed the minimum criteria. Plot #6 was discussed in the Vegetation Problem Areas section of this report. Plot #5 was damaged by pasture mowing in Year 1; seedlings have not recruited back into this plot. The final plot, Plot #9, is densely covered by *Sericea lespedeza*.

It is likely that the spread of *Sericea lespedeza* throughout much of the project corridor has hindered the growth and survival of woody vegetation. Where present, this species is dominant, providing a thick coverage of growth approximately three feet high through which any species must break in order to receive sunlight or rainfall. After management of this species is conducted in the spring of 2008, as discussed previously, a round of remedial tree plantings will be conducted. These plantings are intended to bring deficient areas of the site back into compliance with the 320 stems per acre minimum, and to replace trees inadvertently impacted by the herbicide treatments. The plantings will be spread throughout the project corridor, with an emphasis placed on those plots below the minimum stem count threshold.

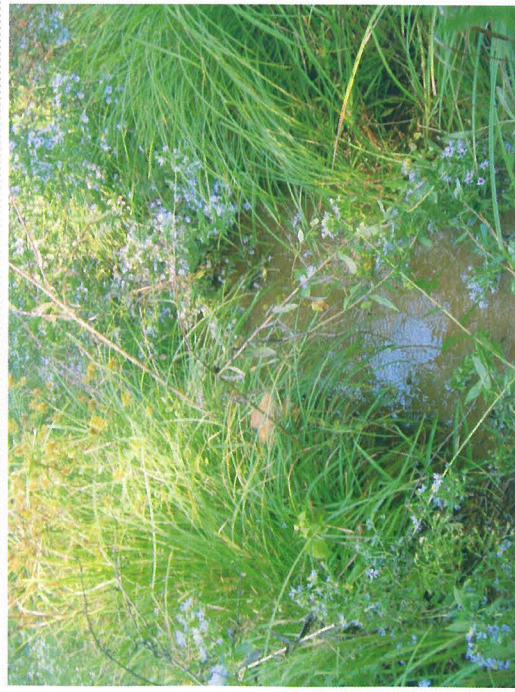
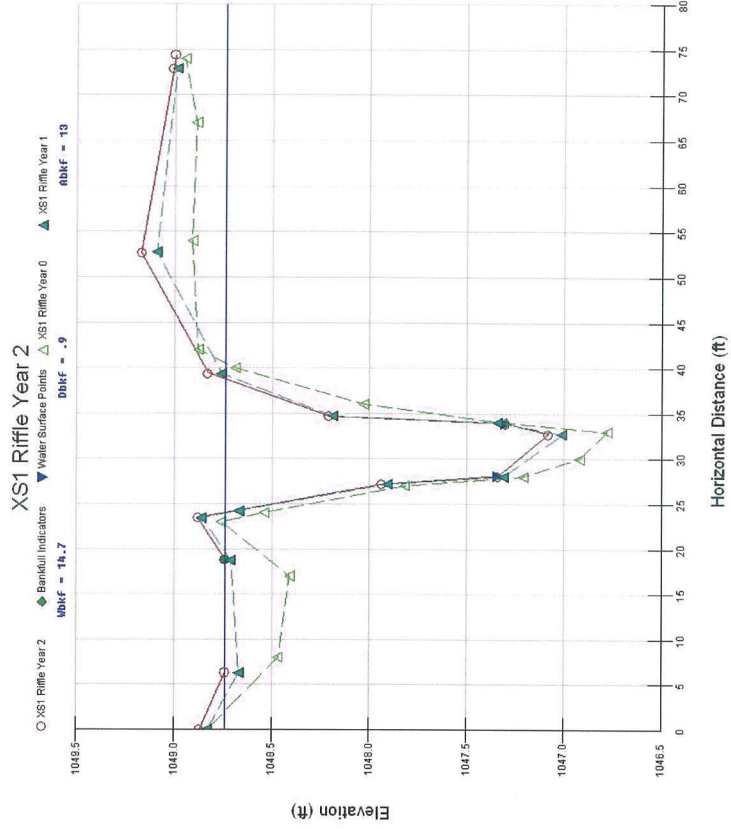
CROSS SECTION: 1
FEATURE: Riffle

Bankfull Area 18.62 ft²
 Bankfull Width 24.25 ft
 Mean Depth 0.77 ft
 Maximum Depth 1.92 ft
 Width/Depth Ratio 31.49
 Entrenchment Ratio 2.2
 Classification C

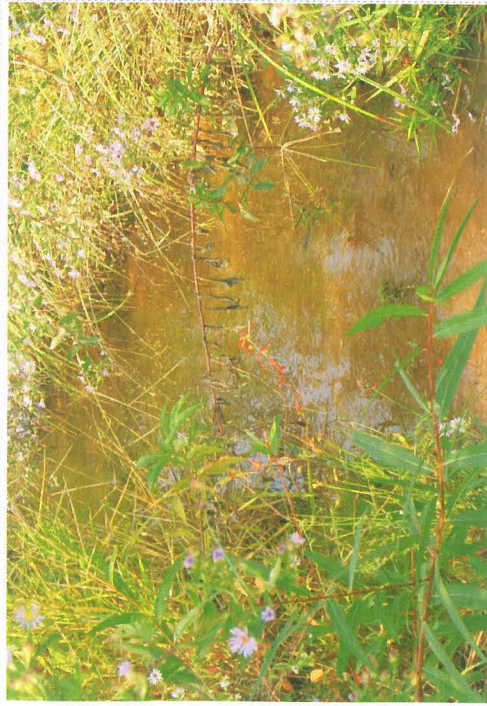
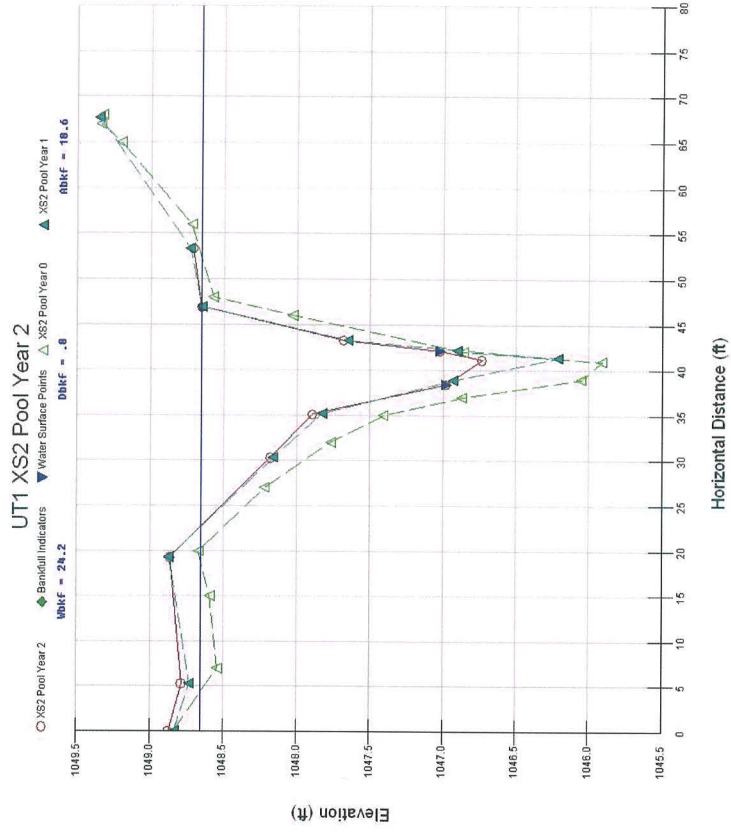
CROSS SECTION: 2
FEATURE: Pool

Bankfull Area 16.08 ft²
 Bankfull Width 16.26 ft
 Mean Depth 0.99 ft
 Maximum Depth 2.03 ft
 Width/Depth Ratio 16.42
 Entrenchment Ratio 3.59
 Classification C

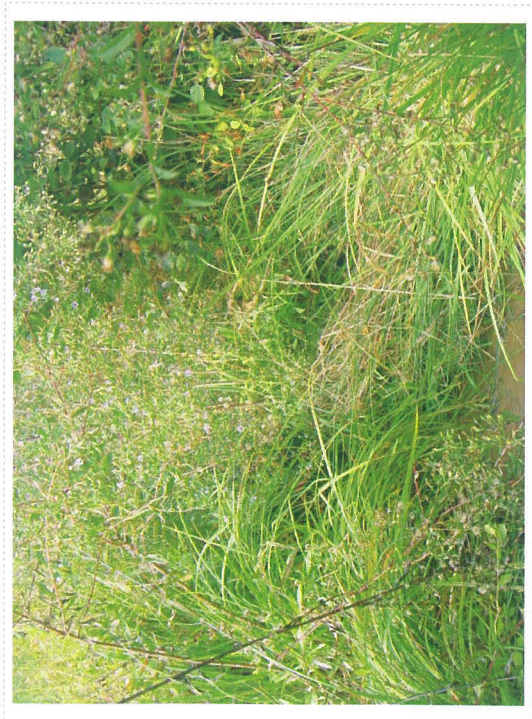
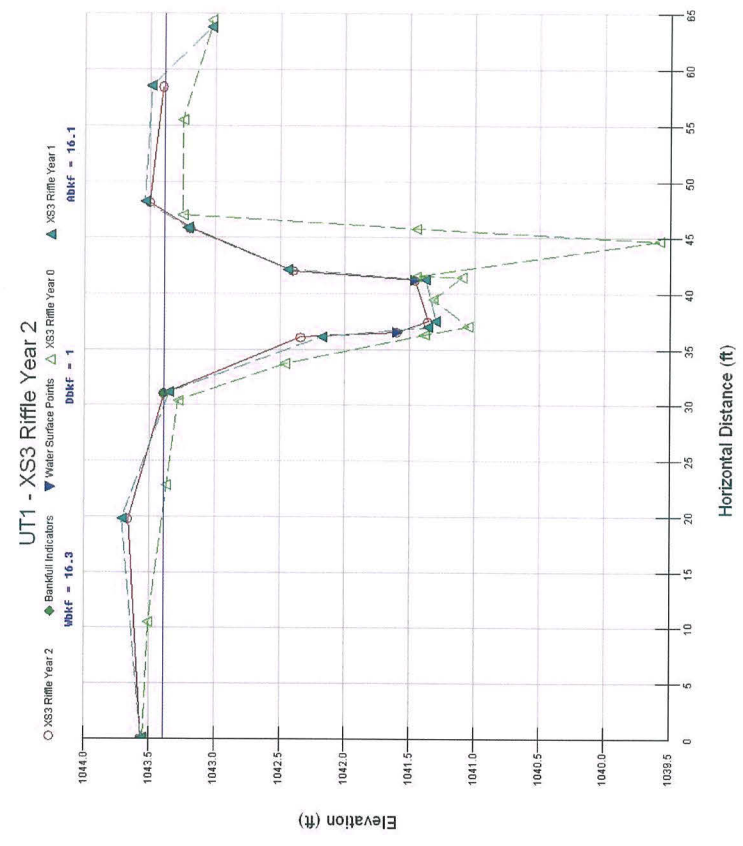
CROSS SECTION: 3
FEATURE: Riffle

Bankfull Area 9.17 ft²
 Bankfull Width 13.07 ft
 Mean Depth 0.70 ft
 Maximum Depth 1.64 ft
 Width/Depth Ratio 18.67
 Entrenchment Ratio 4.38
 Classification C

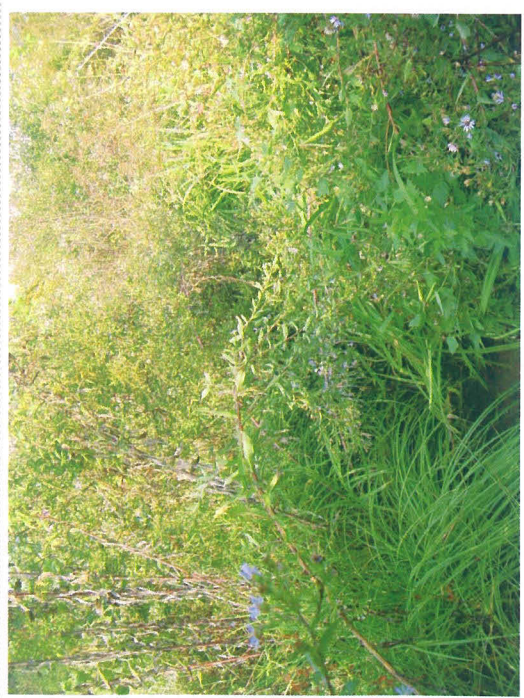
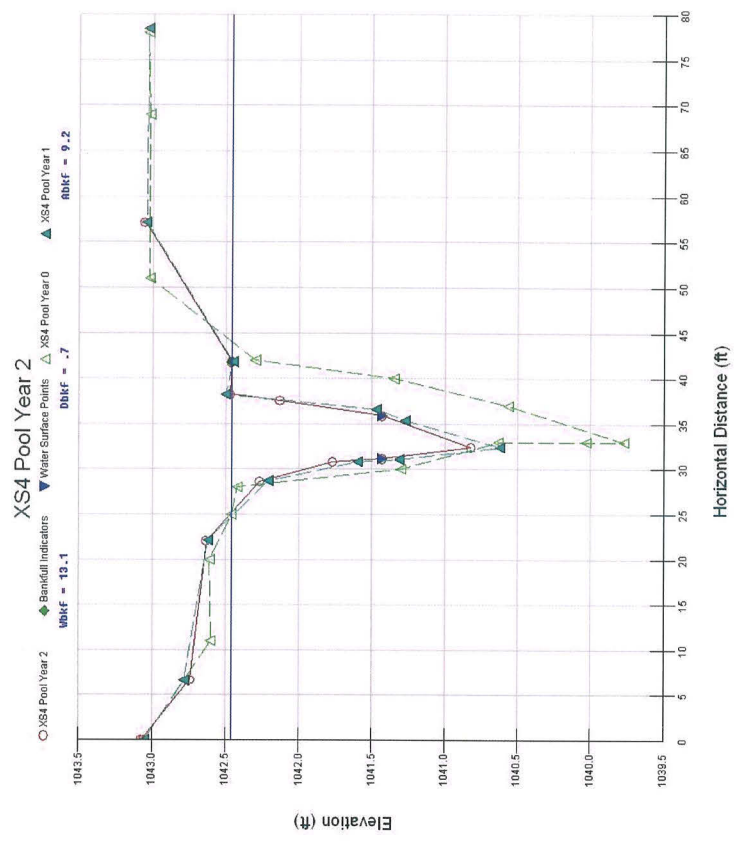
CROSS SECTION: 4
FEATURE: Pool

Bankfull Area 77.14 ft²
 Bankfull Width 28.89 ft
 Mean Depth 2.67 ft
 Maximum Depth 4.25 ft
 Width/Depth Ratio 10.82
 Entrenchment Ratio 3.46
 Classification E

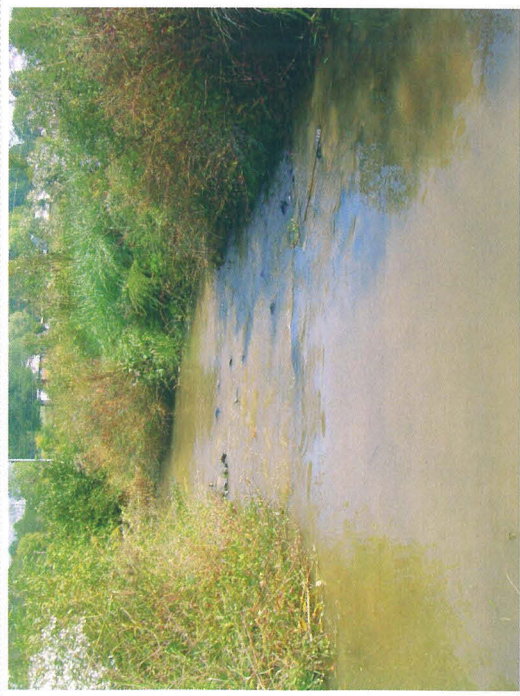
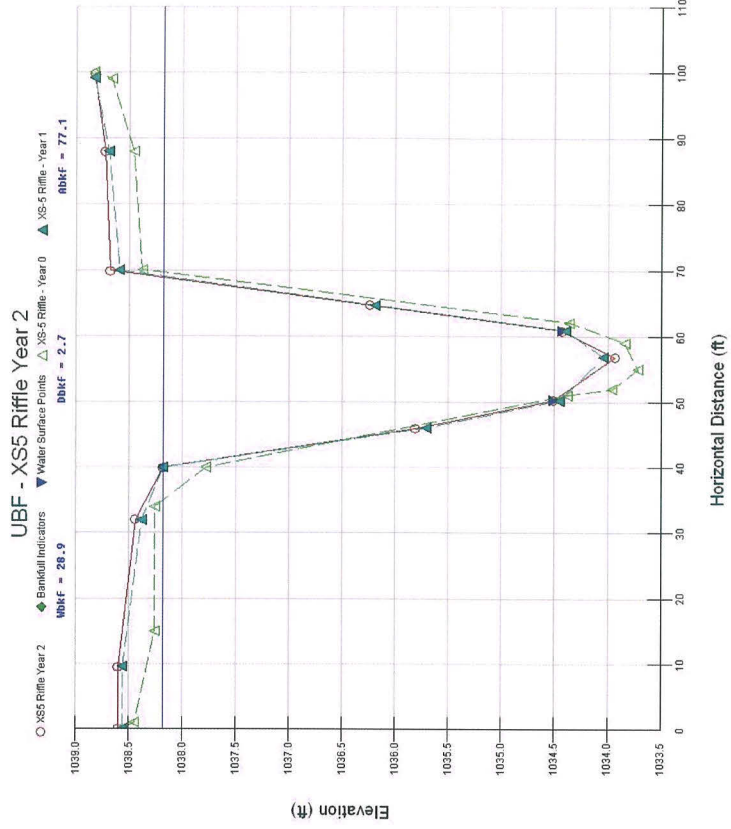
CROSS SECTION: 5
FEATURE: Riffle

Bankfull Area 104.83 ft²
 Bankfull Width 46.78 ft
 Mean Depth 2.24 ft
 Maximum Depth 4.18 ft
 Width/Depth Ratio 20.88
 Entrenchment Ratio 2.65
 Classification C

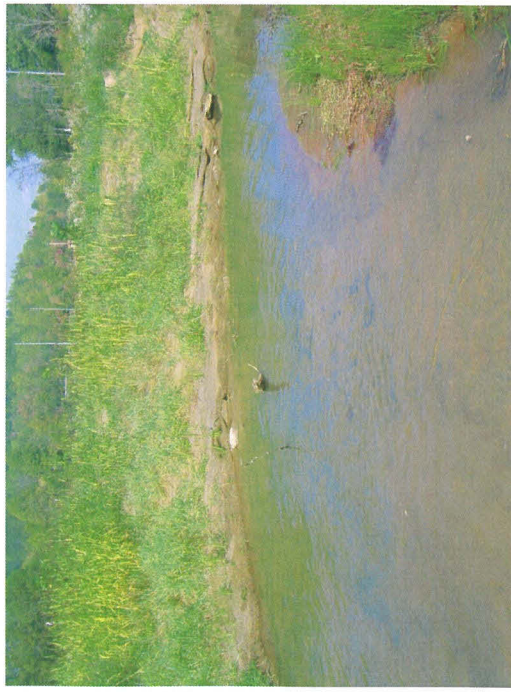
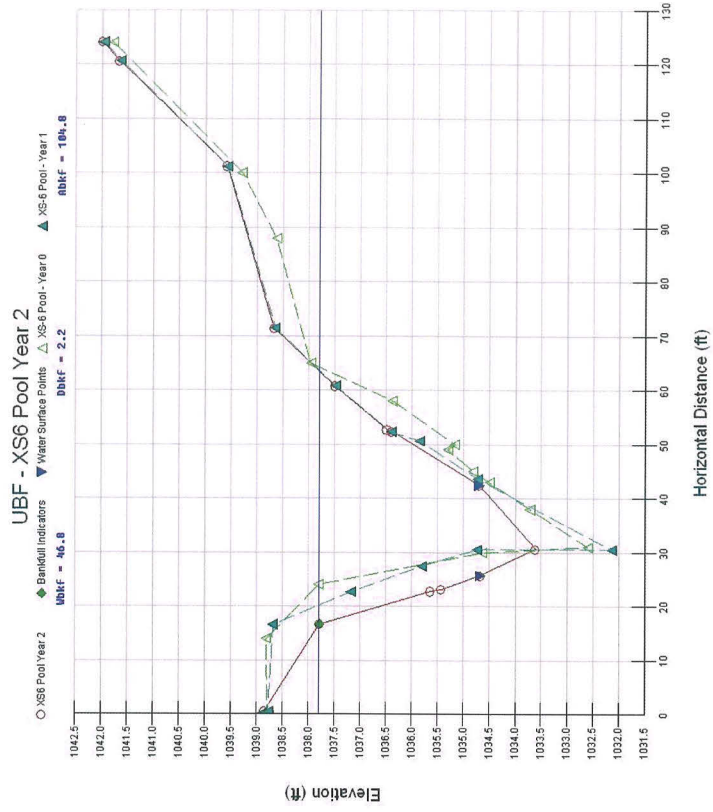
CROSS SECTION: 6
FEATURE: Pool

Bankfull Area 46.71 ft²
 Bankfull Width 19.61 ft
 Mean Depth 2.38 ft
 Maximum Depth 3.64 ft
 Width/Depth Ratio 8.24
 Entrenchment Ratio 4.07
 Classification E

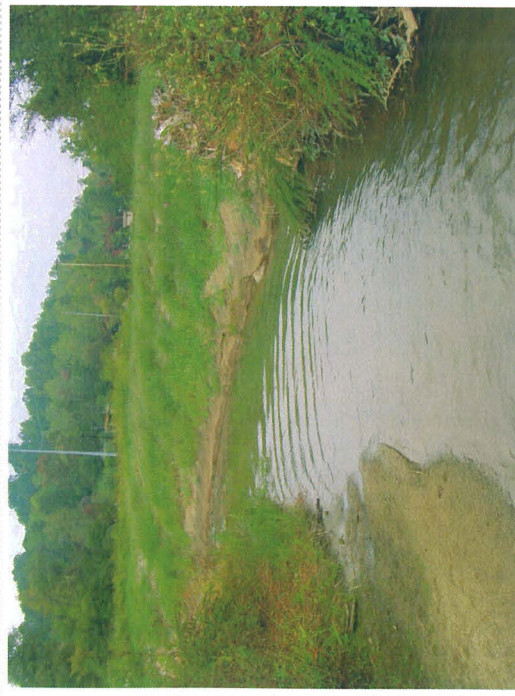
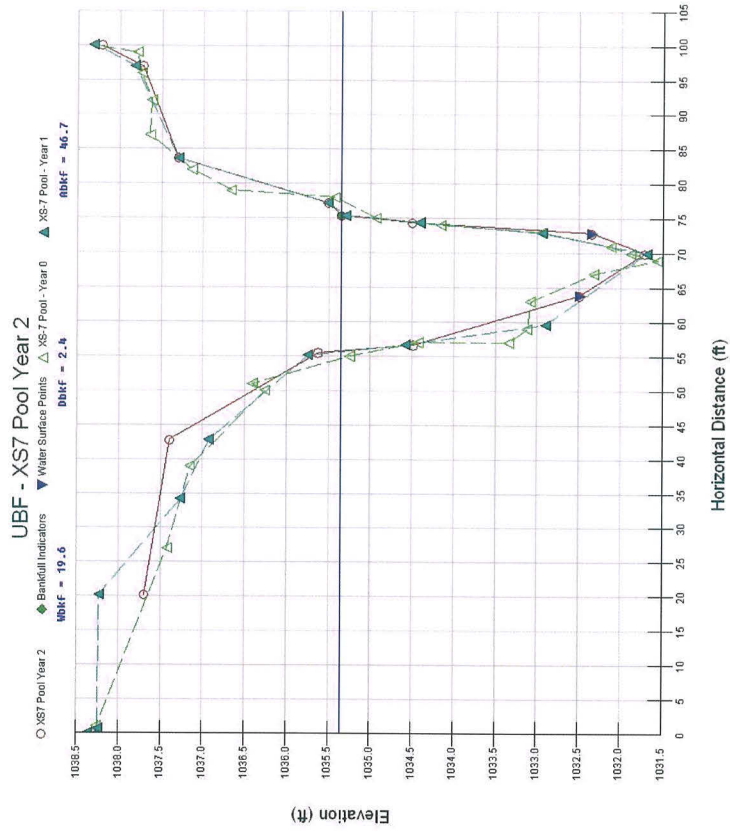
CROSS SECTION: 7

Bankfull Area 89.37 ft²
 Bankfull Width 36.63 ft
 Mean Depth 2.44 ft
 Maximum Depth 4.63 ft
 Width/Depth Ratio 15.01
 Entrenchment Ratio 2.99
 Classification E
