Year 3 Monitoring Report for Stream Restoration of Bailey Fork

Burke County, NC
SCO # D04006-02

Submitted: November 2008

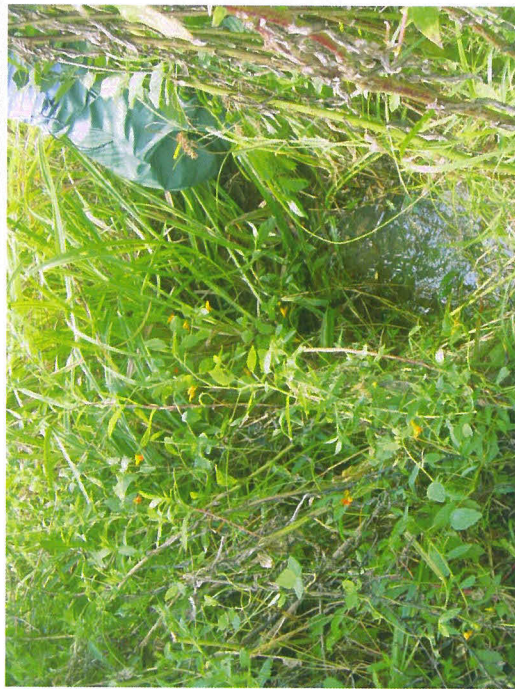
CROSS SECTION: 2

Cross-section photo – looking upstream
 Channel is obscured by vegetation.

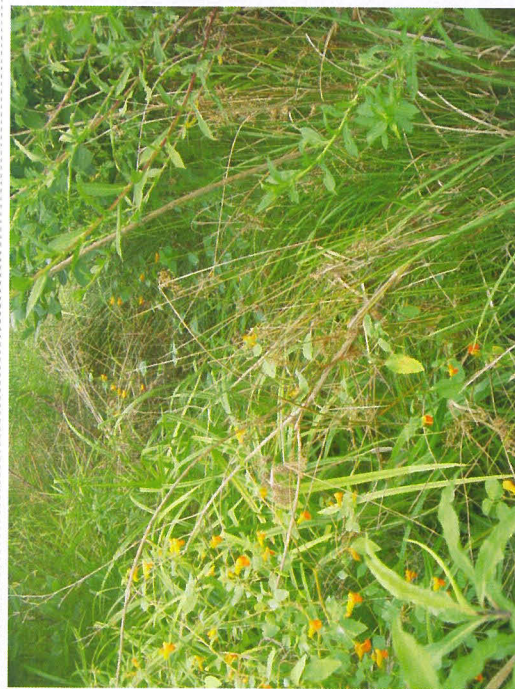
CROSS SECTION: 4
FEATURE: Pool

Cross-section photo – looking downstream
 Channel is obscured by vegetation.
