Year 4 Monitoring Report for Stream Restoration of Bailey Fork

Burke County, NC
SCO # D04006-02

Submitted: December 2009

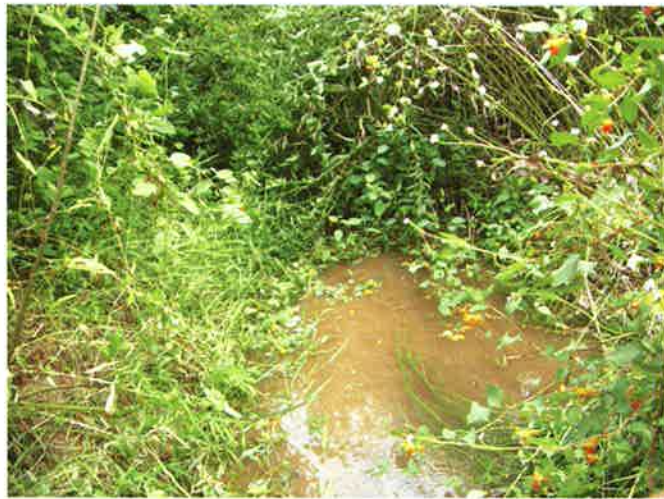
CROSS SECTION: 9
FEATURE: Pool

**Cross-section photo – looking downstream
 Channel is obscured by vegetation.**
