# **MONITORING YEAR 1 ANNUAL REPORT**

## **BANNER FARM MITIGATION SITE**

Henderson County, NC  
French Broad River Basin  
HUC 06010105

DMS Project No. 100062  
DEQ Contract No. 7530  
DMS RFP No. 16-007334  
Date of Issue: September 8, 2017  
USACE Action ID No. SAW-2018-01153  
DWR Project No. 20181032

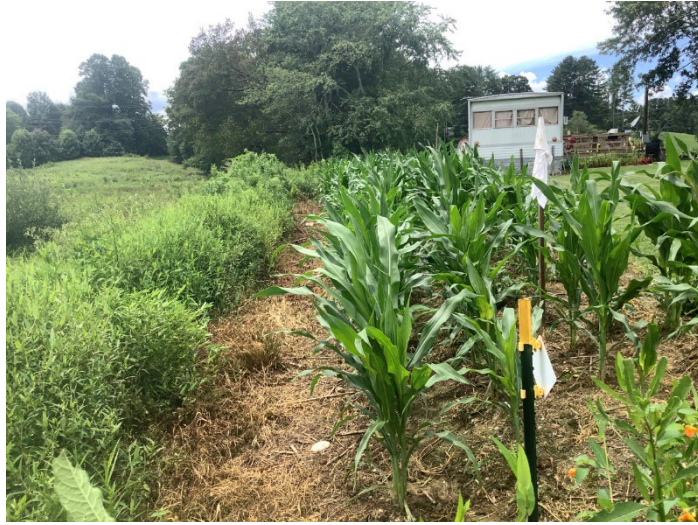
**Easement Encroachment - Unresolved:** Banner Creek Reach 2 STA 15+00, Left floodplain boundary, Garden row crop overreach (07/14/2022)

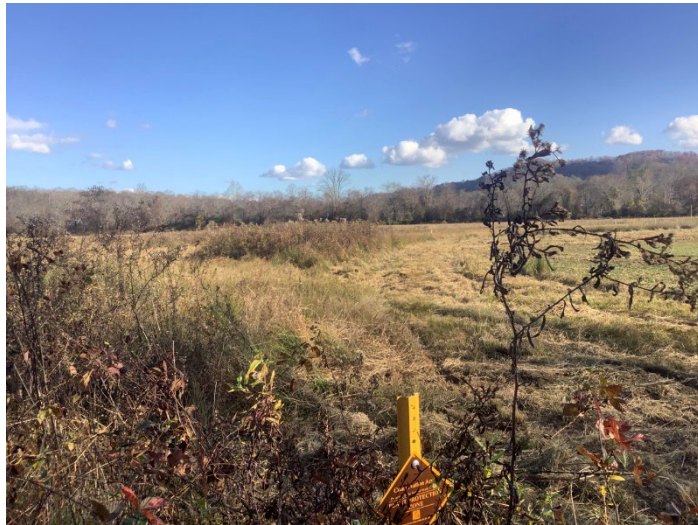
**Easement Encroachment - Unresolved:** UT2 STA 201+00, Right floodplain boundary, Slight mowing scalloping (11/03/2022)

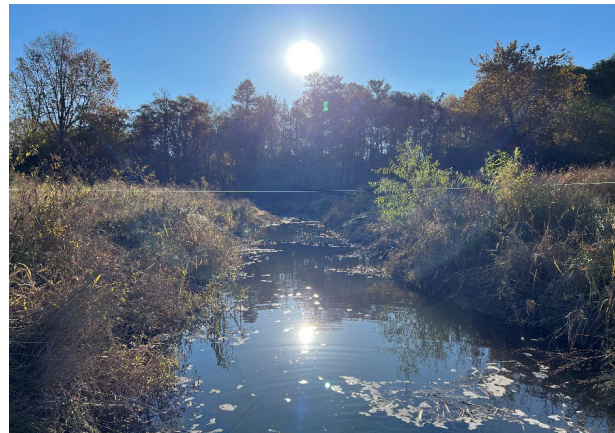
<sup>3</sup>Cross-section 12 is located in the MY1 repair area and was not rebuilt to the original design or as-built condition.

Note: XS12 is in the MY1 repair area and not rebuilt to the original design or as-built condition

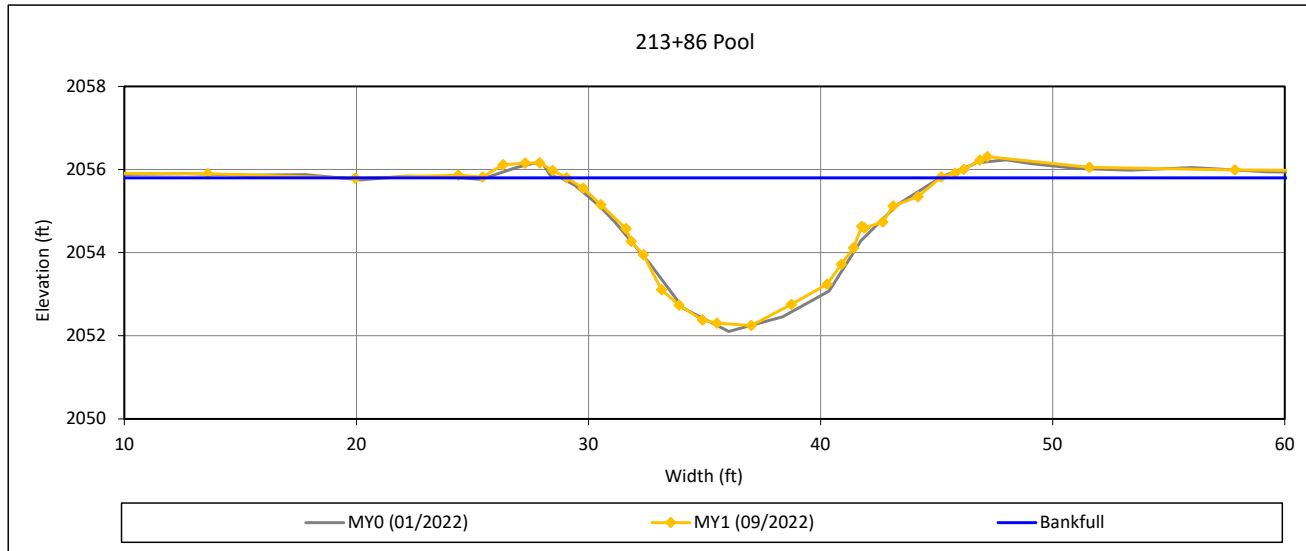
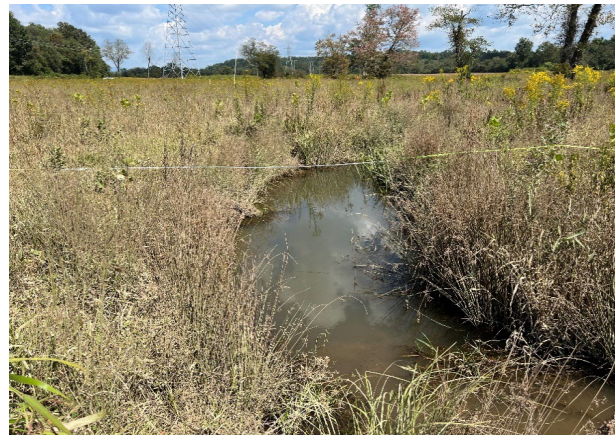
#### Cross-Section 20-UT2

32.4	x-section area (ft.sq.)
16.1	width (ft)
2.0	mean depth (ft)
3.6	max depth (ft)
18.2	wetted perimeter (ft)
1.8	hydraulic radius (ft)
8.0	width-depth ratio
