MONITORING YEAR 2 ANNUAL REPORT

BANNER FARM MITIGATION SITE

Henderson County, NC
French Broad River Basin
HUC 06010105

DMS Project No. 100062
DEQ Contract No. 7530
DMS RFP No. 16-007334
Date of Issue: September 8, 2017
USACE Action ID No. SAW-2018-01153
DWR Project No. 20181032

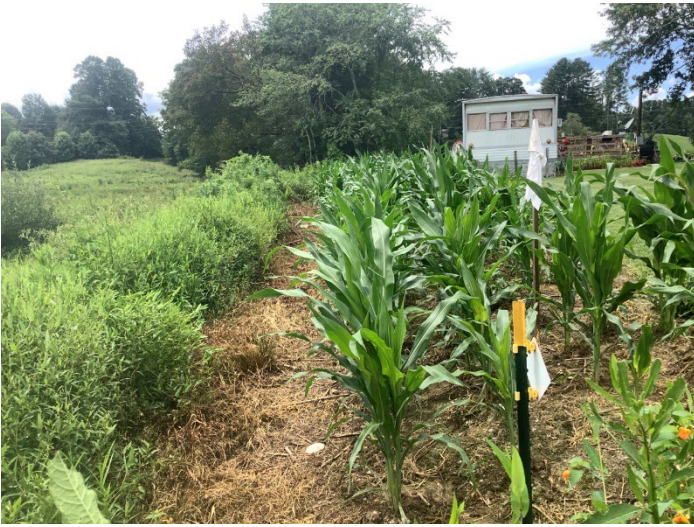
Easement Encroachment – MY1, Banner Creek Reach 2 STA 15+00, Left floodplain boundary, Garden row crop overreach (07/14/2022)

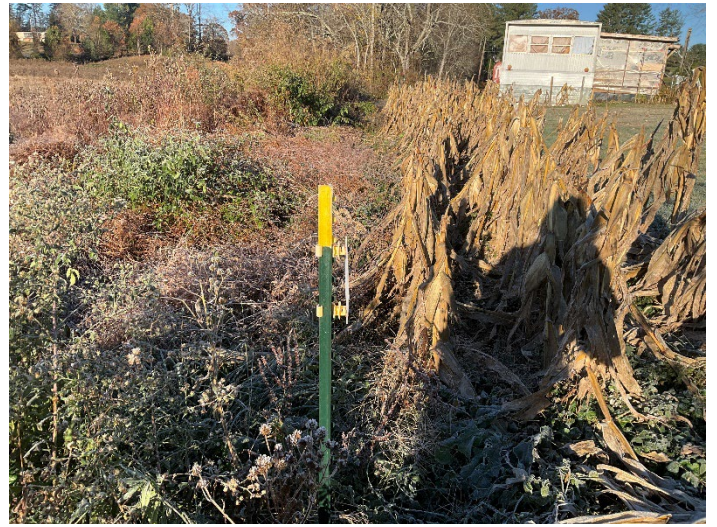
Resolved Easement Encroachment List – MY2				
Encroachment Location	MY2 Status	Description	MY2 Adaptive Management	Area (Acres)
Banner Creek Reach 2 STA 15+00 – Left Floodplain	Resolved	Slight crop overreach from small garden behind trailer observed in MY1.	Installed additional posts in May 2023.	0.0012
UT2 STA 201+00 – Right Floodplain	Resolved	Slight mowing scalloping observed in MY1.	Installed additional posts/ horse tape in January 2023.	0.0058

Resolved Encroachment – MY2, Banner Creek Reach 2 STA 15+00, Left floodplain boundary, Added posts & garden outside CE (11/02/2023)

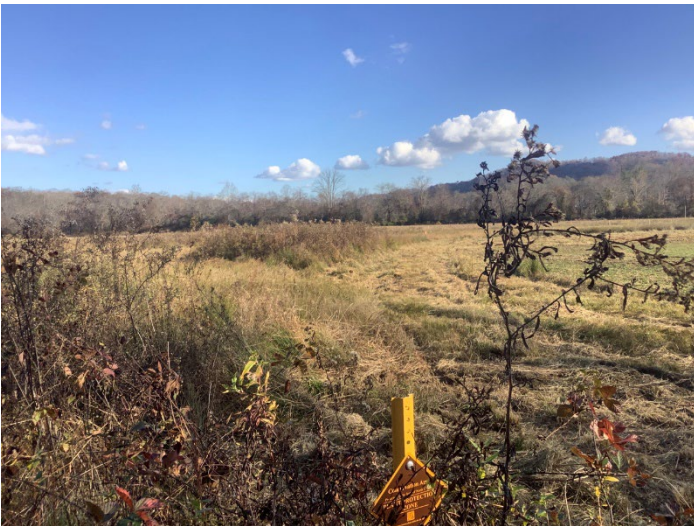
Easement Encroachment – MY1, UT2 STA 201+00, Right floodplain boundary, Slight mowing scalloping (11/03/2022)

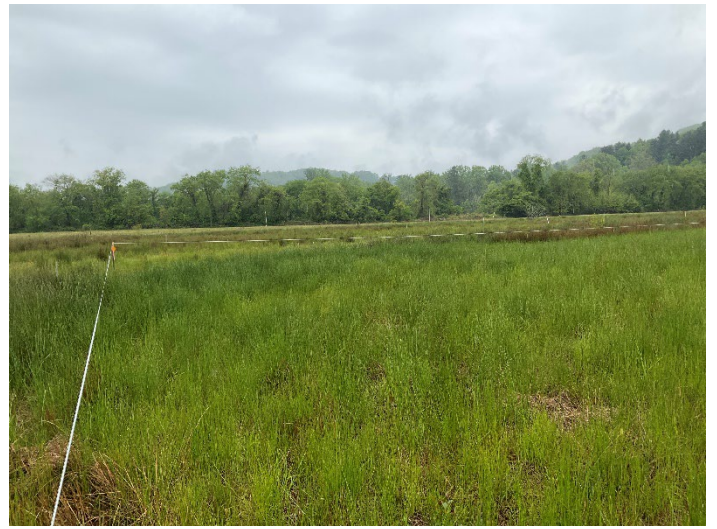
Resolved Encroachment – MY2, UT2 STA 201+00, Right floodplain boundary, Horse tape added along boundary (04/26/2023)

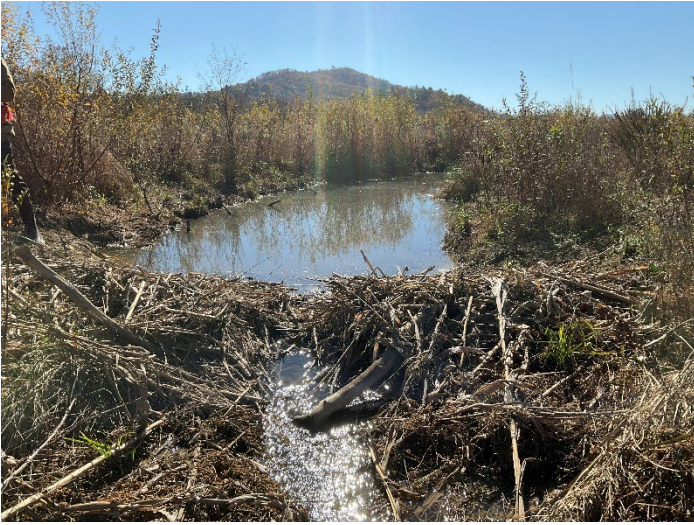
Minor beaver dam – MY2, Banner Creek Reach 4a STA 26+75, view upstream (11/02/2023)

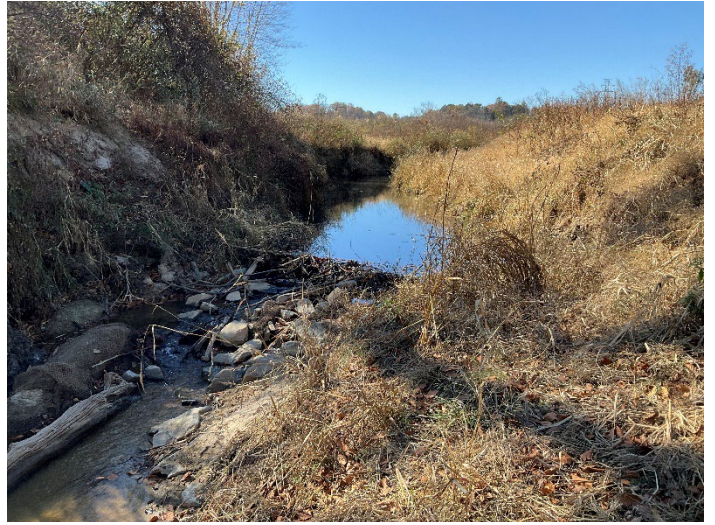
Minor beaver dam – MY2, Banner Creek Reach 4b STA 37+75 near FBR confluence, view upstream (11/02/2023)

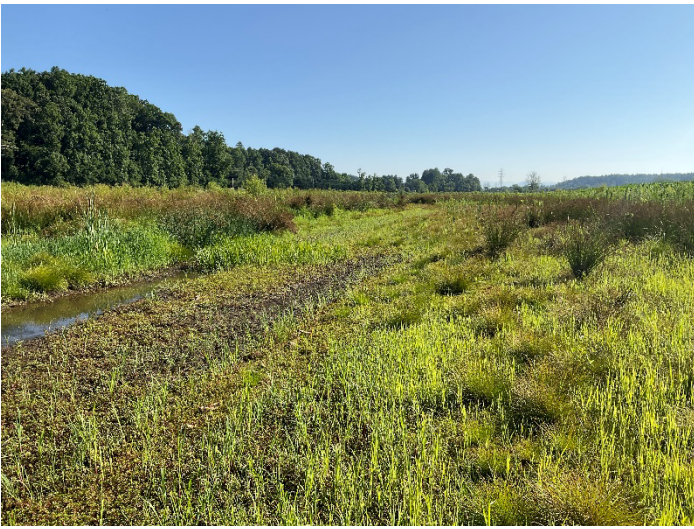
Floodplain Pool – MY2, Southernmost portion of the site, photo taken across from VP23, view away from Banner Farm Road (07/13/2023)

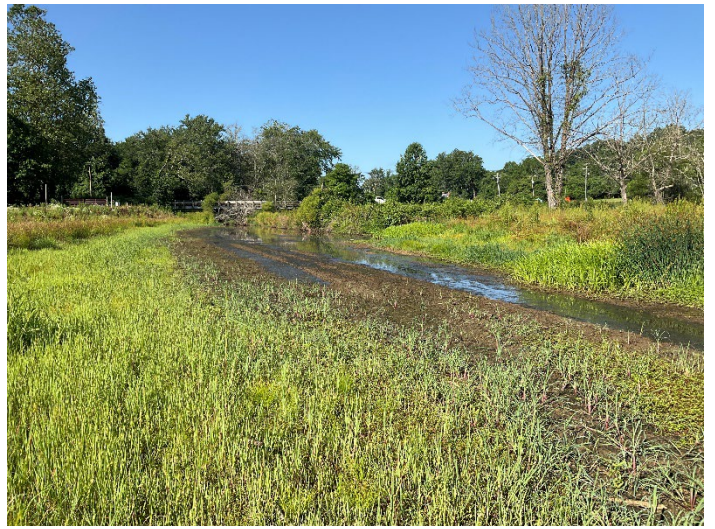
Floodplain Pool – MY2, Southernmost portion of the site, photo taken across from VP23, view towards Banner Farm Road (07/13/2023)
