ANNUAL REPORT FOR 2003

**Little Ivy Creek Stream Mitigation Site (Barnhill Site)
Madison County
WBS Element 32573.4.1
TIP No. A-10WM**

Prepared By:
Office of Natural Environment & Roadside Environmental Unit
North Carolina Department of Transportation
December 2003

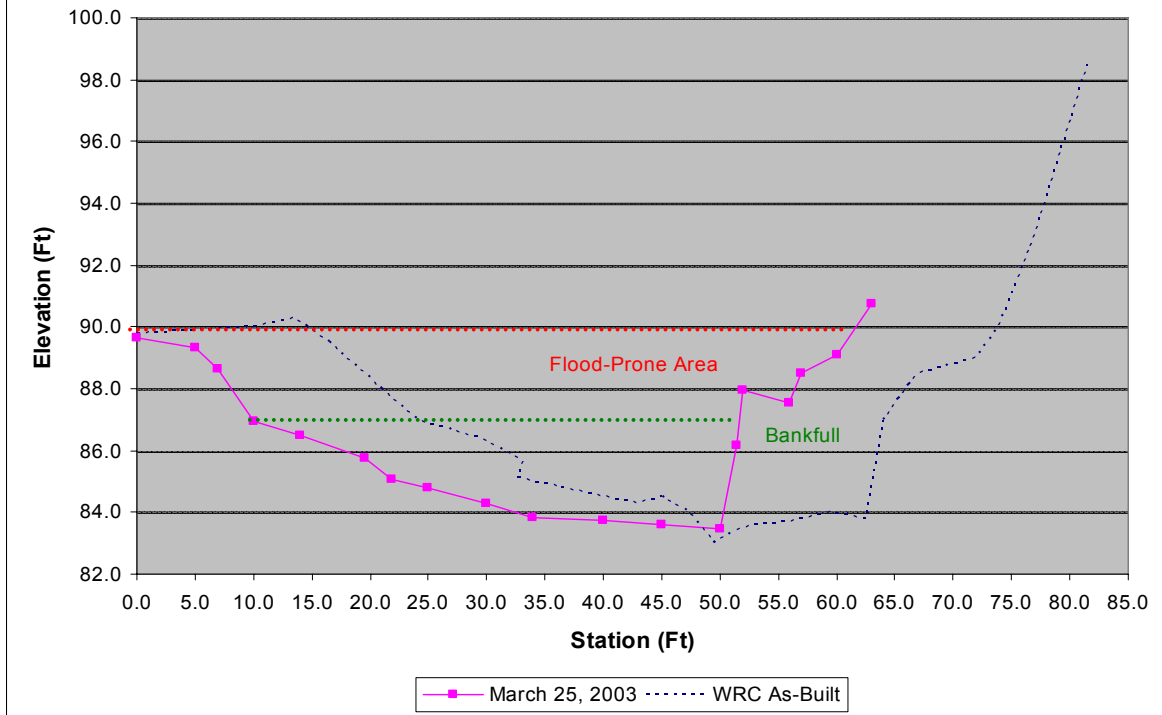
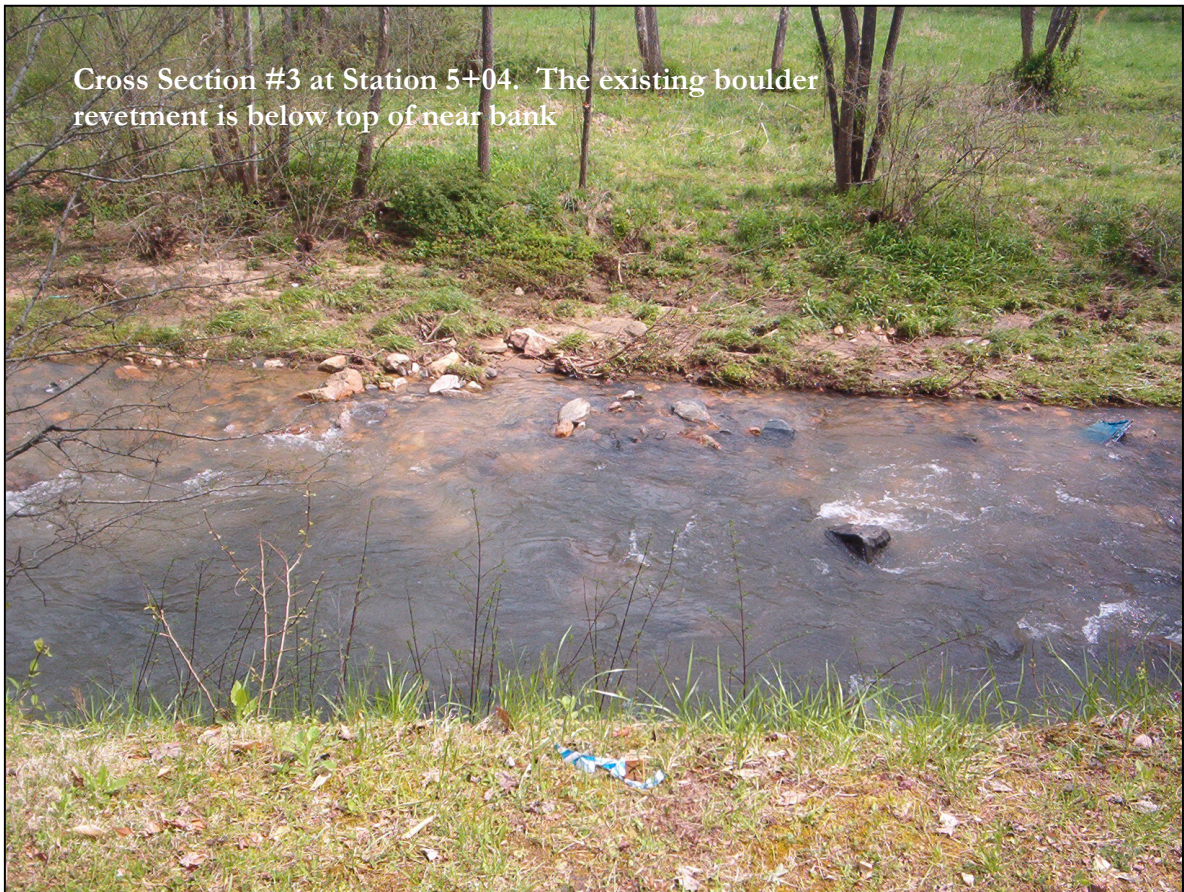
Cross Section-3, Station 5+04 (Little Ivy Creek)

All three of the cross sections have remained intact based on comparisons with the as-built data and visual observations. Several benchmarks associated with the as-built surveys were not found; therefore exact data comparisons were not feasible. The Year 2003 data will be used for future comparisons. Based on the comparison of cross section survey results with the as-built sections, all three of the cross sections remain stable. These cross sections will be monitored during the next several years to determine the actual extent of aggradation or degradation. All of the cross sections appeared stable with little or no active bank erosion. Survey data will also vary depending on actual location of rod placement and alignment; however, this information should remain similar in overall appearance. The cross section comparison is presented in Appendix B.

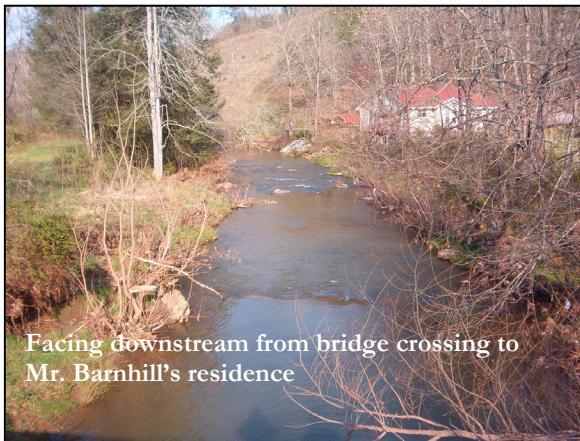
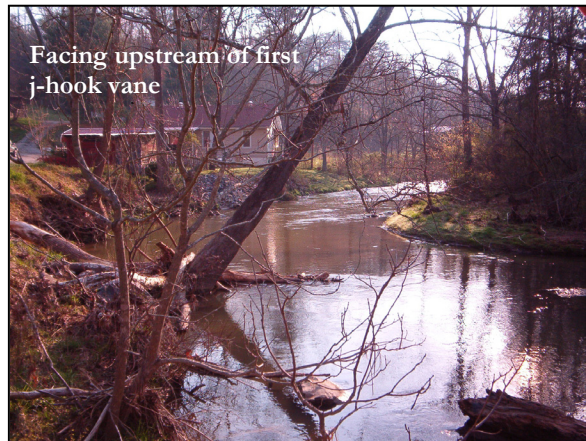
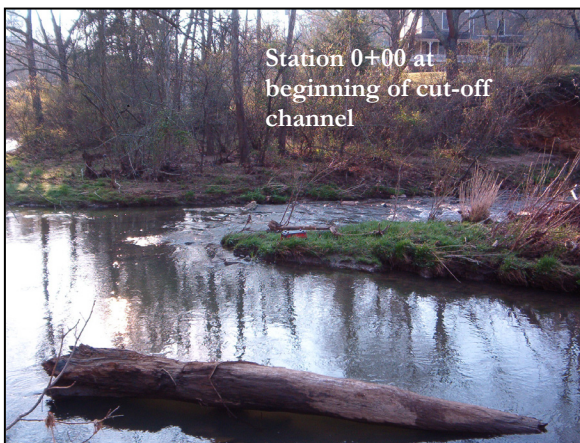
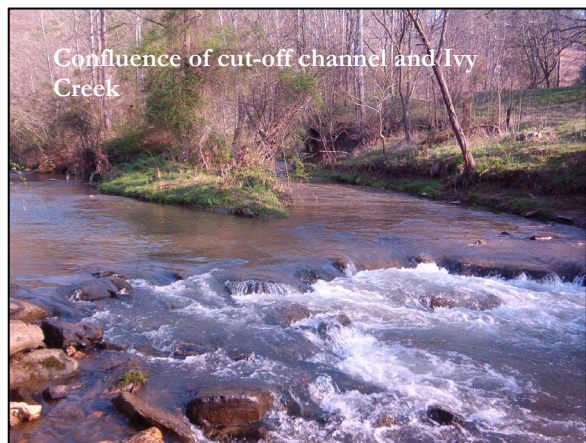
Little Ivy Creek

Longitudinal profile surveys were conducted along a 700 linear foot segment of this reach. Bank stability was assessed during the longitudinal profile survey. One area of active scouring was observed. Descriptions relating to this area as well as several other notables are listed below:

- ◆ A large amount of debris was noted along the project during the survey. This debris had been deposited during the abnormally wet spring months of 2003.
- ◆ Stations 0+00 to 1+50. The high bank associated with the cut-off channel continues to erode. Boulders were installed along the toe of this bank for added protection; however active erosion is still occurring above the elevation of these rocks. This area should be assessed during the next monitoring period to determine remedial actions, if necessary.
