YEAR 3 MONITORING and CLOSEOUT REPORT
for the
BARNHILL MITIGATION SITE
LITTLE IVY CREEK,
MADISON COUNTY, NORTH CAROLINA
EEP PROJECT NUMBER 92651

December 2008

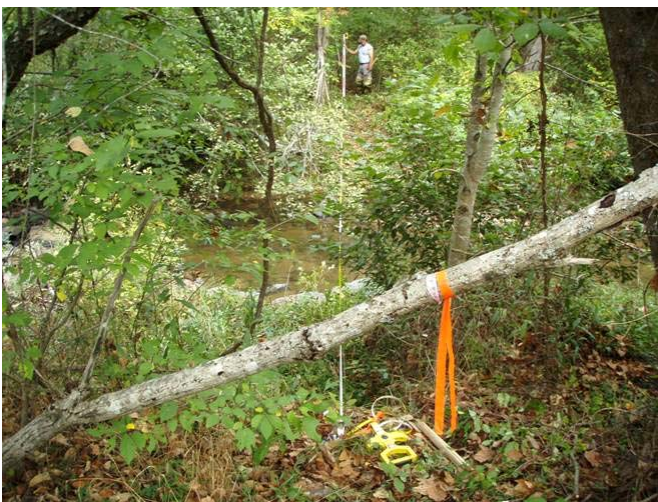
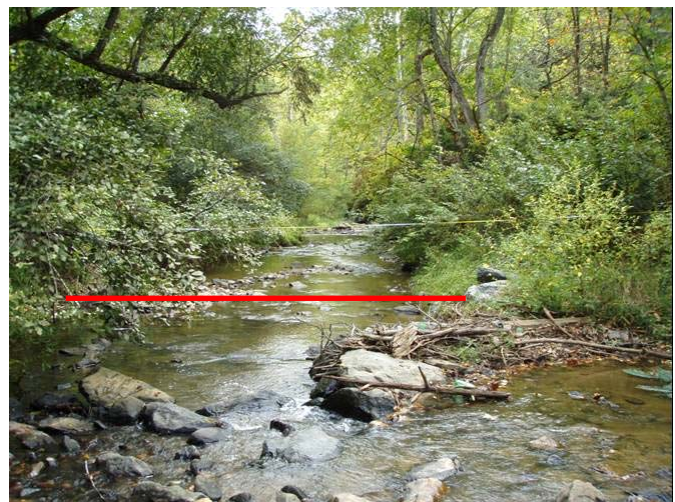
Cross-section 1, Glide (Appendix Table A.1.1.).—There has been little change in this cross-section since construction in 2000. This cross-section has remained stable with no lateral movement (bank erosion) observed along either streambank. The right bank has aggraded slightly between the constructed rock arm of the J-hook structure and the toe of the right bank terrace.

Cross-section 1, right to left bank, October 2007.

Cross-section 1, facing downstream, October 2007.

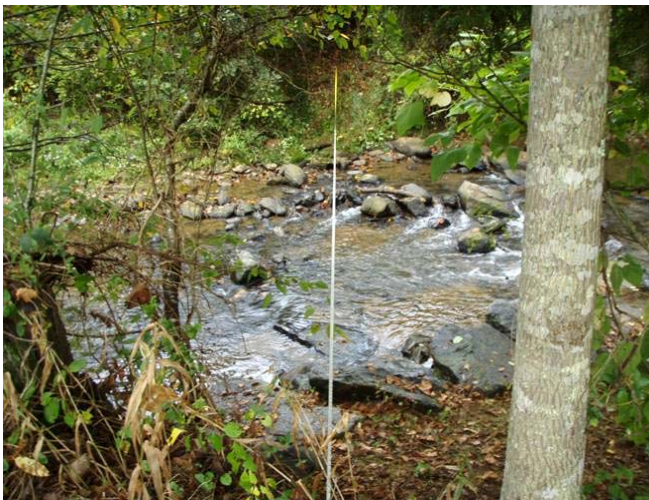
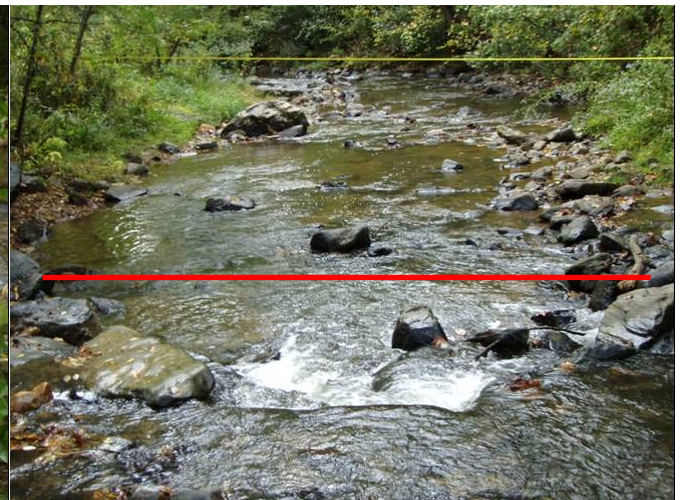
Cross-section 2, left bank to right bank, October 2007.

Cross-section 2, facing downstream, October 2007.

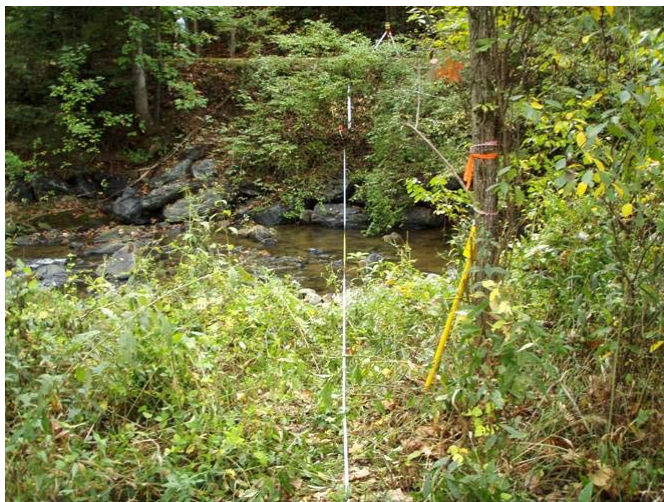
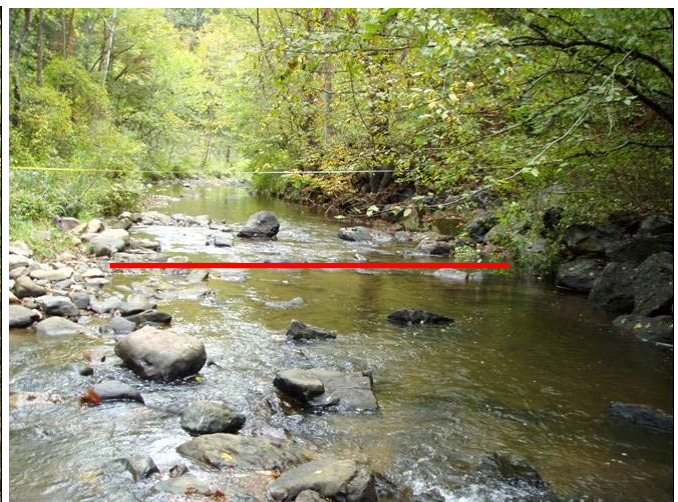
Cross-section 3, left bank to right bank, October 2007.

Cross-section 3, facing downstream, October 2007.

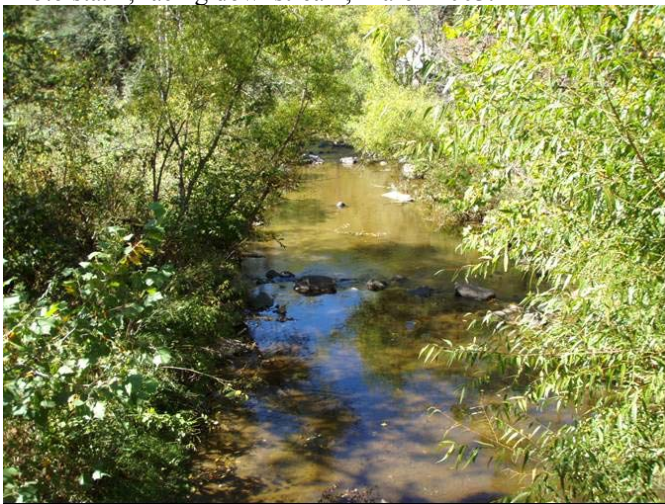
Photo sta. 1, facing downstream, March 2007.

Seven fixed station photo locations document project site conditions from 1999 (before construction) through 2007 (Appendix A.6.). The planted vegetation along the right bank has become well established over the seven years since installation. Planted woody vegetation is \geq 10 ft in height and has enhanced channel bank stability. With the riparian buffer on each channel bank well established, channel banks are stable and tree foliage is blocking direct sunlight to the channel, which should help reduce daytime water temperature increases.

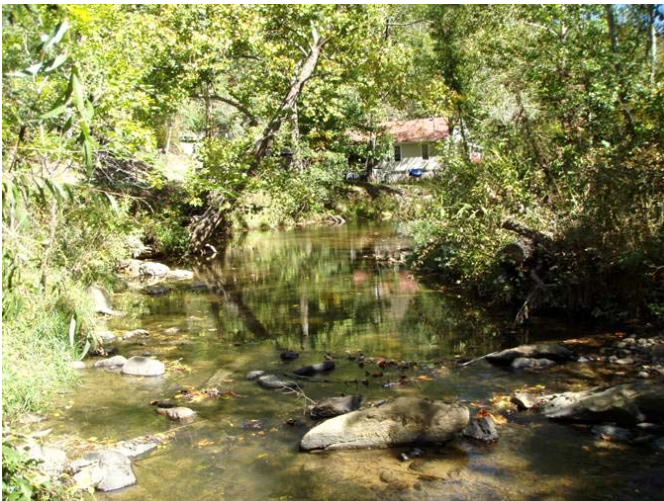
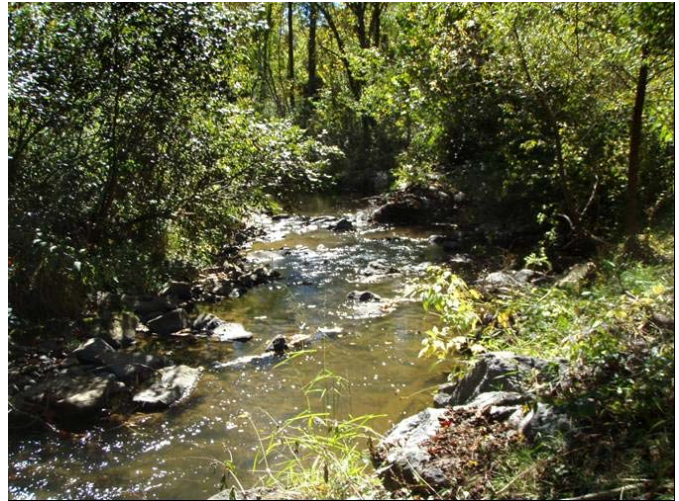
Photo sta. 2, facing upstream, October 2007.

Photo sta. 2, facing downstream, October 2007.

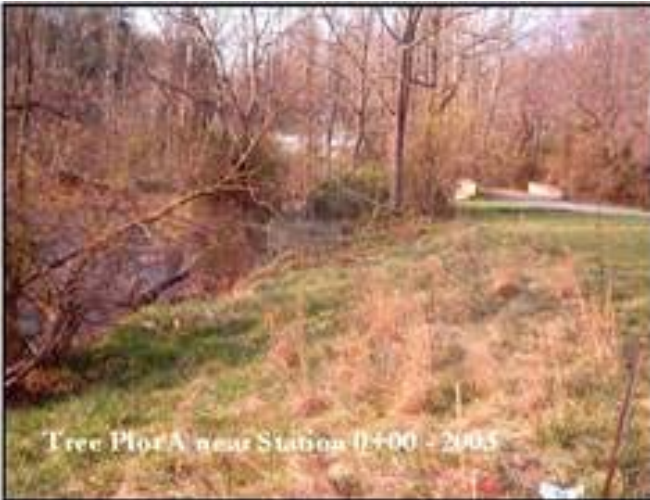
Tree plot A, right bank, facing downstream, March 2003.

Tree Plot A.—The number of woody stems present in tree plot A decreased from 7 to 4 between MY2 and MY3 (Exhibit Table 5). Some of this decrease can be attributed to NCDOT roadside mowing during the fall of 2007. Tree plot A is adjacent to SR 1540; therefore, the plot is susceptible to right-of-way maintenance mowing. The mowed stems included two green ash *Fraxinus pennsylvanica* trees and a red maple *Acer rubra*. Moreover, of the three river birch *Betula nigra* stems noted in the MY1 survey, only one stem was found in MY2, whereas none was found in MY3. It is uncertain if the river birch stems succumbed to natural mortality or if mowing was the cause for their loss. Eastern gamagrass *Tripsacum dactyloides*, goldenrod *Solidago* sp., and blackberry *Rubus* sp. also were observed in tree plot A.

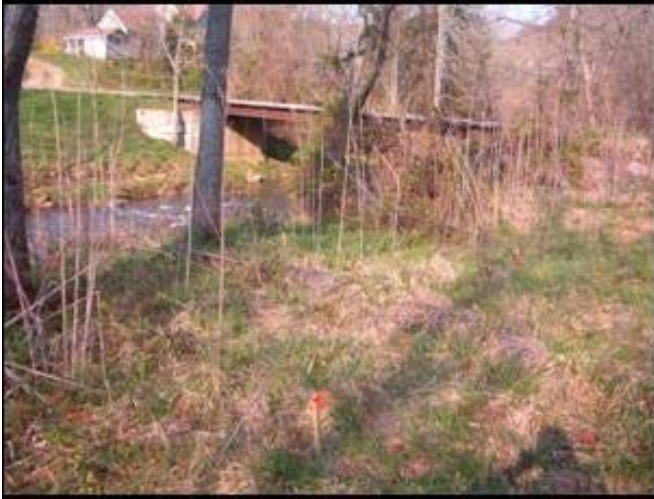
Tree plot B, right bank, facing downstream, March 2003.

Tree Plot B.—The number of woody stems present in tree plot B increased from 5 to 12 between MY2 and MY3 (Exhibit Table 5). This is likely due to recruitment of new stems. In addition to the recruitment noted in the MY2 report (black walnut *Juglans nigra* and black cherry *Prunus serotina*), woody stems of staghorn sumac *Rhus typhina* (2) and persimmon *Diospyros virginiana* (1) were noted during the MY3 vegetation survey. The addition of recruited stems has helped to offset the loss of green ash stems. Seven green ash stems were noted in MY1; only three stems were noted in MY3. Herbaceous species included goldenrod, muscadine *Vitis rotundifolia*, and greenbrier *Smilax* sp.

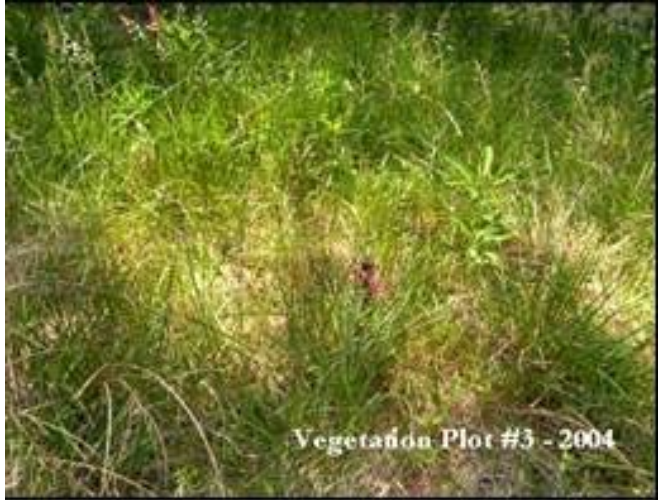
Vegetation plot 3, left bank, May 2004.

No 2008 photo available for vegetation plot 3 as it could not be relocated.

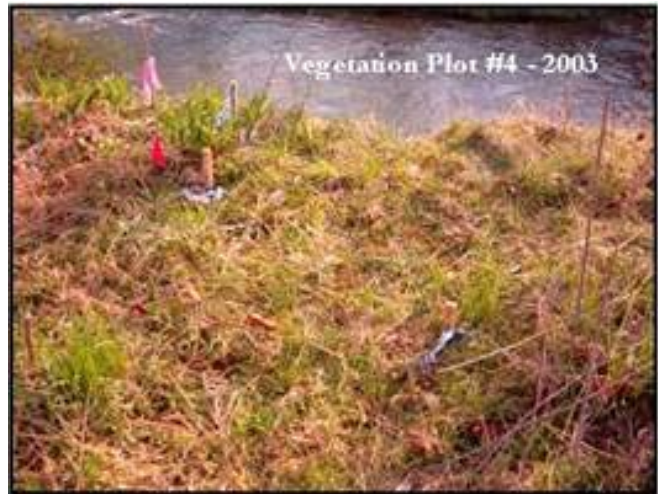
Vegetation plot 4, left bank, March 2003.

Vegetation Plot 4.—No woody stems have been observed in vegetation plot 4 during any of the three vegetation monitoring surveys. Tall fescue was the dominant species in the herbaceous layer, which also included wild onion *Allium canadense*, henbit deadnettle *Lamium amplexicaule*, and black berry.

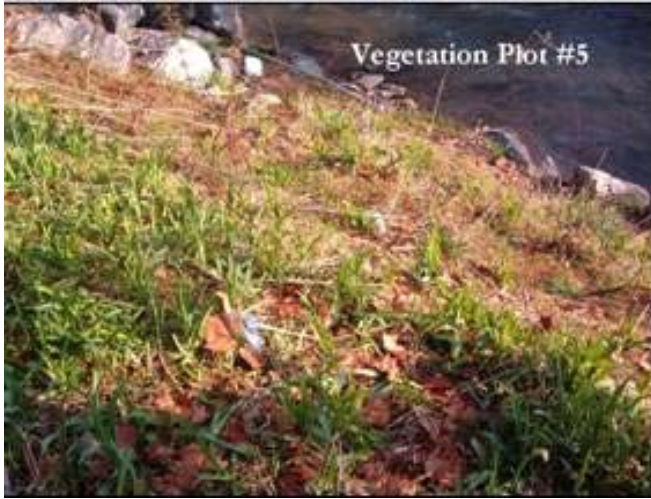
Vegetation plot 5, left bank, March 2003.

Vegetation Plot 5.—One silky dogwood *Cornus amomum* stem has been observed in vegetation plot 5 during each of the three vegetation monitoring surveys. Tall fescue was the dominant ground cover. Sparse sprigs of Japanese honeysuckle were present.
