BEAMON'S RUN BUFFER AND WETLAND RESTORATION SITE
(BARNHILL FARM)
MONITORING REPORT (2009)

Greene County, North Carolina
EEP Project No. 24

Status of Plan: Final
Submission Date: December 2009

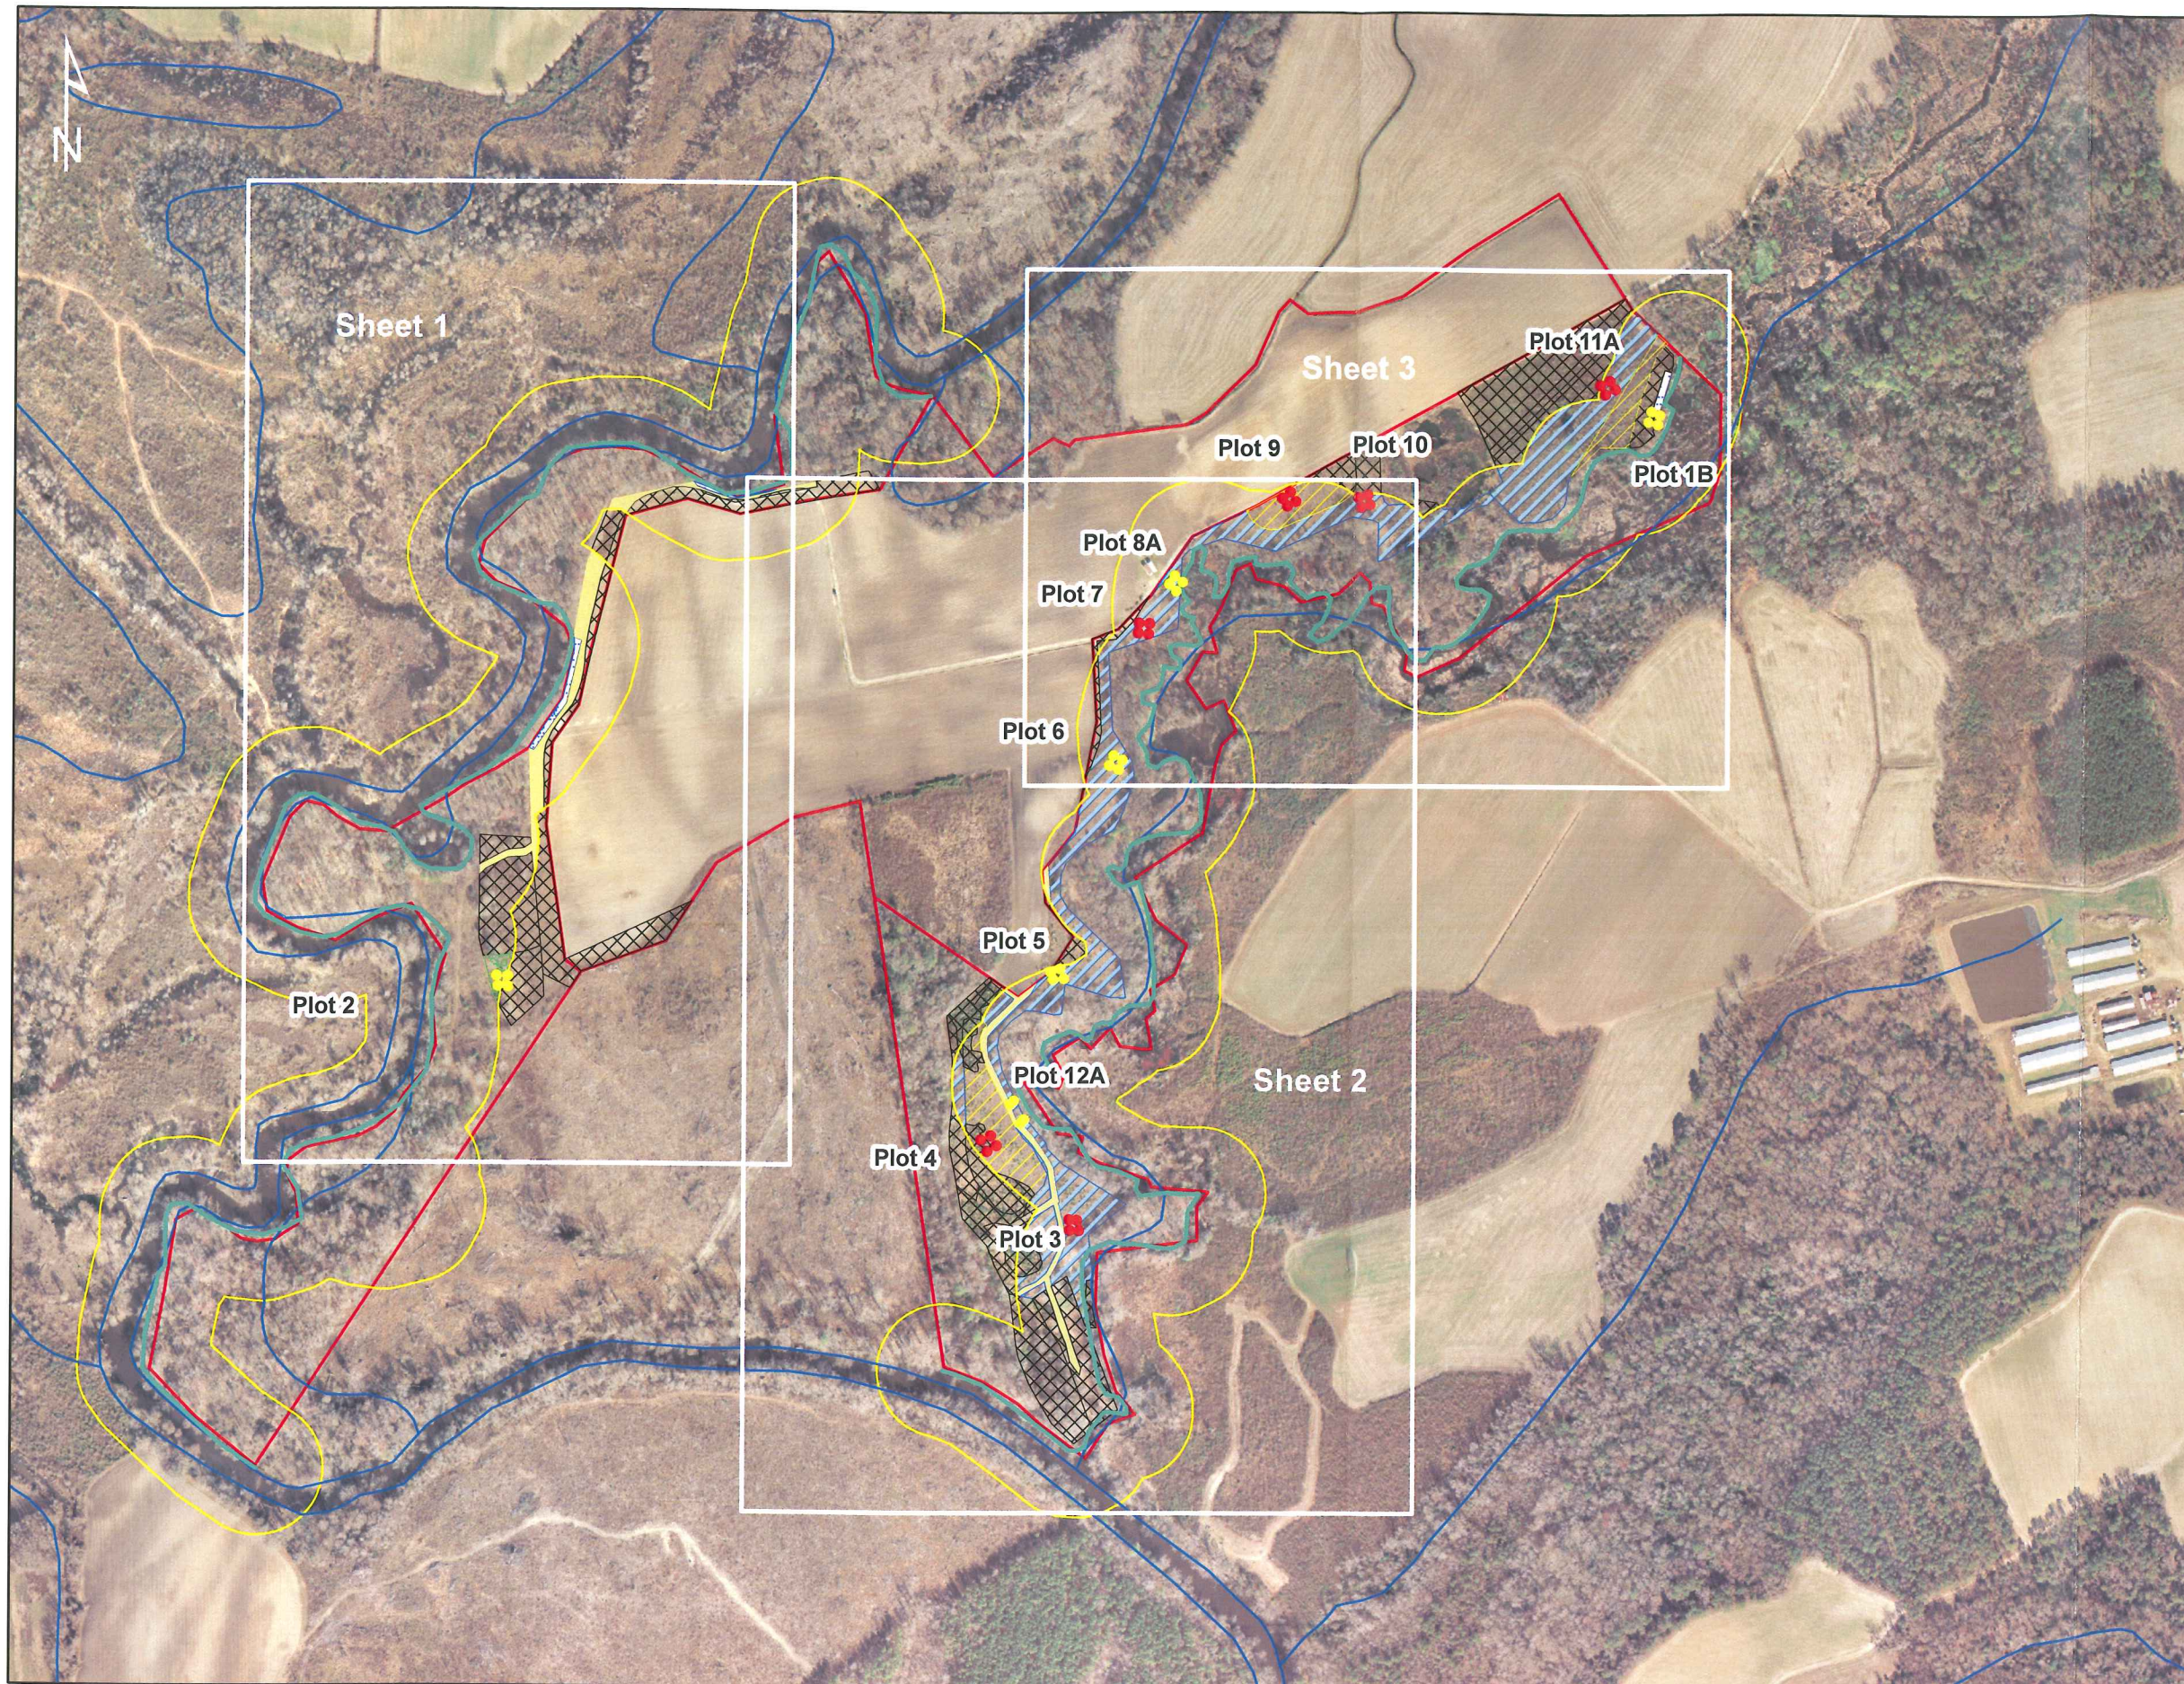
Figure 2 - Overview

Monitoring revealed that 6 of the 12 plots (50%) met the vegetative success criteria of 320 planted stems or greater per acre. The remaining 6 plots failed to meet the success criteria (plots 3, 4, 7, 9, 10 and 11A). There are a number of issues causing the failure of these plots. Vegetation Plots 4 and 9 (VP-4, VP-9) exhibited poor survival of planted longleaf likely resulting from high densities of volunteer loblolly recruitment. This may be an issue related to a lack of forest management for longleaf pines after planting. VP-7 was located in an area that appeared to have poor soil due to residual debris from the site's history of being a tire dump. It could have been attributed to early mortality of oak species after planting. It is difficult to discern the exact reasons for poor planted species survival in the vegetation plots and elsewhere on the site since it has been 9 years since vegetation installation. Seedlings may have been shaded out, eaten by wildlife, affected by recent droughts, or in some cases affected by mowing.

Vegetative problem areas are shown on the Current Condition Plan View in Appendix D.
