FINAL
YEAR 5 (2018) ANNUAL MONITORING REPORT
BEAR CREEK (PHILLIPS SITE) RESTORATION PROJECT

Chatham County, North Carolina
DMS Project No. 26 (Contract No. 5715)
DWR Project No. 0713-94
SCO No. 09-07726-01A

Data Collection – January-September 2018

RE: Bear Creek (Phillips) Monitoring (DMS Project # 26, Contract #5715)
Final MY5 (2018) Annual Monitoring Report

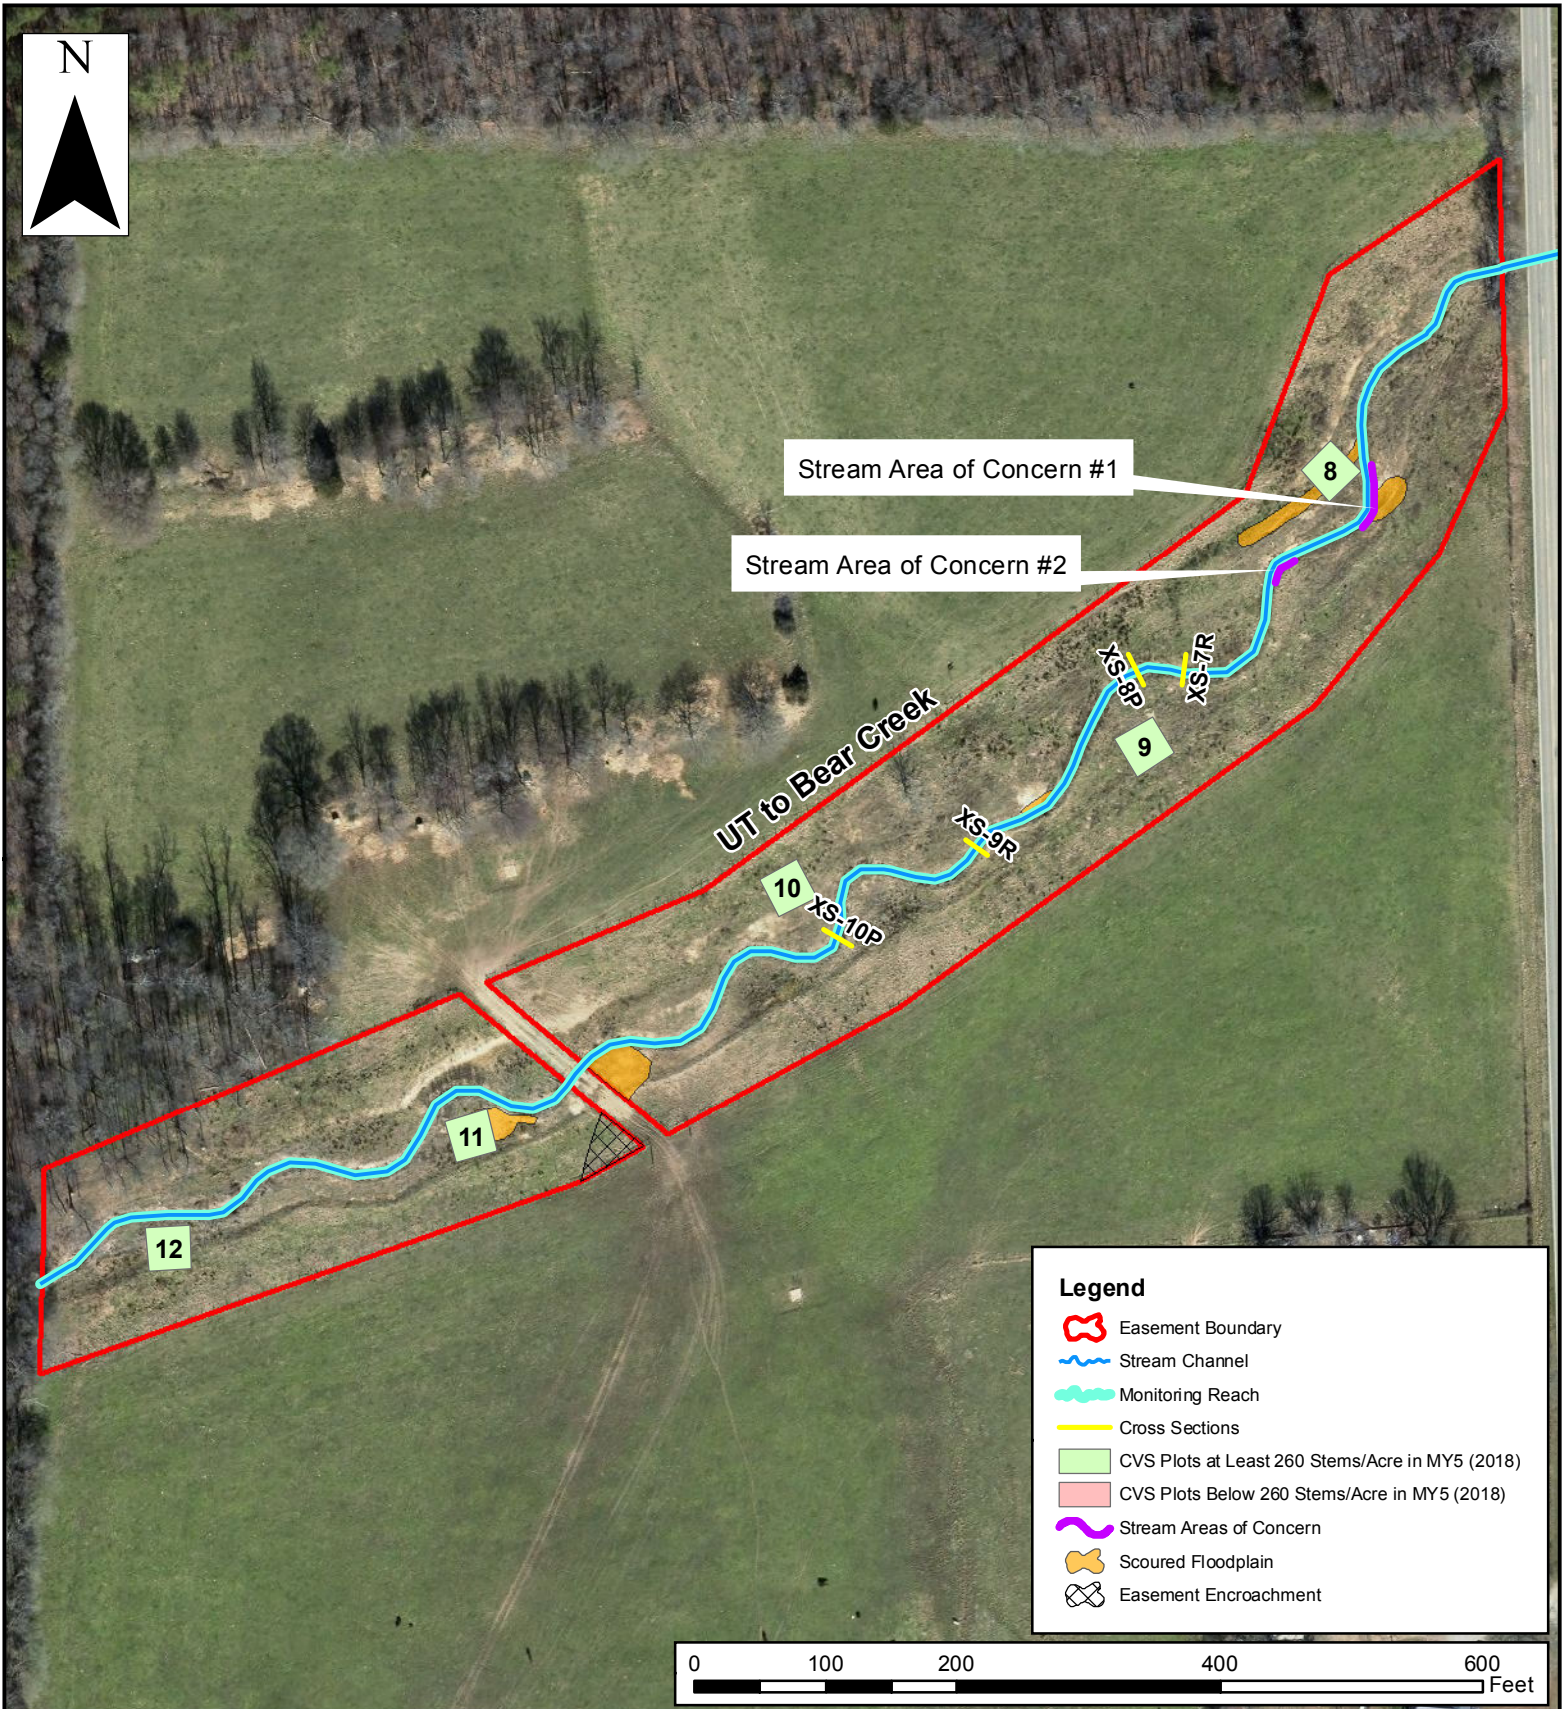
2

Two stream areas of concern were observed during monitoring year 5 (2018). They are depicted on Figure 2A in Appendix B. Area of Concern #1 was observed during the previous four monitoring years, and it has remained relatively unchanged. The right bank of the Unnamed Tributary to Bear Creek has failed causing the water to leave the stream channel and scour a new, smaller channel during storm events. Area of Concern #2 consists of bank scour in the inner bend of a pool caused by instream vegetation that has altered the flow path causing undercutting of the stream bank. Both areas have changed little from previous monitoring years, and both appear relatively stable with herbaceous vegetation becoming well-established.

Shortly after construction was complete, several large rain events caused flooding that scoured the floodplain, leaving it bare. Vegetation has established throughout much of the floodplain, but there are still a few small bare areas. These scoured areas have been depicted on Figures 2A-2B in Appendix B.

One area of easement encroachment was observed during year 5 (2018) monitoring. Due to a scoured hole within the crossing on the upstream portion of the unnamed tributary, making it impassable to livestock, the adjacent landowner had removed a section of fencing within the crossing in order to walk cattle to the next pasture. The cattle were walking through a small corner of the easement. This area is depicted on Figure 2A (Appendix B) and has been addressed by NCDMS. The landowner has made necessary repairs to the fence, and the easement encroachment has ceased.

In April 2018, NCDMS contracted with River Works, Inc. undertake minor repair work consisting of grading banks and installation of matting in nine (9) erosional areas on Bear Creek Reach 2. The repair work also included the installation of soil stabilizing ground cover and supplemental planting of a total of 350 trees (tublings) in all areas impacted by the repair work. A small number of the 350 tublings were planted in other areas of the site where there was low stem density.
