FINAL
YEAR 1 (2014) ANNUAL MONITORING REPORT
BEAR CREEK (PHILLIPS SITE) RESTORATION PROJECT

Chatham County, North Carolina
EEP Project No. 26 (Contract No. 5715)
DWR Project No. 0713-94
SCO No. 09-07726-01A

Data Collection – May-October 2014

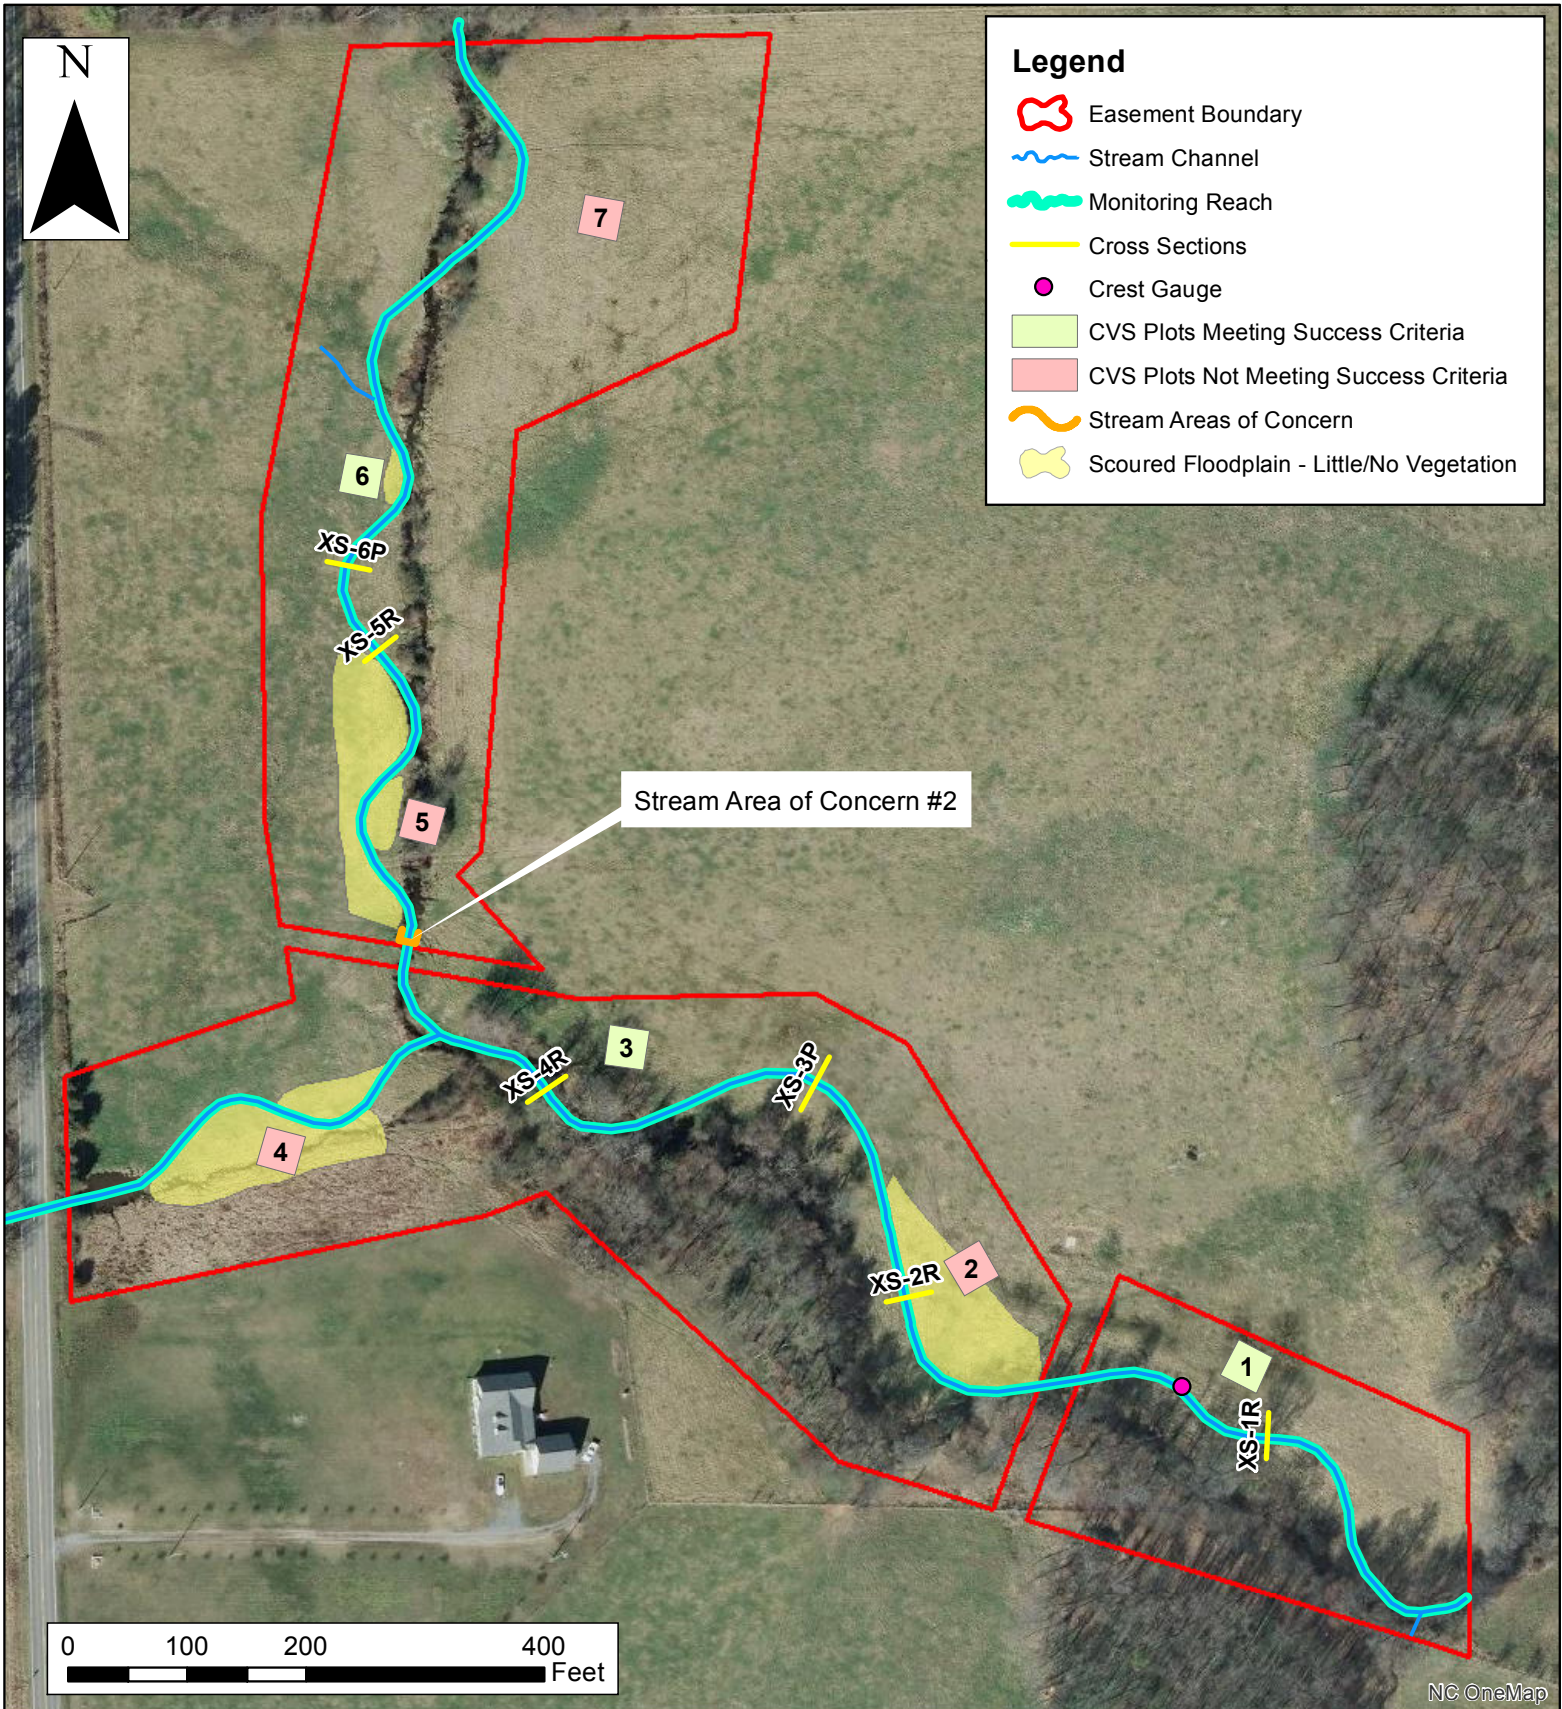
FIGURE
2B

During monitoring year 1 (2014), two stream areas of concern were observed. An outer bend on the Unnamed Tributary to Bear Creek has been severely scoured (Area of Concern #1). The bank appears unstable and is void of all vegetation. One additional area of concern is the upstream culverted crossing on Bear Creek (Area of Concern #2). Rain events since construction have caused a significant amount of debris to block the culverts. Efforts to remove debris manually have been unsuccessful. During storm events the stream is bypassing the culvert and scouring the crossing. These areas of concern are depicted on Figures 2A-2B in Appendix B.

monitored include species composition and species density. Visual observations of the percent cover of shrub and herbaceous species will also be documented by photograph. Vegetation plot information can be found in Appendix C. MY1 (2014) stem count measurements indicate an average of 314 planted stems per acre (excluding livestock) across the Site, which is slightly below success criteria for monitoring year 1 (2014). Additionally, six of the twelve vegetation monitoring plots met success criteria. The lack of vegetation survival can be attributed to poor soils in the graded floodplain throughout the site. Also, just after construction was complete, several large rain events caused flooding that scoured the floodplain, leaving it bare. Vegetation is slowly establishing, but there are still many bare areas. These scoured areas have been depicted on Figures 2A-2B in Appendix B.
