**FINAL**  
**YEAR 3 (2016) ANNUAL MONITORING REPORT**  
**BEAR CREEK (PHILLIPS SITE) RESTORATION PROJECT**

Chatham County, North Carolina  
DMS Project No. 26 (Contract No. 5715)  
DWR Project No. 0713-94  
SCO No. 09-07726-01A

**Data Collection – January-September 2016**

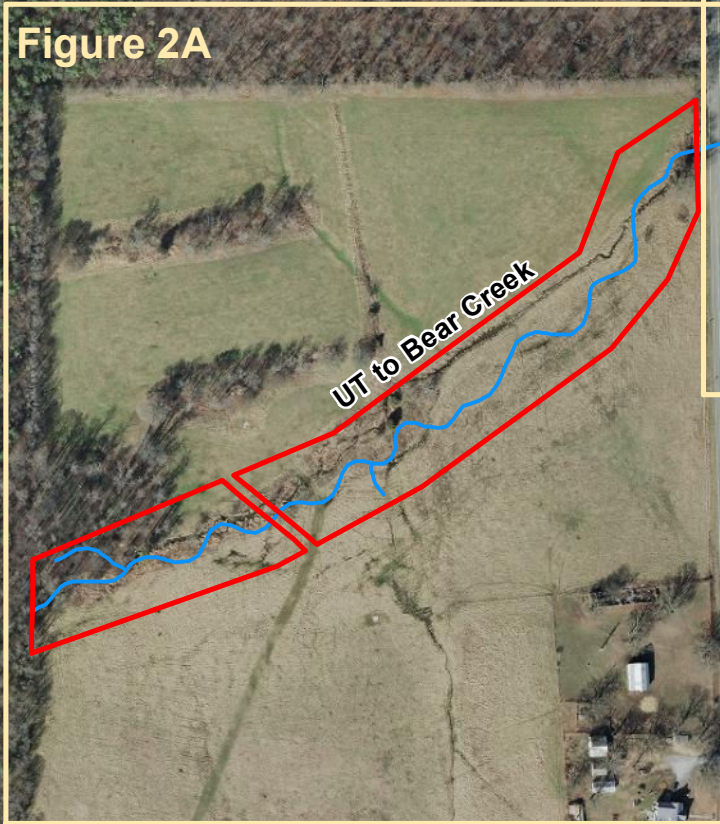
Two stream areas of concern were observed during monitoring year 3 (2016). Area of Concern #1 was observed during the previous two monitoring years, and it remains concerning during monitoring year 3 (2016). The right bank of the Unnamed Tributary to Bear Creek has failed causing the water to leave the stream channel and scour a new, smaller channel during heavy flow events. The bank and new channel appear unstable and are void of vegetation. Area of Concern #2 consists of bank scour in the inner bend of a pool caused by instream vegetation that has changed the flow path causing it to undercut the stream bank. These areas of concern are depicted on Figure 2A in Appendix B and will be closely monitored throughout the remainder of the monitoring period.

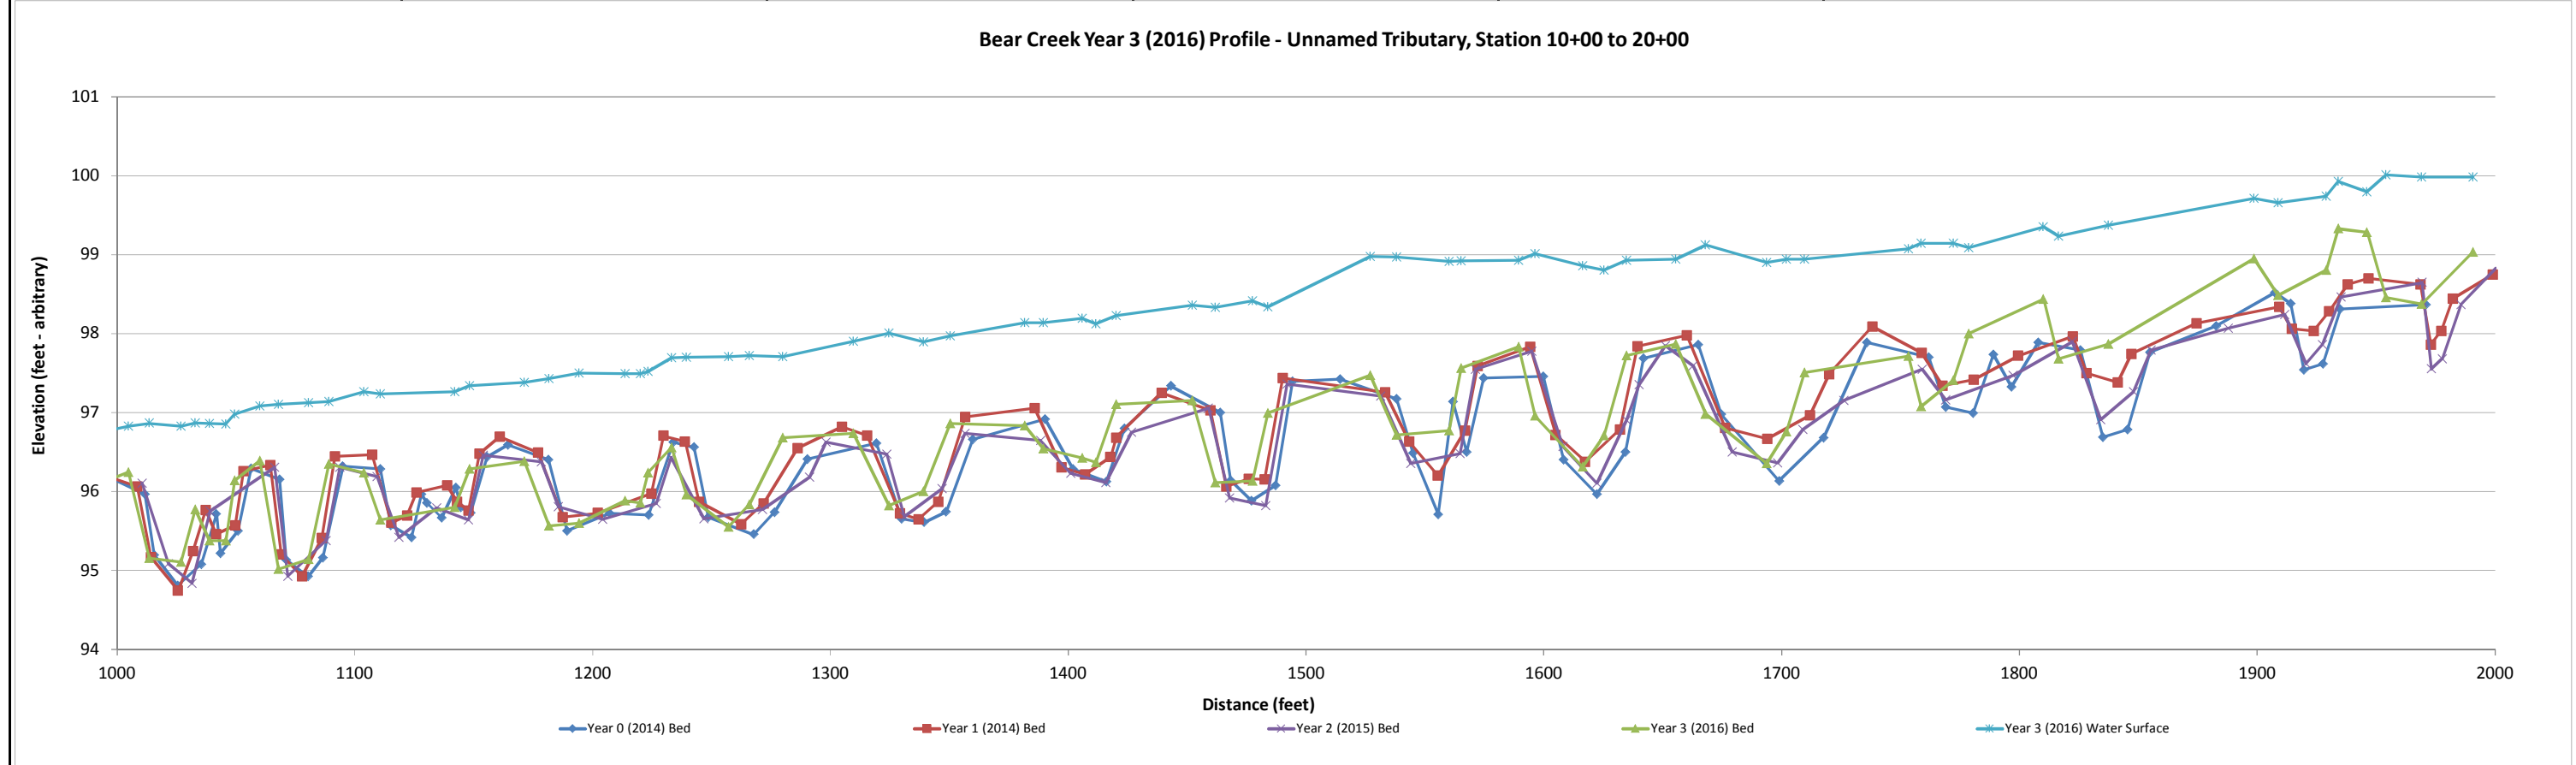
2014	2014	2015	2016	2017
Avg. Water Surface Slope	0.0041	NA	0.0036	0.0044	
Riffle Length	35	32	33	28	
Avg. Riffle Slope	0.0081	NA	0.0075	0.0086	
Pool Length	23	21	22	25	
Pool to Pool Spacing	69	68	77	70
