**UNNAMED TRIBUTARY TO BEAR SWAMP CREEK  
STREAM RESTORATION SITE  
2005 Annual Monitoring Report (Year 3)**

**Franklin County  
EEP Project No. 27  
Design Firm: Arcadis G&M of North Carolina, Inc.**

**February, 2006**

**Prepared by: ECOSCIENCE CORPORATION  
1101 Haynes Street, Suite 101  
Raleigh, NC 27604**

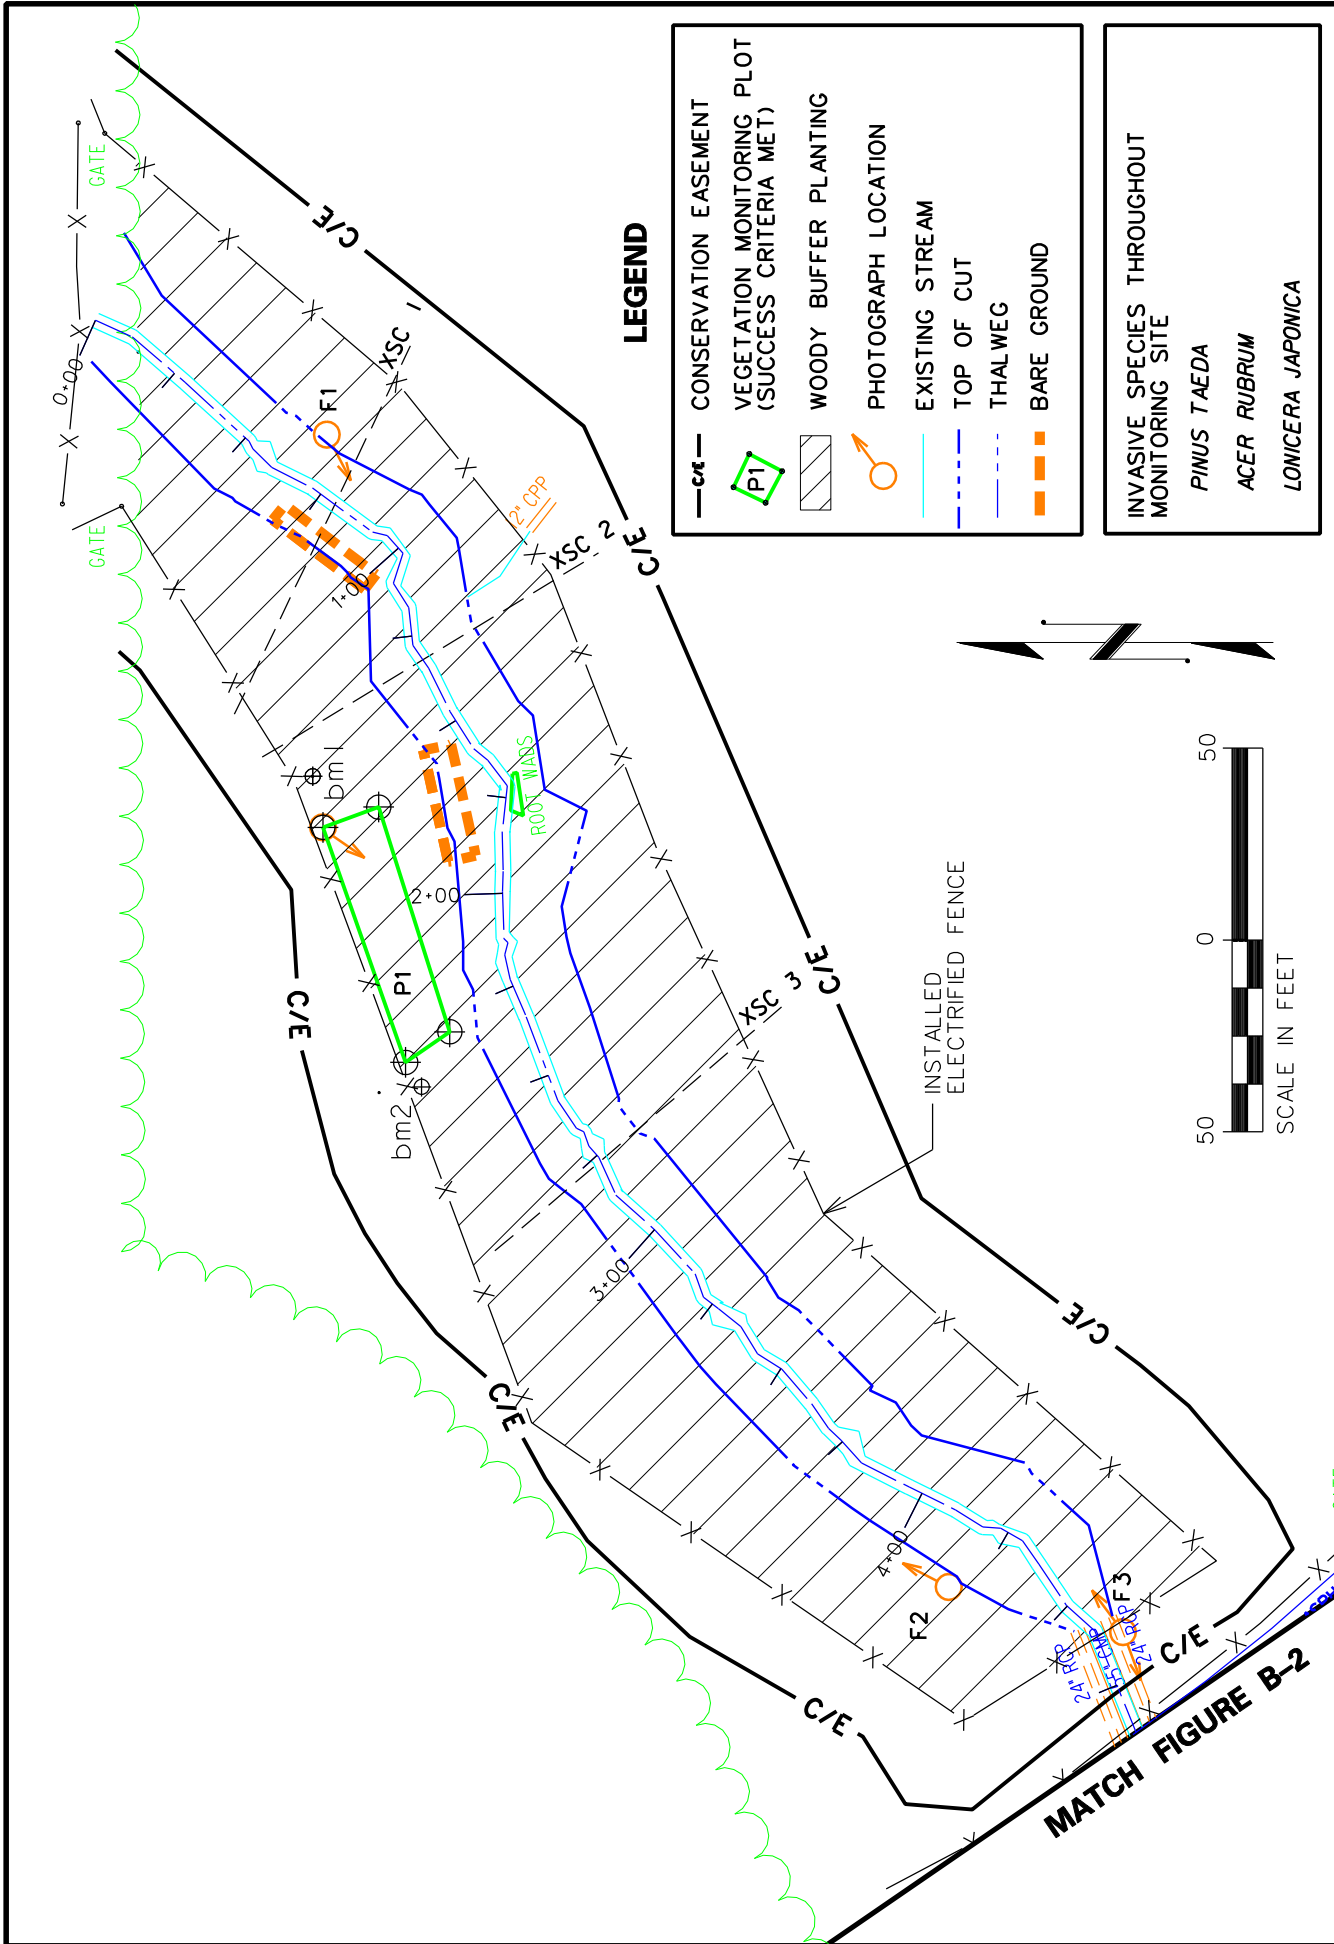
Feature / Issue	Station # / Range	Probable Cause	Photo #
Invasive Populations	Throughout, but especially at Vegetation Plot 1	<i>Pinus taeda</i> : seeding from adjacent stands	1 and 2
	Near Vegetation Plots 1 and 4	<i>Acer rubrum</i> : outside seed source	--
	Mainly at upstream end of site	<i>Lonicera japonica</i> : outside seed source	--
Bare Ground	0+50 to 1+00 and 1+50 to 2+00	Steep dry cut slope	3

INVASIVE SPECIES THROUGHOUT MONITORING SITE	
	PINUS TAEDA
	ACER RUBRUM
	LONICERA JAPONICA

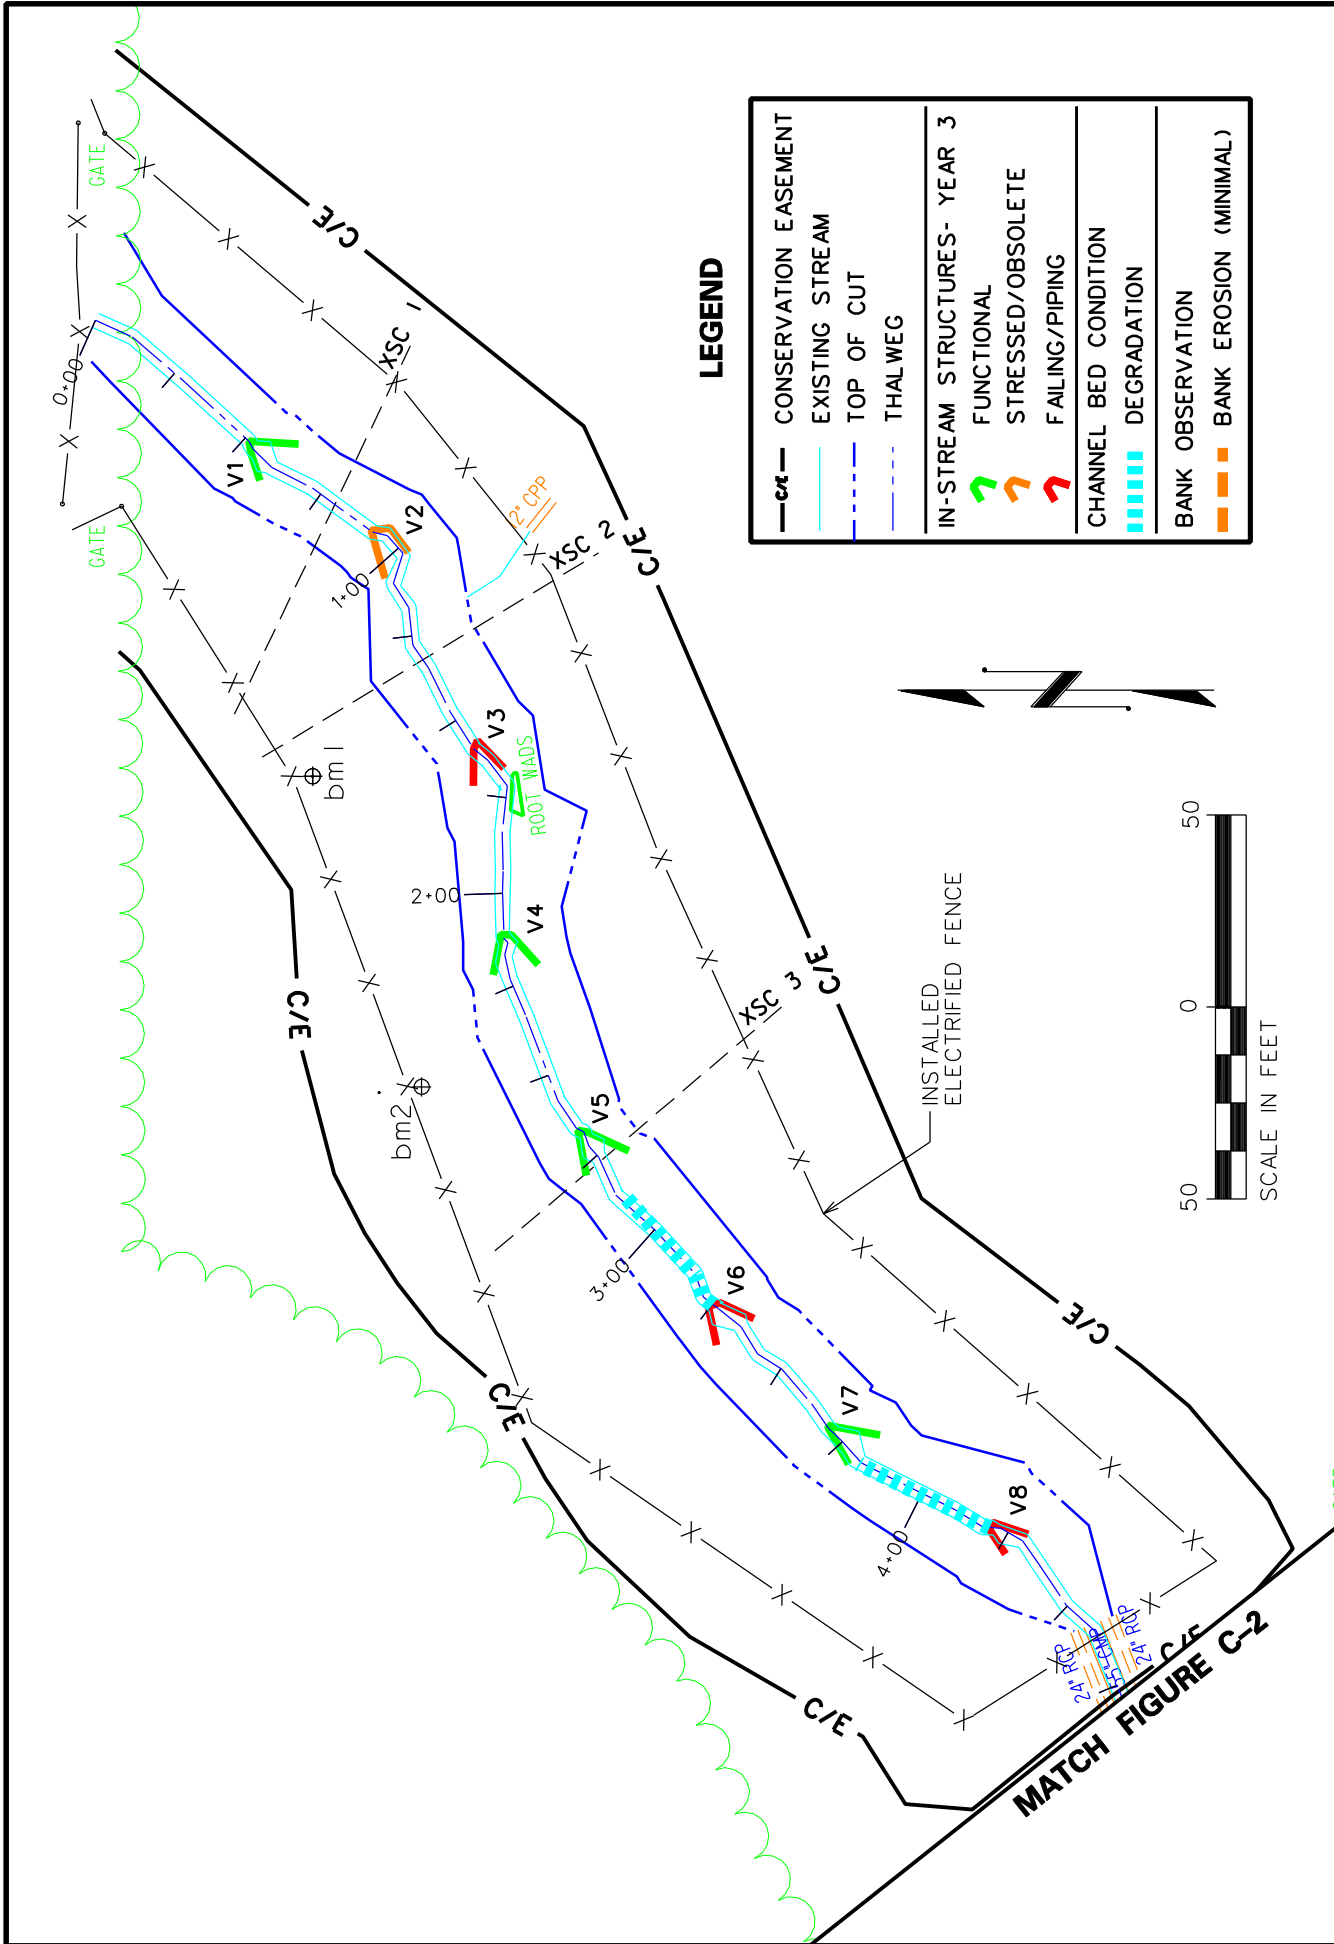
<b>Table 9. Stream Problem Areas</b>			
<b>UT to Bear Swamp Creek Stream Restoration Site / EEP Project No. 27</b>			
<b>Feature Issue</b>	<b>Station Numbers</b>	<b>Suspected Cause</b>	<b>Photo Number</b>
Vane 2, filled in		low slope, excess sediment	1
Vane 3, structure failure		Piping, inadequate use of filter fabric, steep vane arms	2
Vane 6, structure failure		Piping, inadequate use of filter fabric, steep vane arms	3
Vane 8, structure failure		Piping, inadequate use of filter fabric, steep vane arms	4
Vane 10, structure failure		Piping, inadequate use of filter fabric, steep vane arms	5
Vane 11, structure failure		Piping, inadequate use of filter fabric, steep vane arms	6
Vane 14, filled in		low slope, excess sediment	7
Vane 17, filled in		low slope, excess sediment	8
Vane 19, structure failure		Piping, inadequate use of filter fabric, steep vane arms	9
Vane 24, filled in		low slope, excess sediment	Not available
