# UNNAMED TRIBUTARY TO BEAR SWAMP CREEK STREAM RESTORATION SITE

2006 Annual Monitoring Report (Year 4)

Franklin County  
EEP Project No. 27  
Design Firm: Arcadis G&M of North Carolina, Inc.

January, 2007

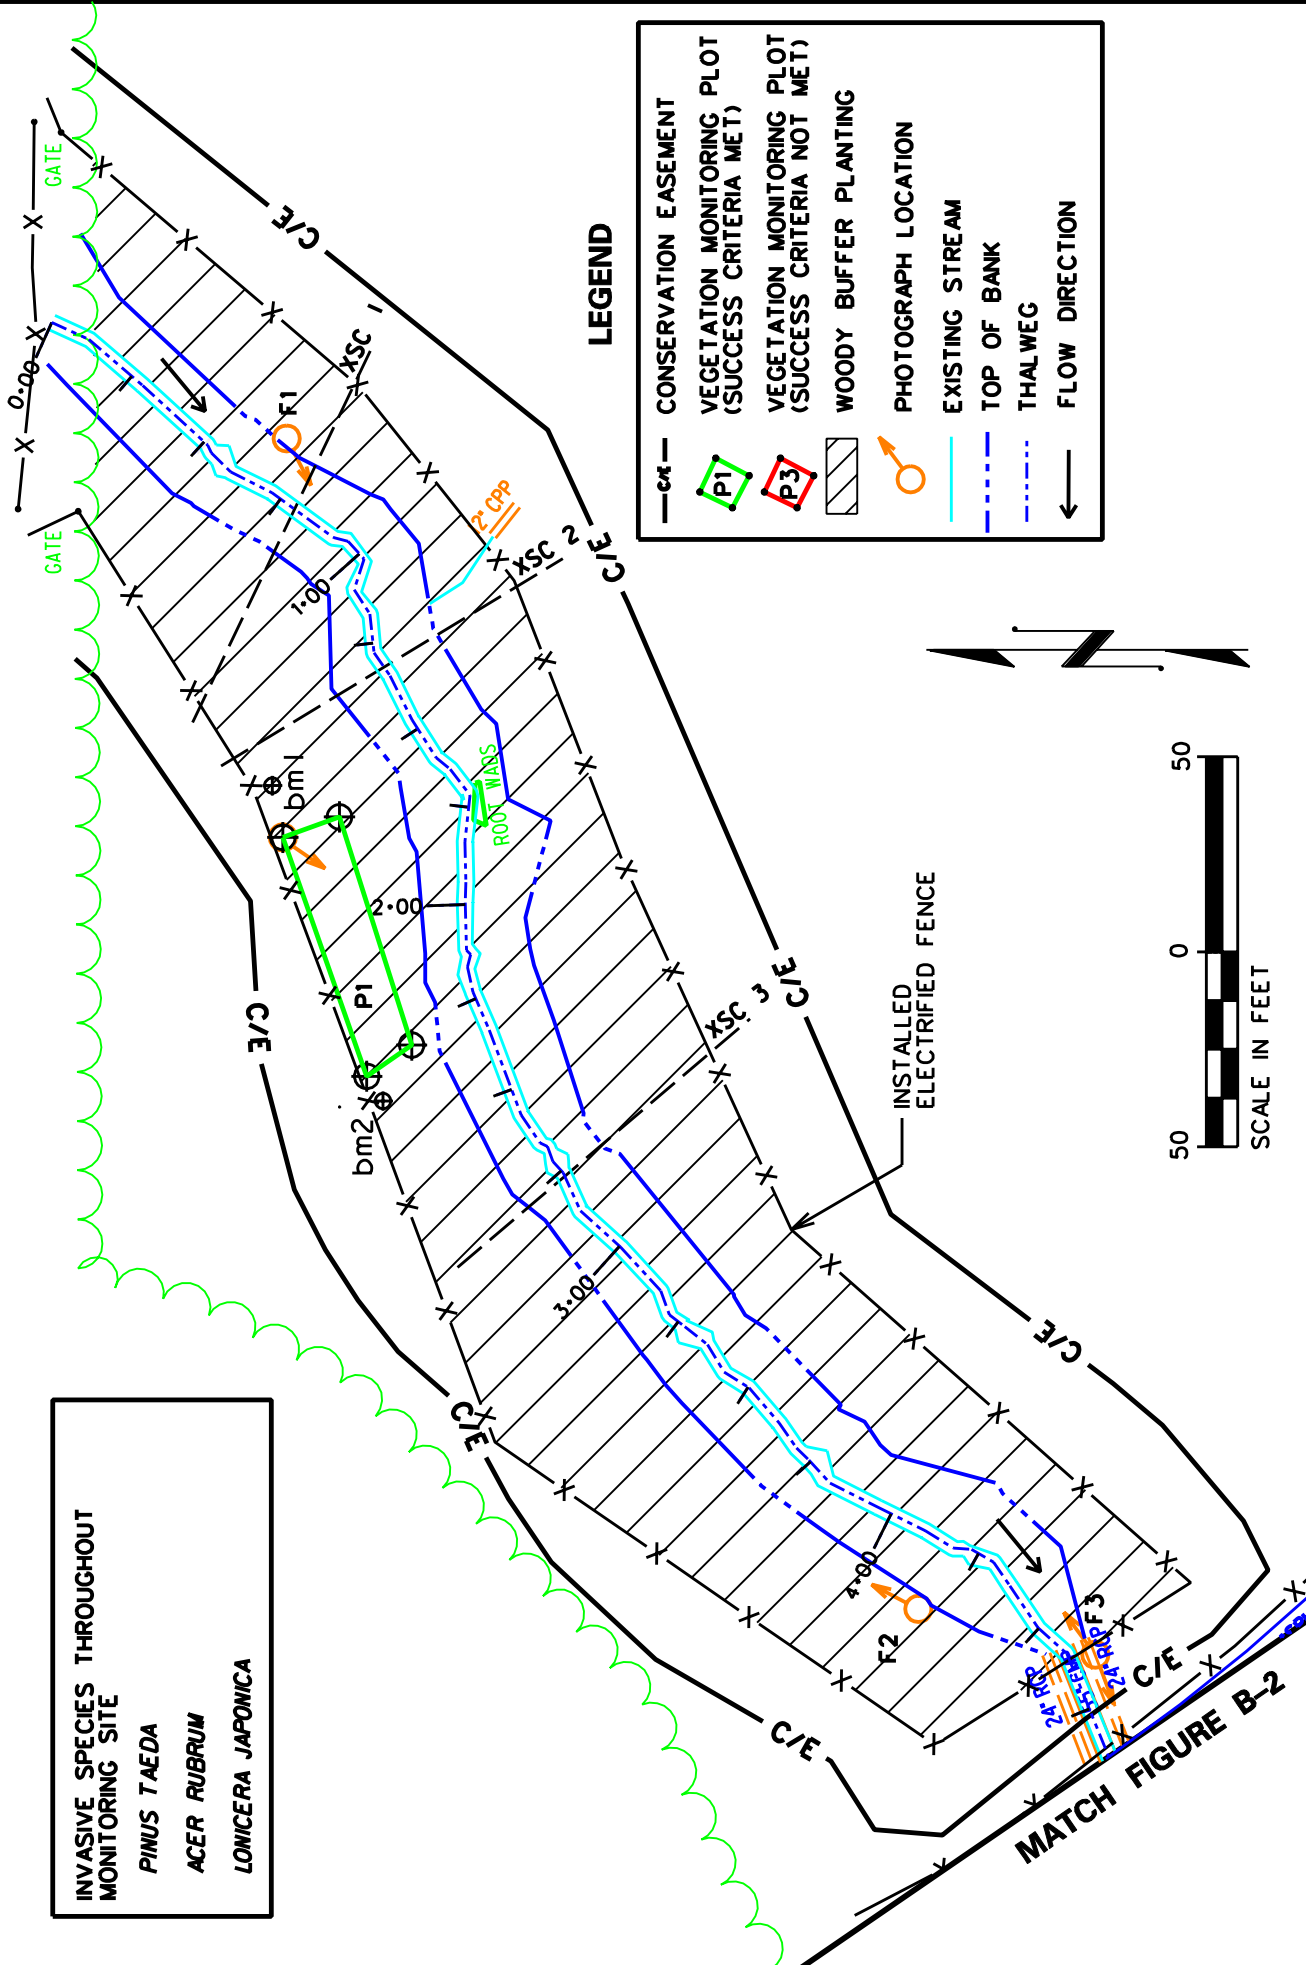
**INVASIVE SPECIES THROUGHOUT MONITORING SITE**  
**PINUS TAEDA**  
**ACER RUBRUM**  
**LONICERA JAPONICA**

Exhibit Table VI. Vegetative Problem Areas UT to Bear Swamp Creek Stream Restoration Site / EEP Project No. 27			
Feature / Issue	Station # / Range	Probable Cause	Photo #
Invasive Populations	Throughout, but especially at Vegetation Plot 1	<i>Pinus taeda</i> : seeding from adjacent stands	1 and 2

Aggressive recruitment of *Pinus taeda* continues at the site, especially at the northeastern end (Appendix B). A mixed pine-hardwood woodlot near this area provides a nearby source of pine propagules. The northeastern end of the Site, near Plot 1, also features abundant *Rhus* shrubs, principally *Rhus glabra*. While these are abundant, they do not generate the dense shade found under pine saplings. The unbranched stems and weak vegetative growth result in an open understory where grasses and herbs flourish. It was noted that the *Rhus* thickets were used by deer as a bedding area.

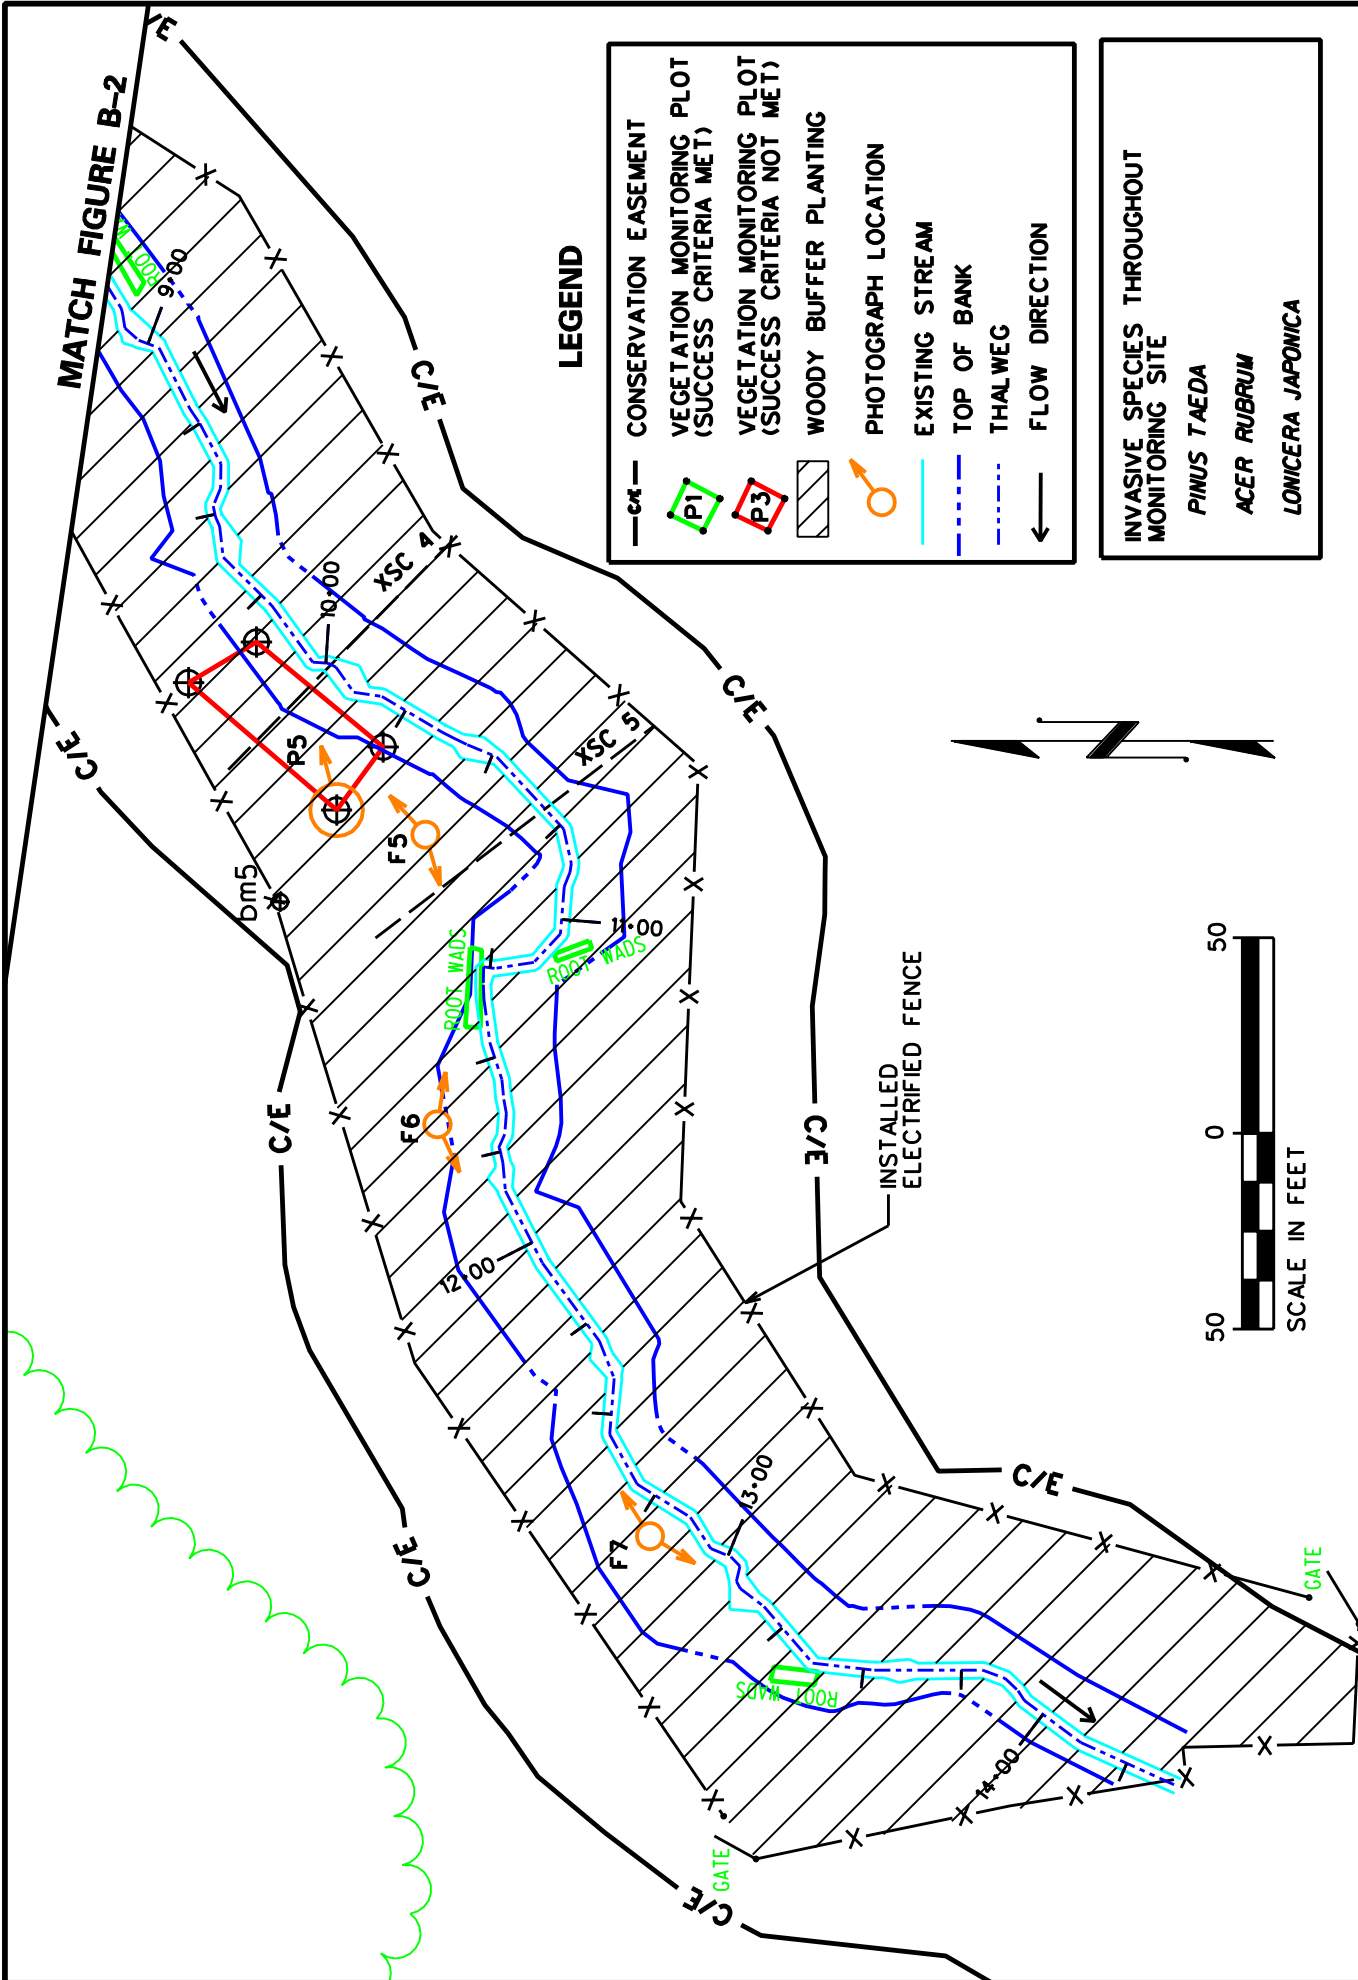
Project:	<b>VEGETATION PROBLEM AREAS</b>		FIGURE	<b>B-3</b>

- INVASIVE SPECIES THROUGHOUT MONITORING SITE**
- PINUS TAEDA
  - ACER RUBRUM
  - LOWICERA JAPONICA

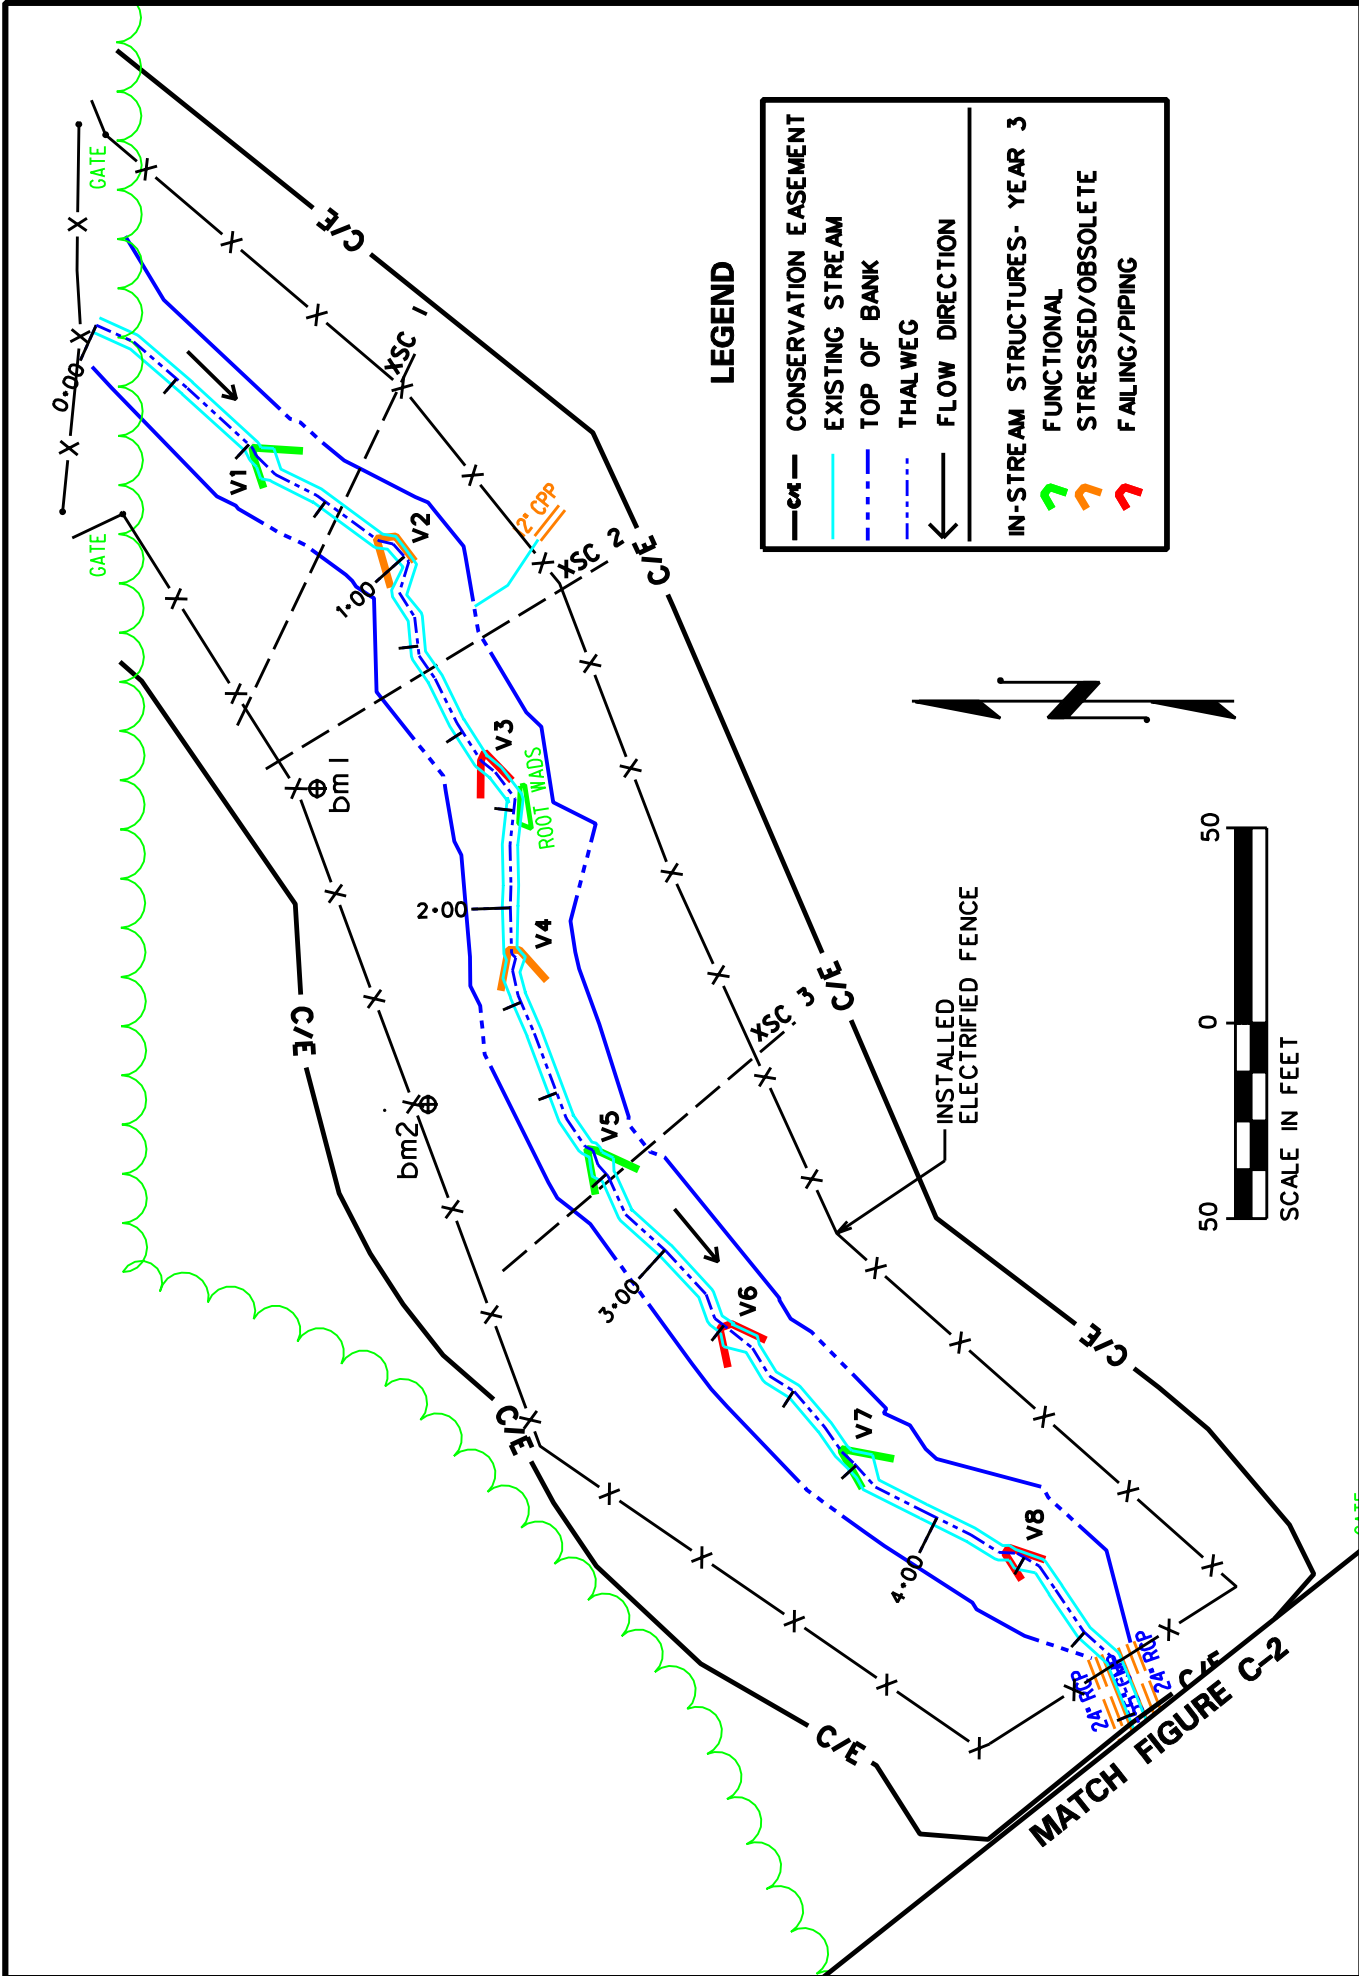
FIGURE  
**C-1**

**STREAM PROBLEM AREAS**  
**Unnamed Tributary to Bear Swamp Creek Stream Restoration Site**  
**EEP Project No. 27**  
 FRANKLIN COUNTY, NORTH CAROLINA

Overall, the stream channel bed form is stable. However, many of the grade control structures (rock vanes) in the stream have failed which has led to low to moderate bed degradation immediately behind

Exhibit Table X. Stream Problem Areas UT to Bear Swamp Creek Stream Restoration Site / EEP Project No. 27			
Feature Issue	Station Numbers	Suspected Cause	Photo Number
Vane 2, filled in		low slope, excess sediment	1
Vane 3, structure failure		Piping, inadequate use of filter fabric, steep vane arms	2
Vane 4, filled in		low slope, excess sediment	3
Vane 6, structure failure		Piping, inadequate use of filter fabric, steep vane arms	4
Vane 8, structure failure		Piping, inadequate use of filter fabric, steep vane arms	5
Vane 10, structure failure		Piping, inadequate use of filter fabric, steep vane arms	6
Vane 11, structure failure		Piping, inadequate use of filter fabric, steep vane arms	7
Vane 14, filled in		low slope, excess sediment	8
Vane 16, filled in		low slope, excess sediment	9
Vane 17, filled in		low slope, excess sediment	10
Vane 19, structure failure		Piping, inadequate use of filter fabric, steep vane arms	11

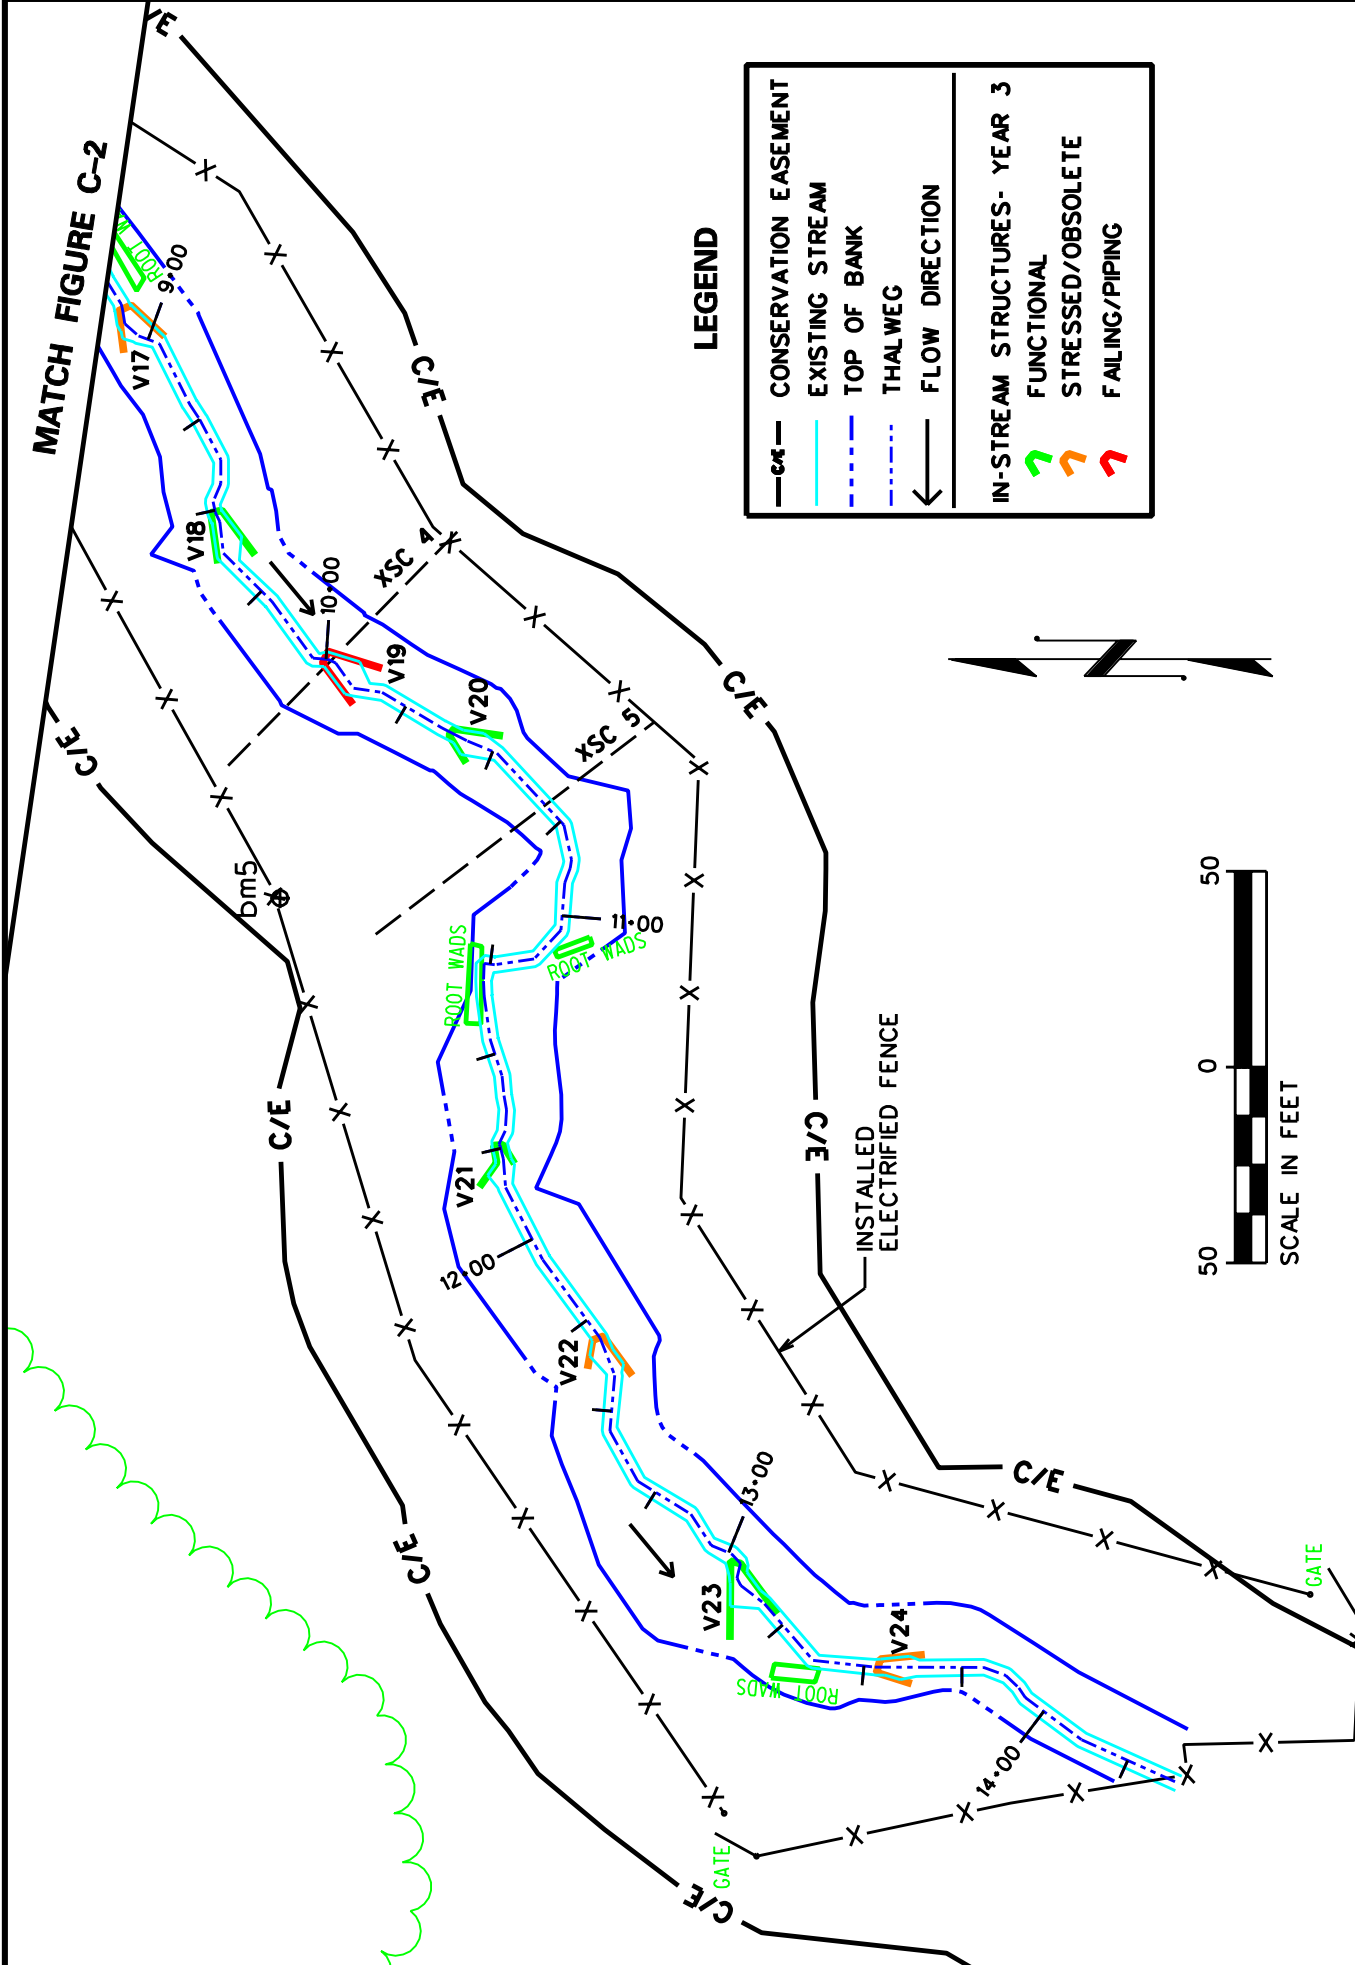
FIGURE  
**C-3**

**STREAM PROBLEM AREAS**  
**Unnamed Tributary to Bear Swamp Creek Stream Restoration Site**  
**EEP Project No. 27**  
 FRANKLIN COUNTY, NORTH CAROLINA
