**UNNAMED TRIBUTARY TO BEAR SWAMP CREEK  
STREAM RESTORATION SITE**

**2007 Annual Monitoring Report (Year 5)**

**Franklin County  
EEP Project No. 27  
Design Firm: Arcadis G&M of North Carolina, Inc.**

**February 2008**

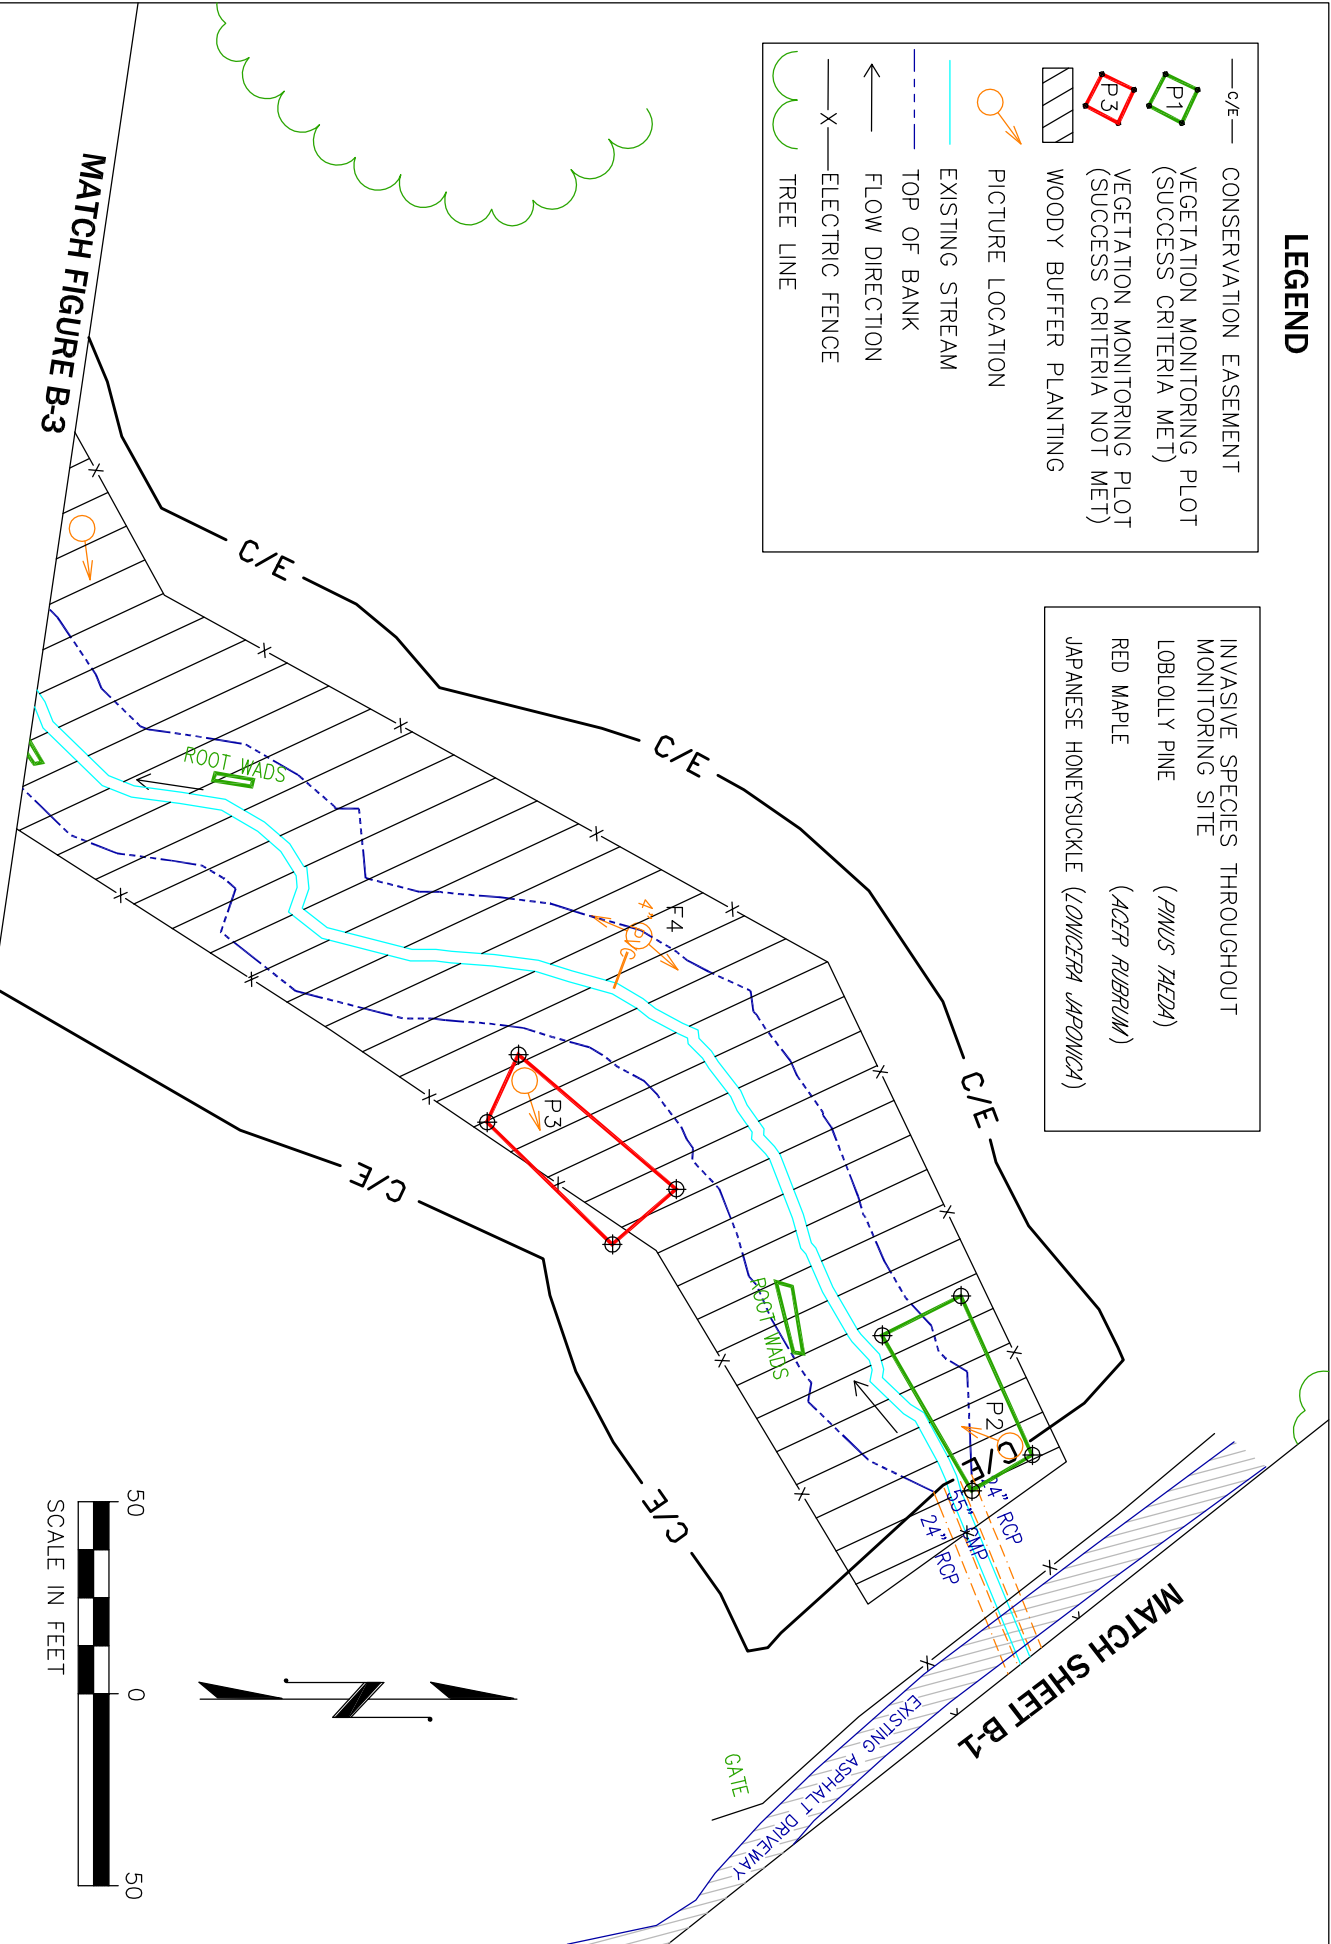
<b>Exhibit Table VI. Vegetative Problem Areas</b> <b>UT to Bear Swamp Creek Stream Restoration Site / EEP Project No. 27</b>			
<b>Feature / Issue</b>	<b>Station # / Range</b>	<b>Probable Cause</b>	<b>Photo #</b>
Invasive Populations	Throughout, but especially at Vegetation Plot 1	loblolly pine ( <i>Pinus taeda</i> ): seeding from adjacent stands	1 and 2 (Appendix B)

Aggressive recruitment of *Pinus taeda* continues at the Site, especially at the northeastern end (Appendix B). A mixed pine-hardwood woodlot near this area provides a nearby source of pine propagules. The northeastern end of the Site, near Plot 1, also features abundant *Rhus* shrubs, principally *Rhus glabra*. While these are abundant, they do not generate the dense shade found under pine saplings. The unbranched stems and weak vegetative growth result in an open understory where grasses and herbs flourish.

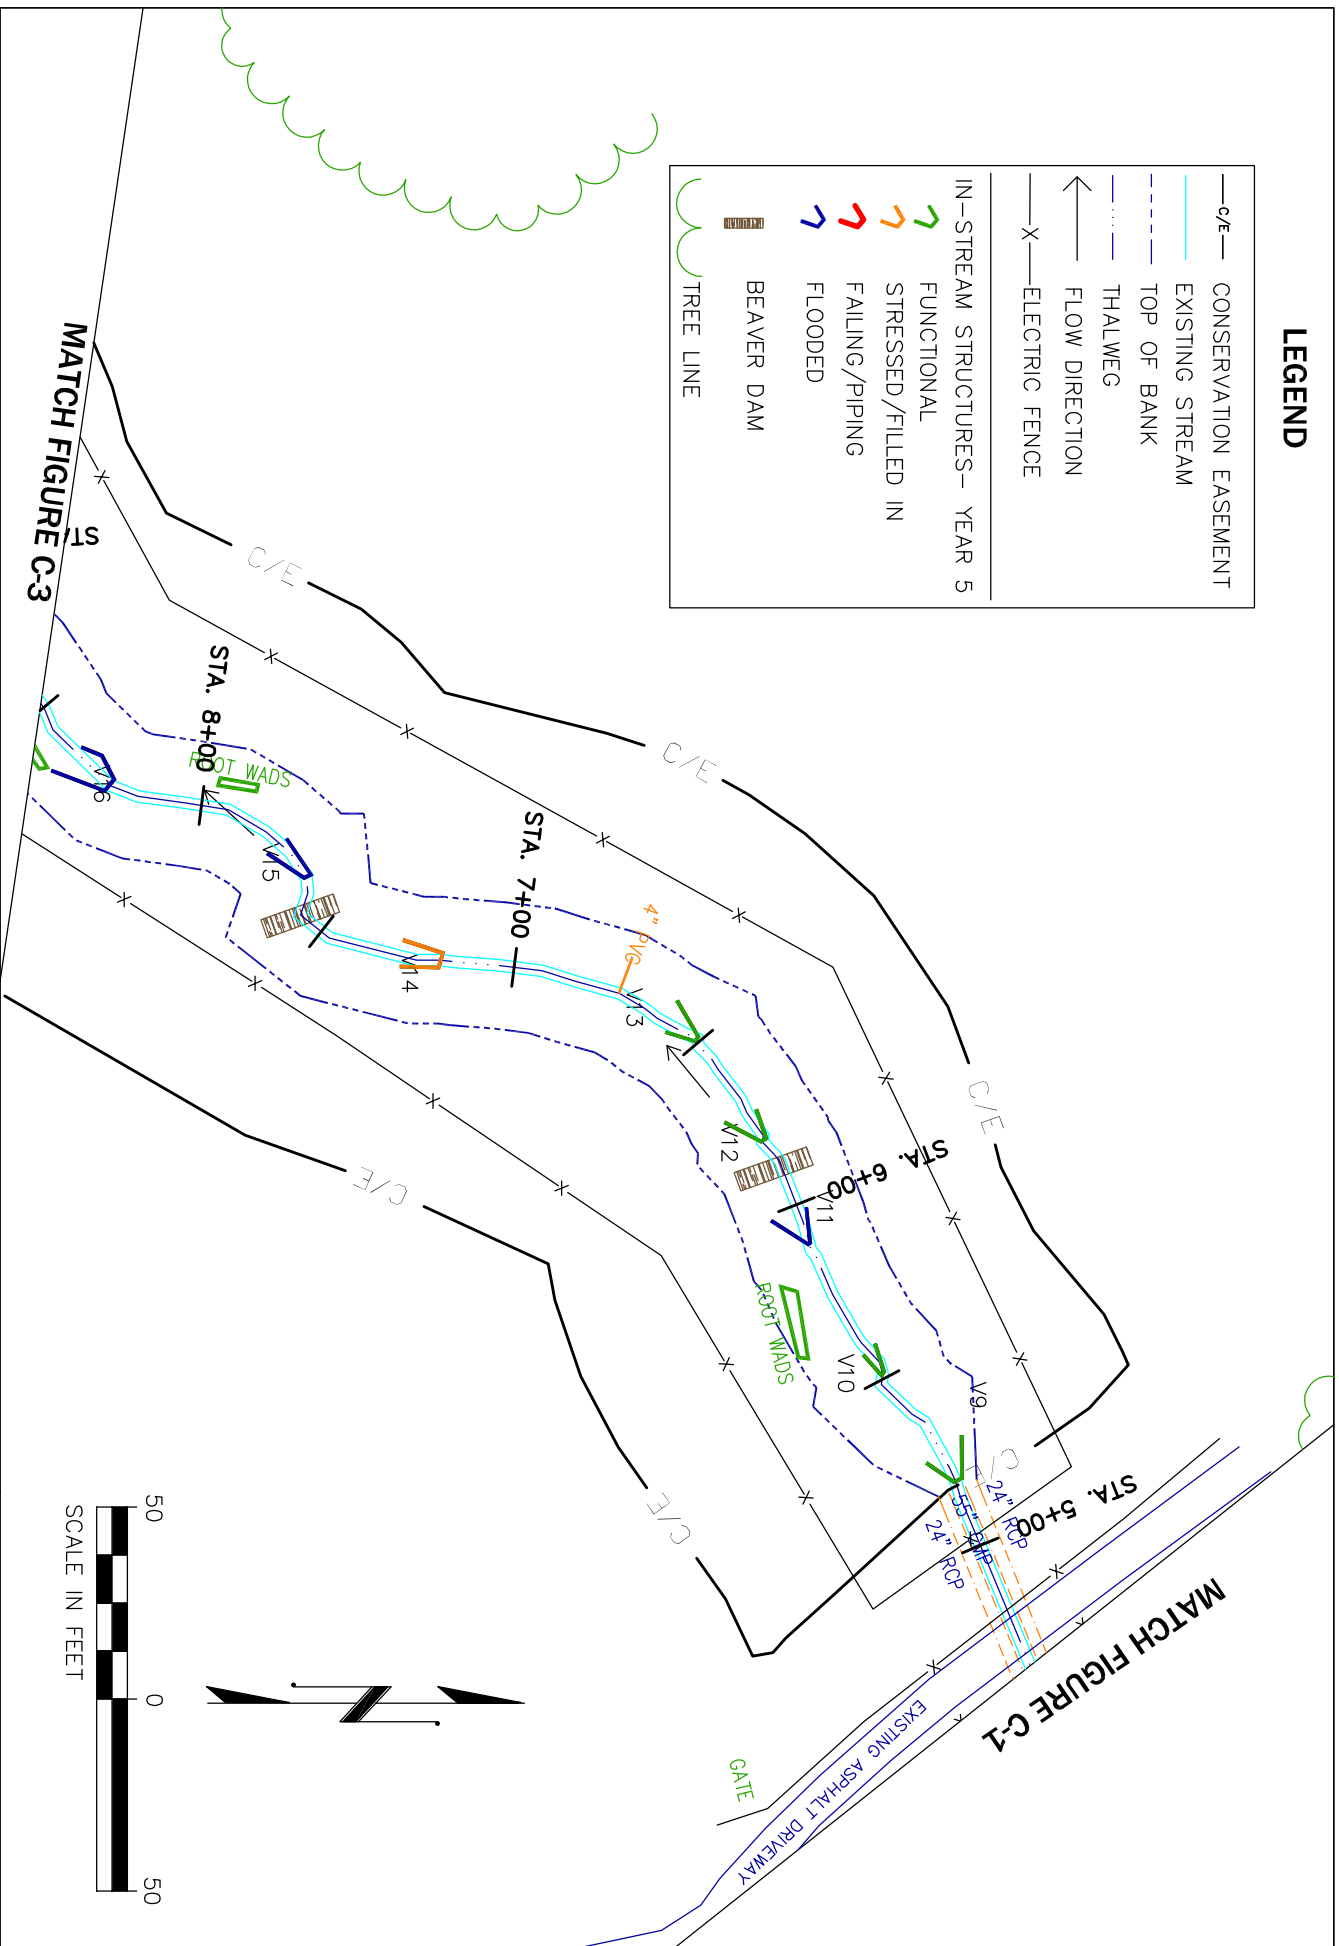
# C-2

Overall, the stream channel bed form is stable. However, many of the grade control structures (rock vanes) in the stream have failed which has led to low to moderate bed degradation immediately behind these structures. Of the twenty-four rock vanes that were installed, sixteen are not performing their intended function. Three vanes have water piping through or behind the structure, six have filled in with sediment and have become obsolete, and the remaining seven are flooded from beaver dams throughout the lower portion of the Site. A total of eight beaver dams were observed within the UT to Bear Swamp Creek and significant impoundments have formed behind them. One beaver dam, constructed at the upstream culvert invert, posed a potential flood hazard to the Murphy Hay Farm driveway. In late 2007, beaver trapping and removal was carried out at the Site to prevent offsite flooding, continued negative impacts to the stream, and potential nuisance impacts to the adjacent landowners.

<b>Exhibit Table X. Stream Problem Areas</b>			
<b>UT to Bear Swamp Creek Stream Restoration Site / EEP Project No. 27</b>			
<b>Feature Issue</b>	<b>Station Numbers</b>	<b>Suspected Cause</b>	<b>Photo Number</b>
Vane 2, filled in		Low slope, excess sediment	8**
Vane 3, structure failure		Piping, steep vane arms	
Vane 4, filled in		Low slope, excess sediment	
Vane 5, filled in		Low slope, excess sediment	
Vane 6, structure failure		Piping, steep vane arms	
Vane 8, structure failure		Piping, steep vane arms	
Vane 11, flooded		Beaver dam downstream of structure*	9**
Vane 14, filled in		Low slope, excess sediment	
Vane 15, flooded		Beaver dam downstream of structure*	
Vane 16, flooded		Beaver dam downstream of structure*	
Vane 17, flooded		Beaver dam downstream of structure*	
Vane 18, flooded		Beaver dam downstream of structure*	
Vane 19, flooded		Beaver dam downstream of structure*	
Vane 20, flooded		Beaver dam downstream of structure*

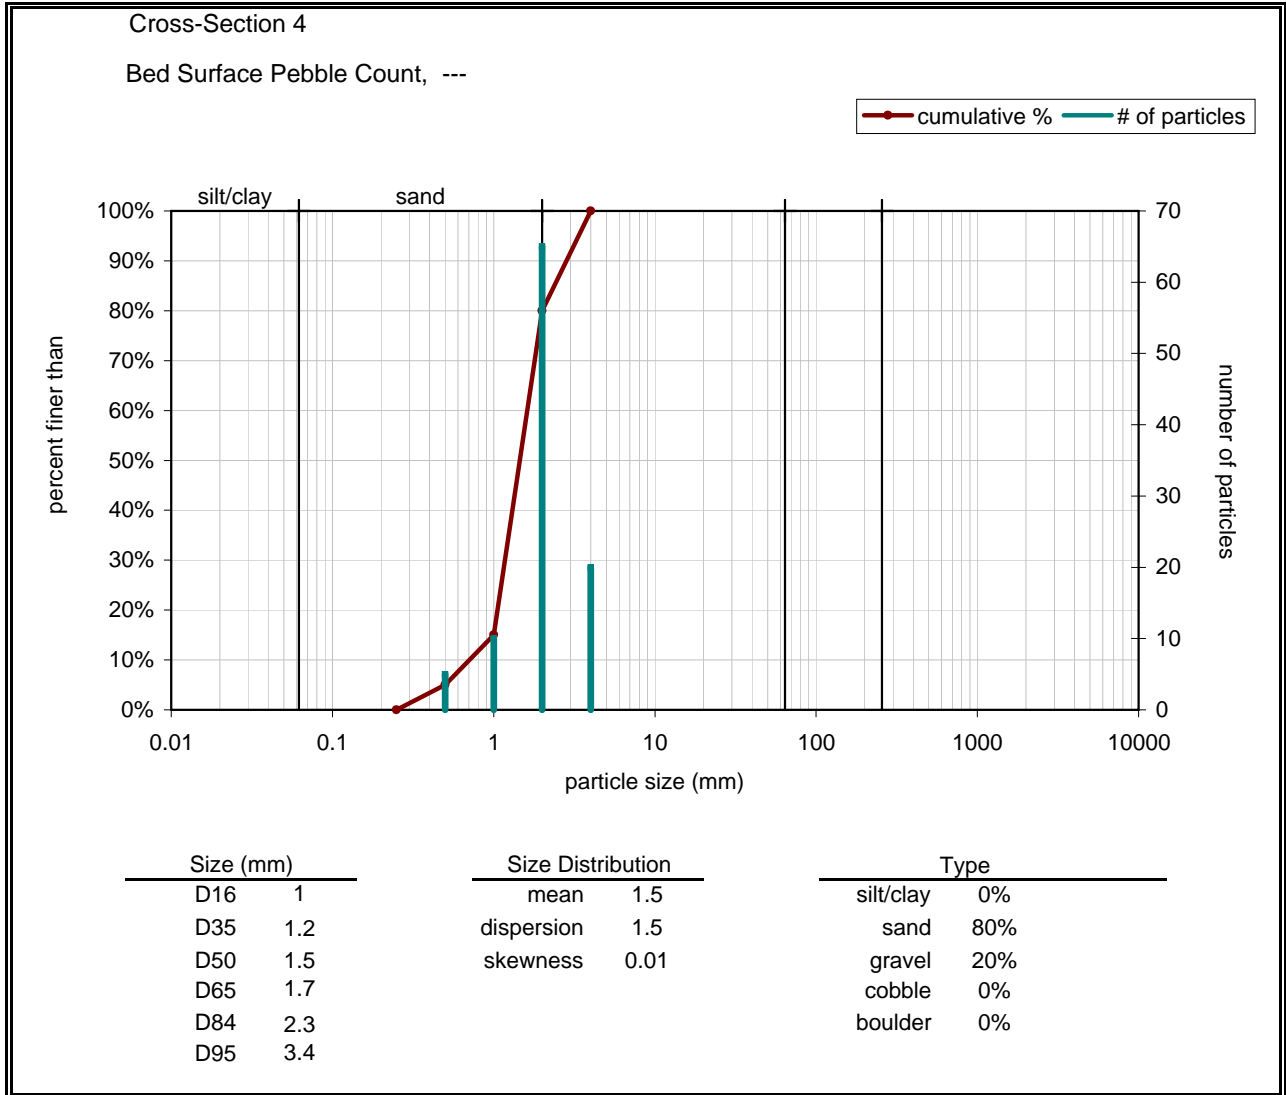
Bed Surface		
Material	Size Range (mm)	Count
silt/clay	0 - 0.062	
very fine sand	0.062 - 0.125	
fine sand	0.125 - 0.25	
medium sand	0.25 - 0.5	5
coarse sand	0.5 - 1	10
very coarse sand	1 - 2	65
very fine gravel	2 - 4	20
fine gravel	4 - 6	
fine gravel	6 - 8	
medium gravel	8 - 11	
medium gravel	11 - 16	
coarse gravel	16 - 22	
coarse gravel	22 - 32	
very coarse gravel	32 - 45	
very coarse gravel	45 - 64	
small cobble	64 - 90	
medium cobble	90 - 128	
large cobble	128 - 180	
very large cobble	180 - 256	
small boulder	256 - 362	
small boulder	362 - 512	
medium boulder	512 - 1024	
large boulder	1024 - 2048	
very large boulder	2048 - 4096	
total particle count:		100
bedrock	-----	
clay hardpan	-----	
detritus/wood	-----	
artificial	-----	
total count:		100
Note: XS4 (Pool) Pebble Count

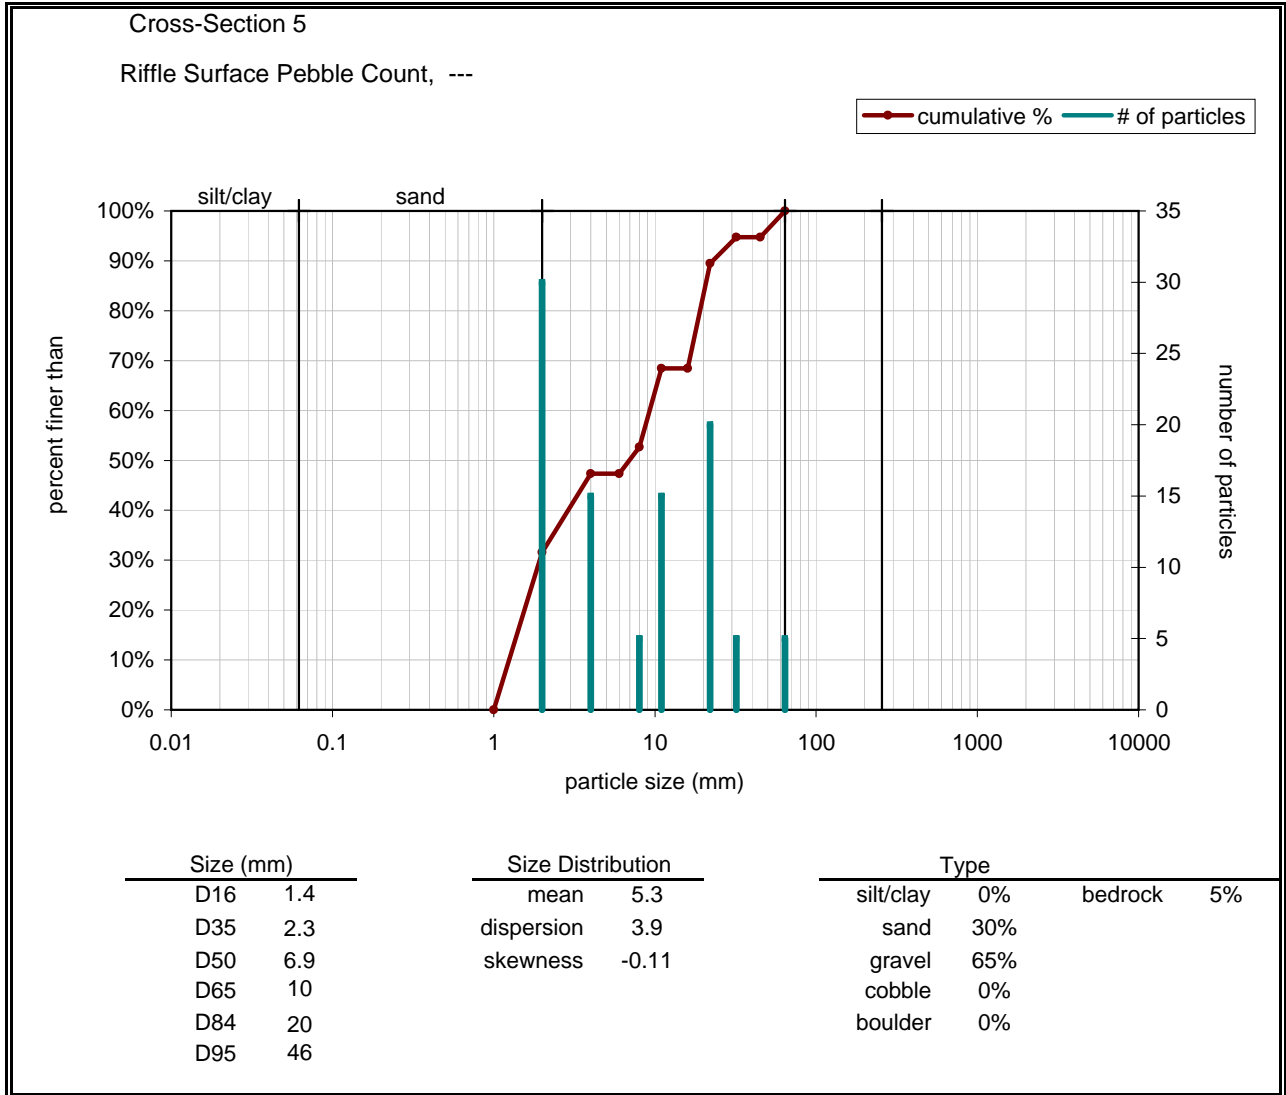
Riffle Surface		
Material	Size Range (mm)	Count
silt/clay	0 - 0.062	
very fine sand	0.062 - 0.125	
fine sand	0.125 - 0.25	
medium sand	0.25 - 0.5	
coarse sand	0.5 - 1	
very coarse sand	1 - 2	30
very fine gravel	2 - 4	15
fine gravel	4 - 6	
fine gravel	6 - 8	5
medium gravel	8 - 11	15
medium gravel	11 - 16	
coarse gravel	16 - 22	20
coarse gravel	22 - 32	5
very coarse gravel	32 - 45	
very coarse gravel	45 - 64	5
small cobble	64 - 90	
medium cobble	90 - 128	
large cobble	128 - 180	
very large cobble	180 - 256	
small boulder	256 - 362	
small boulder	362 - 512	
medium boulder	512 - 1024	
large boulder	1024 - 2048	
very large boulder	2048 - 4096	
total particle count:		95
bedrock	-----	5
clay hardpan	-----	
detritus/wood	-----	
artificial	-----	
total count:		100
Note: XS5 (Riffle) Pebble Count
