Beaver Creek Stream Restoration Annual Monitoring Report

Monitoring Year: 2004

NCEEP Project Number: 00005

BEAVER CREEK STREAM RESTORATION 2004 MONITORING REPORT

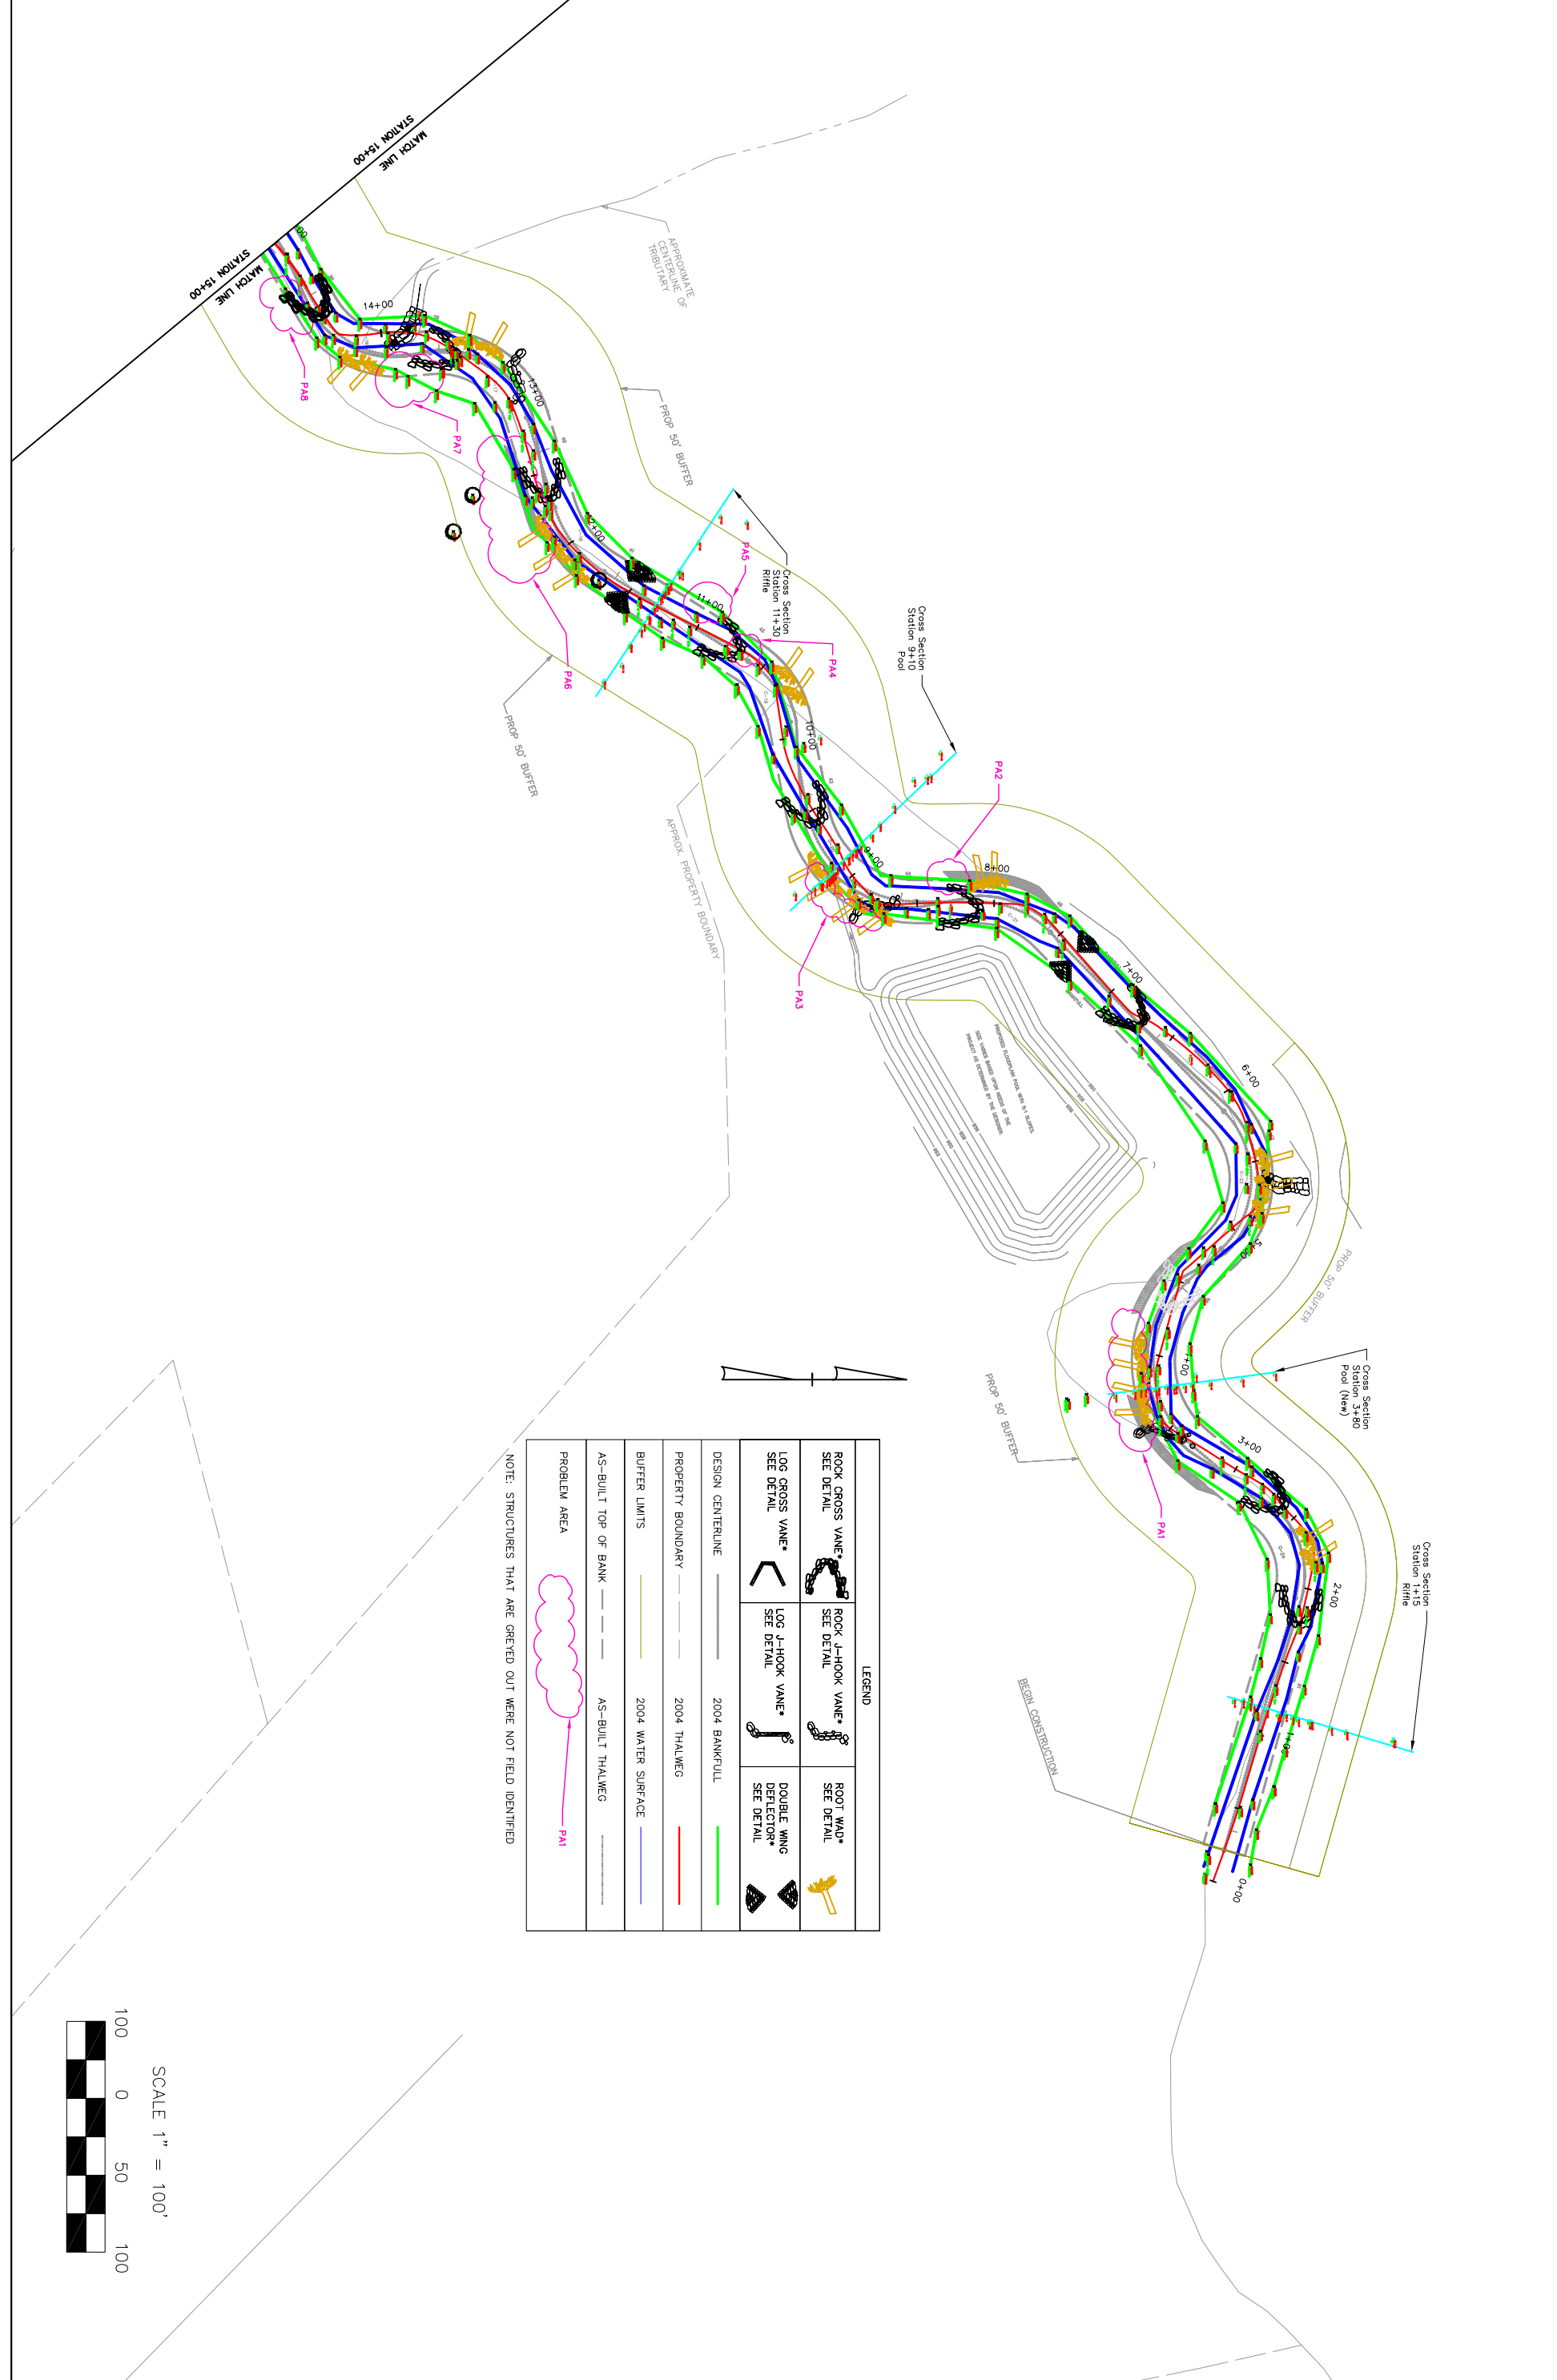
Channel dimension has changed very significantly in four (#1, 5, 6, and 7) of the six monitoring cross-sections. Enlargement in sections 5, 6 and 7 were directly related to the repair work conducted in 2003. Cross section 1 reduced the as-built area but was larger then designed when built. Cross-section 2 was added at station 3+80 to monitor active bank erosion. Significant bank erosion is occurring on sections 2 and 3. Many other areas of significant channel enlargement and bank erosion is occurring along the project. A plan view and photos of problem areas can be found in Appendix B.

Channel profile has changed throughout the project. The most significant problem is downcutting most evident from stations 10+50 to 12+34 and 20+00 to 28+00. This can be seen in cross section 4 at station 11+30 and cross section 5 at station 24+50. Some migration of bedform has occurred between station 18+00 and 23+00 and between 30+00 and 37+00. Riffle-pool complexes have disappeared between stations 11+80 and 17+00 as well as between stations 27+10 and 28+90. New riffle-pool complexes have formed between 37+50 and 39+00. Overall the bed profile is in poor condition.

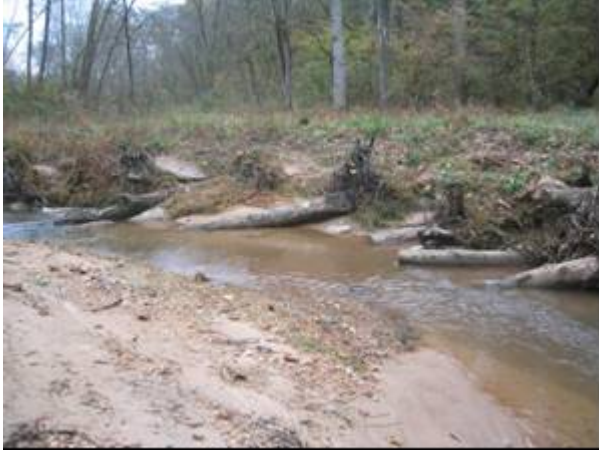
SP20. Station 24+80 to 25+10
Log vane moved

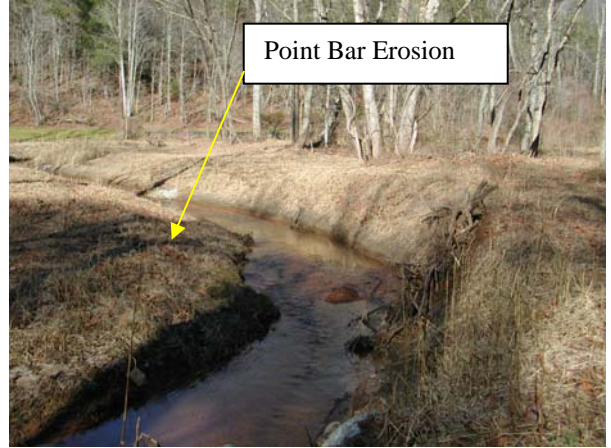
SP21. Station 27+10 to 27+20
Bank scour

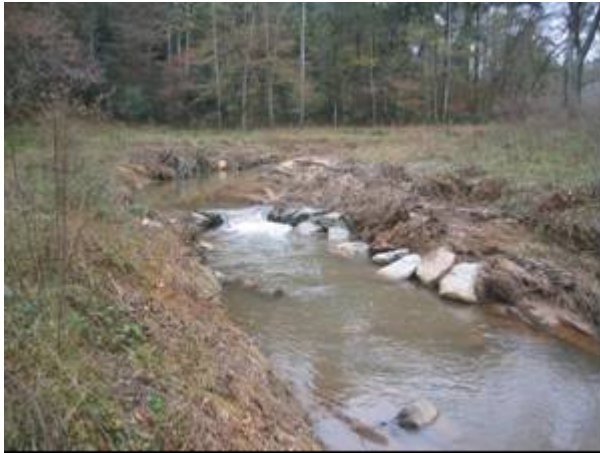
SP26. Station 39+20 to 39+40
Bare lower bank

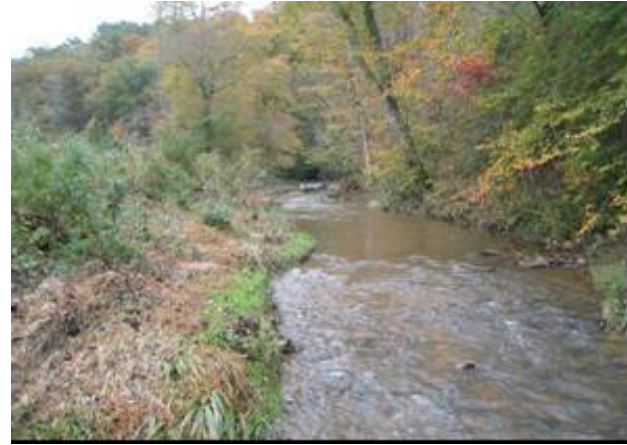
Cross-Section #1 - Looking Downstream

Bankfull Area		
	As-Built	2004
Area	104.6	86.8
Width	33.6	32.0
Mean Depth	3.1	2.7
Max Depth	4.6	4.5
w/d ratio	10.8	11.8

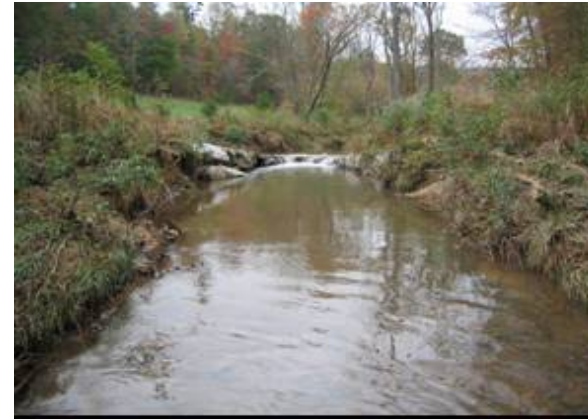
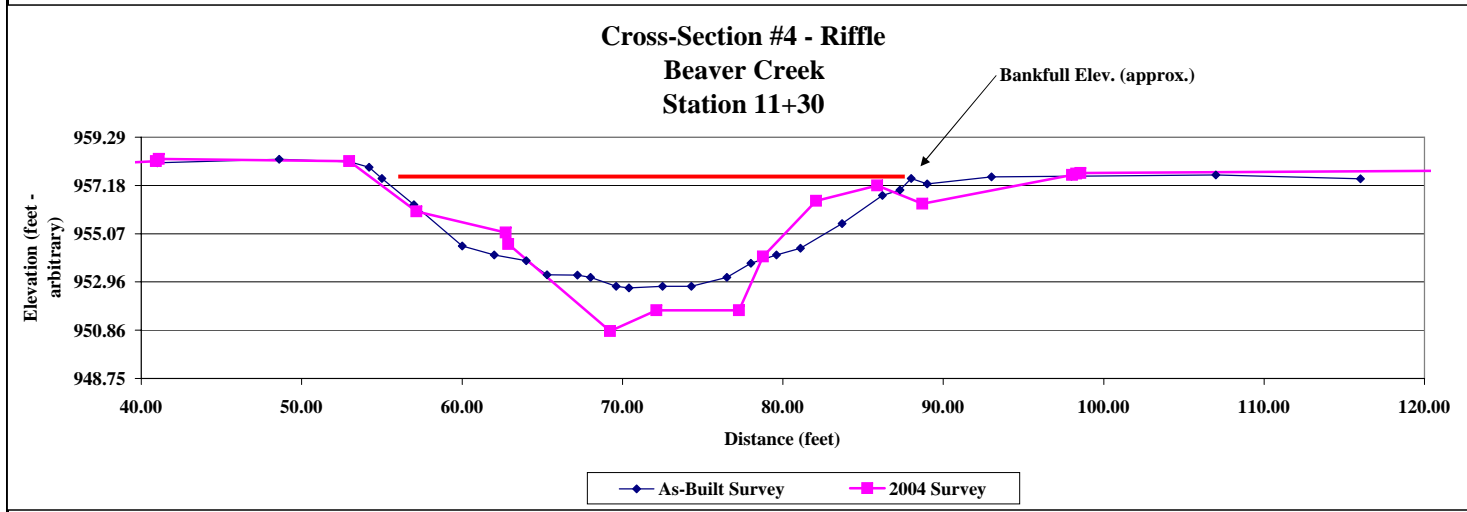
Cross-Section #4- Looking Upstream

Project Name Beaver Creek
Cross Section X4 - Station 11+30 Old Station 41+10
Feature Riffle
Date 10/20/2004
Crew Dan Clinton, David Bidelspach

Bankfull Area	
	As-Built	2004
Area	103.8	107.9
Width	33.0	32.9
Mean Depth	3.1	3.3
Max Depth	4.8	6.7
w/d ratio	10.5	10.0

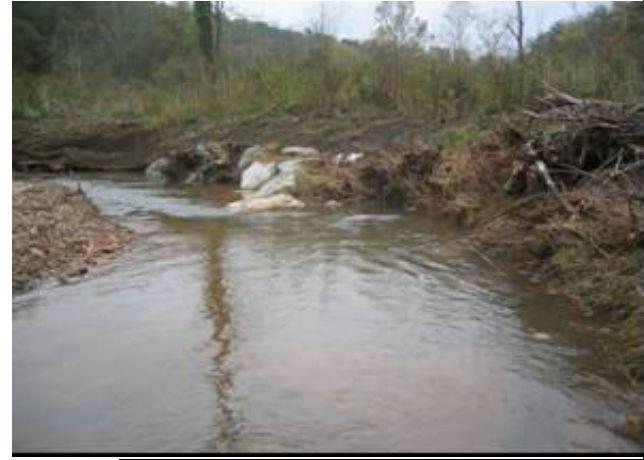
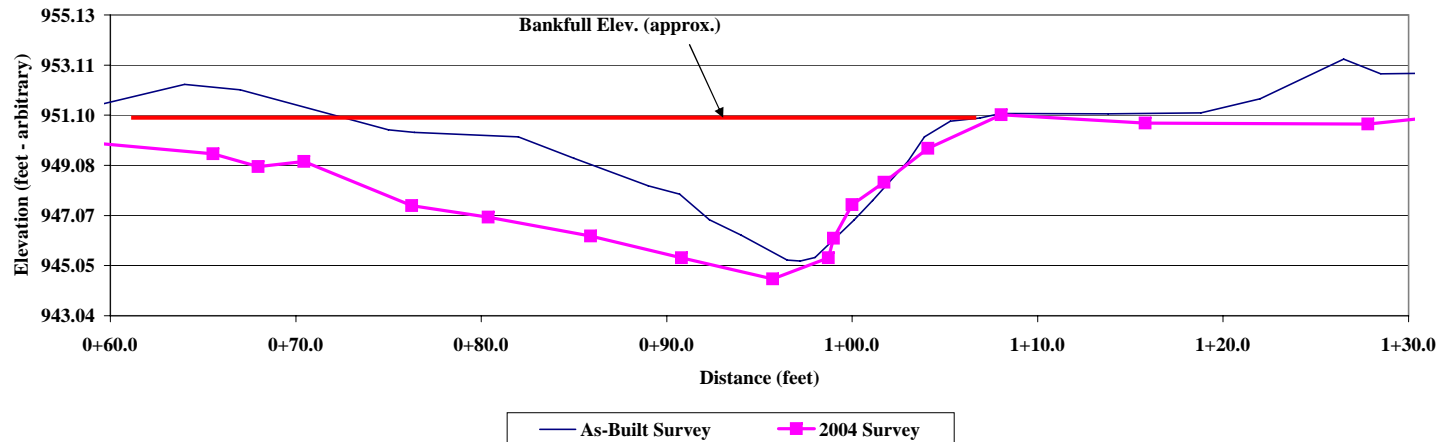
Cross-Section #5 - Looking Downstream

Project Name	Beaver Creek	
Cross Section	X5 - Station 24+50	Old Station 28+50
Feature	Pool	
Date	10/20/2004	
Crew	Dan Clinton, David Bidelspach

Bankfull Area		
	As-Built	2004
Area	55.1	125.8
Width	21.9	48.0
Mean Depth	2.5	2.6
Max Depth	5.0	5.7

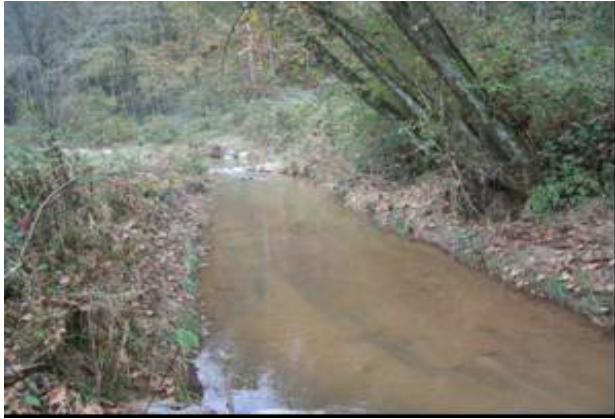
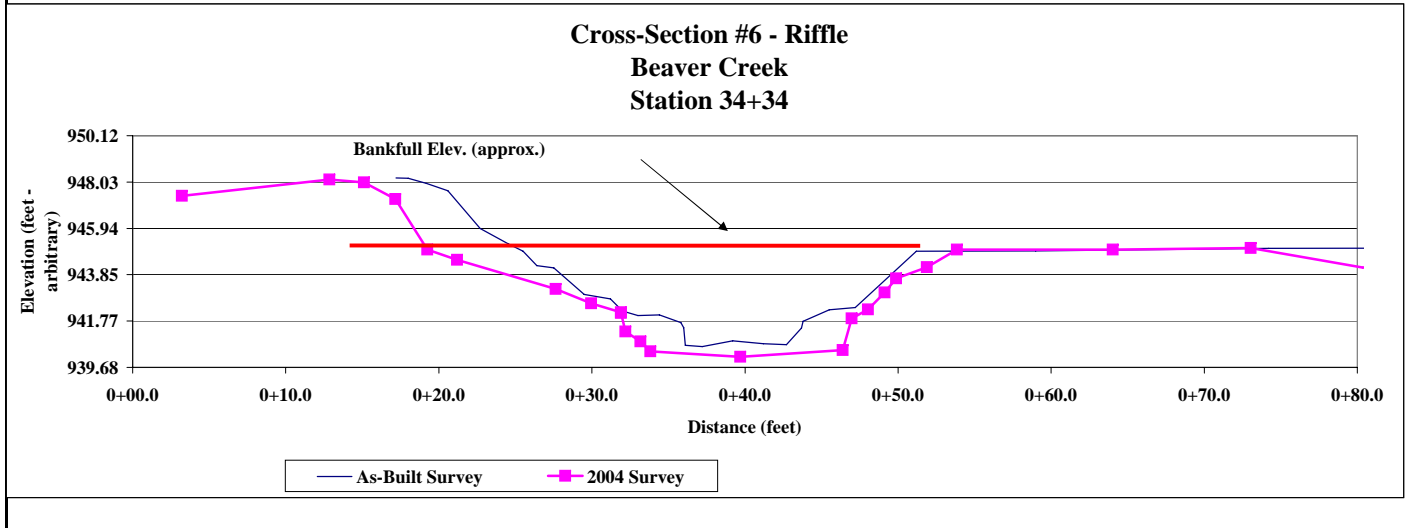
Cross-Section #6 - Looking Upstream

Project Name	Beaver Creek	
Cross Section	X6 - Station 34+34	Old Station 18+50
Feature	Riffle	
Date	10/20/2004	
Crew	Dan Clinton, David Bidelspach

Bankfull Area	
	As-Built	2004
Area	67.4	93.6
Width	25.7	34.6
Mean Depth	2.6	2.7
Max Depth	4.3	4.8
w/d ratio	9.8	12.8

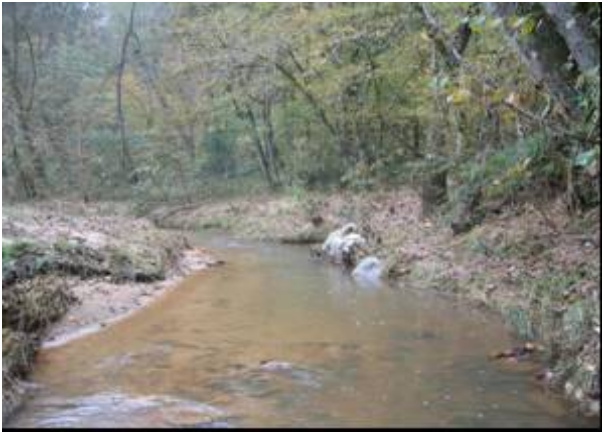
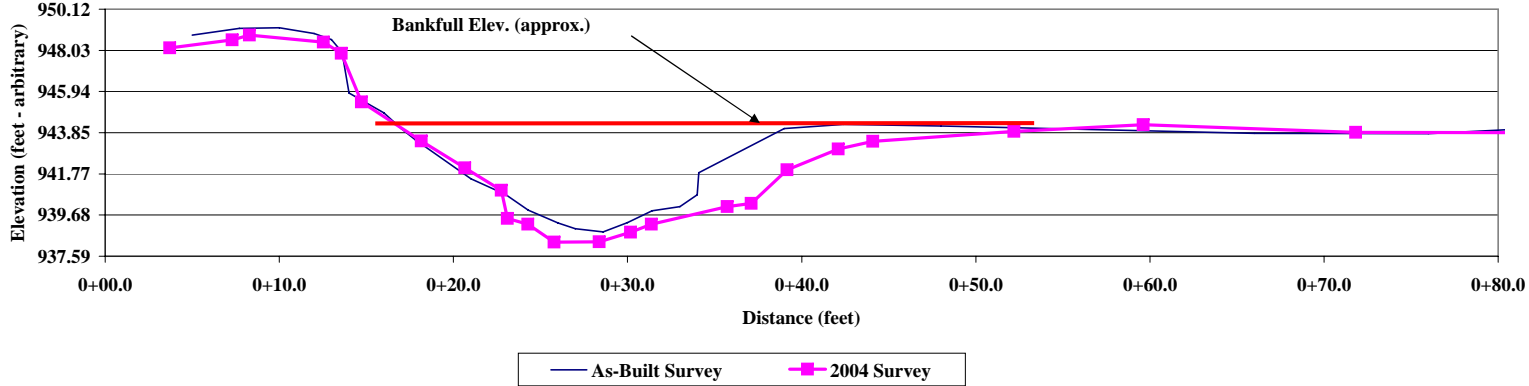
Cross-Section #7- Looking Upstream

Project Name	Beaver Creek	
Cross Section	X7 - Station 36+50	Old Station 16+10
Feature	Pool	
Date	10/20/2004	
Crew	Dan Clinton, David Bidelspach

Bankfull Area	
	As-Built	2004
Area	66.0	95.2
Width	22.0	38.2
Mean Depth	3.0	2.5
Max Depth	5.2	5.8
