Beaver Creek Stream Restoration 2005 Monitoring Report Year Two of Monitoring

Ecosystem Enhancement Program Project Number 00028

Prepared by: EcoLogic Associates, P.C.
4321-A S. Elm-Eugene St.
Greensboro, NC 27406

Submitted: March, 2006

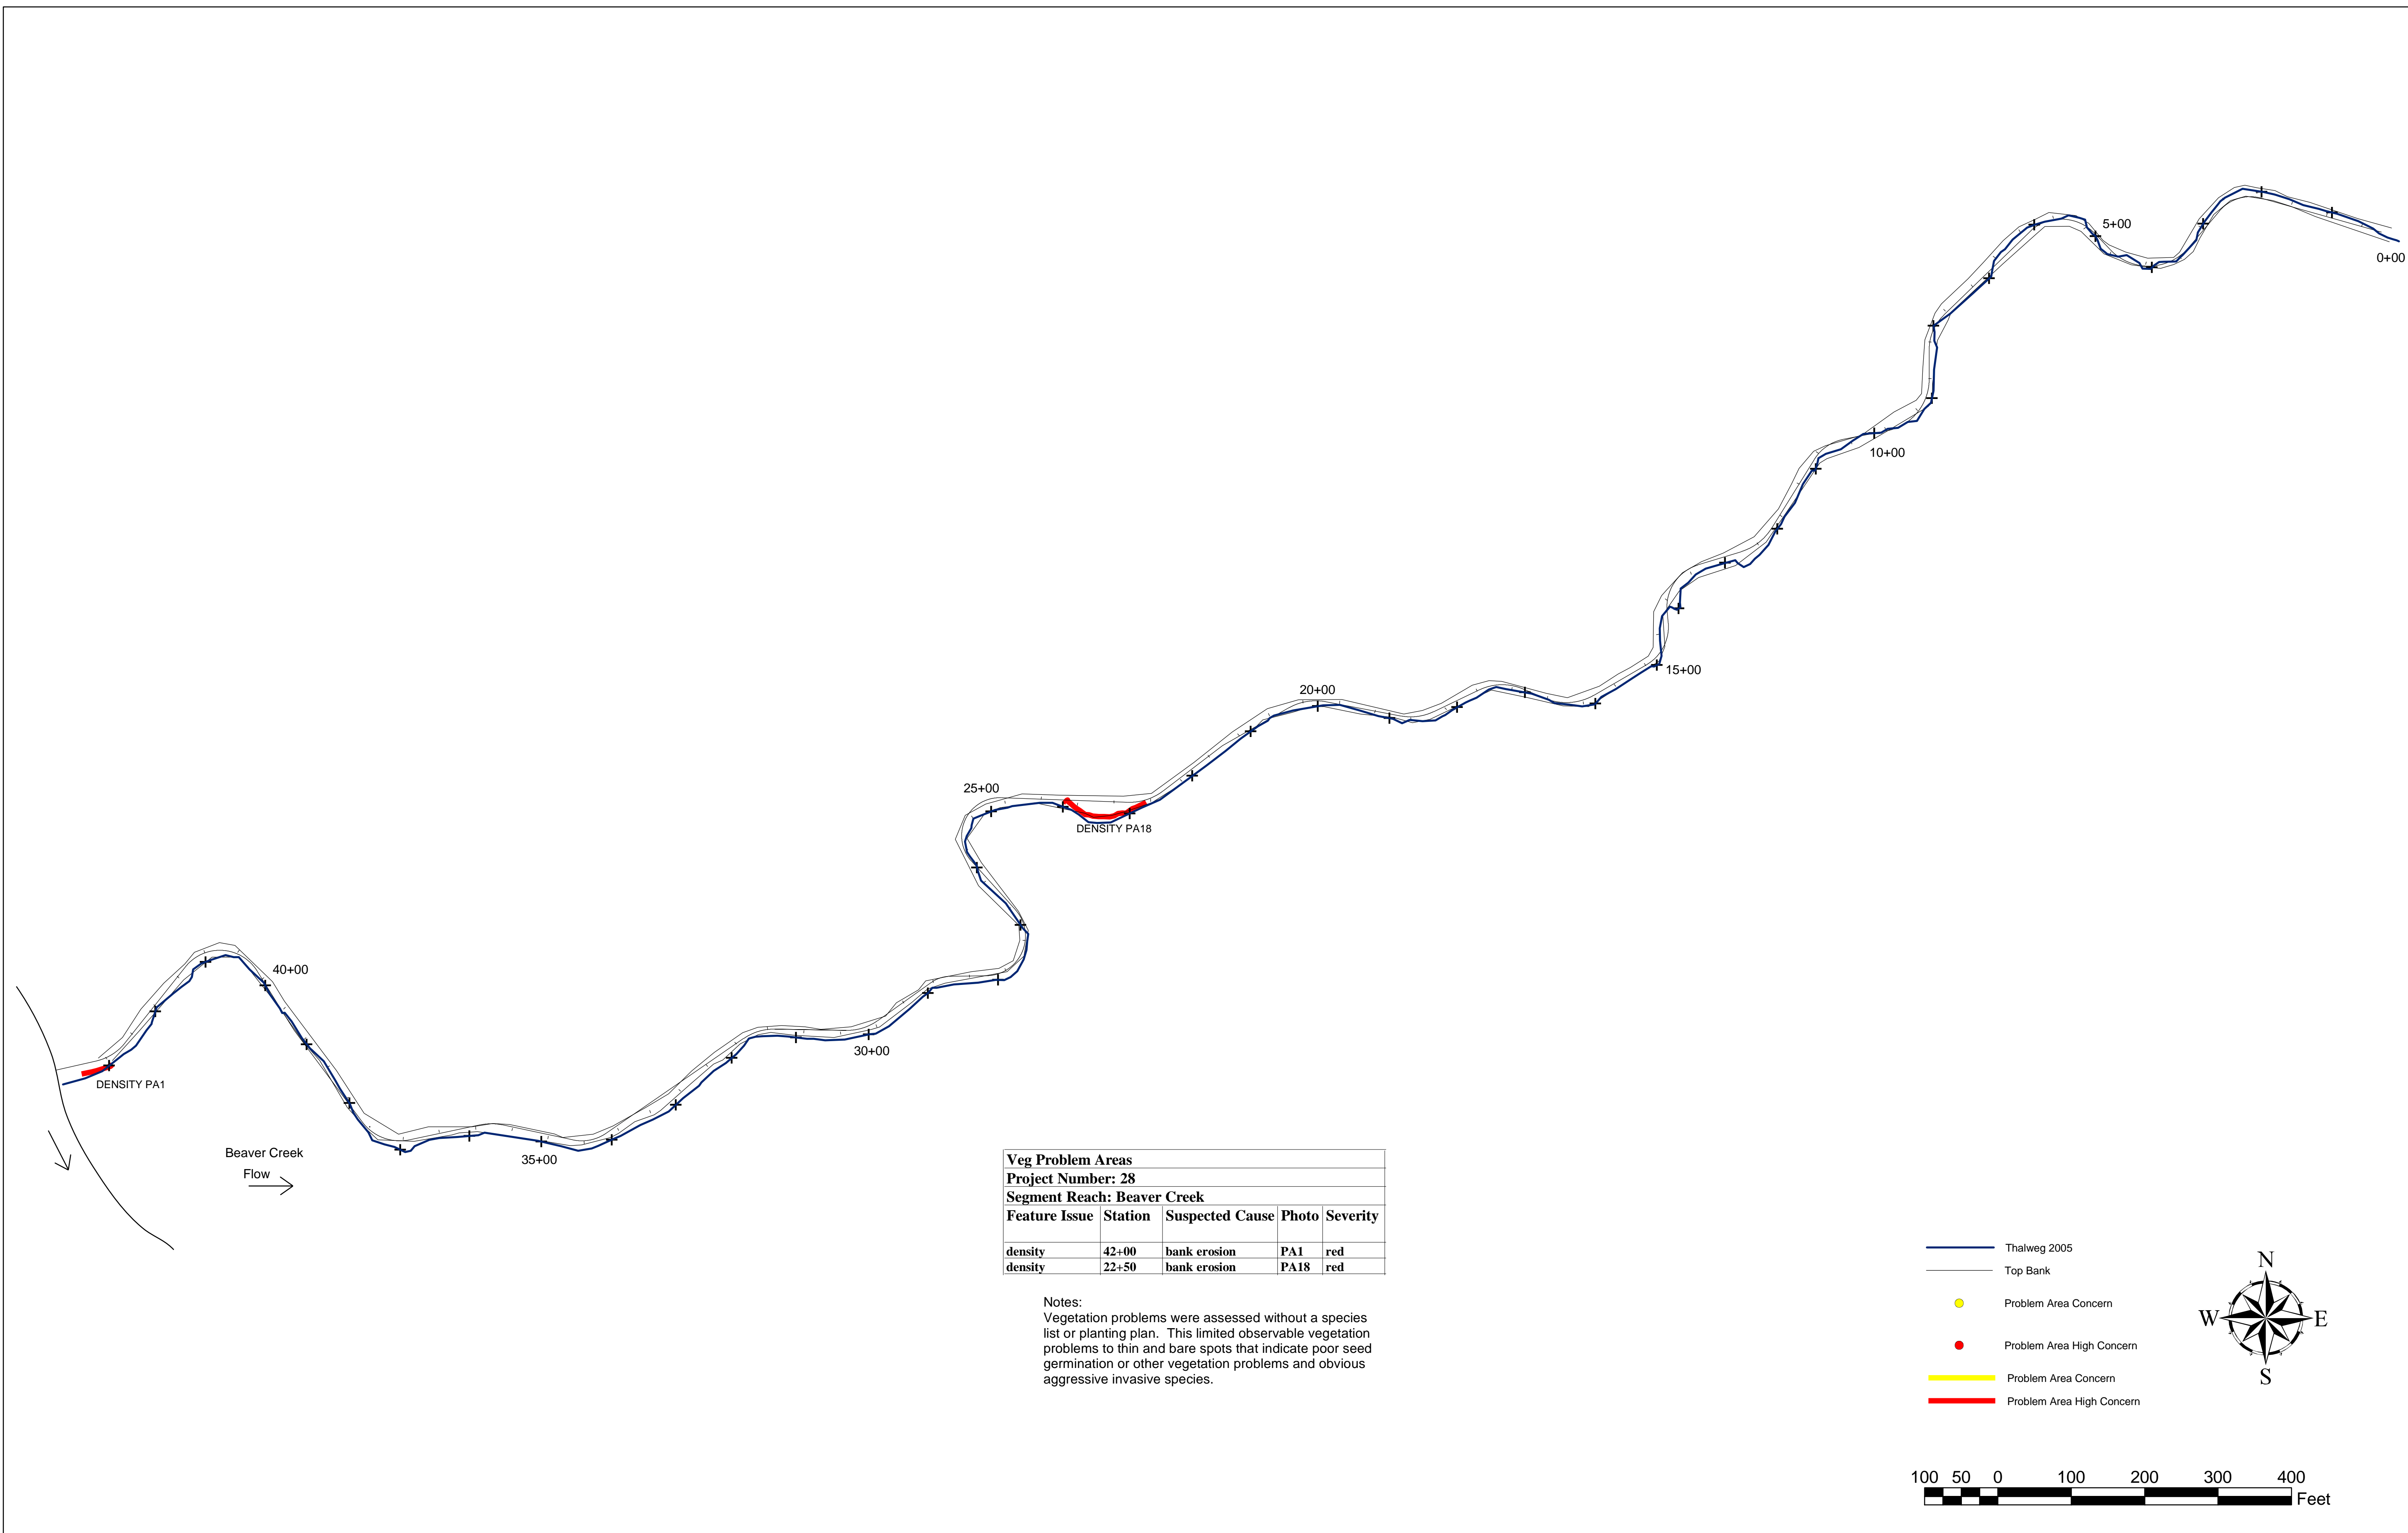
Appendix A. 1

Veg Problem Areas				
Project Number: 28				
Segment Reach: Beaver Creek				
Feature Issue	Station	Suspected Cause	Photo	Severity
density	42+00	bank erosion	PA1	red
density	22+50	bank erosion	PA18	red

Notes:
 Vegetation problems were assessed without a species list or planting plan. This limited observable vegetation problems to thin and bare spots that indicate poor seed germination or other vegetation problems and obvious aggressive invasive species.

Recommendations include replanting larger containerized trees to obtain mitigation requirements and staking in areas where erosion is problematic. Measures should be taken to prevent deer browse of planted vegetation. Although invasive vegetation is not a major issue on this project site, exotic invasive species present include *Microstegium vimineum* (Japanese grass), *Lonicera japonica* (Japanese honeysuckle), *Puerariaia montana* var. *lobata* (Kudzu) and *Paulownia tomentosa* (Princess tree). Control measures may be necessary if these species become dense.

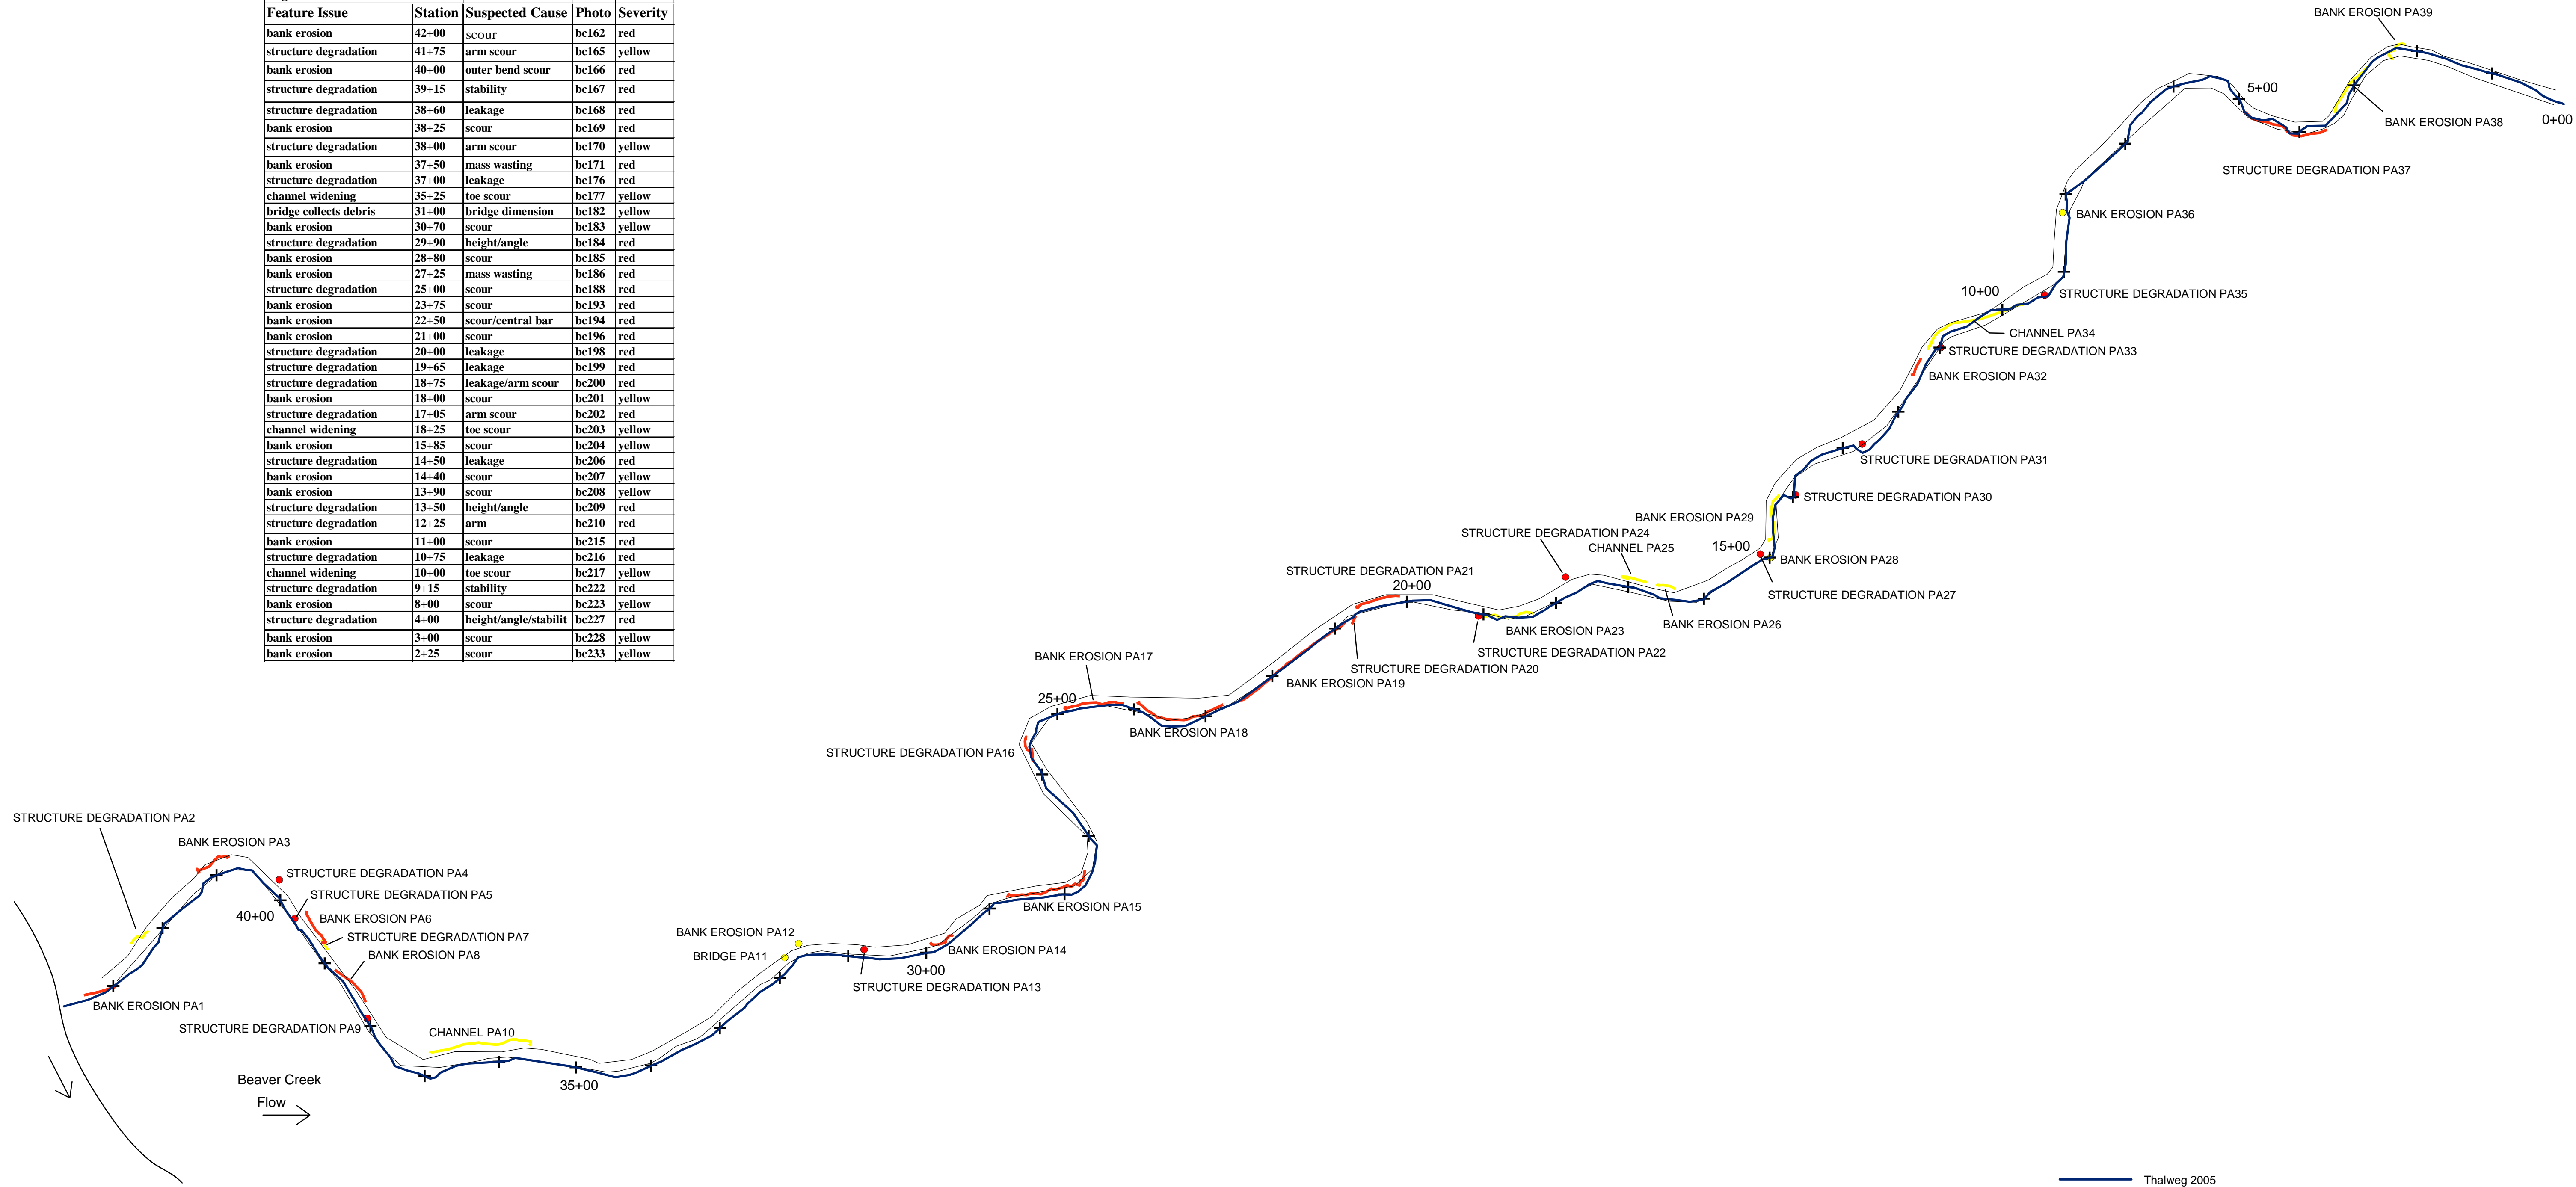
Appendix B. 1

Stream Problem Areas				
Project Number: 28				
Segment Reach: Beaver Creek				
Feature Issue	Station	Suspected Cause	Photo	Severity
bank erosion	42+00	scour	bc162	red
structure degradation	41+75	arm scour	bc165	yellow
bank erosion	40+00	outer bend scour	bc166	red
structure degradation	39+15	stability	bc167	red
structure degradation	38+60	leakage	bc168	red
bank erosion	38+25	scour	bc169	red
structure degradation	38+00	arm scour	bc170	yellow
bank erosion	37+50	mass wasting	bc171	red
structure degradation	37+00	leakage	bc176	red
channel widening	35+25	toe scour	bc177	yellow
bridge collects debris	31+00	bridge dimension	bc182	yellow
bank erosion	30+70	scour	bc183	yellow
structure degradation	29+90	height/angle	bc184	red
bank erosion	28+80	scour	bc185	red
bank erosion	27+25	mass wasting	bc186	red
structure degradation	25+00	scour	bc188	red
bank erosion	23+75	scour	bc193	red
bank erosion	22+50	scour/central bar	bc194	red

bank erosion	21+00	scour	bc196	red
structure degradation	20+00	leakage	bc198	red
structure degradation	19+65	leakage	bc199	red
structure degradation	18+75	leakage/arm scour	bc200	red
bank erosion	18+00	scour	bc201	yellow
structure degradation	17+05	arm scour	bc202	red
channel widening	18+25	toe scour	bc203	yellow
bank erosion	15+85	scour	bc204	yellow
structure degradation	14+50	leakage	bc206	red
bank erosion	14+40	scour	bc207	yellow
bank erosion	13+90	scour	bc208	yellow
structure degradation	13+50	height/angle	bc209	red
structure degradation	12+25	arm	bc210	red
bank erosion	11+00	scour	bc215	red
structure degradation	10+75	leakage	bc216	red
channel widening	10+00	toe scour	bc217	yellow
structure degradation	9+15	stability	bc222	red
bank erosion	8+00	scour	bc223	yellow
structure degradation	4+00	height/angle/stability	bc227	red
bank erosion	3+00	scour	bc228	yellow
bank erosion	2+25	scour	bc233	yellow
