**Beaver Creek
Stream Restoration Monitoring Report**

DMS Project # 028

Monitoring Year: 2016

**BEAVER CREEK STREAM RESTORATION
PROJECT #28 - MONITORING YEAR 05**
SURRY COUNTY, NORTH CAROLINA

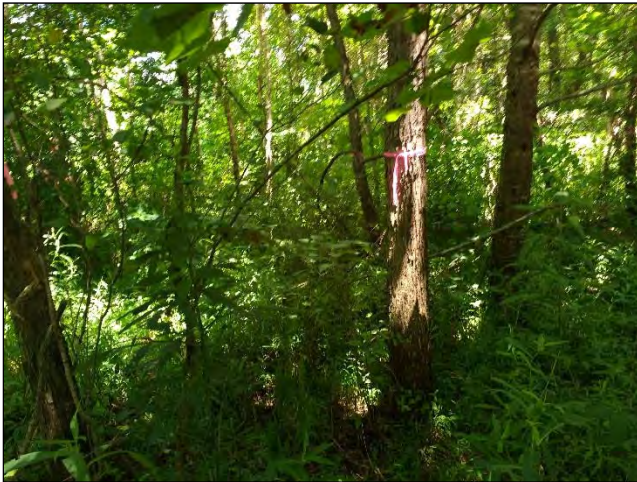
Plot 4 Photo. MY05 – 7/1/2016

Table 7. Vegetation Plot Criteria Attainment	
Project Number and Name: 028 - Beaver Creek	
Vegetation Plot ID	Vegetation Survival Threshold Met?
4	No
10	Yes
11	Yes
12	Yes
15	No

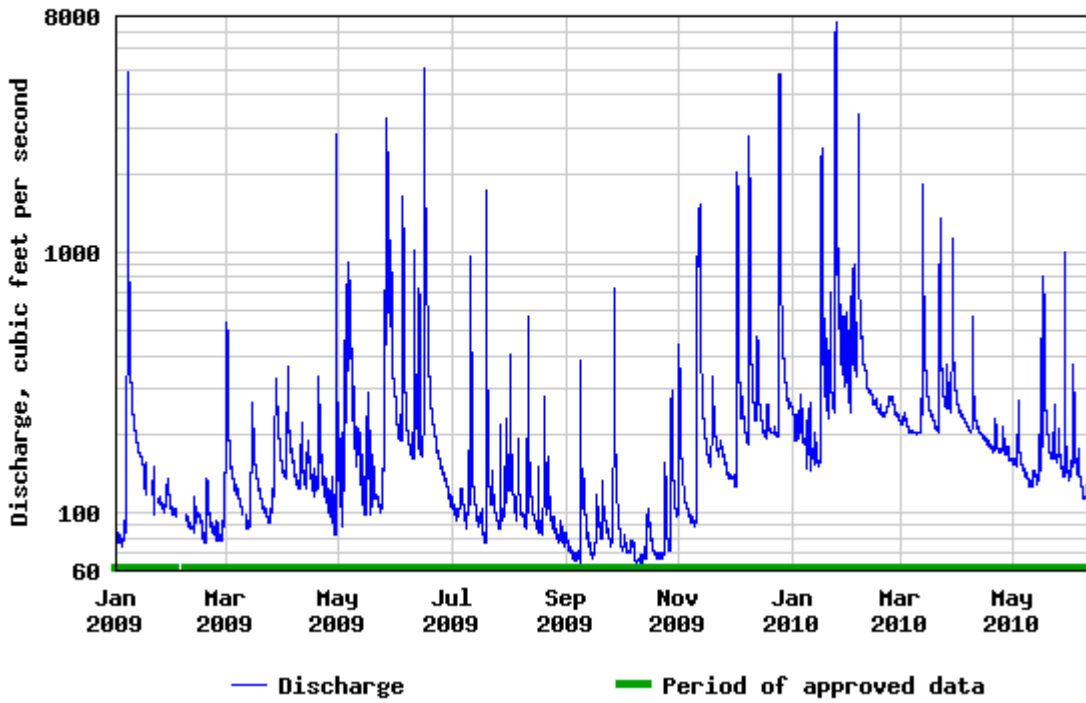
Date of Data Collection	Date of Occurrence	Method	Photo Number
9/19/2008	Oct. 2007	Proximal USGS Gage Resource	N/A
9/19/2008	March 2008	Proximal USGS Gage Resource	N/A
2/2/2016	Dec. 2008	Proximal USGS Gage Resource	N/A
2/2/2016	Jan. 2009	Proximal USGS Gage Resource	N/A
2/2/2016	June 2009	Proximal USGS Gage Resource	N/A
2/2/2016	Dec. 2009	Proximal USGS Gage Resource	N/A
2/2/2016	Jan. 2010	Proximal USGS Gage Resource	N/A
5/20/2016	Unknown	Photographs taken on-site, on-site crest gauge	1-2

Photo 1. Wrack lines at bankfull
