**BEAVERDAM CREEK
STREAM RESTORATION PROJECT**
ANNUAL MONITORING REPORT FOR 2007-2008 (YEAR 2)

Project Number: D05016-1

Prepared by: Michael Baker Engineering, Inc.

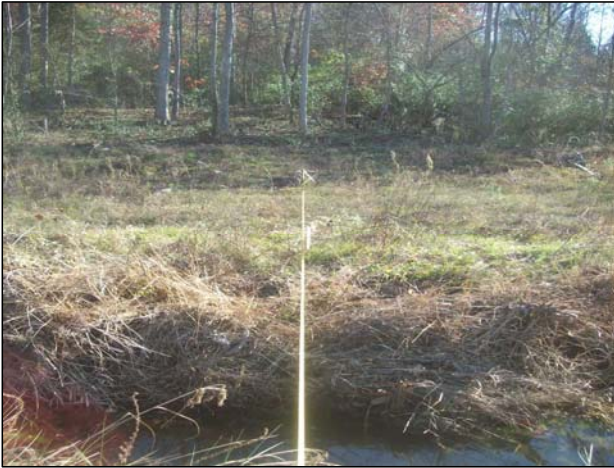
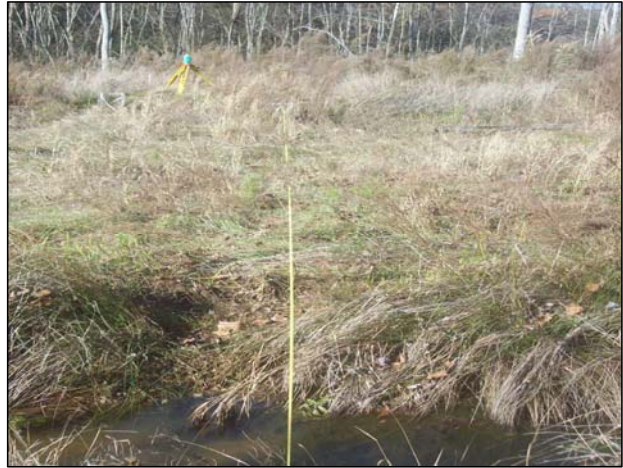
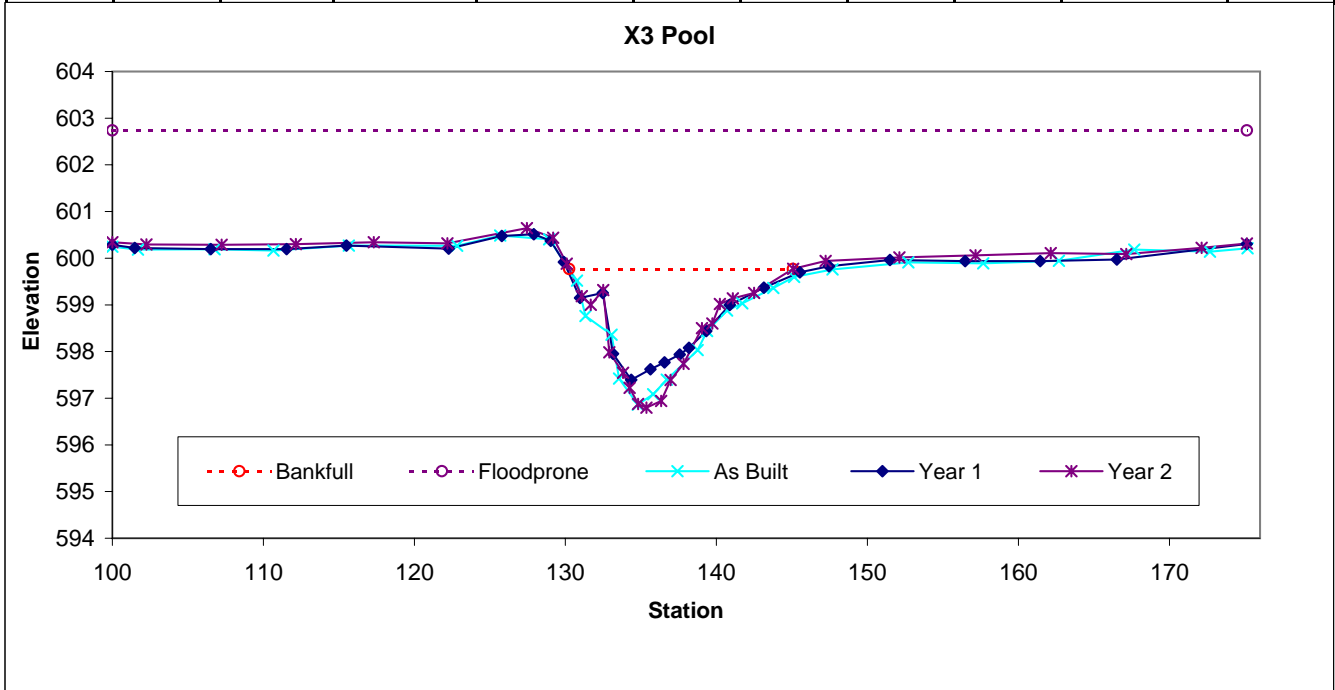
UT1 Permanent Cross Section X3
 (Year 2 Monitoring Data - collected November 2008)

A few cross-sections show evidence of bed scour along UT1 and include cross-sections 3, 13, 16, and 17, which are located across pools found at the apex of a meander bend. The outside of meander bends experience an increase in shear stress during large storm events that can cause scour. The project site experienced a 7.54 inch precipitation event between August 25 and 27, 2008, which likely lead to the scour in these pools. Scour and deepening of some pools is expected and has not resulted in any observed channel instability. The installation of cover logs at meander bends promotes habitat and encourages scour.

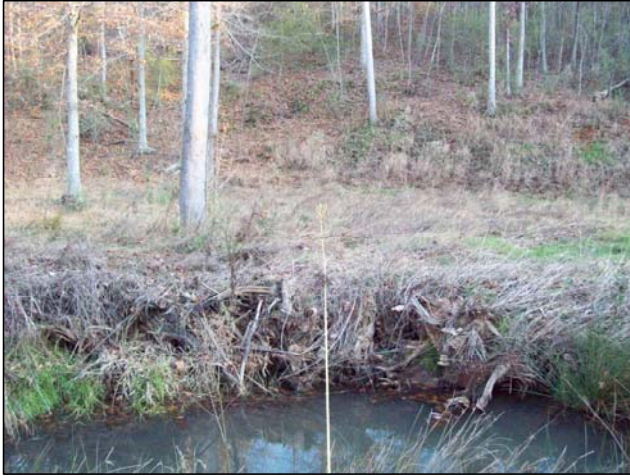
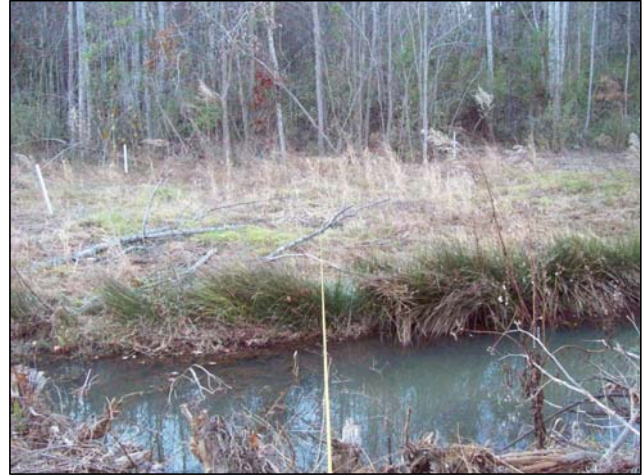
UT1 Permanent Cross Section X10
 (Year 2 Monitoring Data - collected November 2008)

A couple cross-sections show point bar formation along UT1 and include cross-sections 10 and 11, which are located across pools found at the apex of a meander bend. Flow through a meander bend possesses higher conveyance velocity along its boundary with the outer bank of the bend, and lower flow velocity along its boundary with the bend's inner bank. As flow reduces, its sediment transport capacity also reduces, causing flow to drop some of its transported sediment as it slows down. Point bar formation along the inside of a meander bend indicates flow velocity vectors occurring as designed, and is therefore expected.

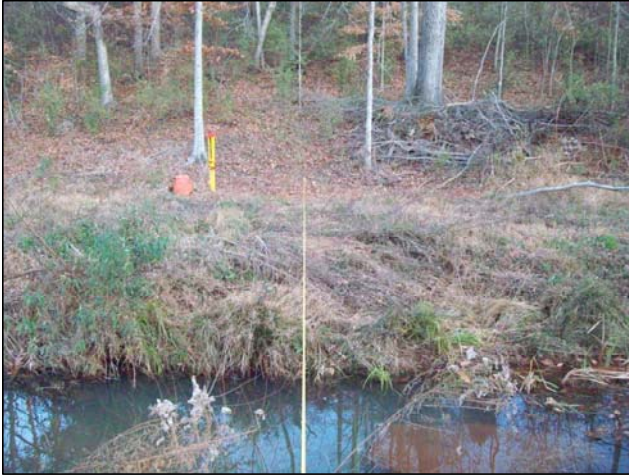
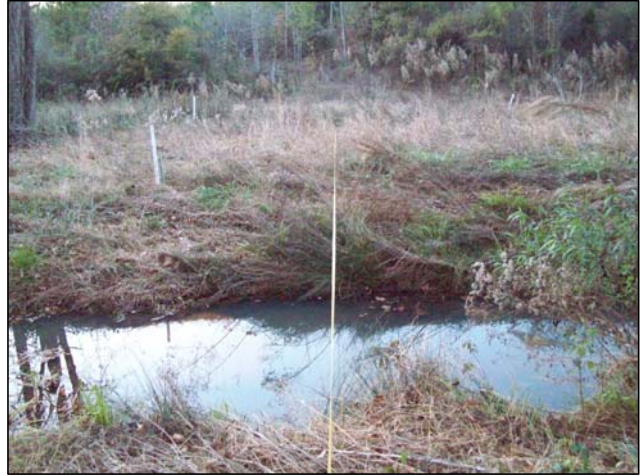
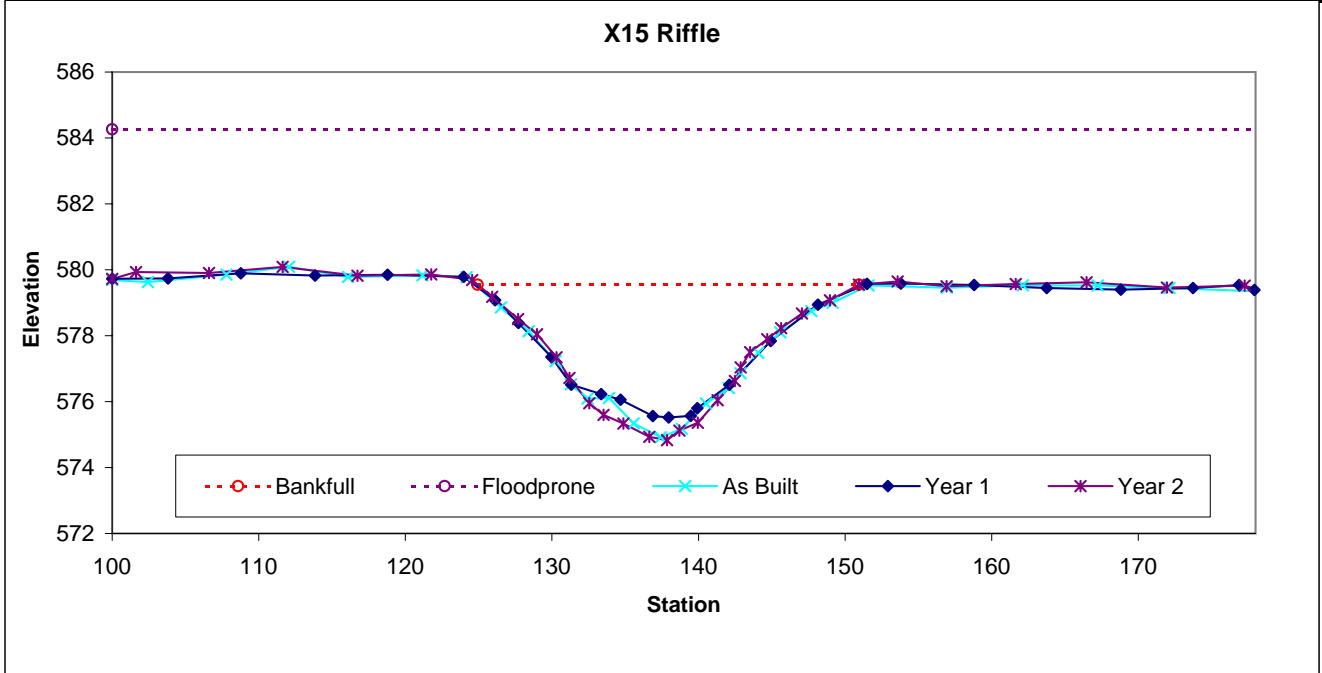
UT1 Permanent Cross Section X15
 (Year 2 Monitoring Data - collected November 2008)

Cross-section 15 also experienced scour but unlike the other cross-sections it's located in a straight section of channel immediately upstream of a large in-stream boulder. During storm events streamflow is diverted around the boulder and has causes bed scour on the upstream side, which is seen in Cross-section 15. This change in channel geometry will be monitored but doesn't require other action.
