**BEAVERDAM CREEK
STREAM RESTORATION PROJECT**
ANNUAL MONITORING REPORT FOR 2008-2009 (YEAR 3)

Project Number: D05016-1

December, 2009

Prepared by: Michael Baker Engineering, Inc.

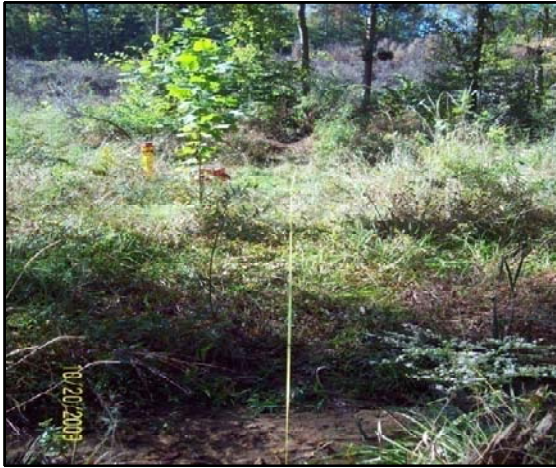
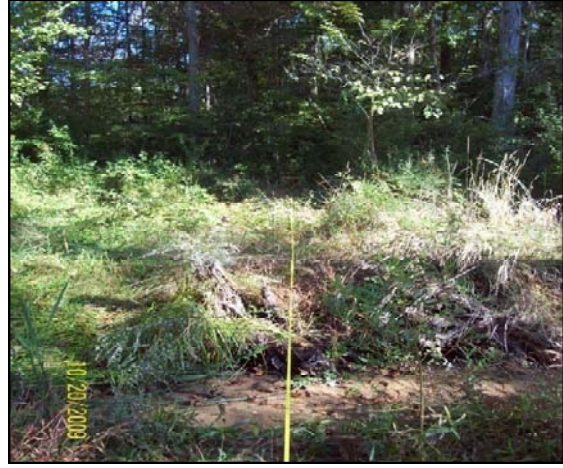
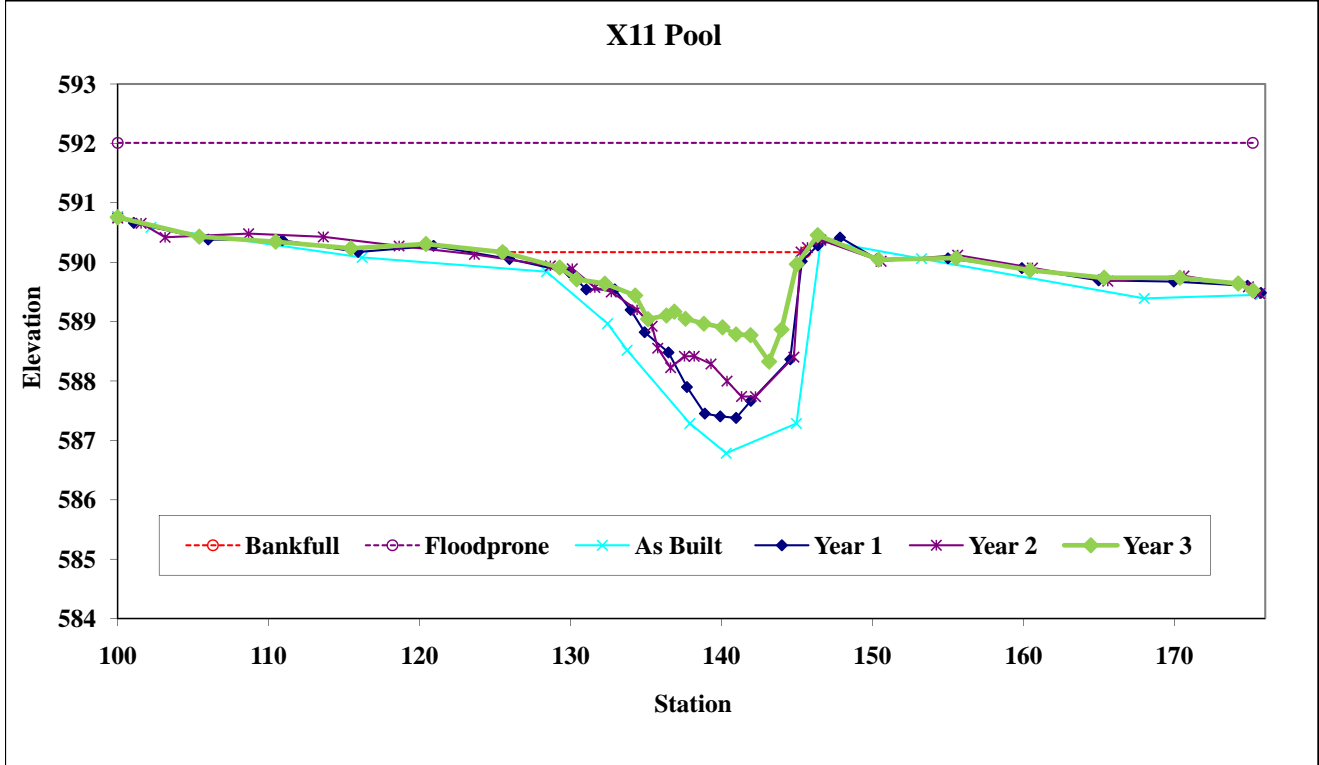
UT1D Permanent Cross Section X11
(Year 3 Monitoring Data - collected October 2009)

Cross-sections 11 and 17, are located across pools that have have experienced aggradation during Year 3. The aggradation documented at X11 is due to an unknown offsite sediment source. The recent deposition is only present at the very top of UT1D. X17 experienced bed scour during Year 2 as a result of 7.54 inch precipitation event between August 25 and 27, 2008. During Year 3 X17 has aggraded back towards its as-built depth. Scour followed by aggradation is a natural cycle in pool features and has not resulted in any observed channel instability. Photographs of X17 indicate that the banks of the stream are stable with vegetation.

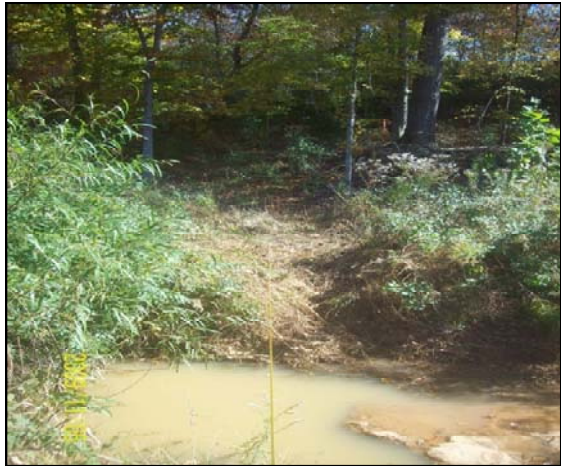
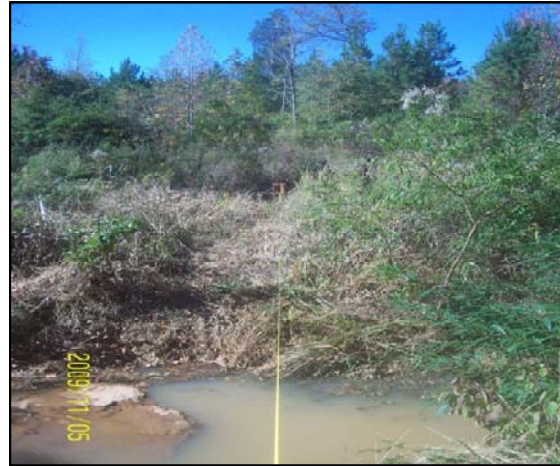
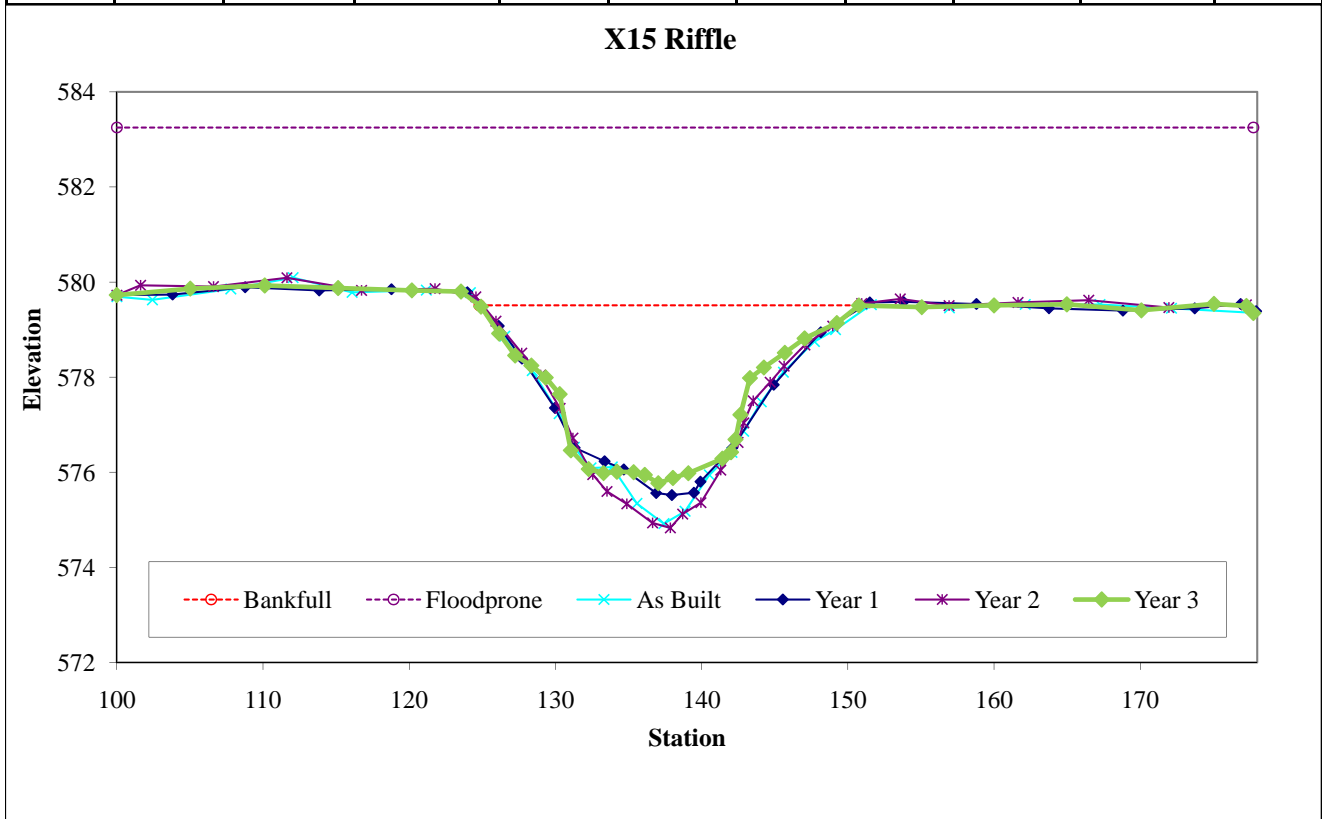
UT1 Permanent Cross Section X15
(Year 3 Monitoring Data - collected October 2009)

Cross-section 15, a riffle, also experienced aggradation. X15 is located immediately upstream of a large in-stream boulder. The aggradation in Year 3 followed scour observed during Year 2. This change in channel geometry is most likely influenced by the boulder structure and will be monitored, however no other action is required at this time.
