BEAVERDAM CREEK STREAM RESTORATION PROJECT

ANNUAL MONITORING REPORT FOR 2009 - 2010 (YEAR 4)

Project Number: D05016-1

Prepared by: Michael Baker Engineering, Inc.

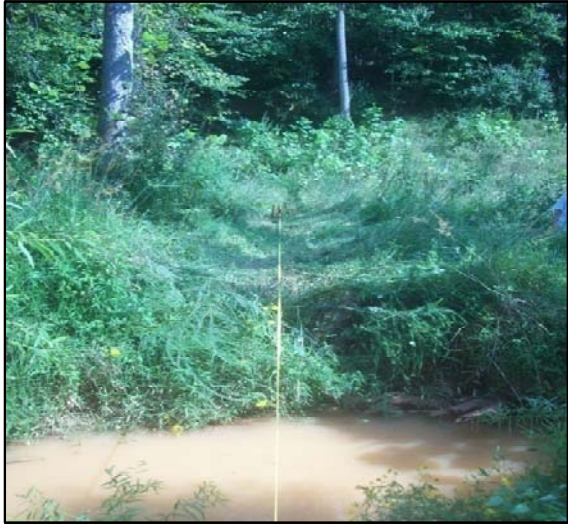
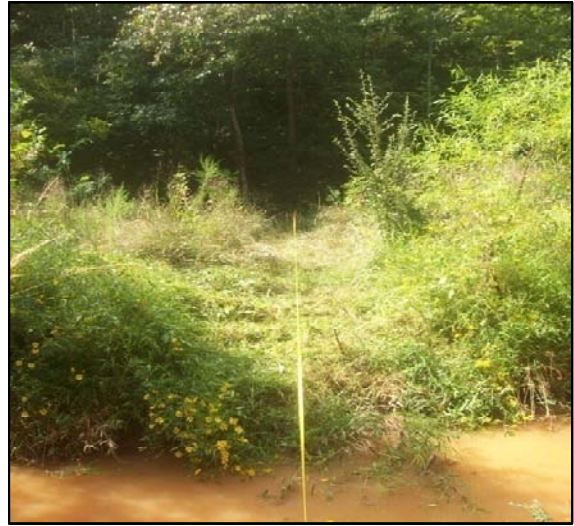
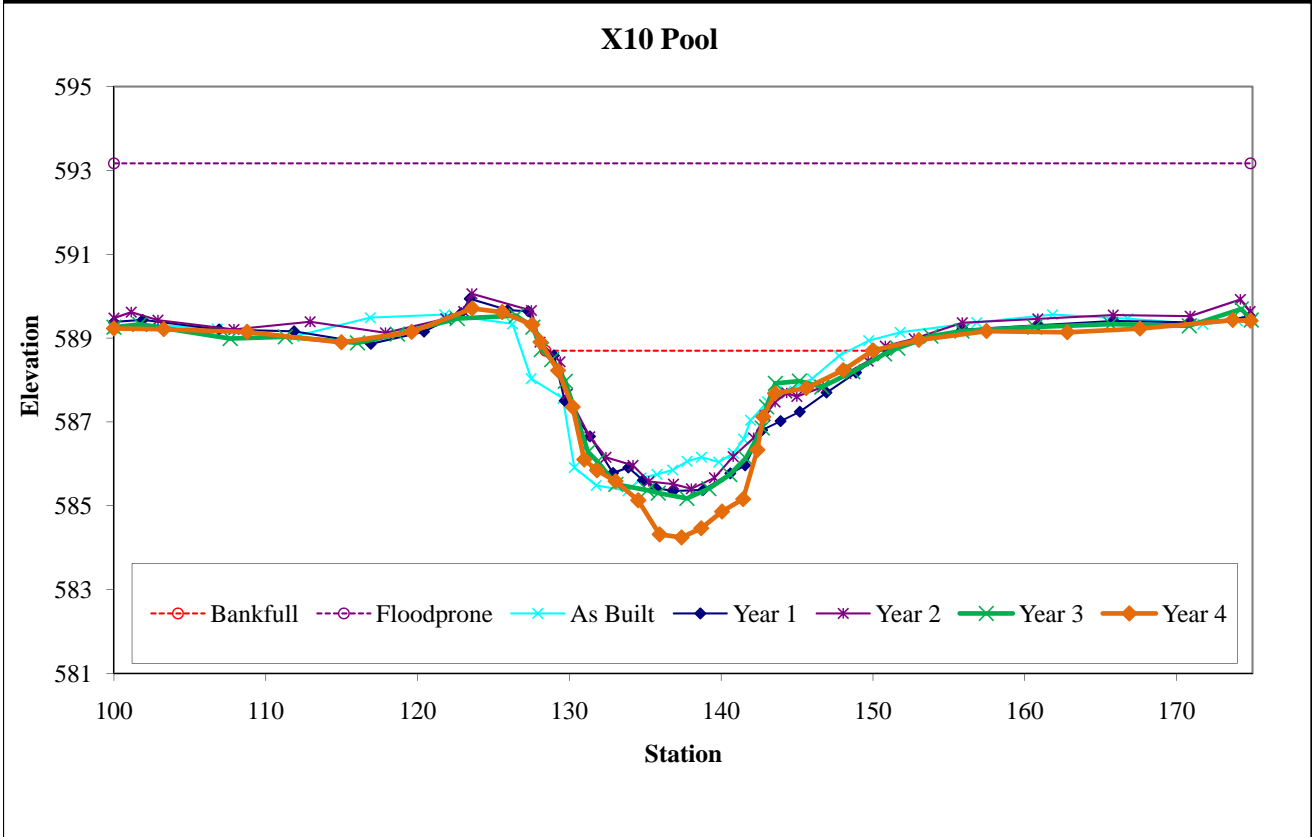
UT1 Permanent Cross Section X10
 (Year 4 Monitoring Data - collected September 2010)

Cross-section 10 is located across a pool that has experienced minor degradation during Year 4. Scour and deepening of some pools is expected and has not resulted in any observed channel instability. Photographs of X10 indicate that the banks of the stream are stable with vegetation.

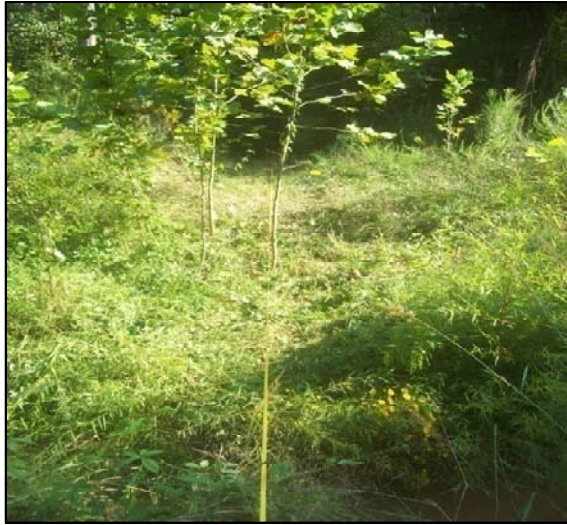
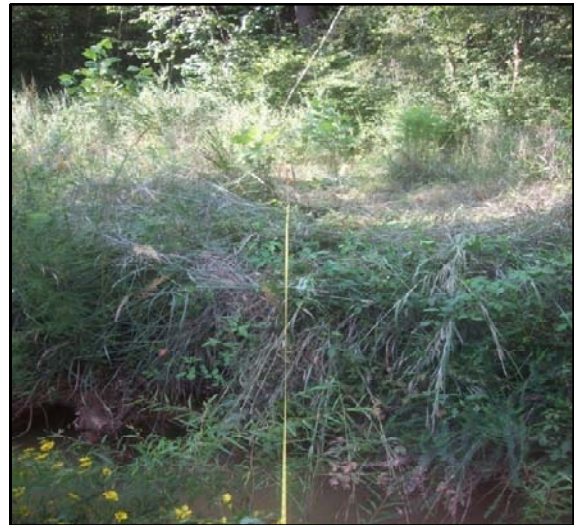
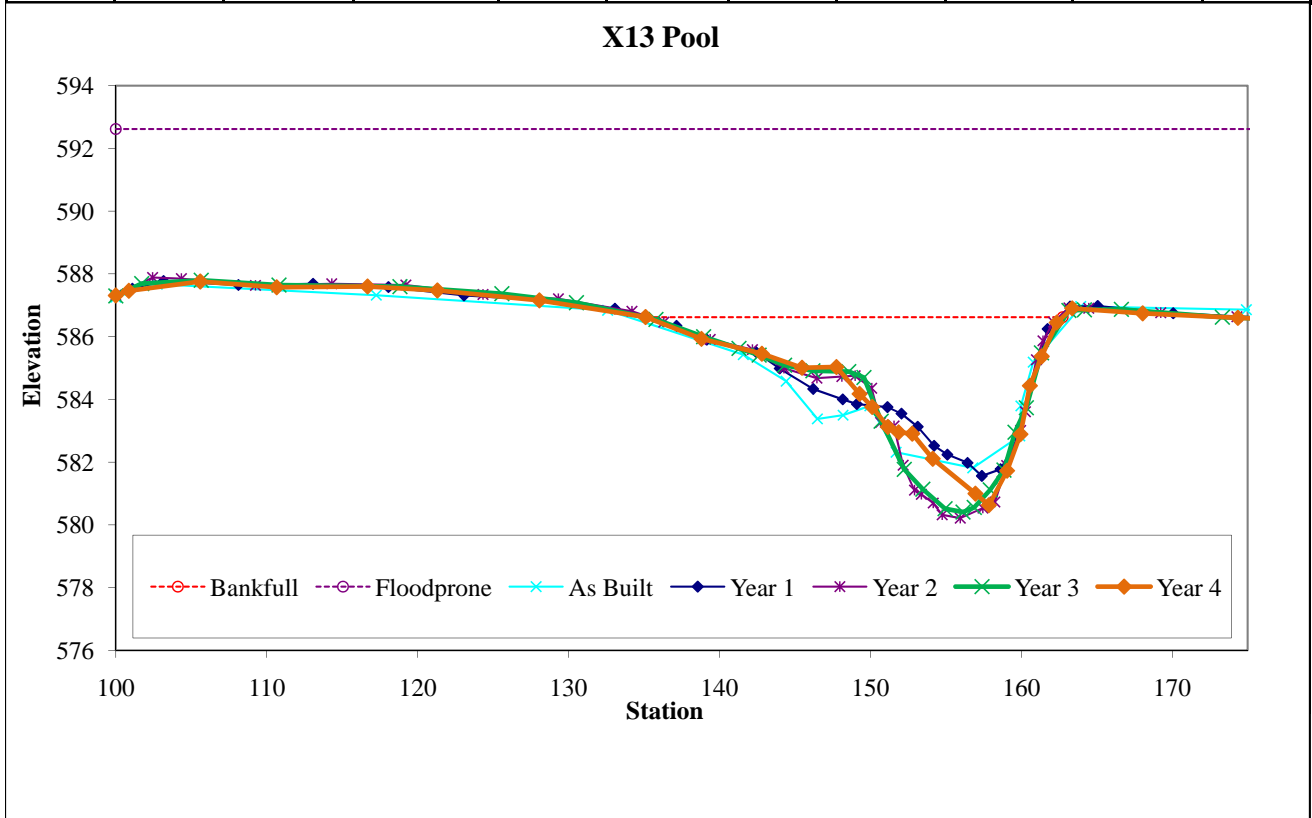
UT1 Permanent Cross Section X13
(Year 4 Monitoring Data - collected September 2010)

Cross-section 13 is located in a pool that has experienced minor bed aggradation along the inner half of the meander bend during Year 4. This slight adjustment has not resulted in any observed channel instability.
