**BEAVERDAM CREEK
STREAM RESTORATION PROJECT**
ANNUAL MONITORING REPORT FOR 2010 - 2011 (YEAR 5)

Project Number: D05016-1

December, 2011

Prepared by: Michael Baker Engineering, Inc.

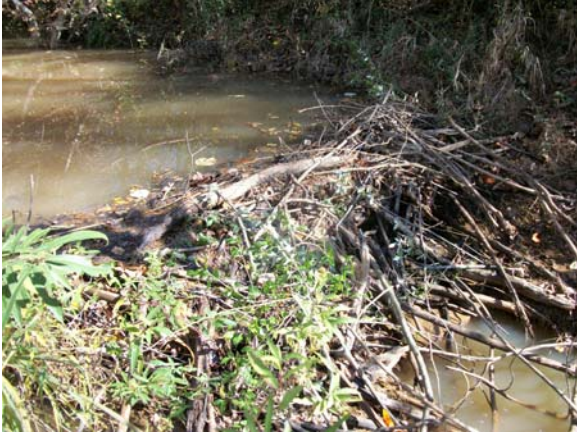
During the Year 5 assessment two beaver dams were observed for the first time in the project's history. The dams were located at Stations 10+20 and 15+70 of UT1. Log sill structures at Stations 21+70, 22+15, 24+60, and 25+90 on UT1 had been bypassed either by scour under the structure or failure of the fabric seal. In addition the right bank immediately below the log sills at 21+70 and 24+60 showed signs of minor bank scour as did root wad structures at station 57+50, 62+60, and 68+60 of UT1. Minor scour was also observed at the root wad at Station 13+00 on UT1B. Fallen trees and limbs are also present within some of the project channels. These observations are reflected in minor changes in the performance scores.

UT1 – Beaver dam at Station 10+20

A wildlife removal specialist has been contacted and is currently trapping any on-site beavers. Both dams have been partially removed to encourage beaver activity and assist in trapping. Complete removal of the dams will occur after the beavers have been removed from the site. Repairs to minor bank scour areas along UT1 will be made using hand tools, as needed. In general, coir logs will be used to help re-seal the log sill structures and bio-engineering will be implemented at all minor bank erosion areas. Additionally, any branches and/or trees that have fallen across the channel will be removed during the project's maintenance activities.

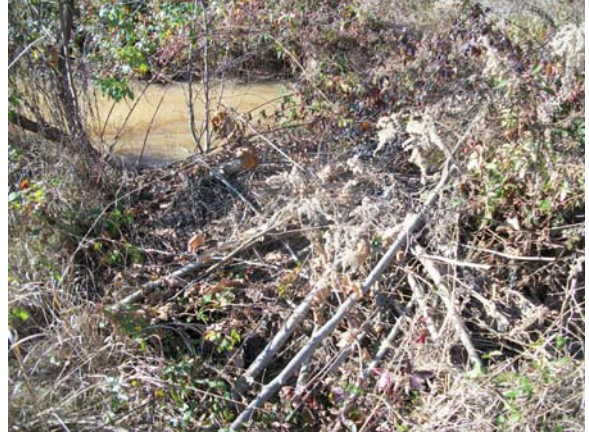
UT1 – Beaver lodge at 14+10

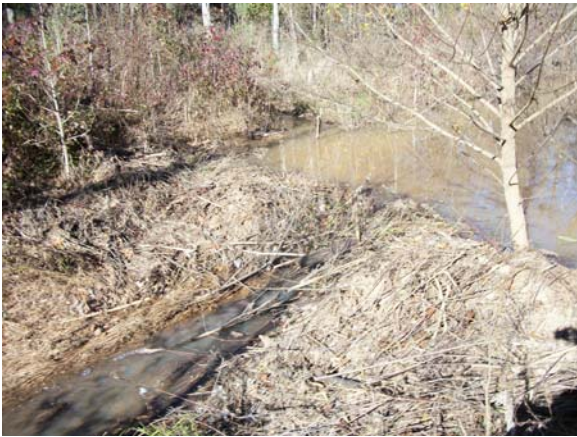
The representative longitudinal profile along the restored channel was resurveyed to document stream profile at the end of monitoring Year 5. Riffle slopes and pool-to-pool spacing were not calculated for Reach 1 of UT1 because the entire reach is experiencing backwater conditions resulting from a beaver dam located at Station 15+70 of UT1.

UT1 – Beaver dam at Station 15+70

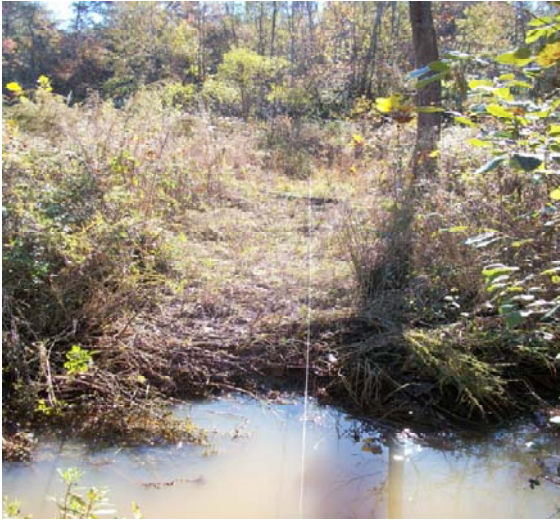
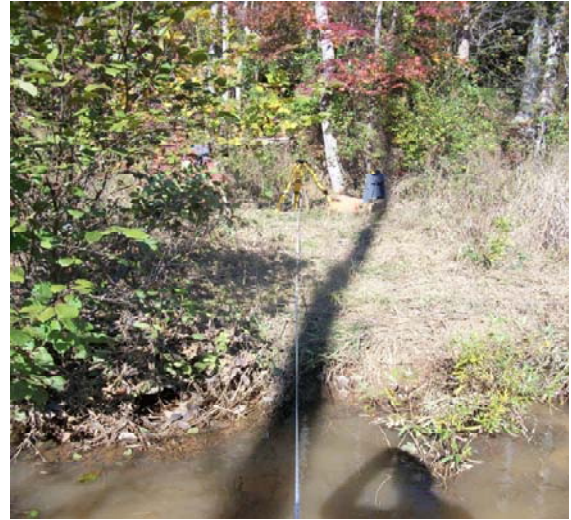
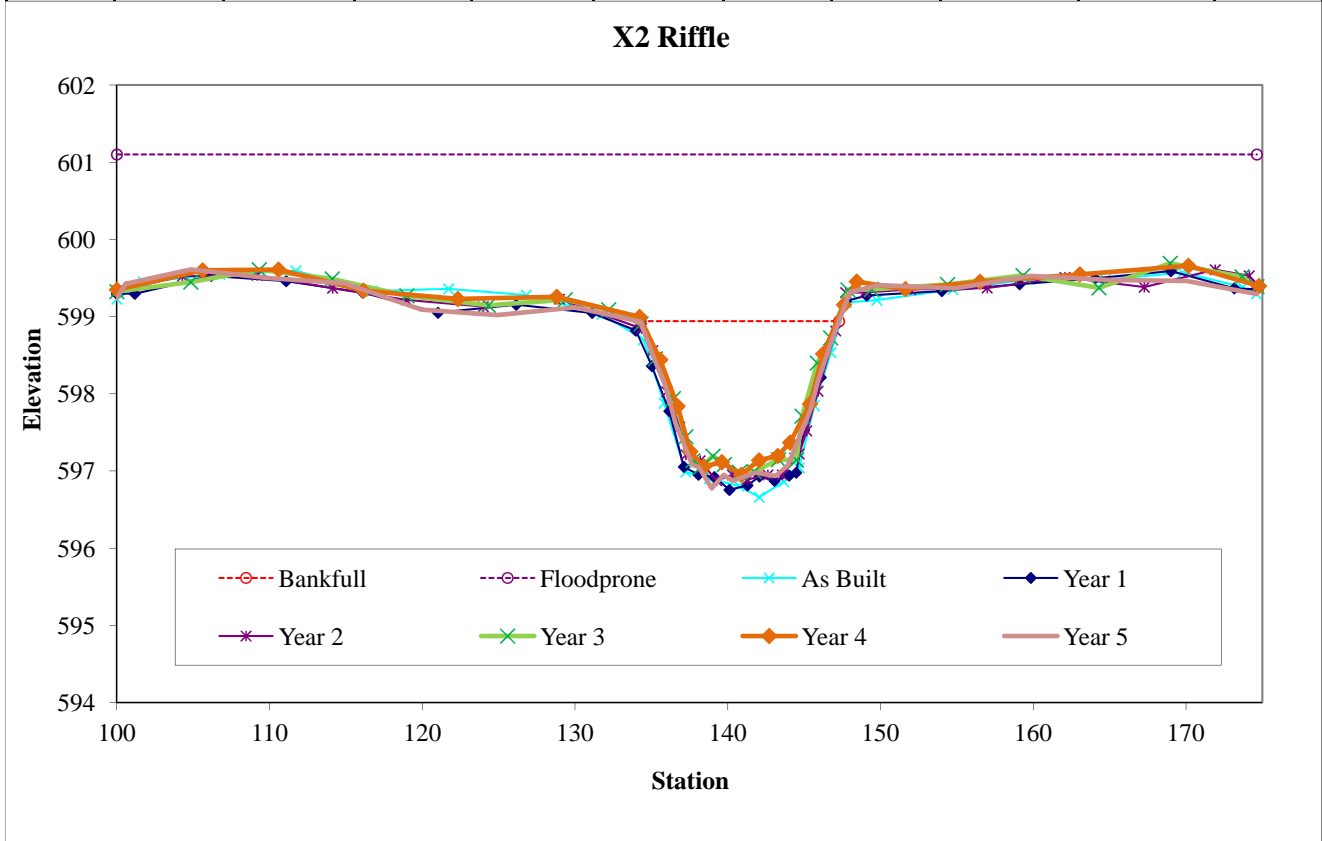
UT1 Permanent Cross Section X2
(Year 5 Monitoring Data - collected October 2011)

a thin layer of fine mud overlying the coarser bed material installed during construction. The finer sediment has accumulated in backwater conditions due to a beaver dam just downstream of Cross-section 2. The accumulation hasn't affected channel stability. All pebble count data are provided in Appendix B.

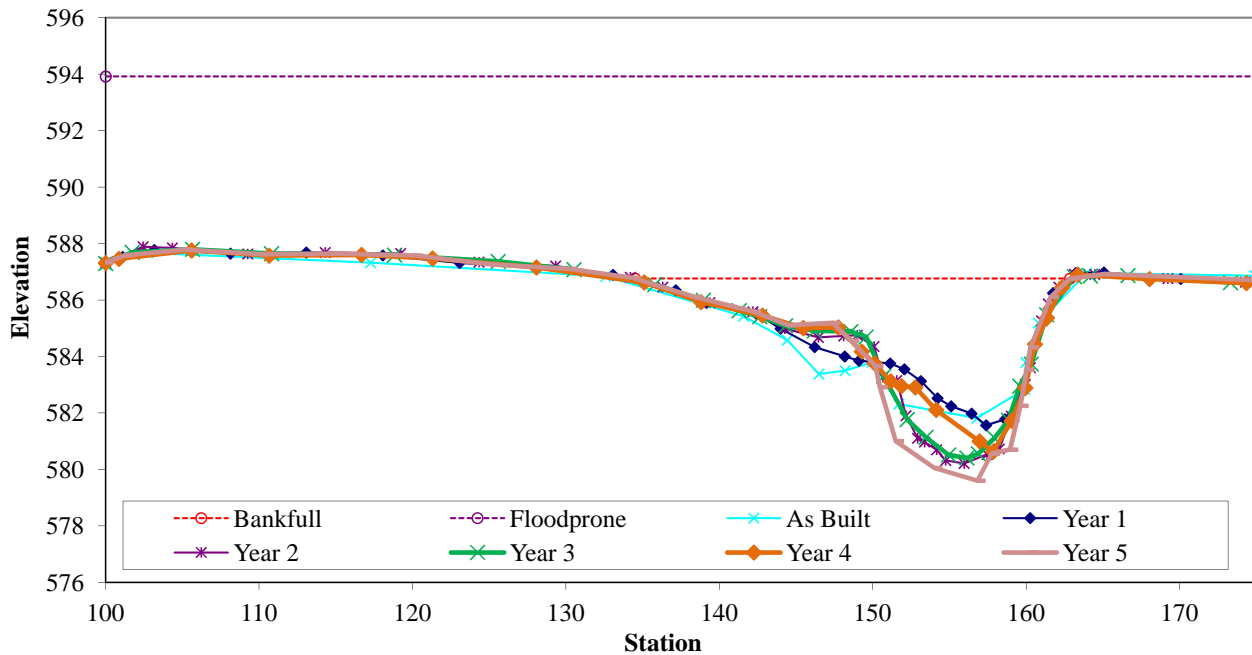
X13 Pool

Cross-section 13 is located across a pool that has experienced minor degradation during Year 5. This cross-section has experienced a cyclic pattern of minor degradation and aggradation through the five years of monitoring. These fluctuations in pool geometry are expected and have not resulted in any observed channel instability.

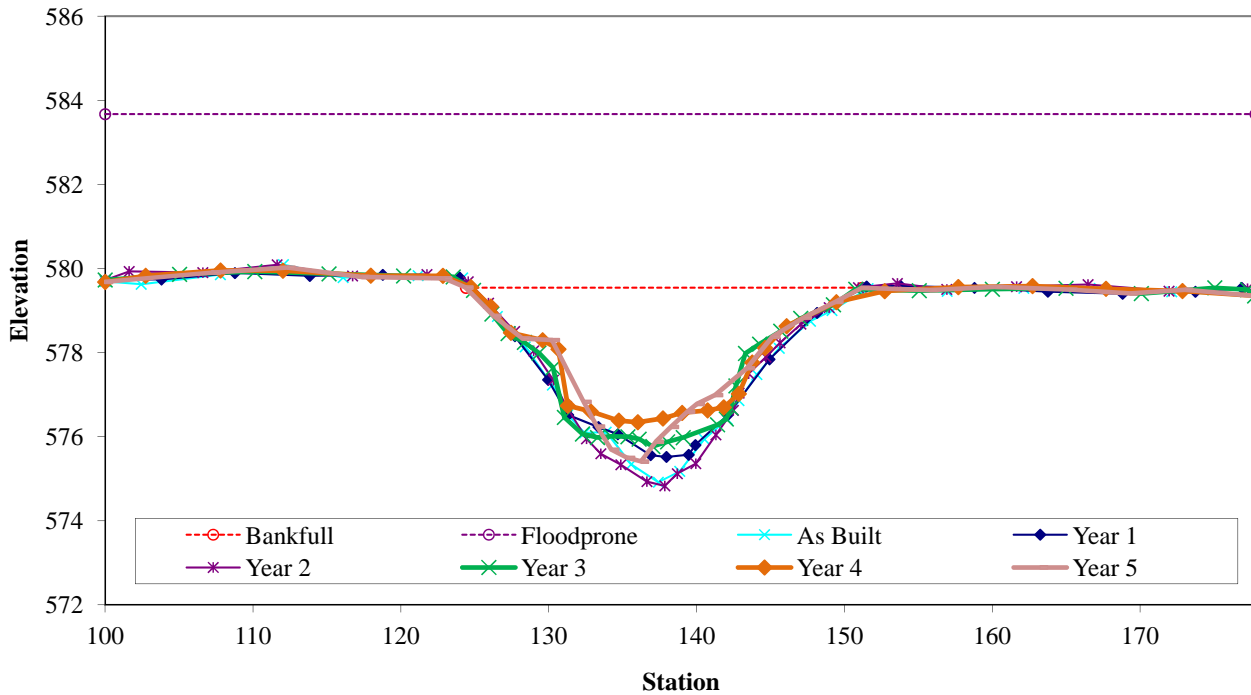
X15 Riffle

Cross-section 15, a riffle, also experienced degradation and similar to X13 this cross-section has exhibited a cyclic pattern of minor degradation and aggradation during post-construction monitoring. These minor fluctuations in channel geometry are likely the result of a large in-stream boulder immediately upstream of X15.
