# **Year 1 Monitoring Report for Stream Restoration of Beaverdam Creek and Unnamed Tributaries**

Union County, NC  
SCO # D06054-C

**Submitted:** December 2009

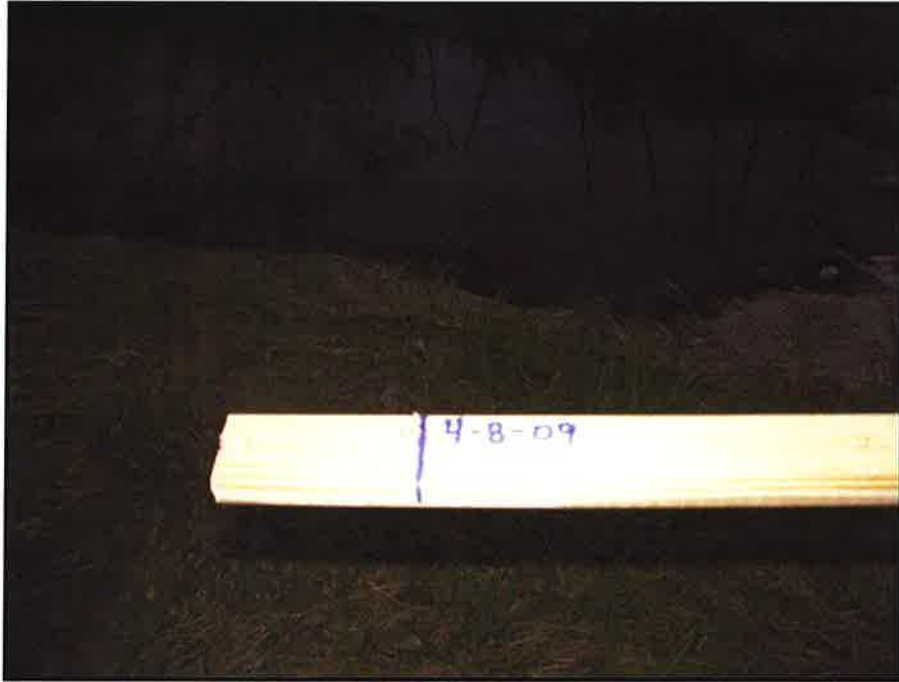
**BF 1**  
**Crest gage at 5+50 on UT1.**  
(EMH&T, Inc. 4/8/09)

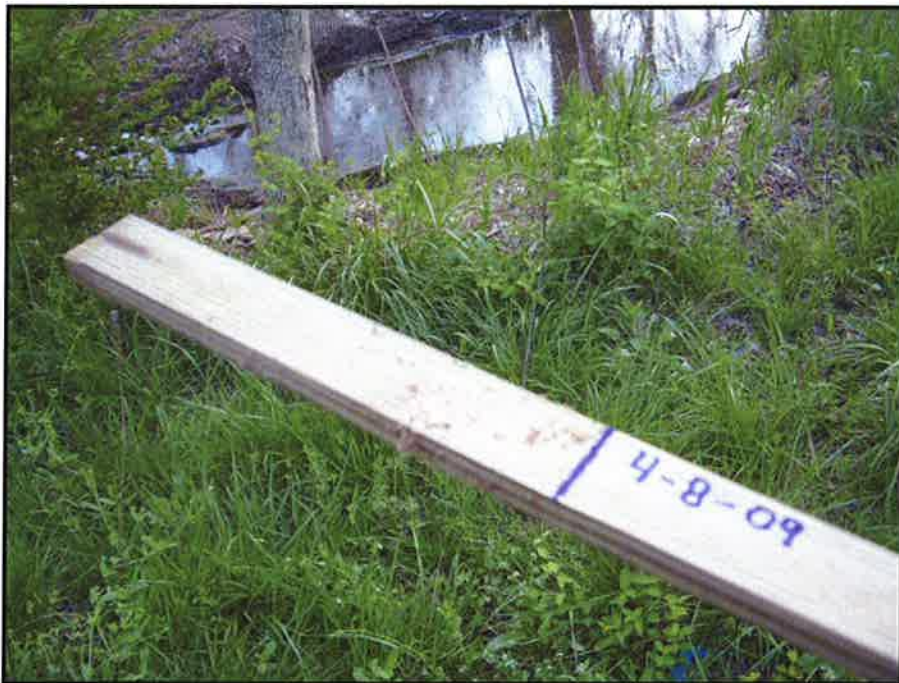
**BF 2**  
**Crest gage at 22+75 on UT1.**  
(EMH&T, Inc. 4/8/09)
