Subject: Year 2 Monitoring Report for Stream Mitigation of Beaverdam Creek
SCO# D06054-C

Year 2 Monitoring Report for Stream Restoration of Beaverdam Creek and Unnamed Tributaries

Union County, NC
SCO # D06054-C

Submitted: December 2010

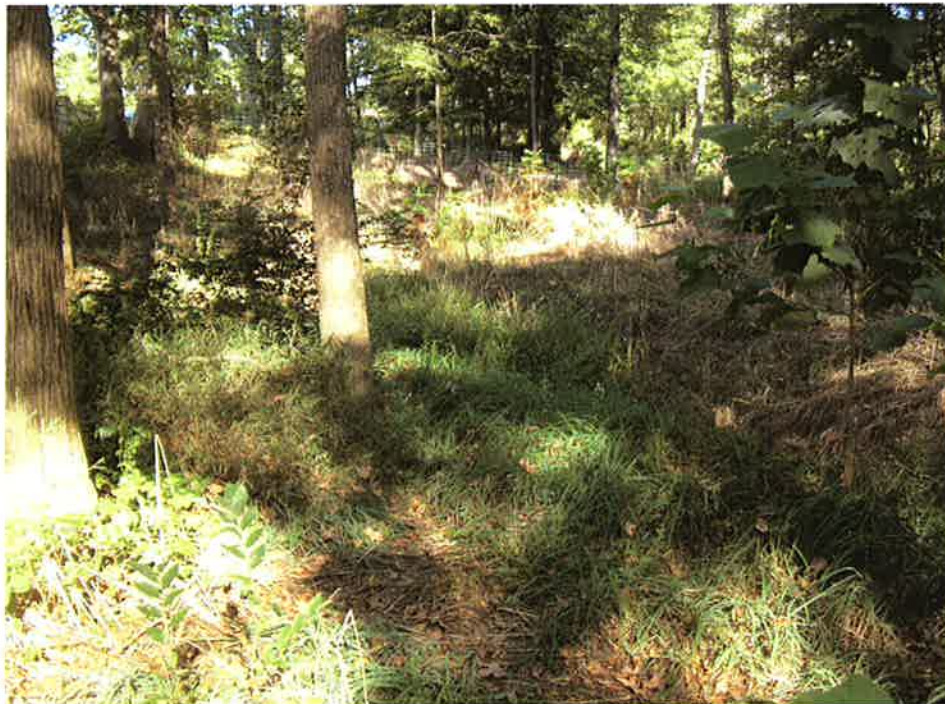
Fixed Station 2
Overview of UT1, looking upstream near station 19+00
(EMH&T, Inc. 9/19/10)

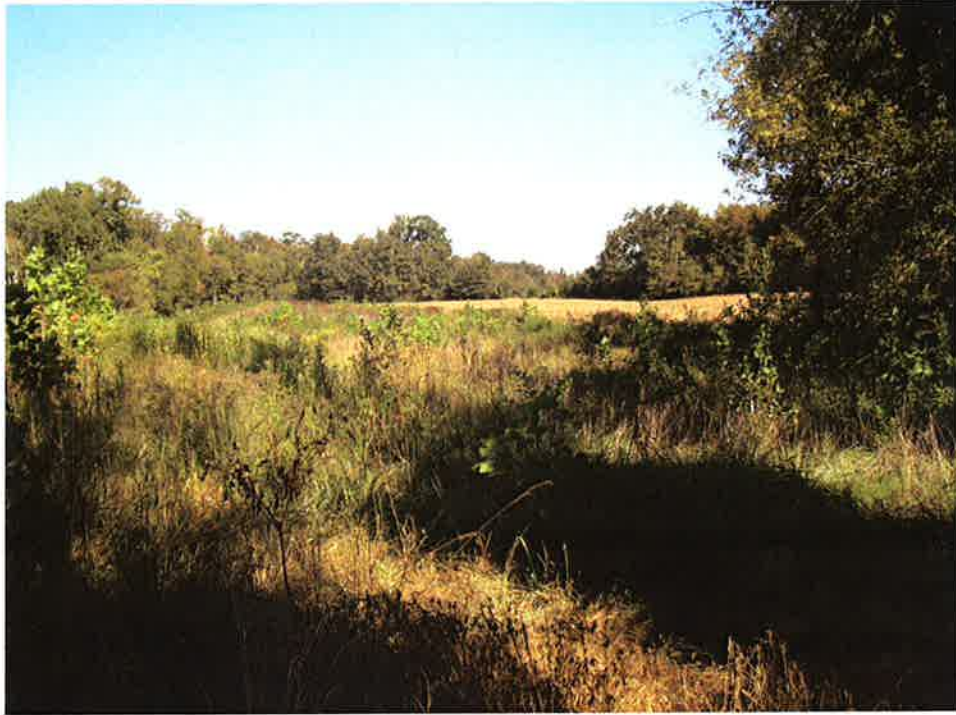
Fixed Station 3
Overview of valley along UT1, looking upstream near station 13+00.
(EMH&T, Inc. 9/19/10)

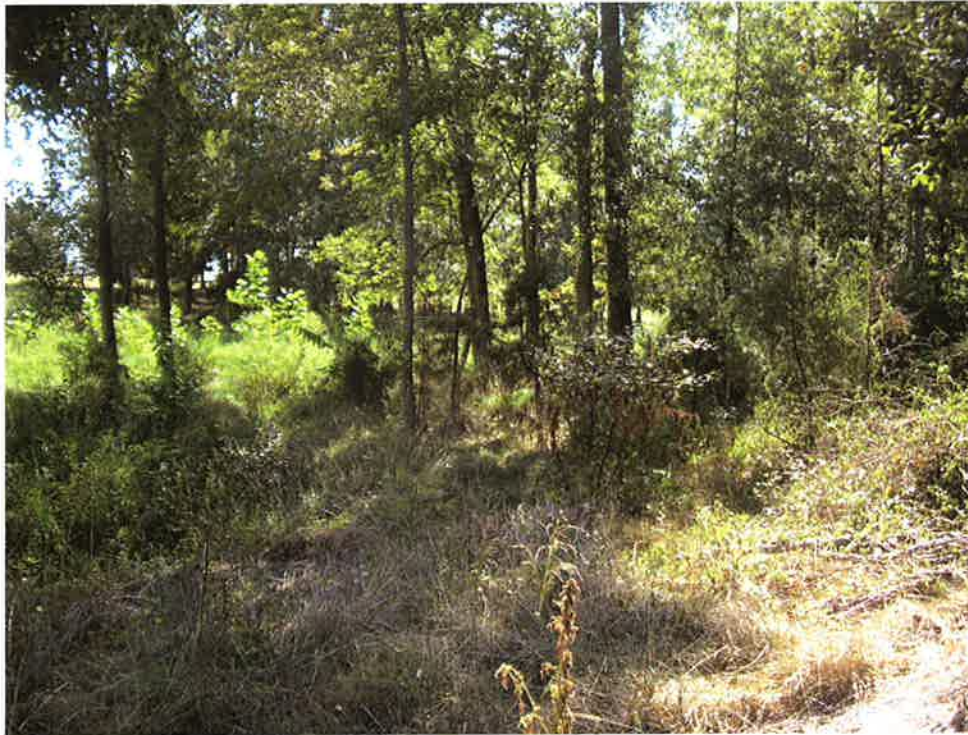
Fixed Station 4
Overview of valley along UT1, looking downstream near station 13+00.
(EMH&T, Inc. 9/19/10)

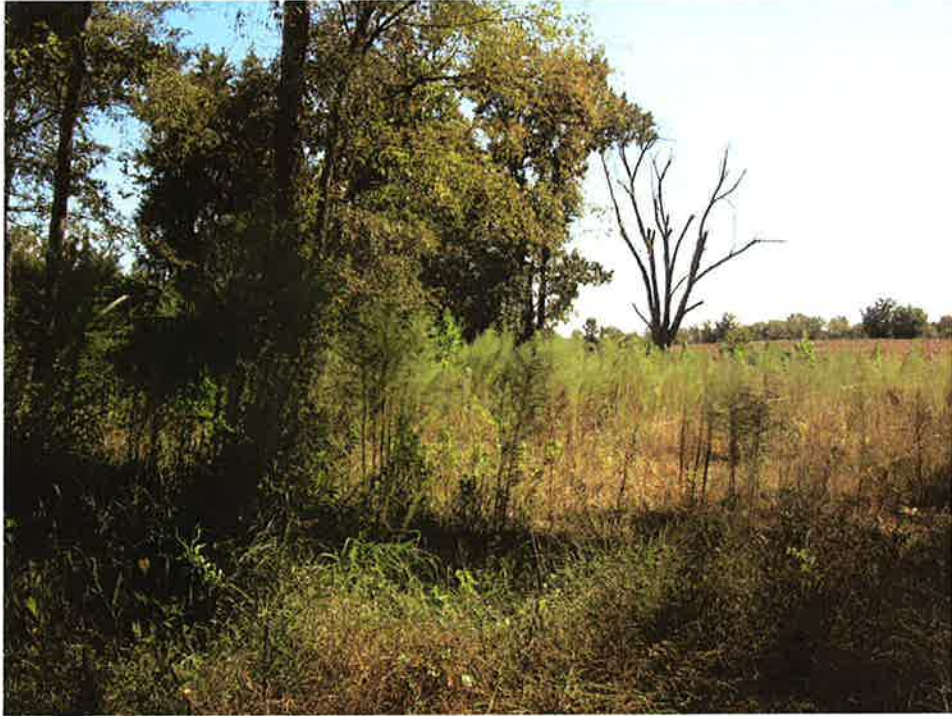
Fixed Station 5
Overview of UT1, looking downstream from upstream project limits.
(EMH&T, Inc. 9/19/10)

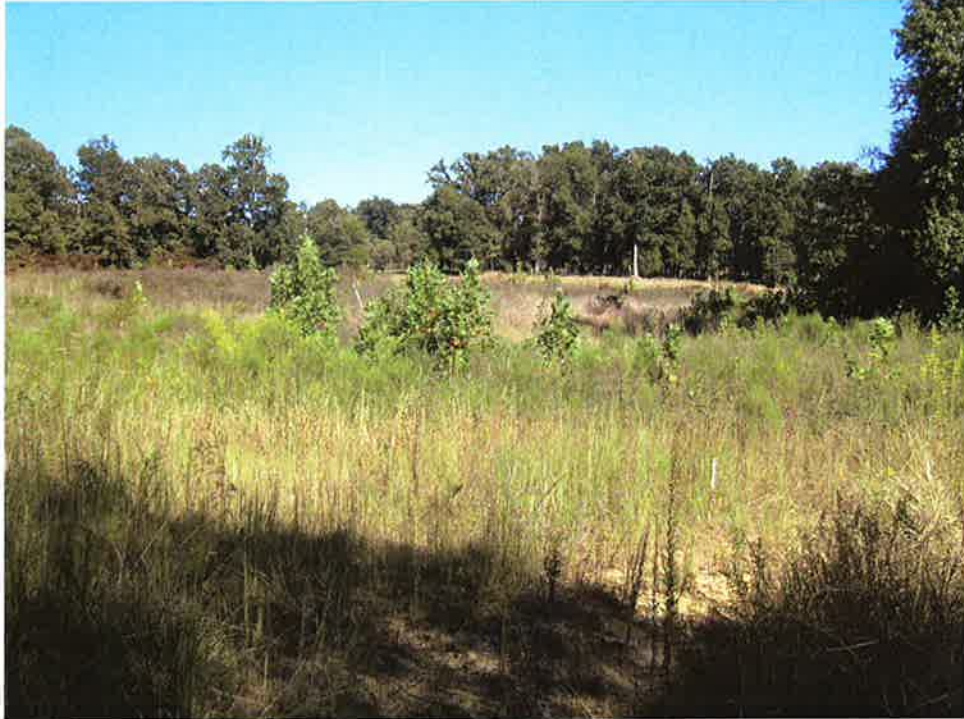
Fixed Station 6
Overview of UT2, looking downstream.
(EMH&T, Inc. 9/19/10)

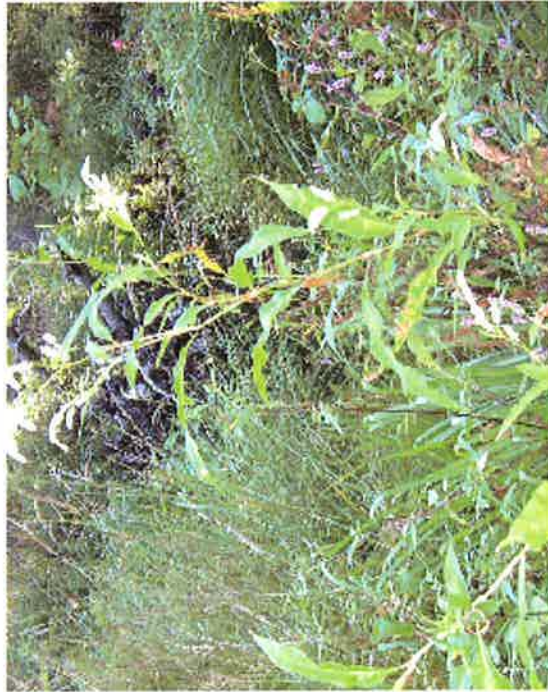
CROSS SECTION: 7

Cross-section photo – looking upstream

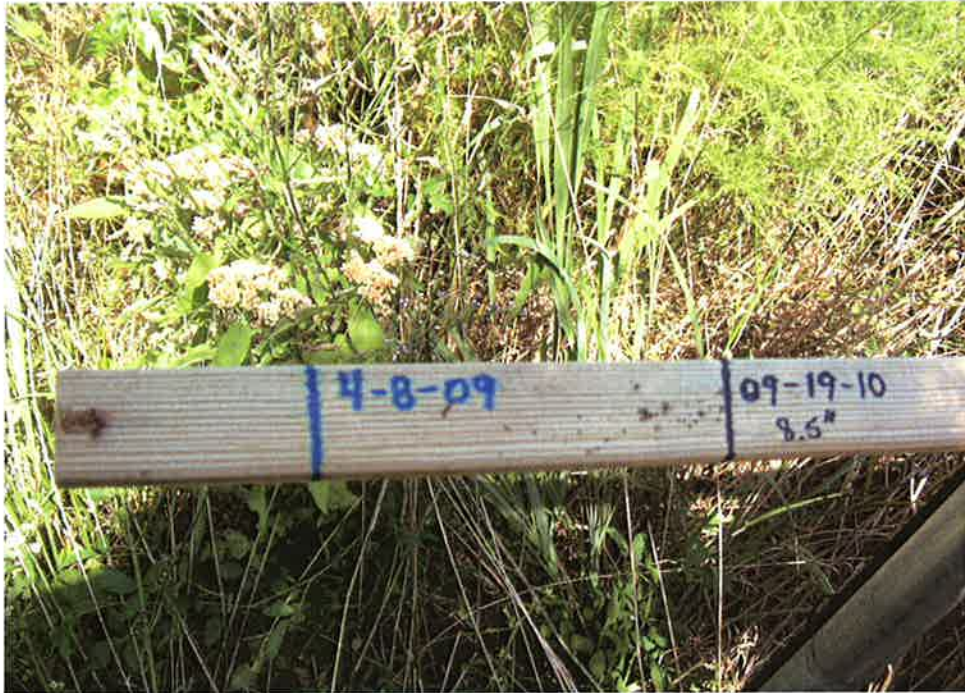
BF 1
Crest gage at 5+50 on UT1.
(EMH&T, Inc. 9/19/10)

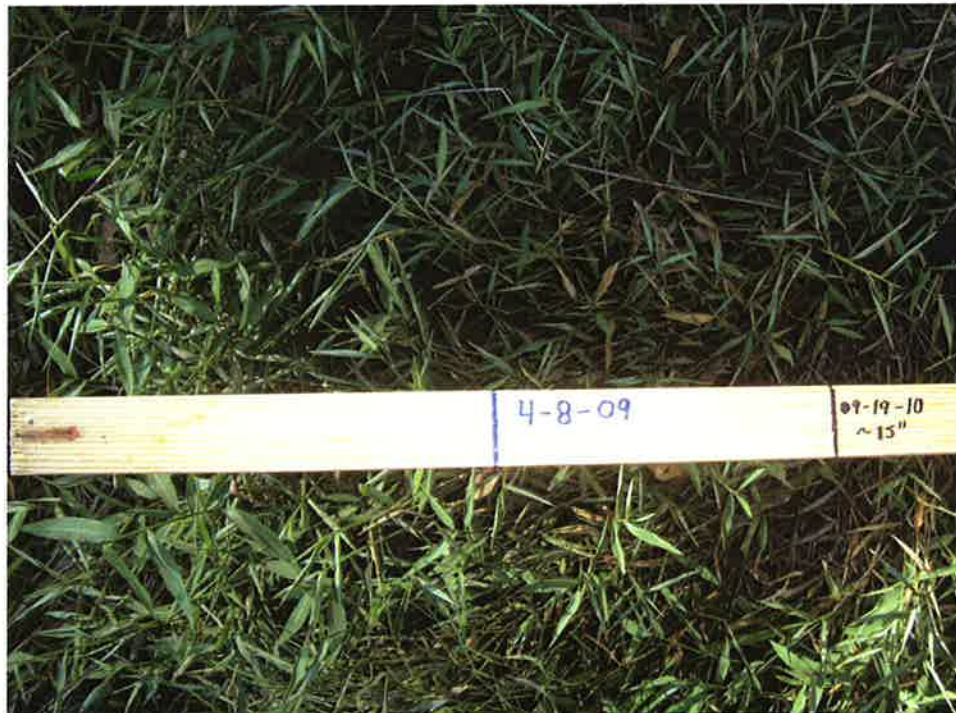
BF 2
Crest gage at 22+75 on UT1.
(EMH&T, Inc. 9/19/10)
