Subject: Year 3 Monitoring Report for Stream Mitigation of Beaverdam Creek  
SCO# D06054-C

# **Year 3 Monitoring Report for Stream Restoration of Beaverdam Creek and Unnamed Tributaries**

Union County, NC  
SCO # D06054-C

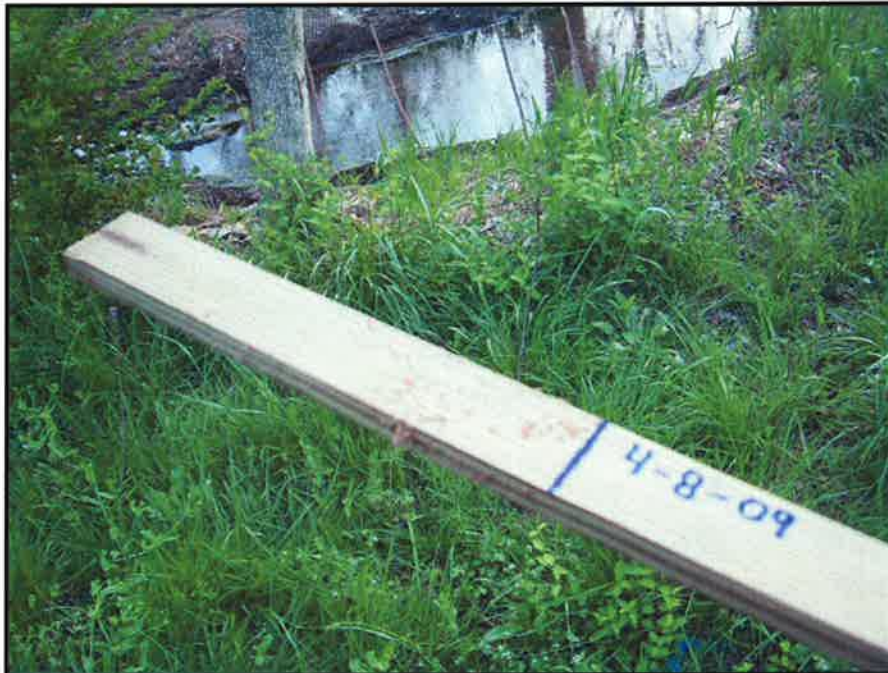
**BF 4**  
Crest gage at 3+80 on Beaverdam Creek Mainstem and 22+75 on UT1, at the confluence of  
the two reaches (Year 1).  
(EMH&T, 4/8/09)
