Subject: Year 4 Monitoring Report for Stream Mitigation of Beaverdam Creek
SCO# D06054-C

Year 4 Monitoring Report for Stream Restoration of Beaverdam Creek and Unnamed Tributaries

Union County, NC
SCO # D06054-C

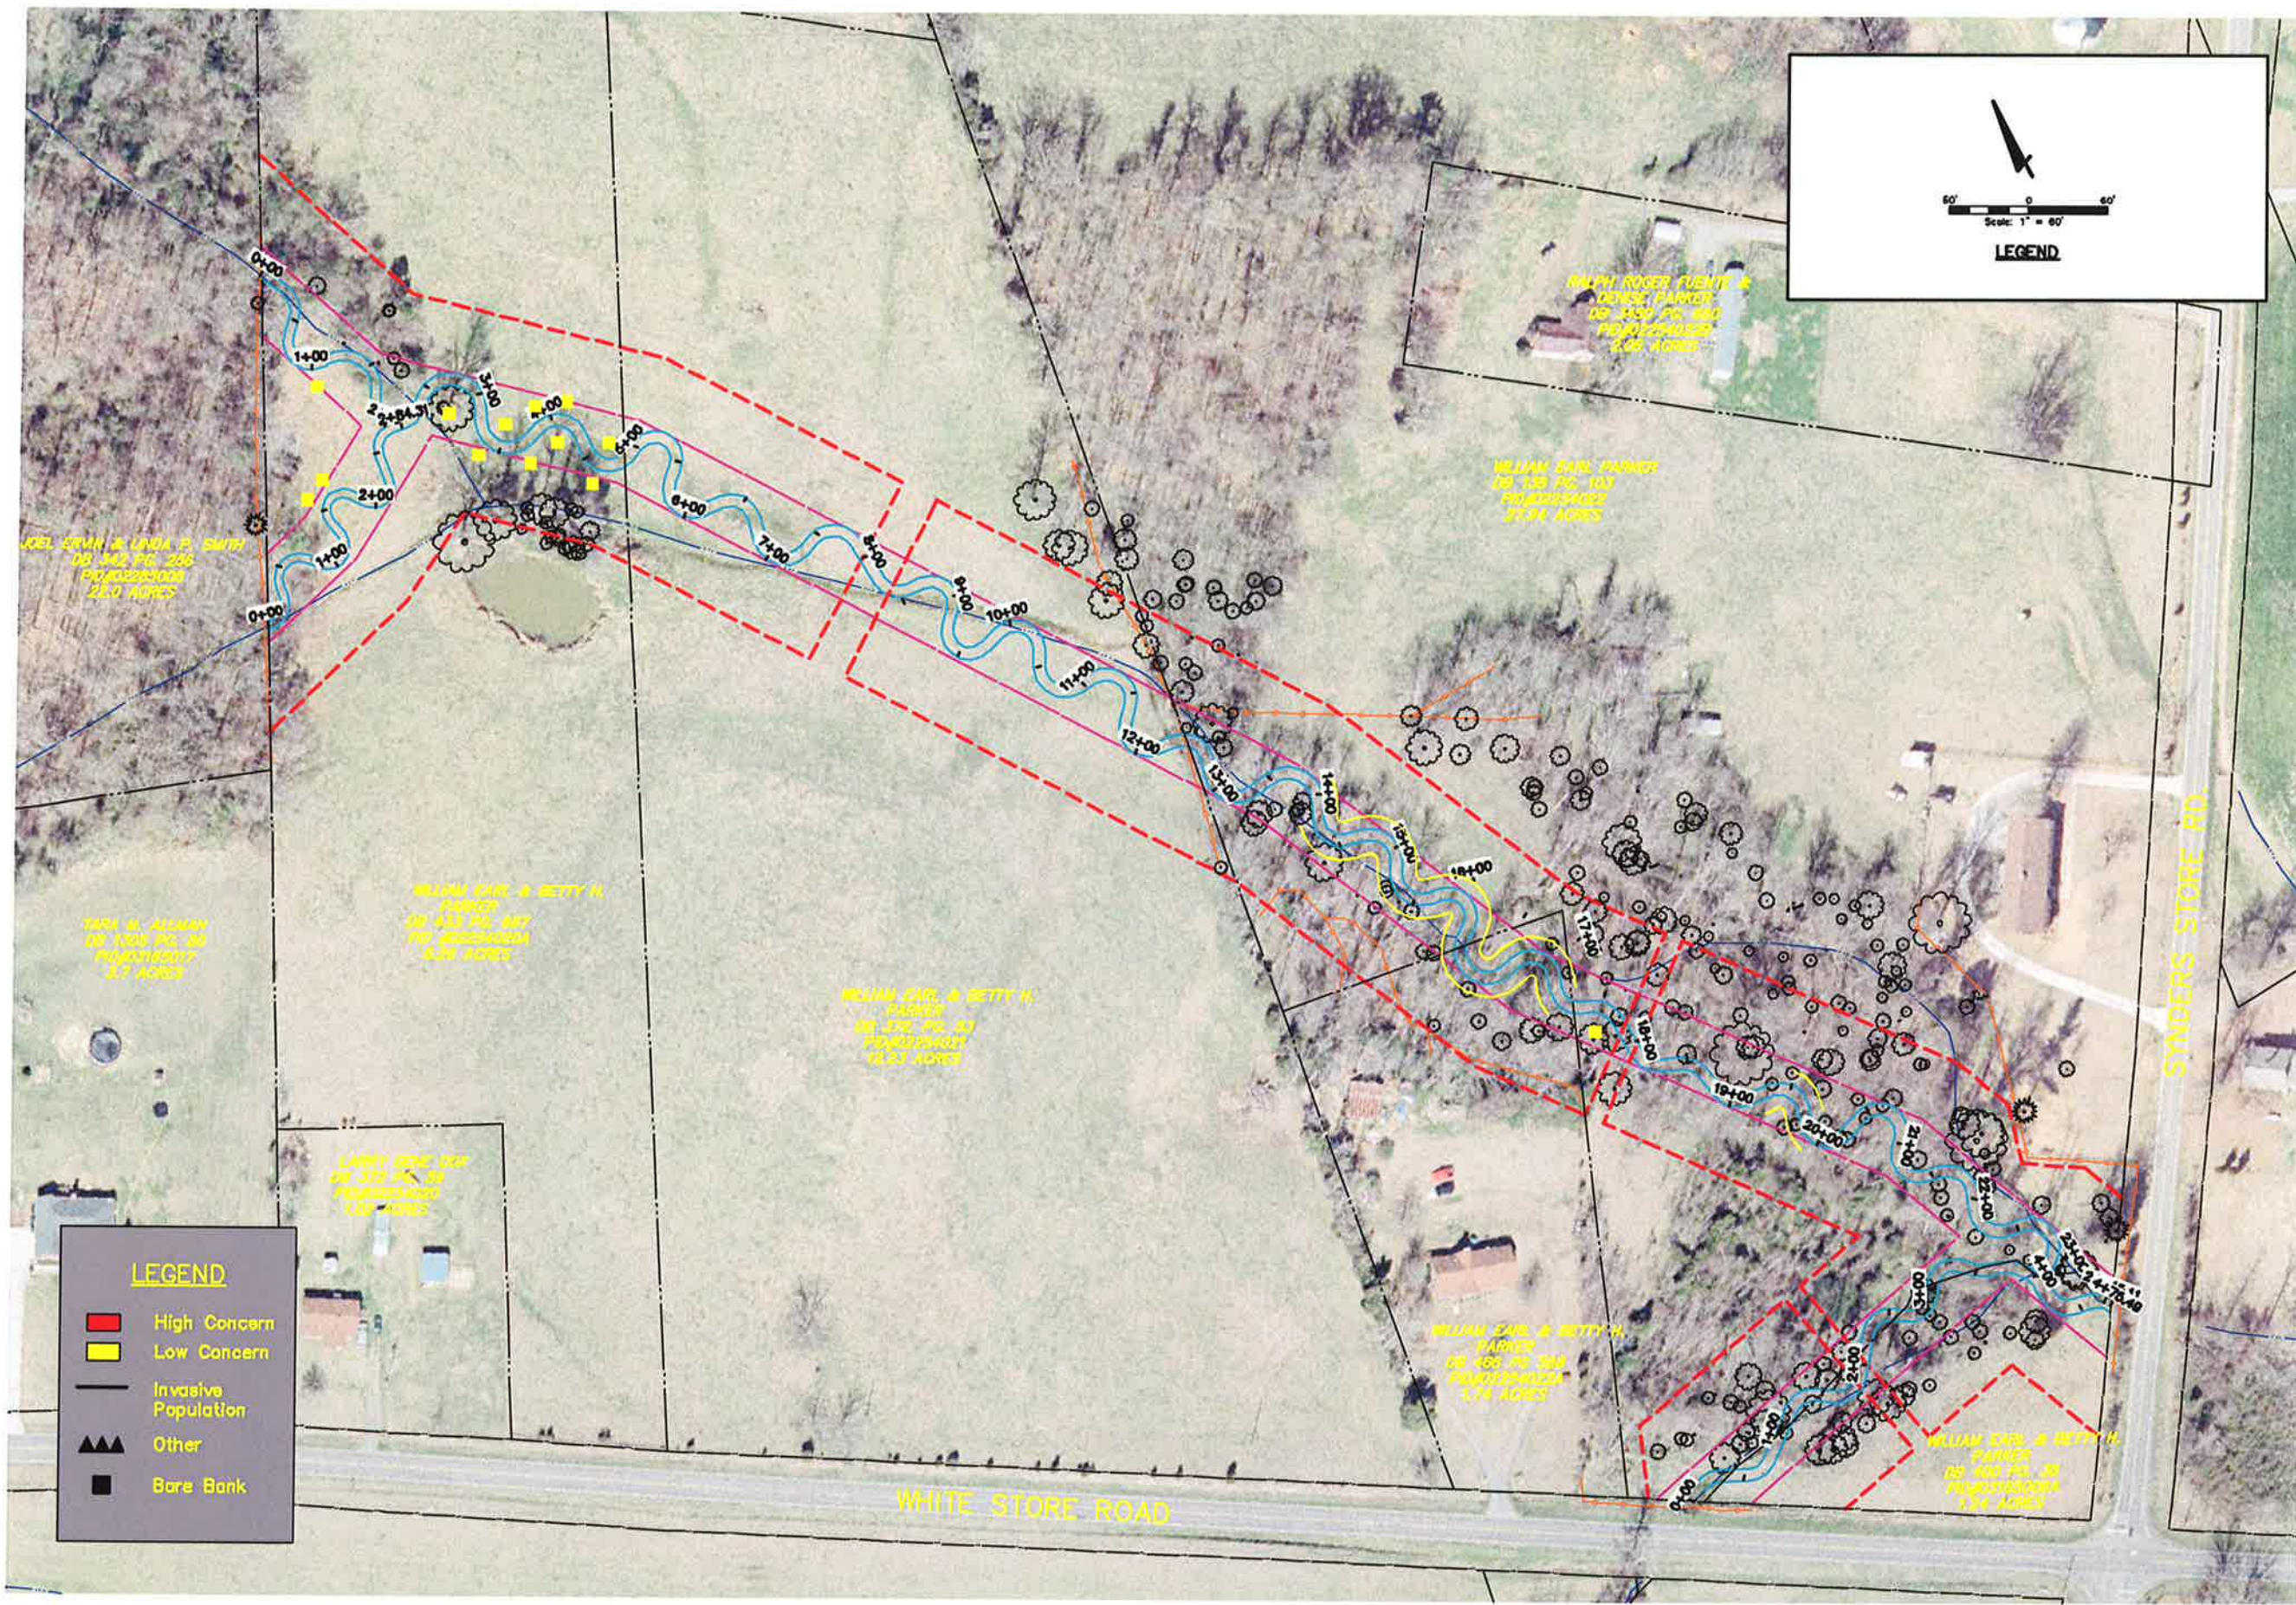
UNION COUNTY, NORTH CAROLINA
 STREAM RESTORATION PLAN
 FOR
 BEAVERDAM CREEK
 AND UNNAMED TRIBUTARIES
 APPENDIX A
 VEGETATION PROBLEM AREA PLAN VIEW

As in Years 2 and 3, a few areas along the tributaries of Beaverdam Creek were noted to have low overall herbaceous cover in the riparian corridor, leading to noticeable bare banks. These areas are small patches near the stream channel and are most likely caused by poor, rocky soil. The areas mentioned above are considered as a low concern at this time.

A few areas with a population of Japanese stiltgrass (*Microstegium vimineum*) were noted during 2010 (Year 2) monitoring. *Microstegium vimineum* continues to infiltrate bare ground along UT1 and the population has grown in Year 4 to cover the channel and/or areas of the riparian corridor between stations 14+00 and 17+50, as well as between stations 19+50 and 20+00. This species is common along streamsides and ditches, and at the edges of forests and damp fields, and as such, was likely present before the onset of restoration activities. As further evidence of a pre-existing population, the locations where this species is present are those areas that were not impacted during restoration of the stream channels.

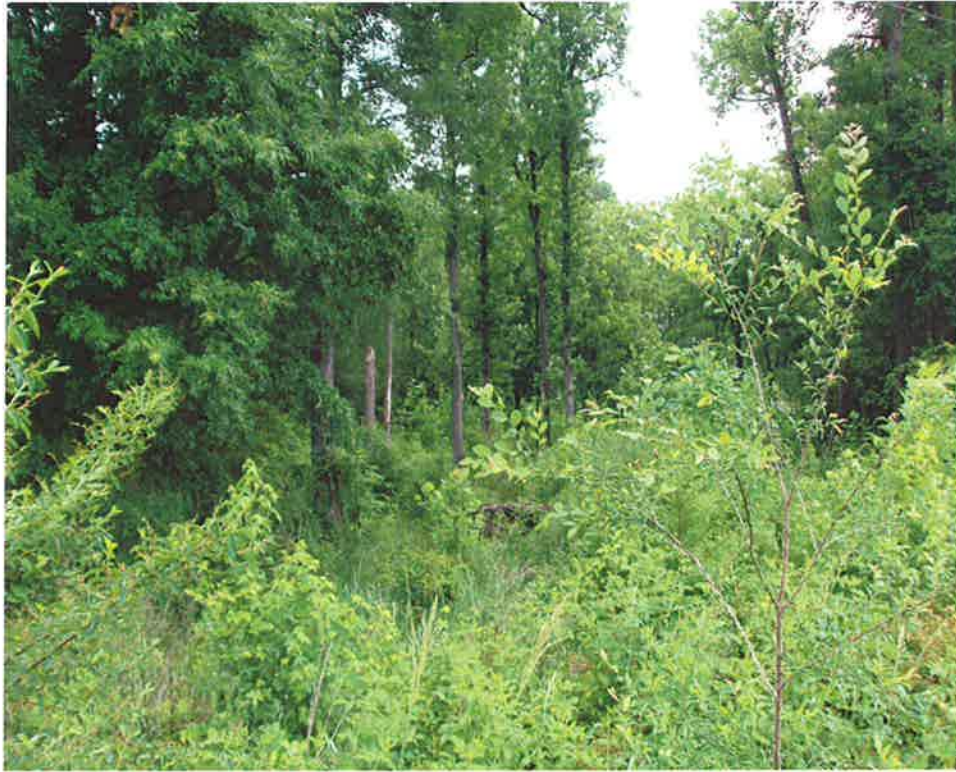
Fixed Station 1
Overview of Beaverdam Creek, looking downstream
(EMH&T, 9/11/12).

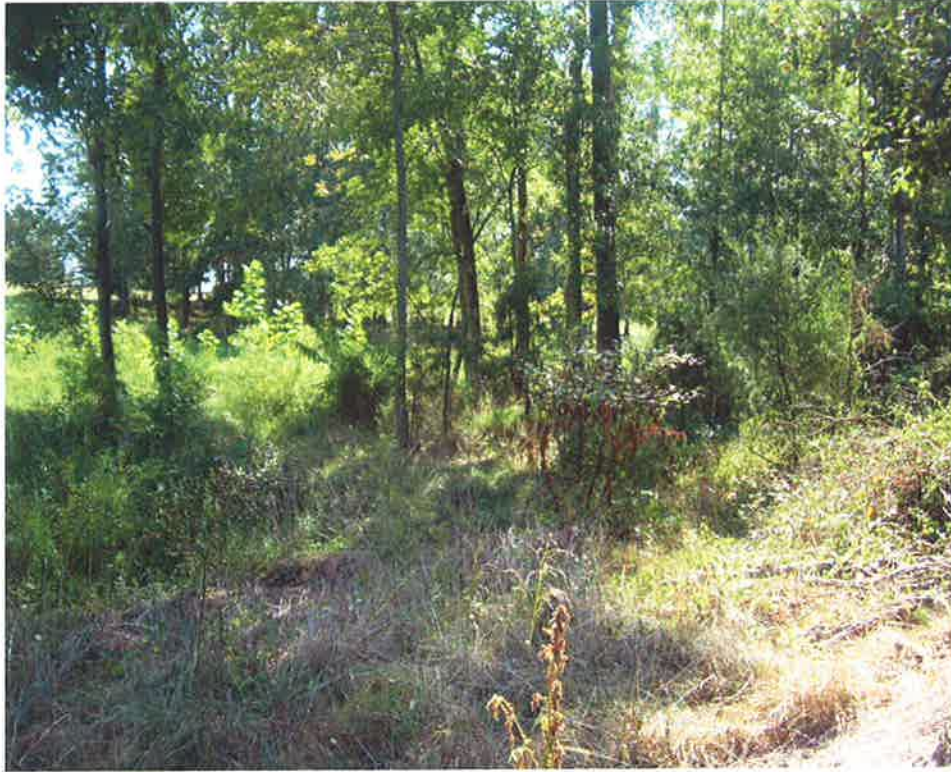
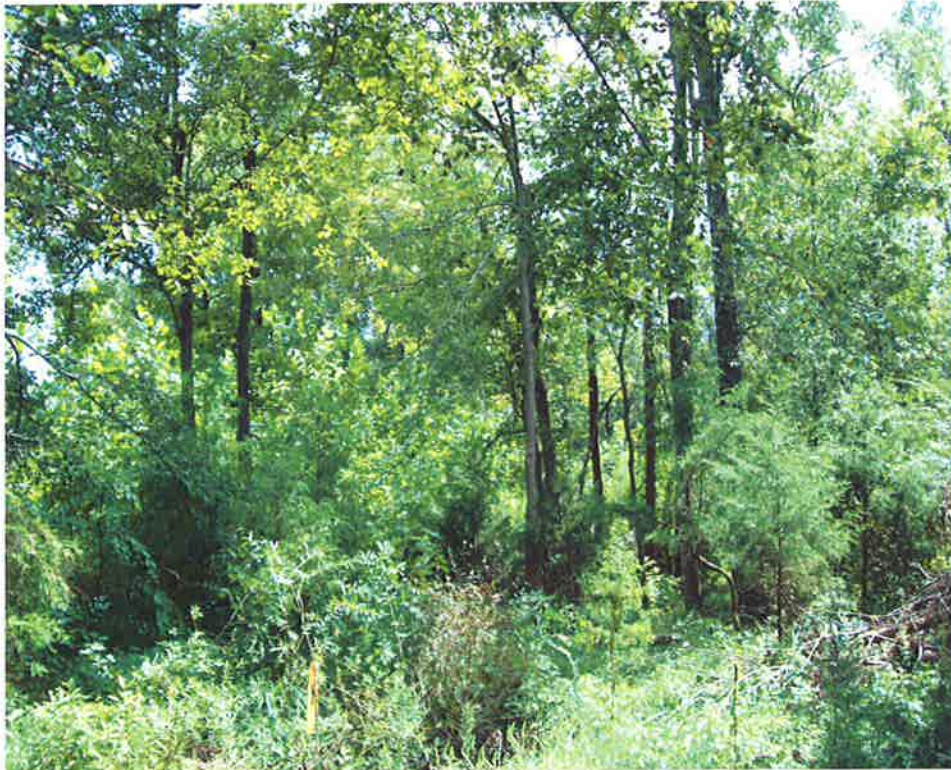
Fixed Station 4
Overview of valley along UT1, looking downstream near station 13+00
(Top Photo – Year 2: 9/19/10, Bottom Photo – Year 4: 9/11/12).
(EMH&T)

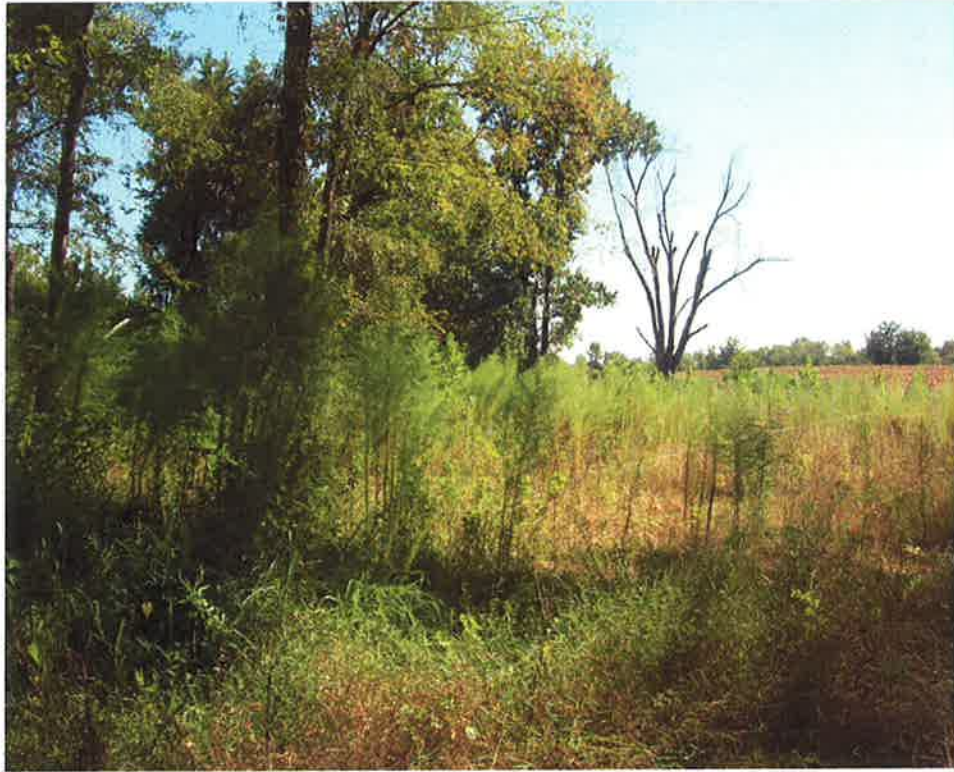
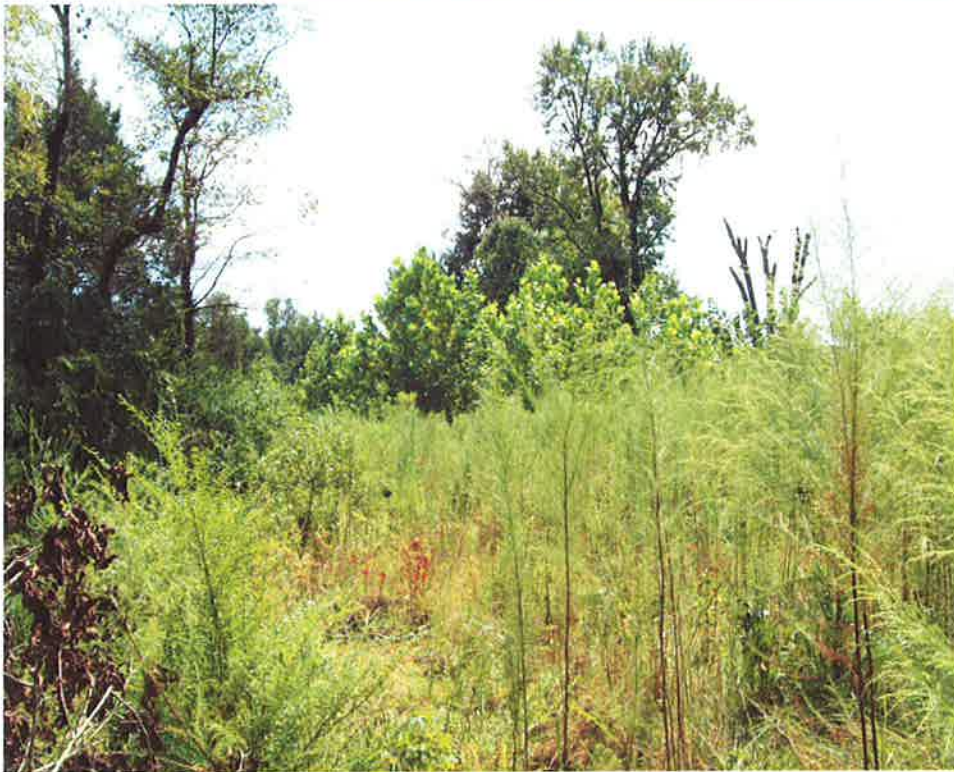
Fixed Station 5
Overview of UT1, looking downstream from upstream project limits
(Top Photo – Year 2: 9/19/10, Bottom Photo – Year 4: 9/11/12).
(EMH&T)

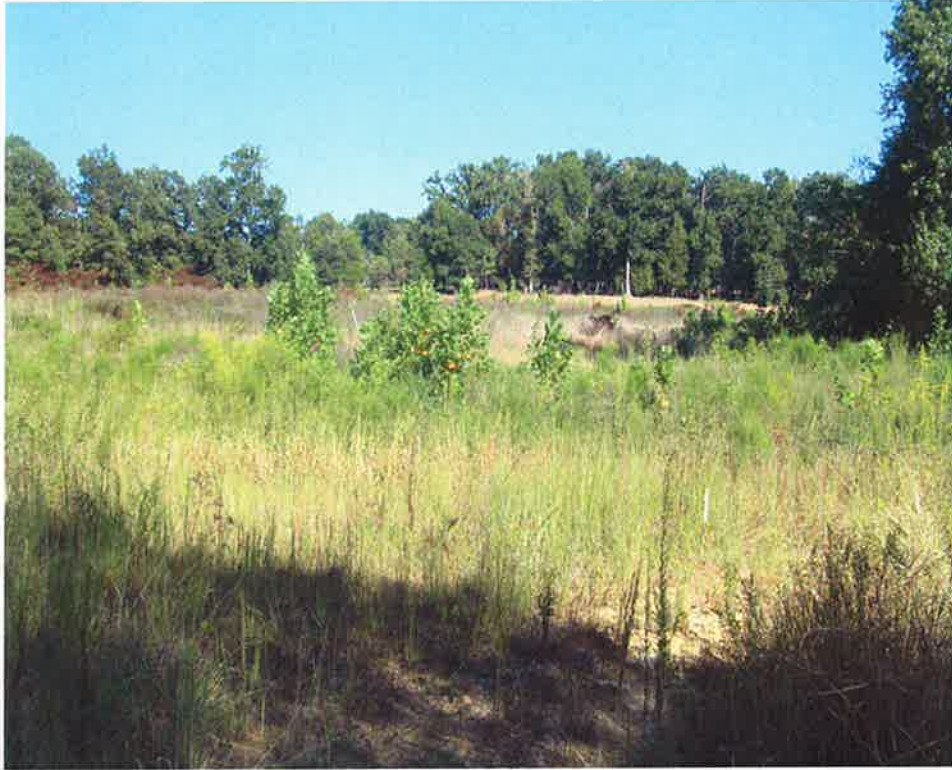
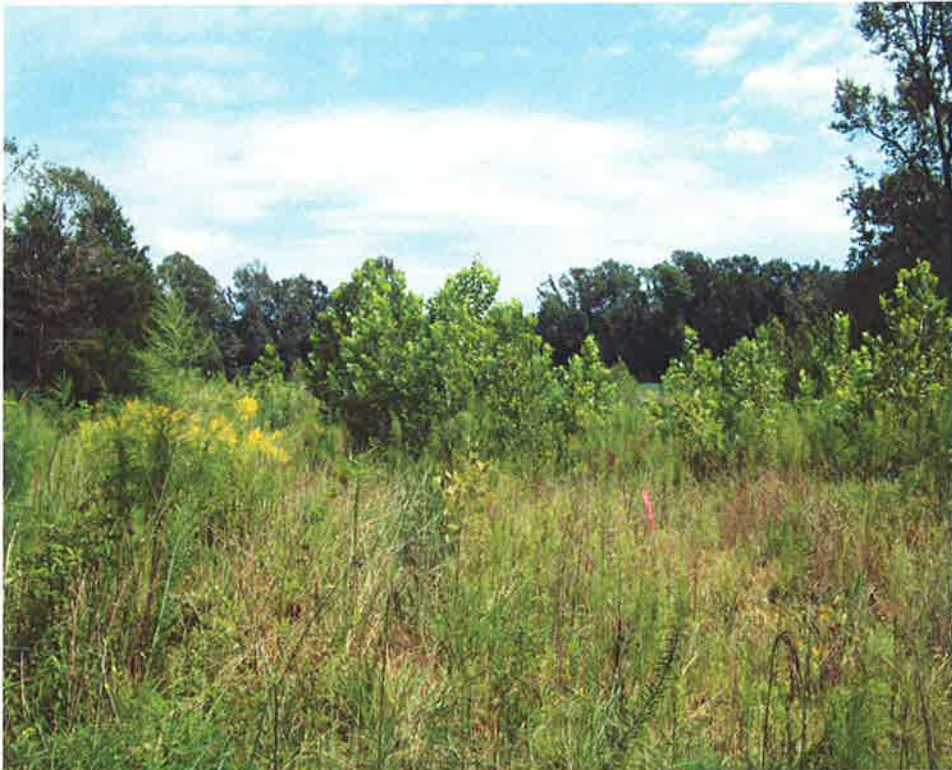
Fixed Station 6
Overview of UT2, looking downstream
(Top Photo – Year 2: 9/19/10, Bottom Photo – Year 4: 9/11/12).
(EMH&T)

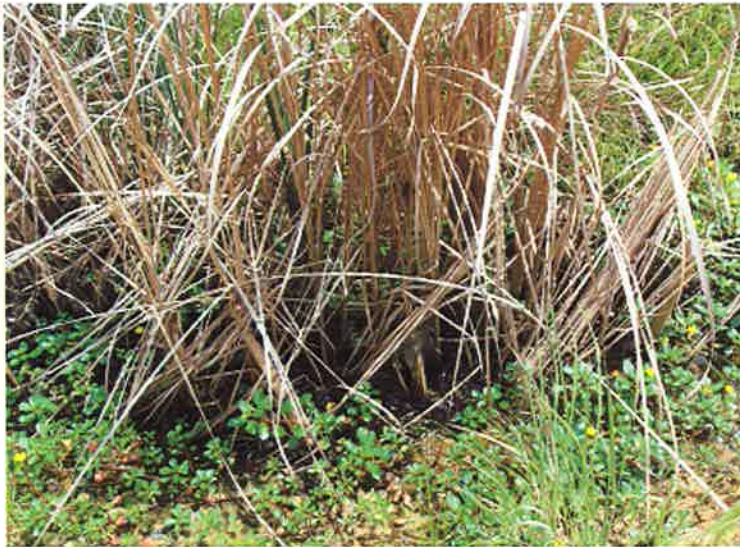
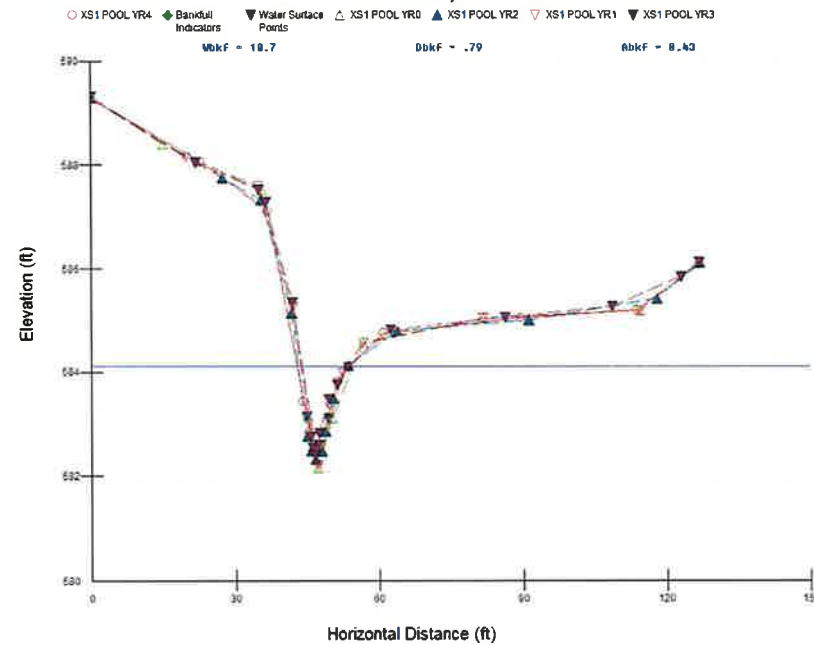
CROSS SECTION: 1

Unnamed Tributary 2 to Beaverdam Creek - Pool XS1 - Year 4 (May 29, 2012)

Bankfull Area	2.79 ft ²
Bankfull Width	6.42 ft
Mean Depth	0.43 ft
Maximum Depth	0.95 ft
Width/Depth Ratio	14.93
Entrenchment Ratio	5.90
Classification	C

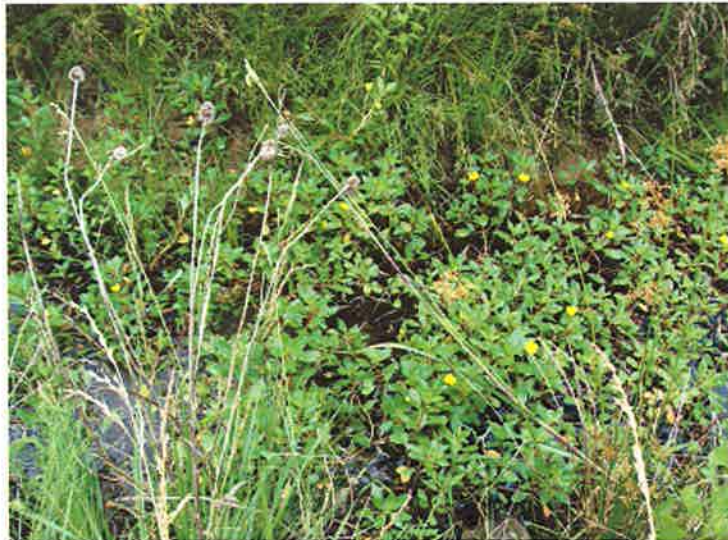
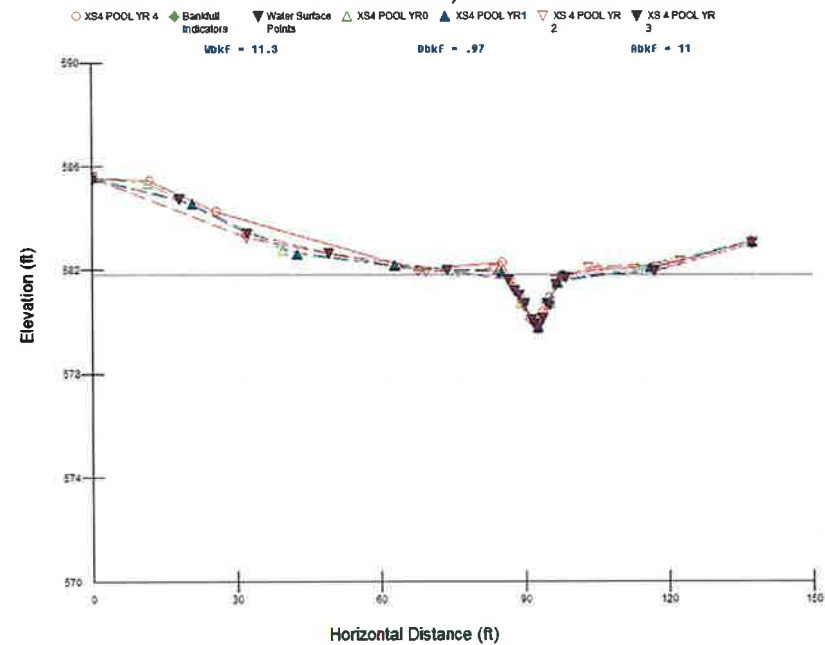
CROSS SECTION: 4
FEATURE: Pool

Unnamed Tributary to Beaverdam Creek - Pool XS4 - Year 4 (May 29, 2012)

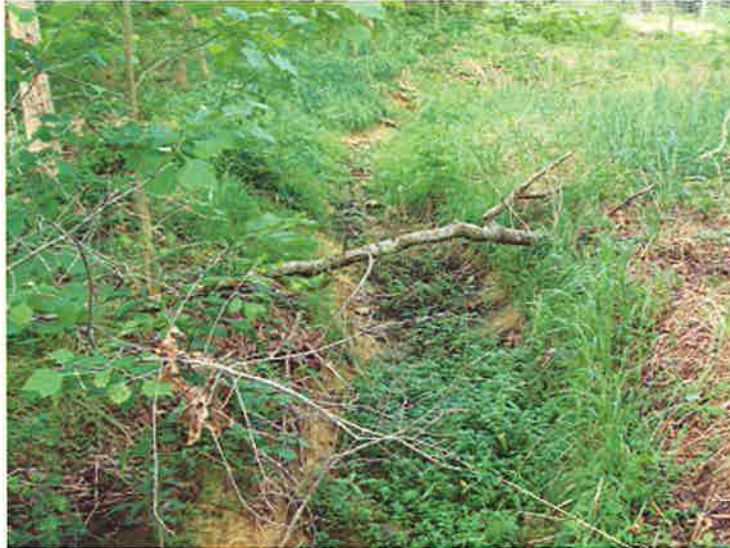
CROSS SECTION: 5

Cross-section photo – looking upstream

Unnamed Tributary to Beaverdam Creek - Pool XS5 - Year 4 (May 29, 2012)

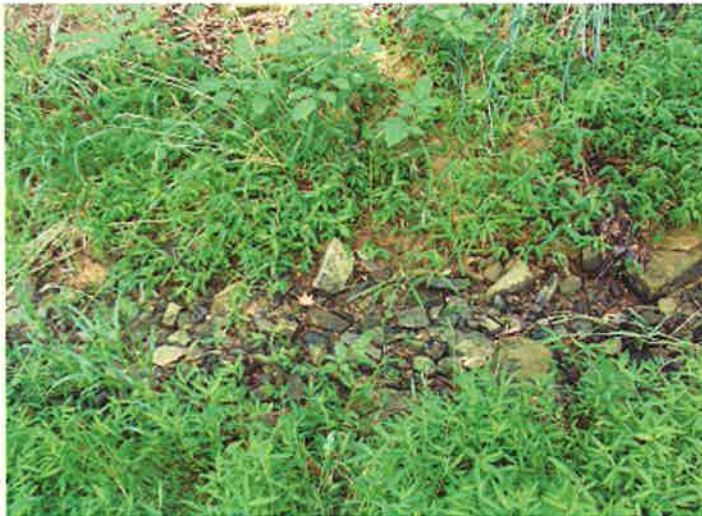
CROSS SECTION: 6

Cross-section photo – looking across channel from left bank to right bank

Unnamed Tributary to Beaverdam Creek - Riffle XS6 - Year 4 (May 29, 2012)

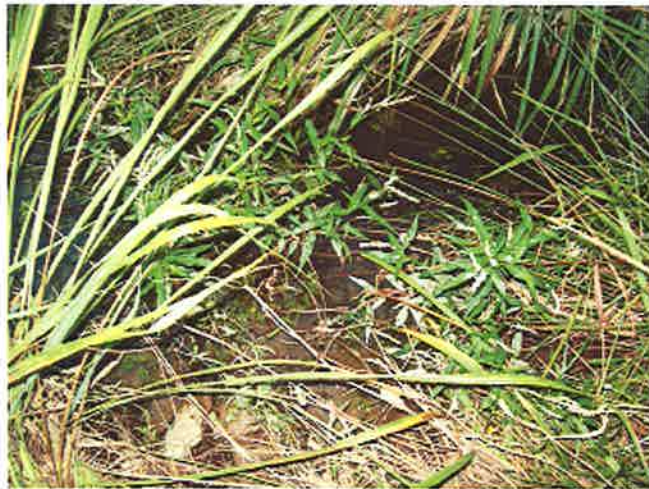
CROSS SECTION: 7

**Cross-section photo – looking across channel,
from right bank to left bank**

Beaverdam Mainstem - Pool XS7 - Year 4 (May 29, 2012)

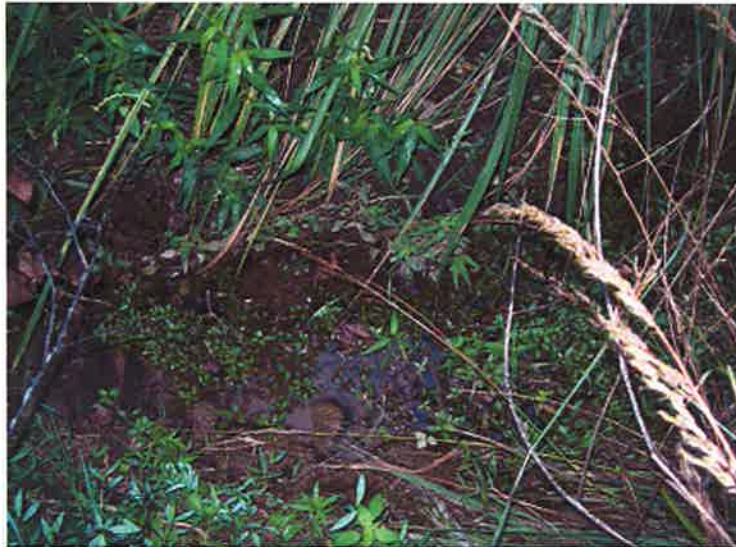
CROSS SECTION: 8
FEATURE: Riffle

Cross-section photo – looking right bank to left bank
