Subject: Year 4 Monitoring Report for Stream Mitigation of Beaverdam Creek
SCO# D06054-C

Year 4 Monitoring Report for Stream Restoration of Beaverdam Creek and Unnamed Tributaries

Union County, NC
SCO # D06054-C

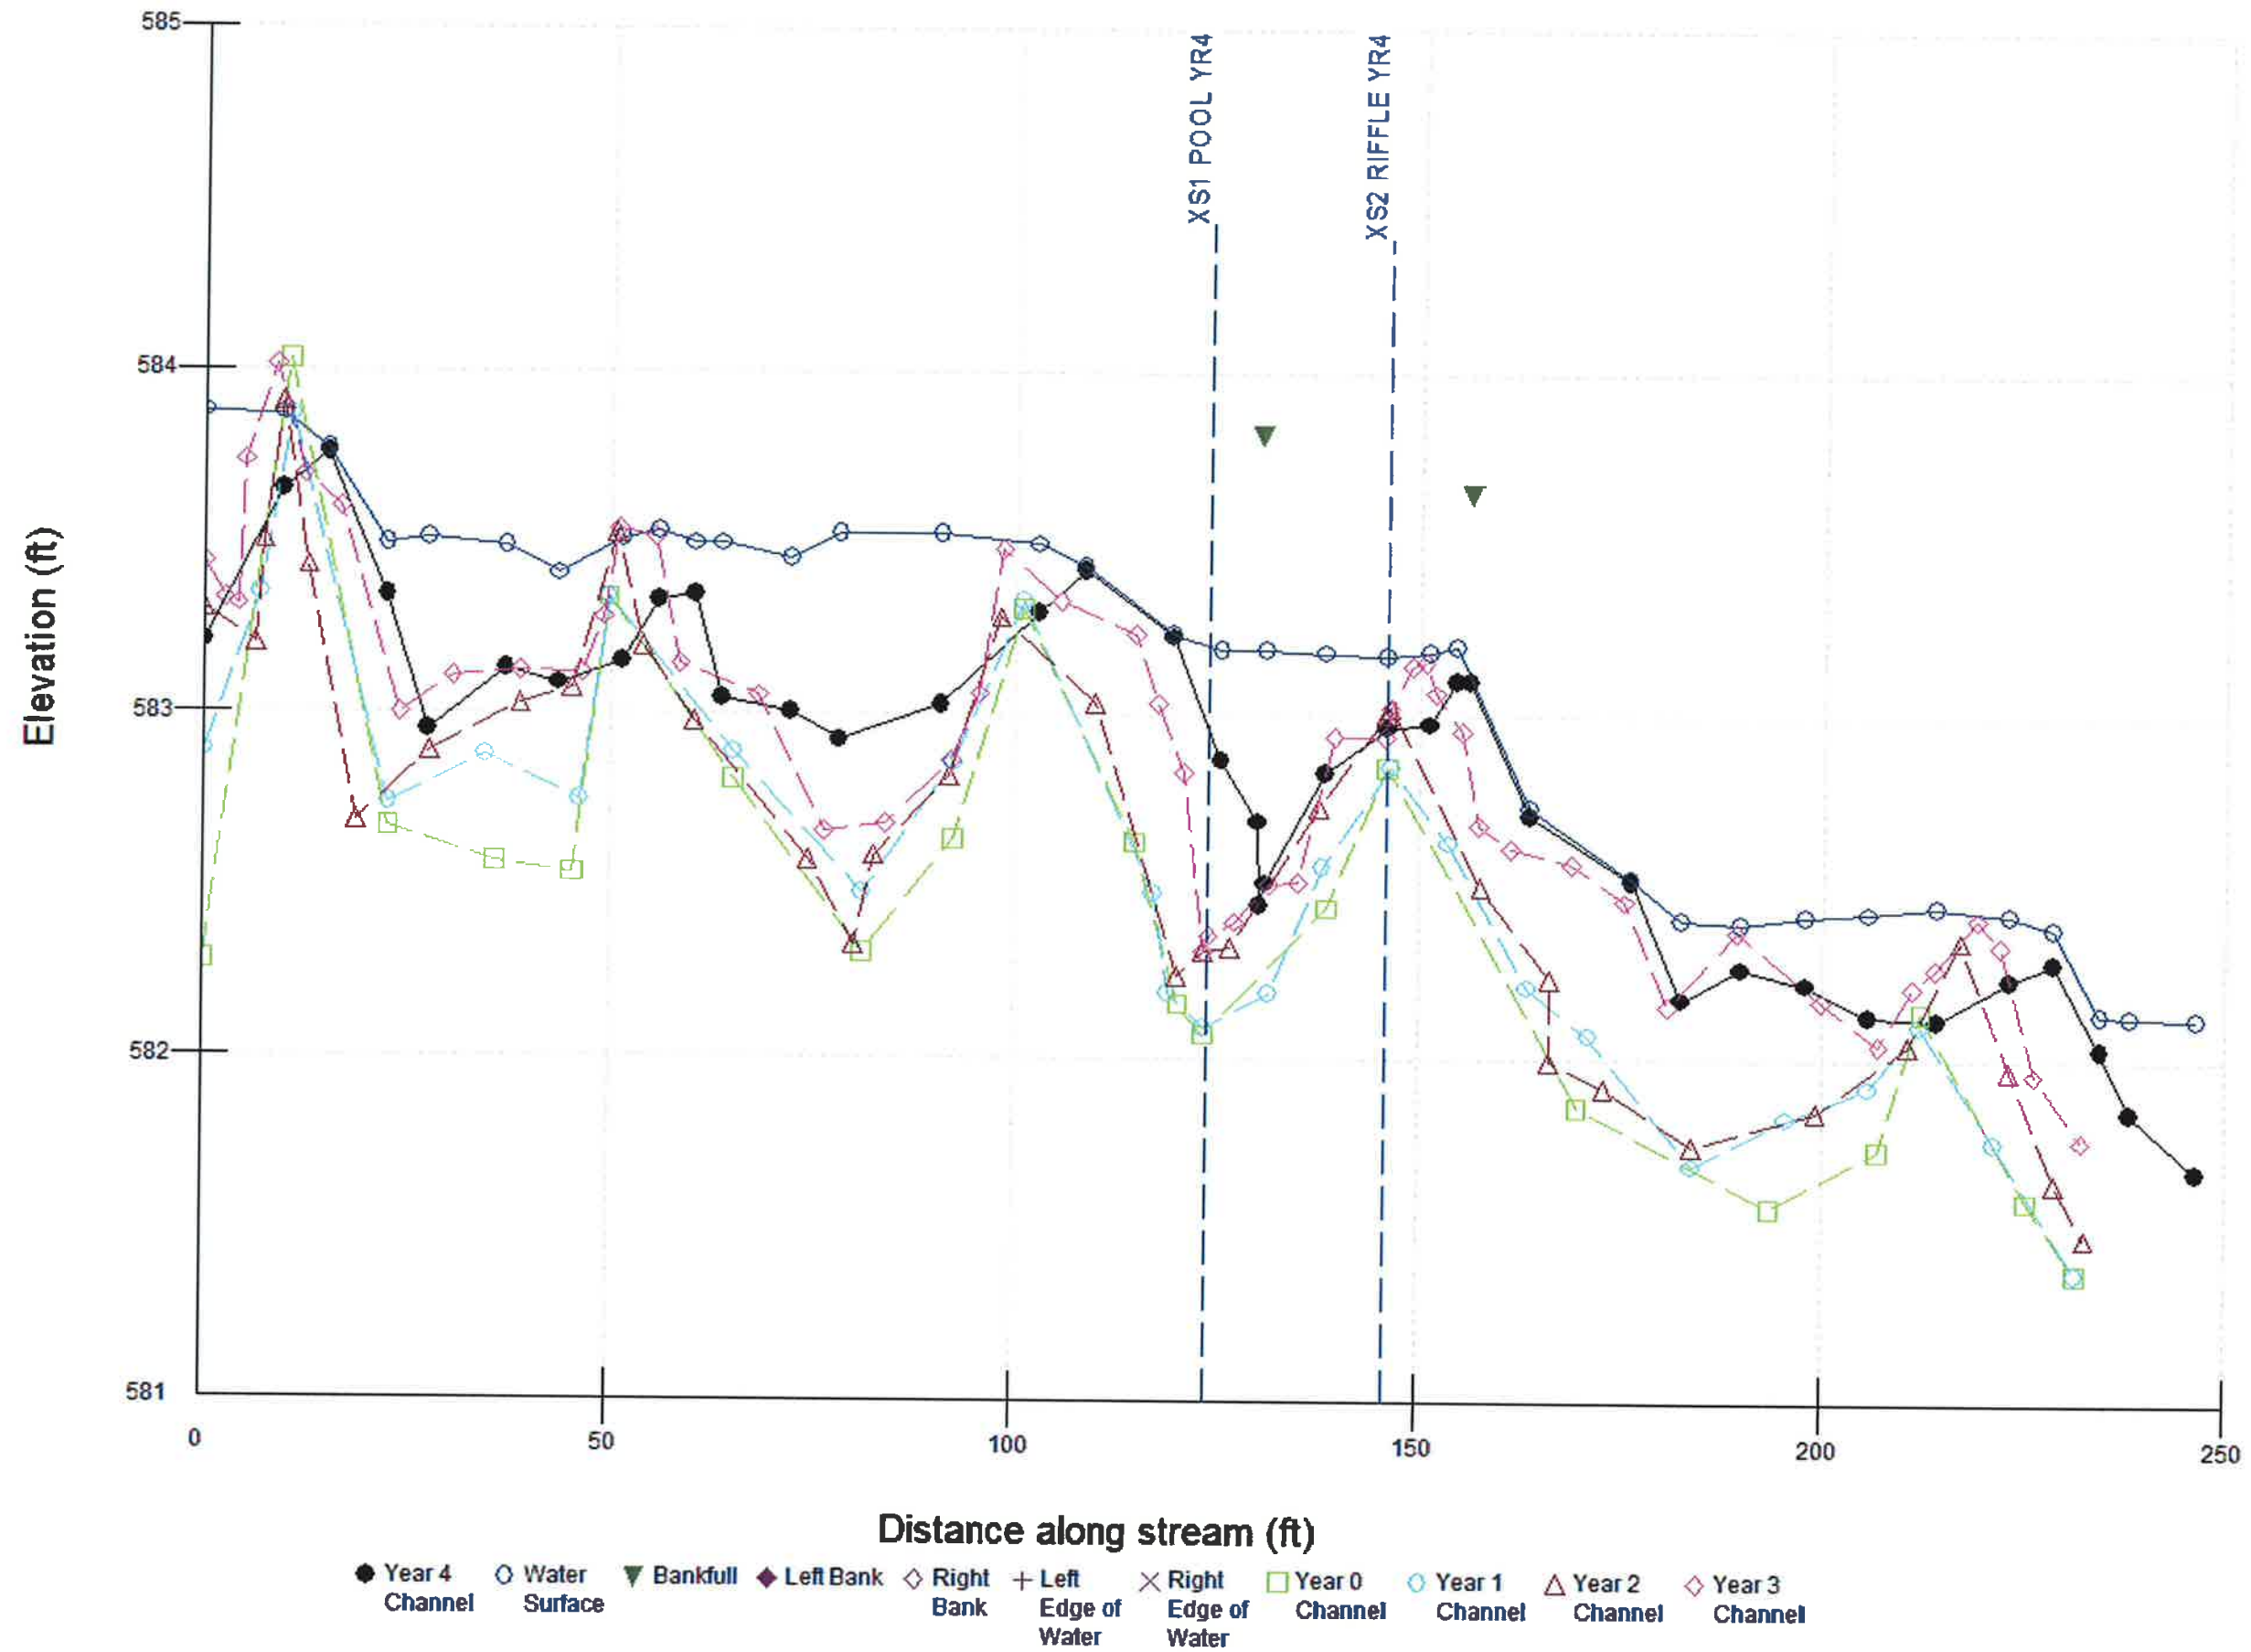
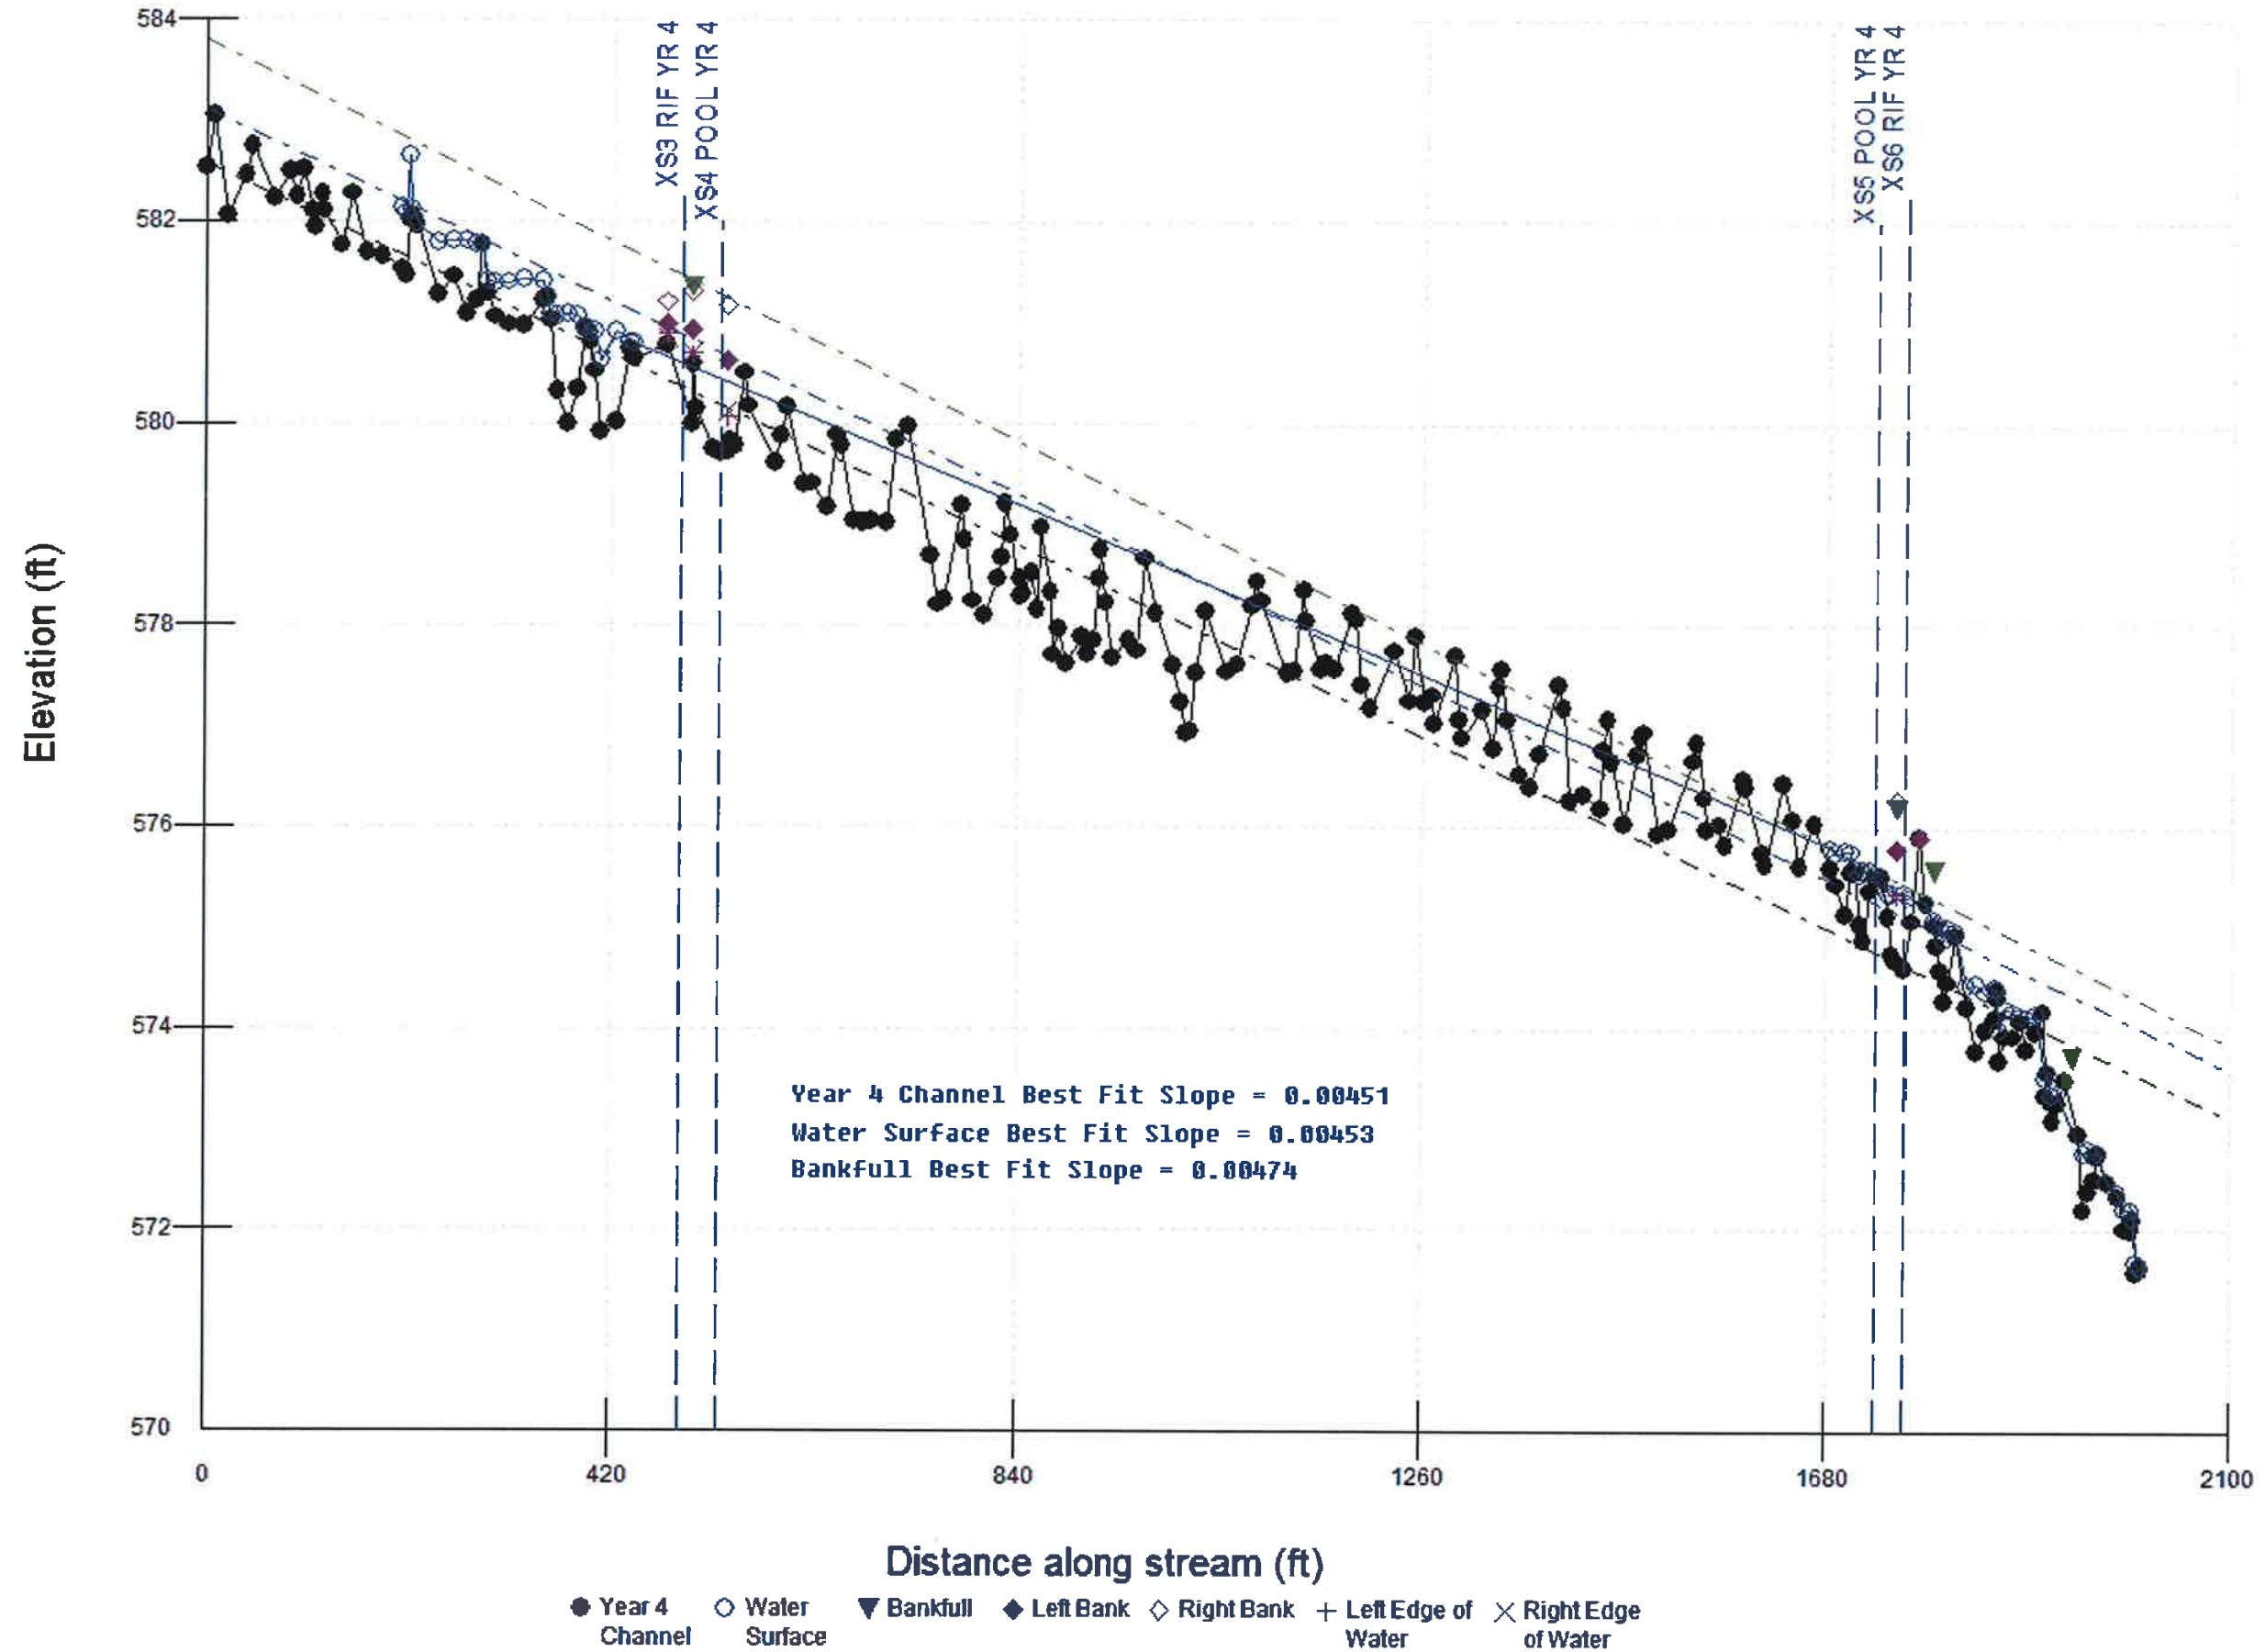
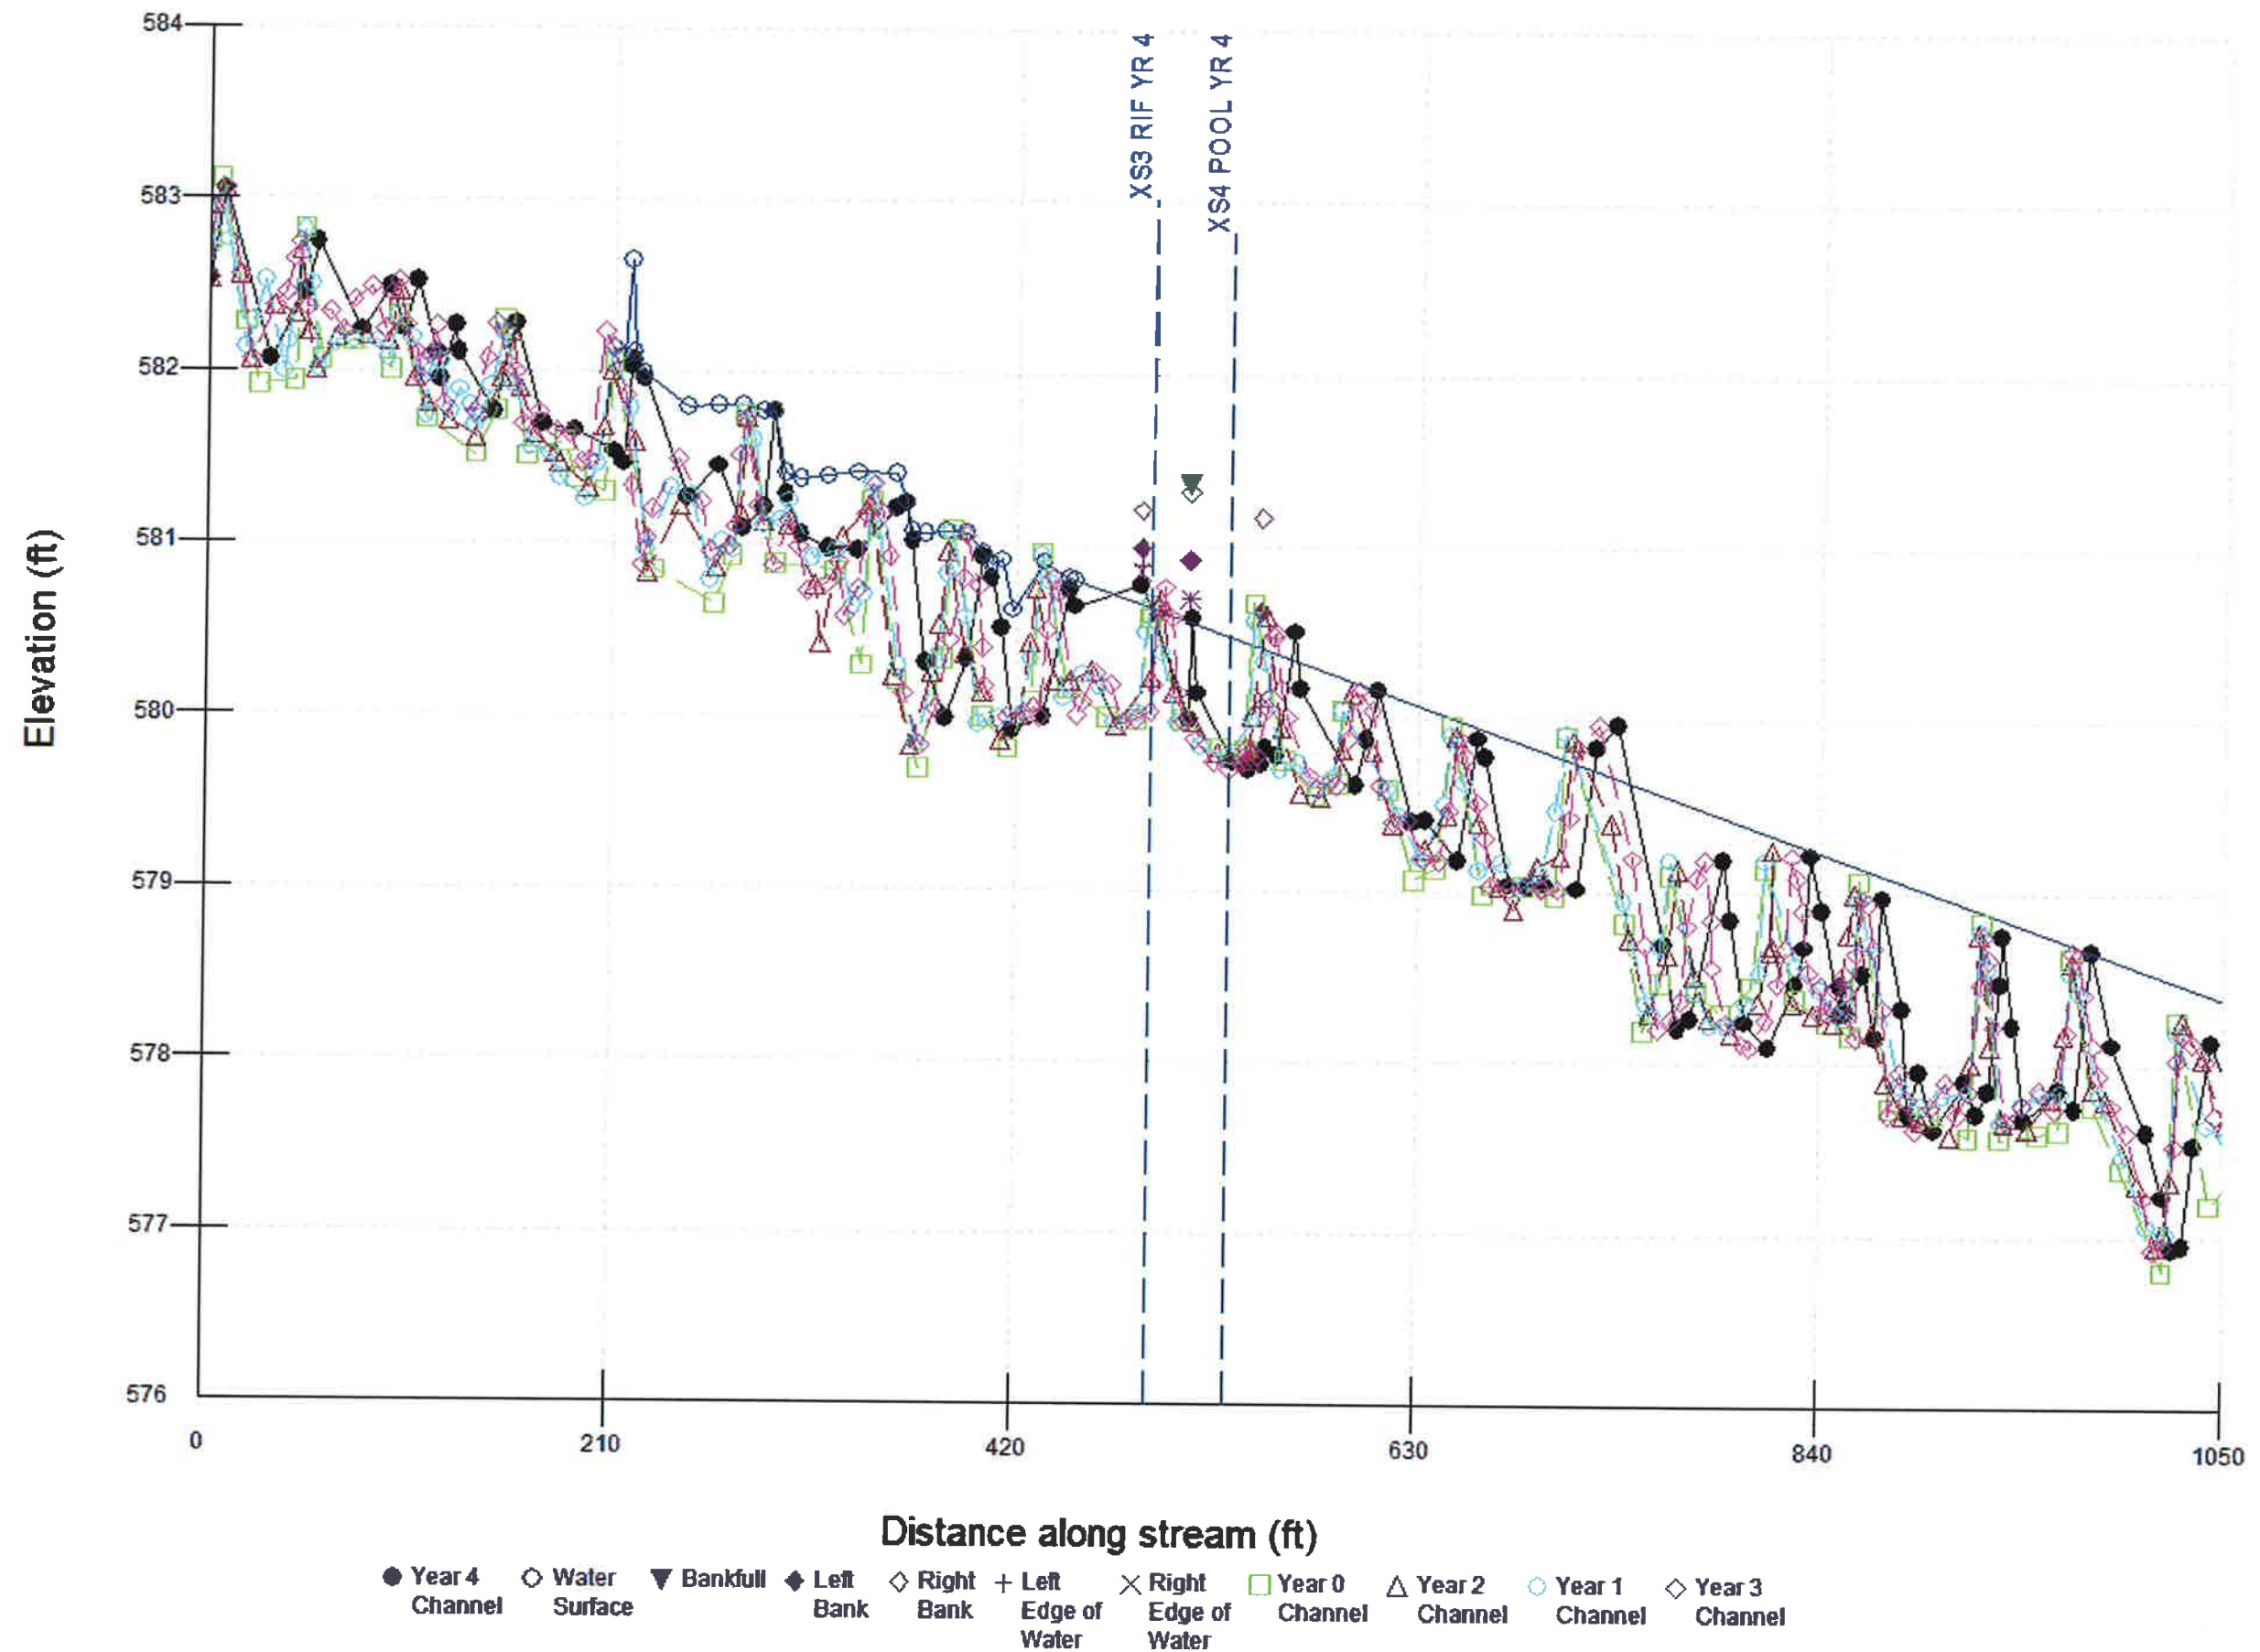
pools along UT1 that did not match the as-built condition, in regards to feature elevations (as presented in the graphs of the longitudinal profile). It appears that sedimentation may be occurring in the center of these pools, although all remain present and retain their essential function.

Unnamed Tributary 1 (to Beaverdam Creek) - Profile - Year 4 (May 29, 2012)

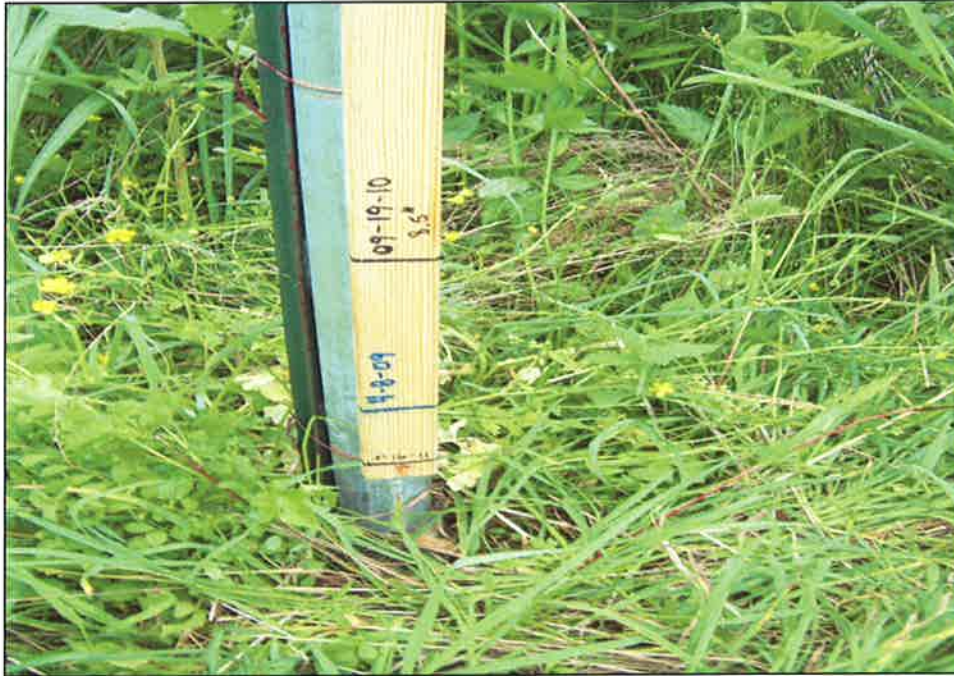
BF 3
Crest gage at 5+ 50 on UT1 (Year 3).
(EMH&T, 5/16/11)

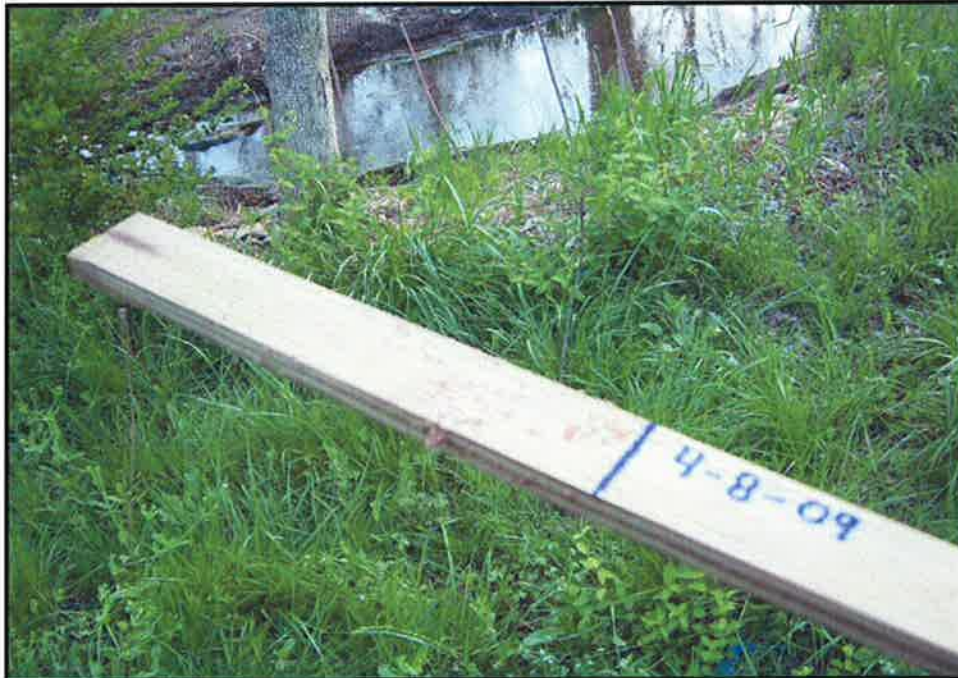
BF 4
Crest gage at 3+80 on Beaverdam Creek Mainstem and 22+75 on UT1, at the confluence of
the two reaches (Year 1).
(EMH&T, 4/8/09)

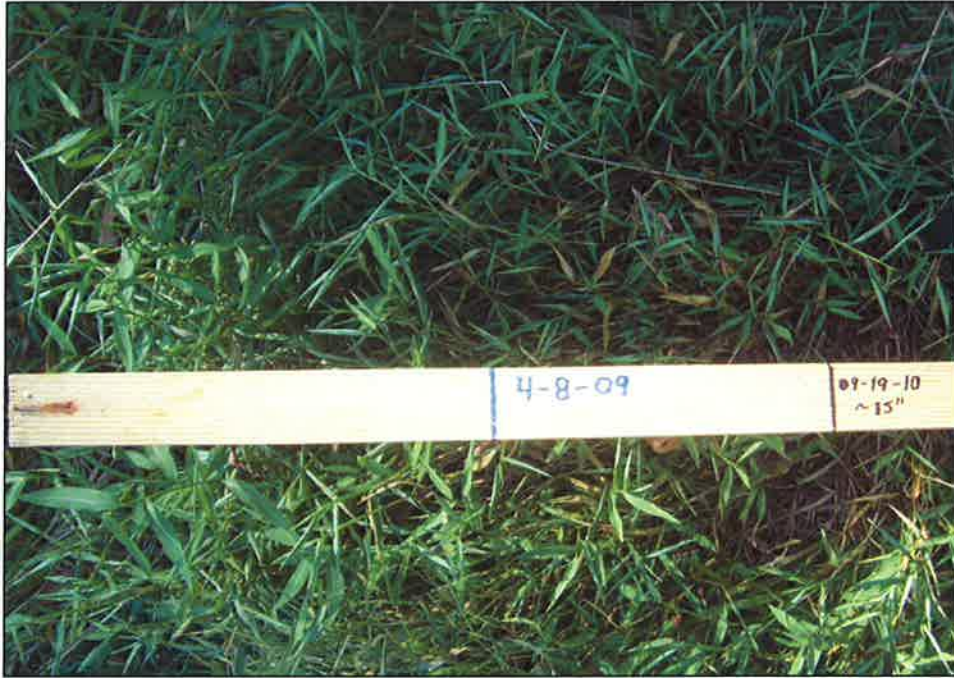
BF 5

**Crest gage at 3+80 on Beaverdam Creek Mainstem and 22+75 on UT1, at the confluence of the two reaches (Year 2).
(EMH&T, 9/19/10)**

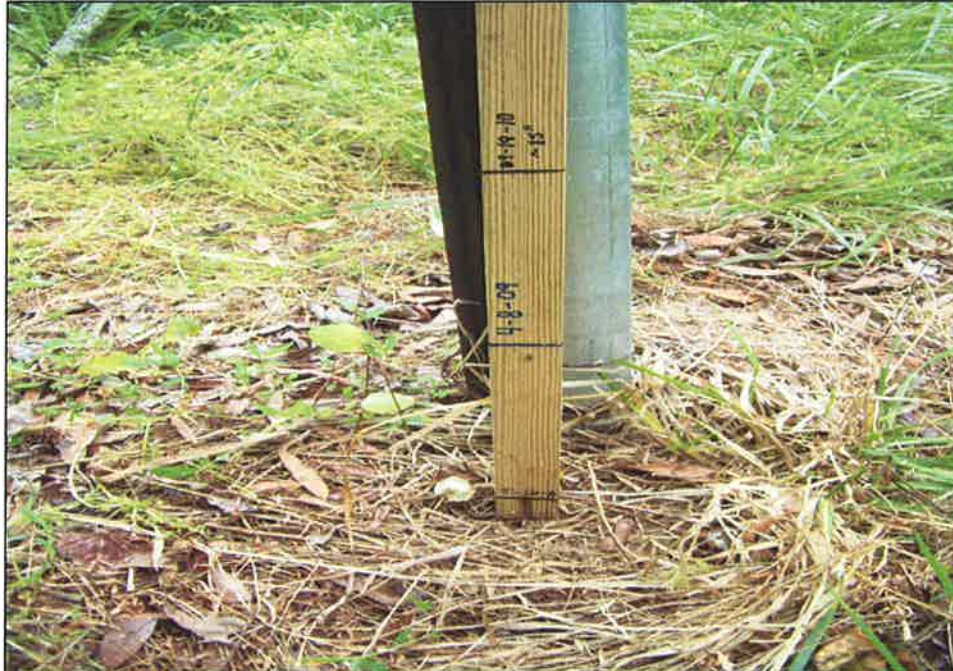
BF 6

**Crest gage at 3+80 on Beaverdam Creek Mainstem and 22+75 on UT1, at the confluence of the two reaches (Year 3).
(EMH&T, 5/16/11)**
