Subject: Year 5 Monitoring Report for Stream Mitigation of Beaverdam Creek; Union County, NC; SCO# D06054-C

Year 5 Monitoring Report for Stream Restoration of Beaverdam Creek and Unnamed Tributaries

Union County, NC
SCO # D06054-C

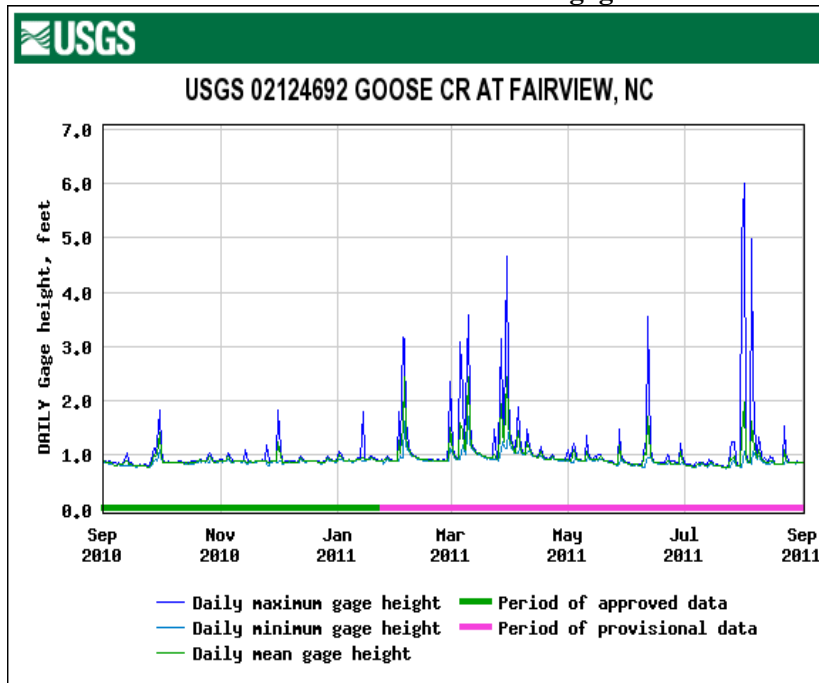
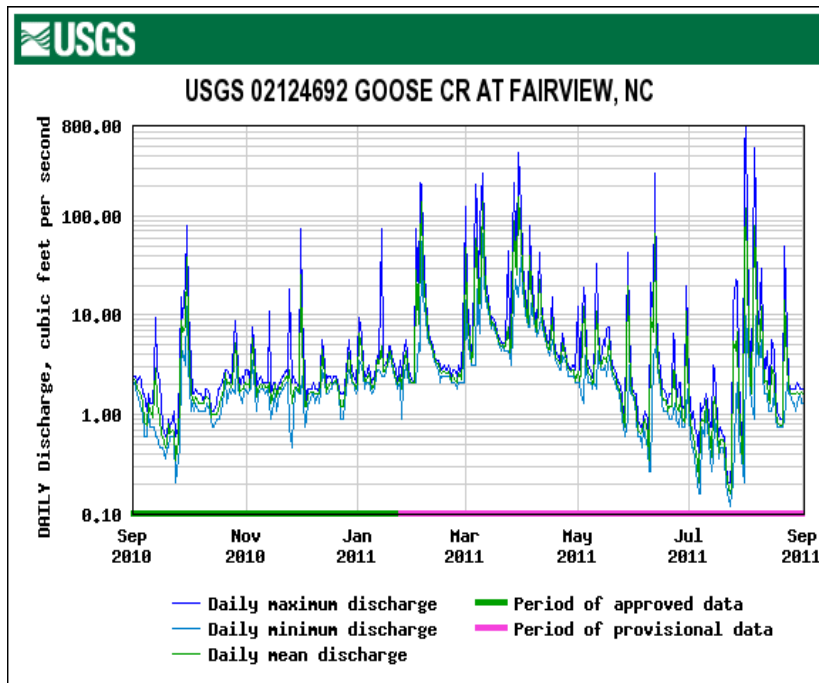
Year 3 bankfull event – recorded gage data

A discussion of the Year 1 and 2 bankfull events is provided in the respective monitoring reports. For Year 3, the most likely dates for the bankfull event(s) are estimated to be after the rain events that led to the elevated gage heights and higher peak flood discharge events recorded at USGS Gage 02124692 on March 10 and 30, 2011. This gage is located along Goose Creek at Fairview, NC, which lies approximately 10 miles north of Monroe and 16 miles northwest of Wingate, NC. As these are the largest precipitation events since the completion of Year 2 monitoring, it is likely that at least one of these lead to the bankfull event recorded by both crest gages during Year 3. On March 10, 2011, the recorded mean gage height at the Goose Creek station was 2.44 feet and maximum gage height was 3.58 feet. On that day, mean daily discharge was 140 ft³/s and maximum daily discharge was 266 ft³/s. On March 30, 2011, the recorded mean gage height measured 2.45 feet and maximum gage height measured 4.66 feet. On that day, mean daily discharge was 154 ft³/s and maximum daily discharge was 424 ft³/s. The discharge and gage height recorded at the Fairview gage station are shown on the graphs below.

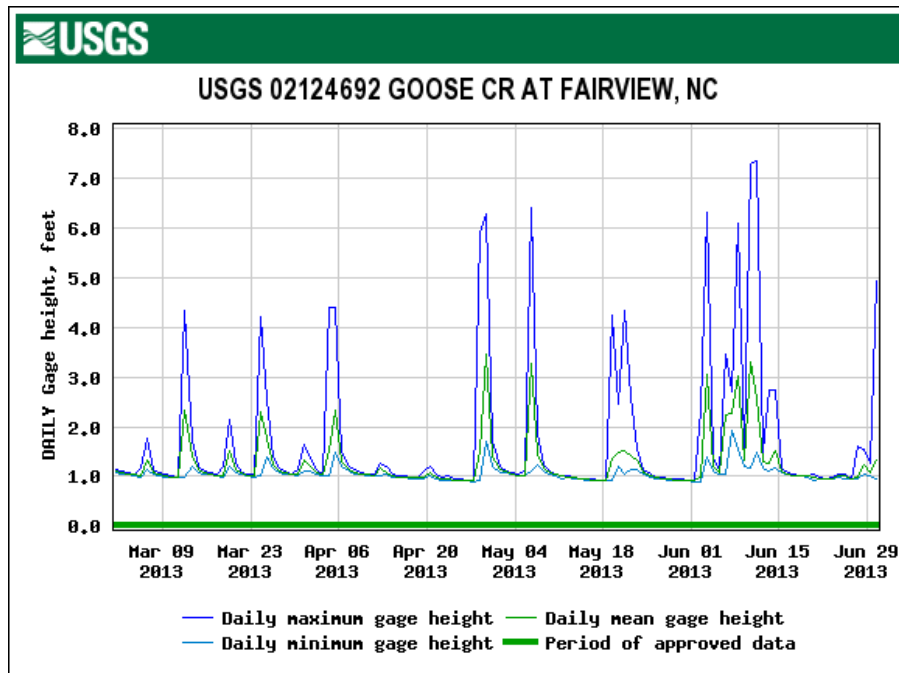
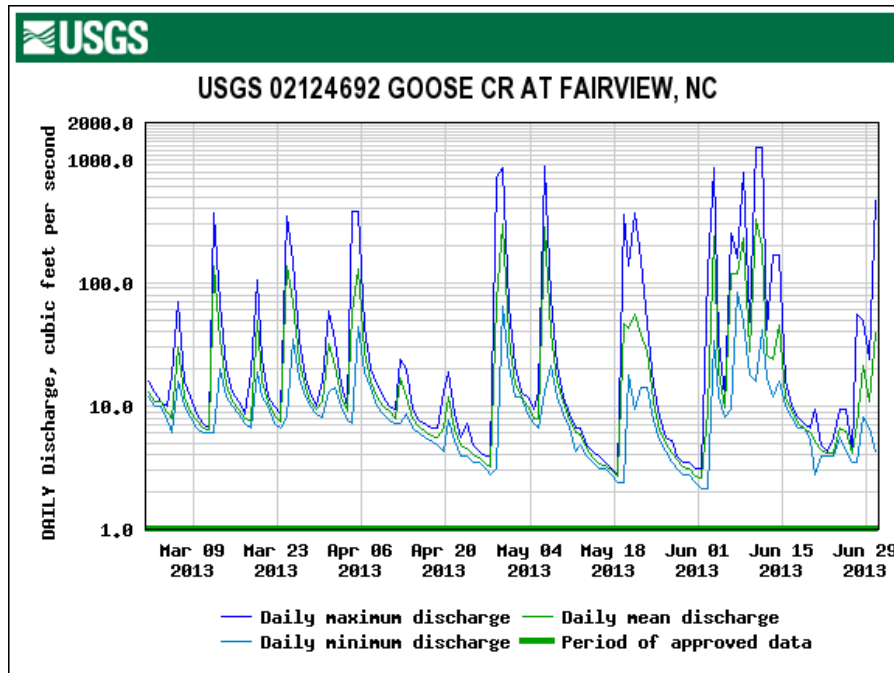
Year 5 bankfull event – recorded gage data

When the crest gages were read in May 2013 for Year 5, the crest gage furthest upstream on UT1 registered a bankfull event at a height of 10-1/2 inches above the bottom of the crest gage. The crest gage along the main stem of Beaverdam Creek near the confluence with UT1 did not document a bankfull event for Year 5, although it is likely to have occurred. Year 3 (May 2011) was the last recorded bankfull event along the main stem, at a height of 1-inch above the bottom of the crest gage. The Year 5 observed bankfull event is likely associated with the rainfall event that led to the elevated gage heights and higher peak flood discharge events recorded at USGS Gage 02124692 on April 29 or May 6, 2013. On April 29, 2013, the recorded maximum gage height at the Goose Creek station was 6.29 feet and the maximum recorded discharge was 856 ft³/s. On May 6, 2013, the recorded maximum gage height was 6.39 feet and the maximum recorded discharge was 892 ft³/s.

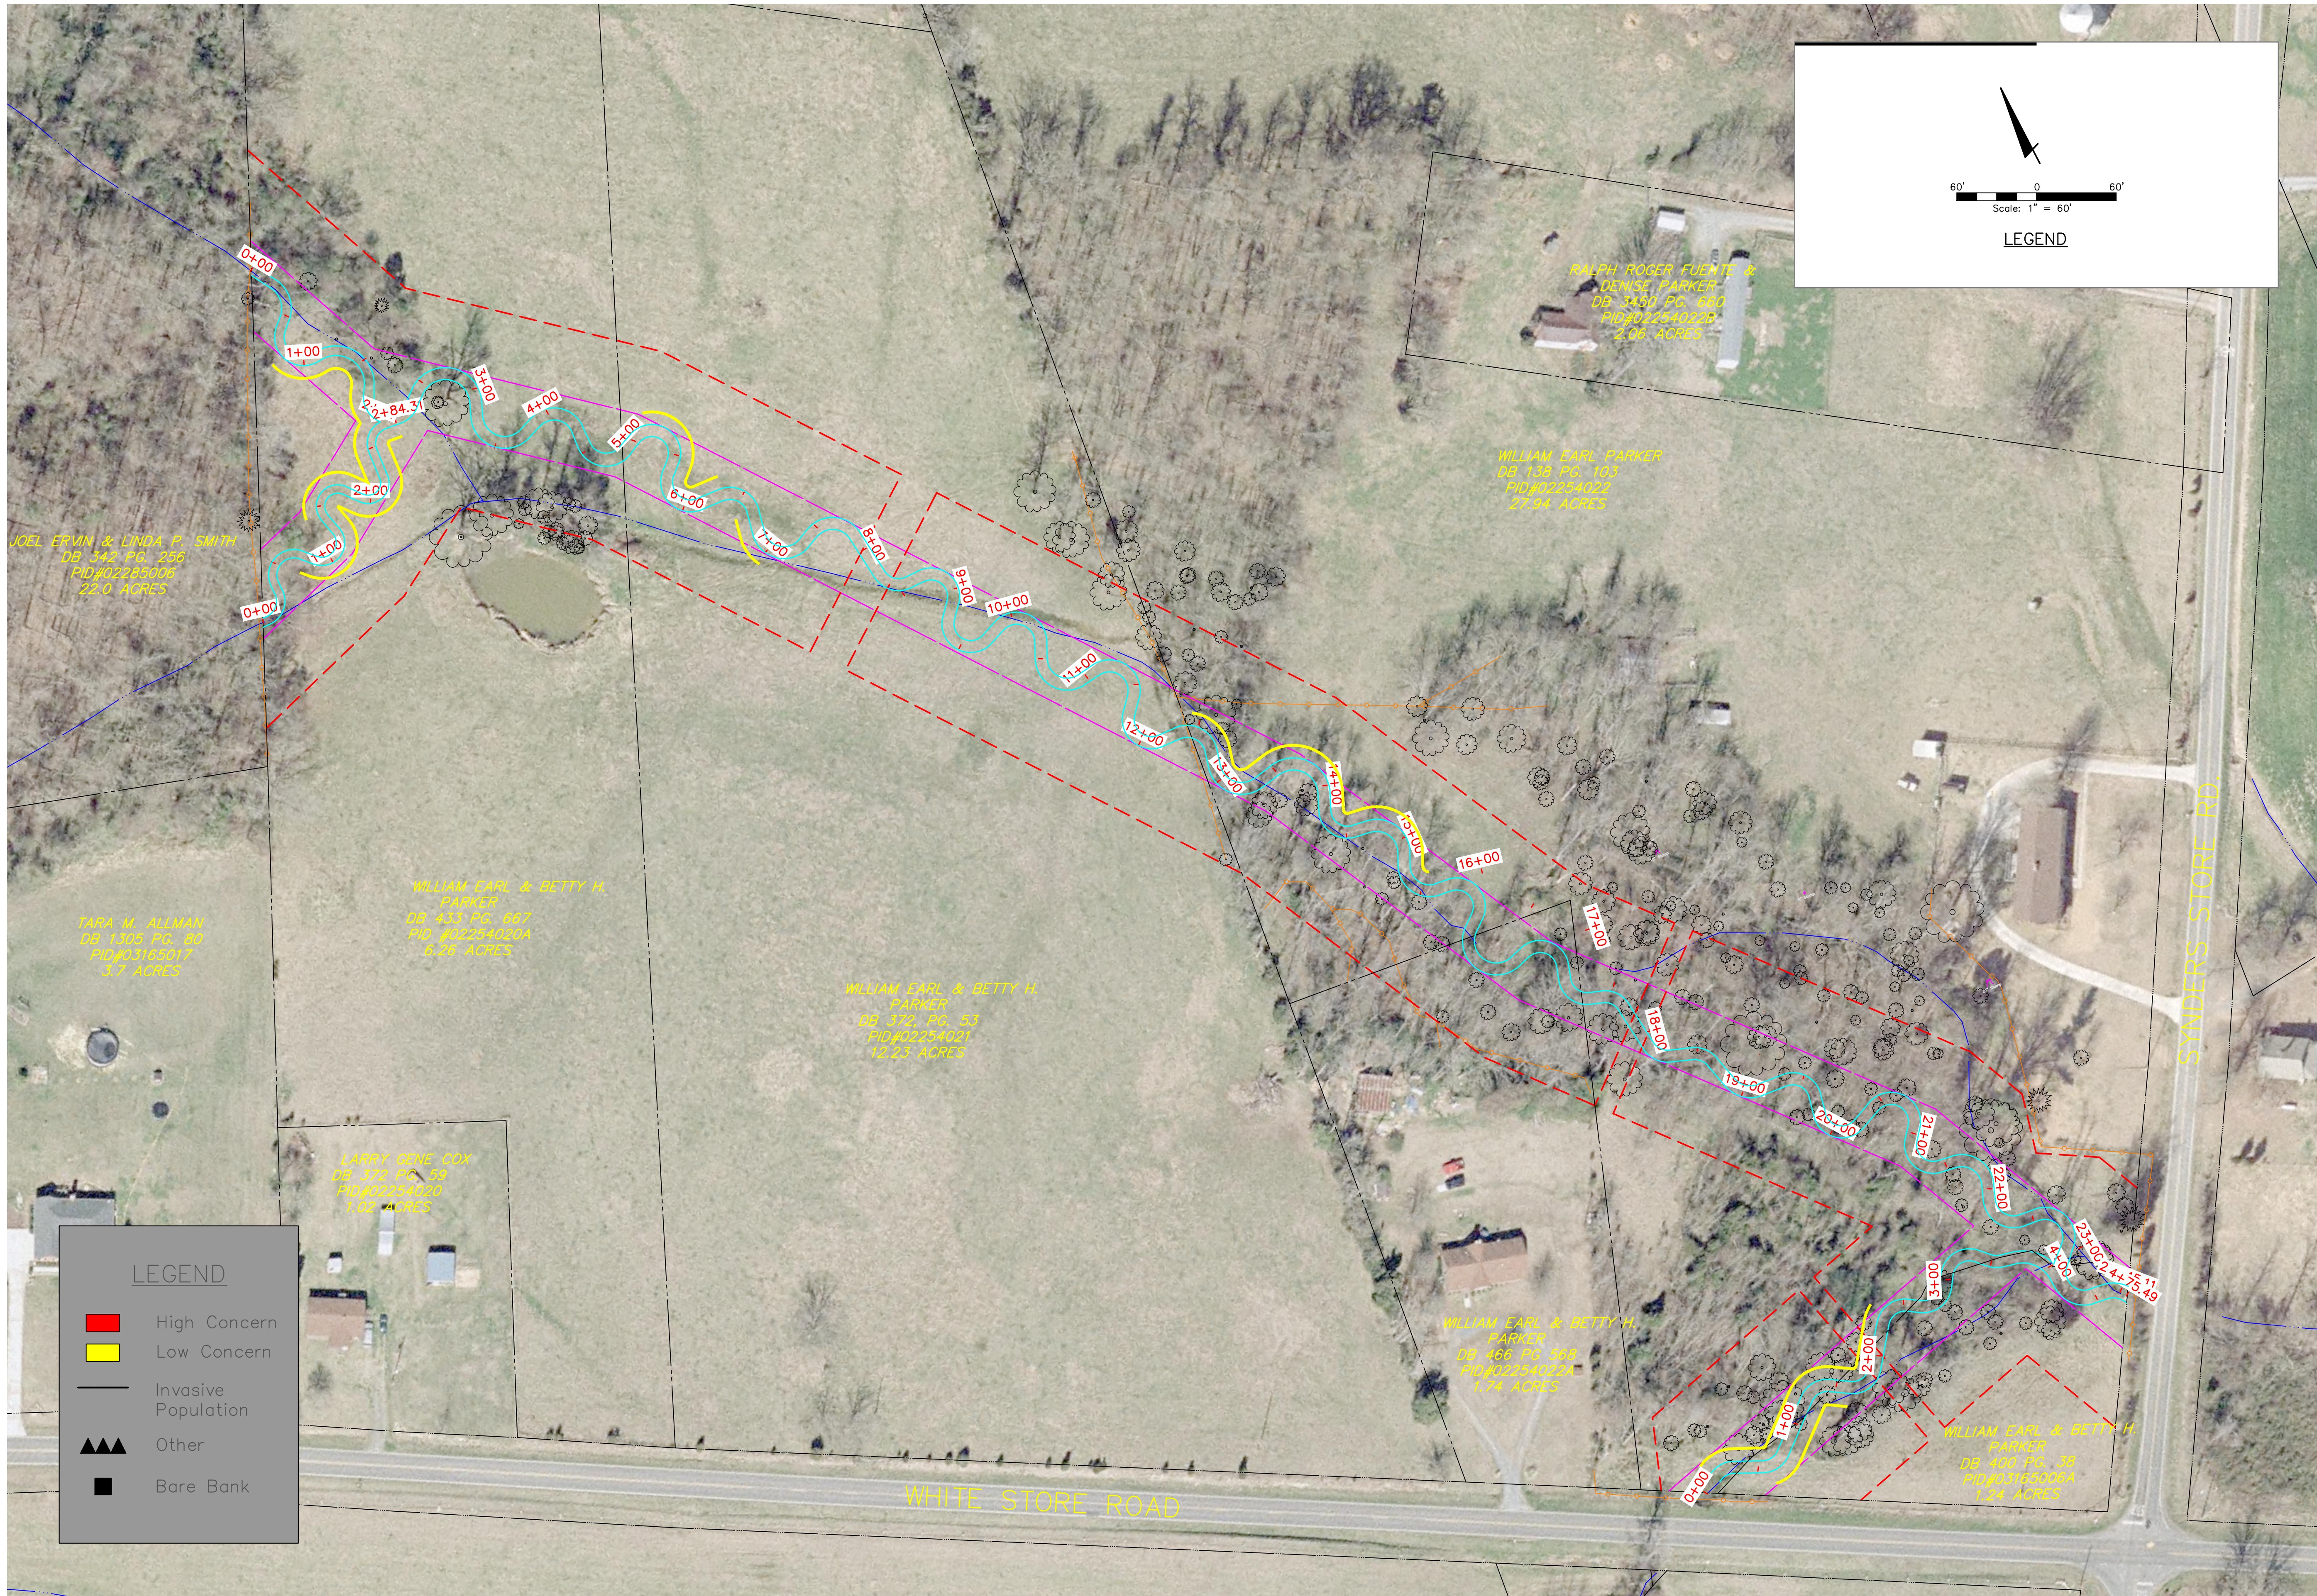
View of the spread of *microstegium* at along UT1, between stations 12+50 and 15+00. This invasive grass is found in various patches along the project corridor, but is most prominent in this area.

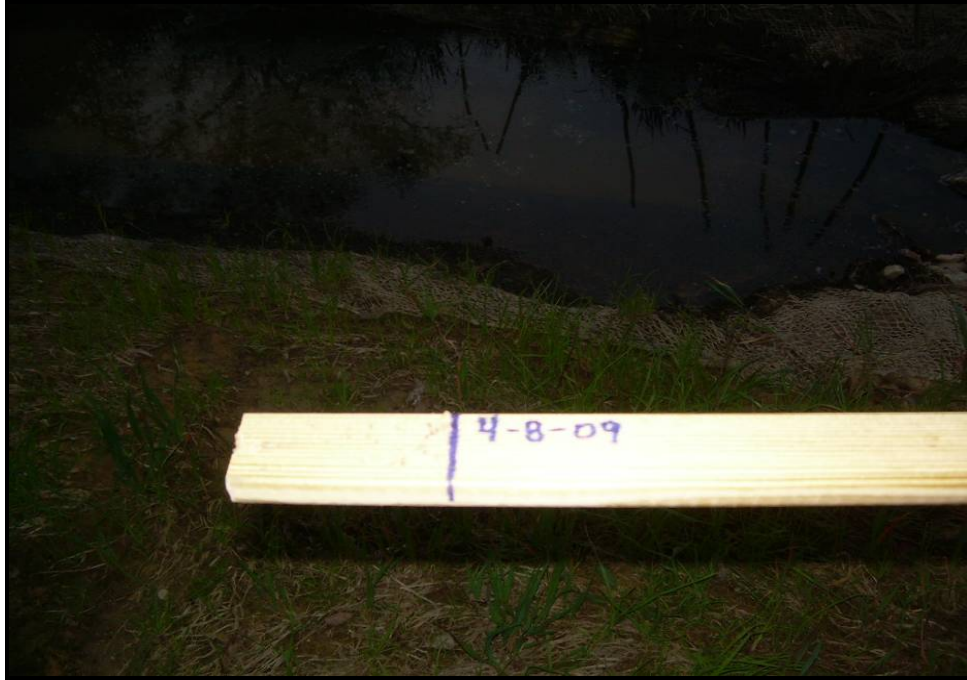
BF 1
Crest gage at 5+50 on UT1 (Year 1).
(EMH&T, 4/8/09)

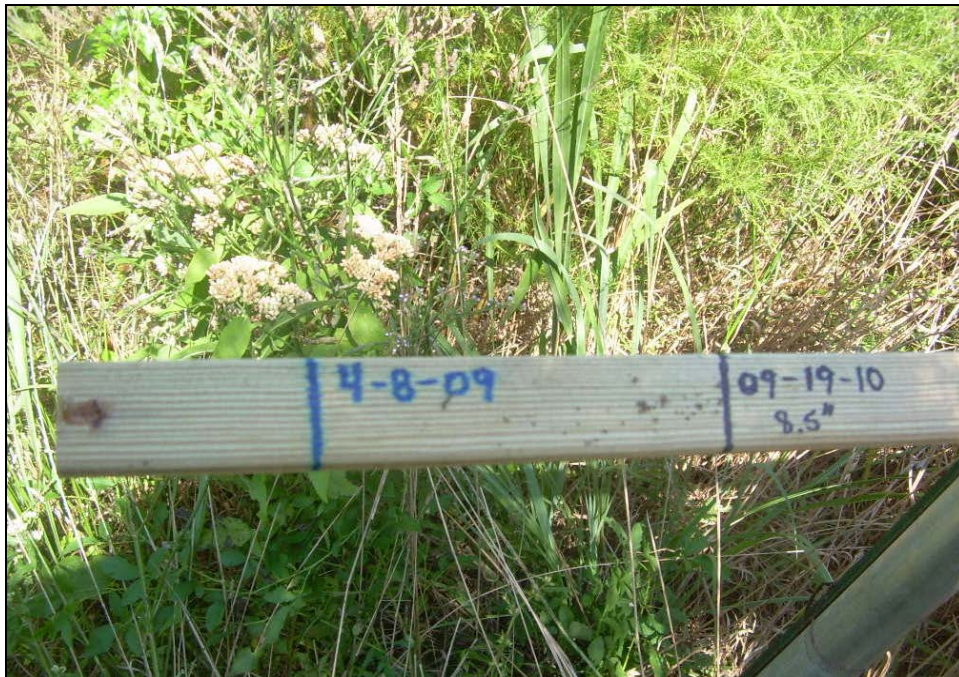
BF 2
Crest gage at 5+50 on UT1 (Year 2).
(EMH&T, 9/19/10)

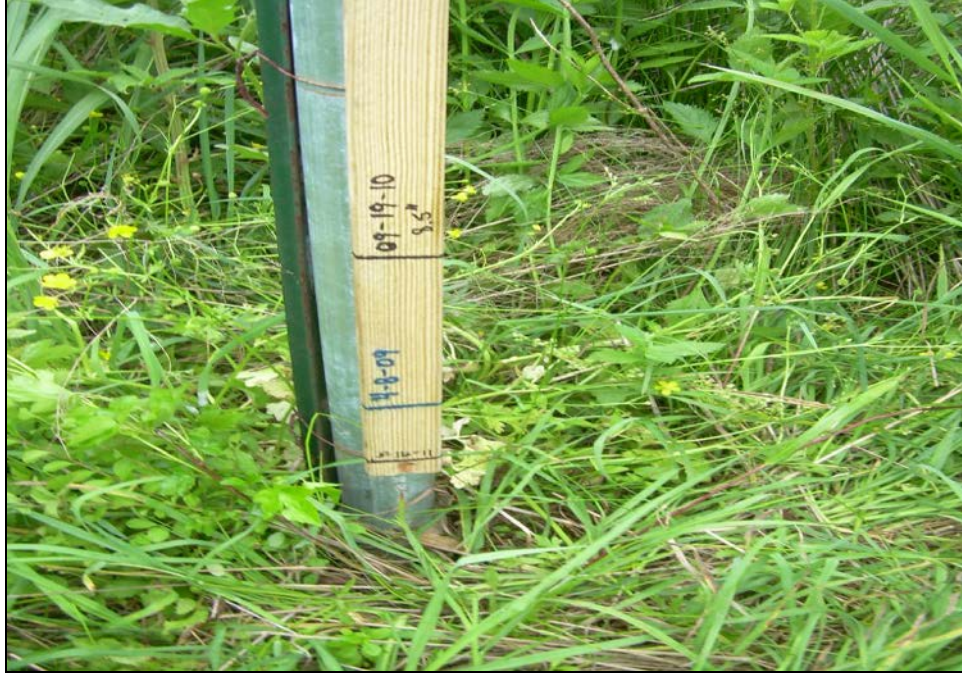
BF 3
Crest gage at 5+ 50 on UT1 (Year 3).
(EMH&T, 5/16/11)

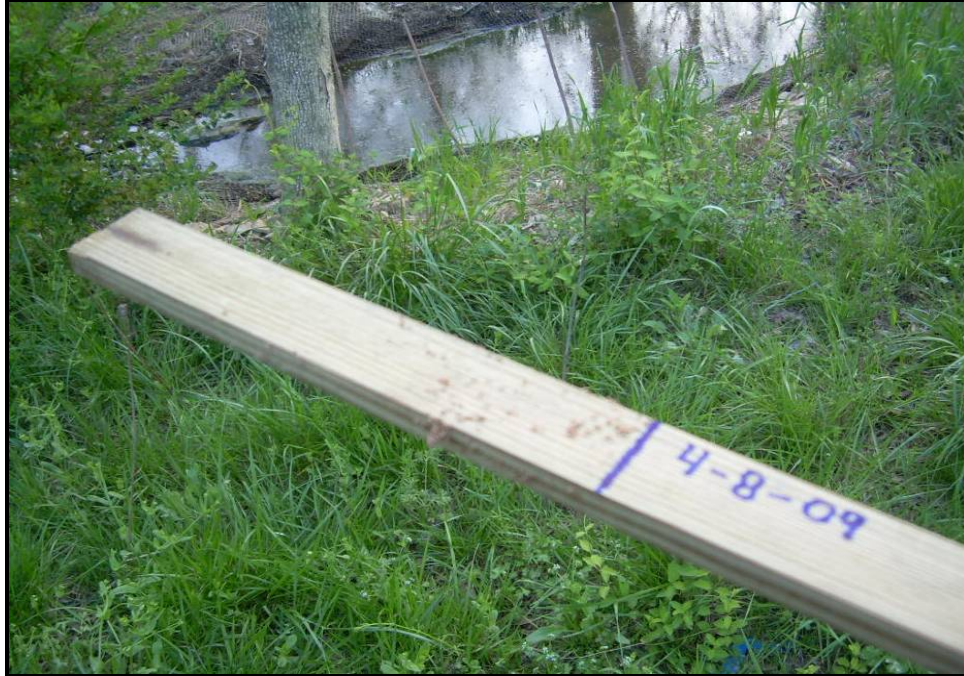
BF 5
Crest gage at 3+80 on Beaverdam Creek Mainstem and 22+75 on UT1, at the confluence of
the two reaches (Year 1).
(EMH&T, 4/8/09)

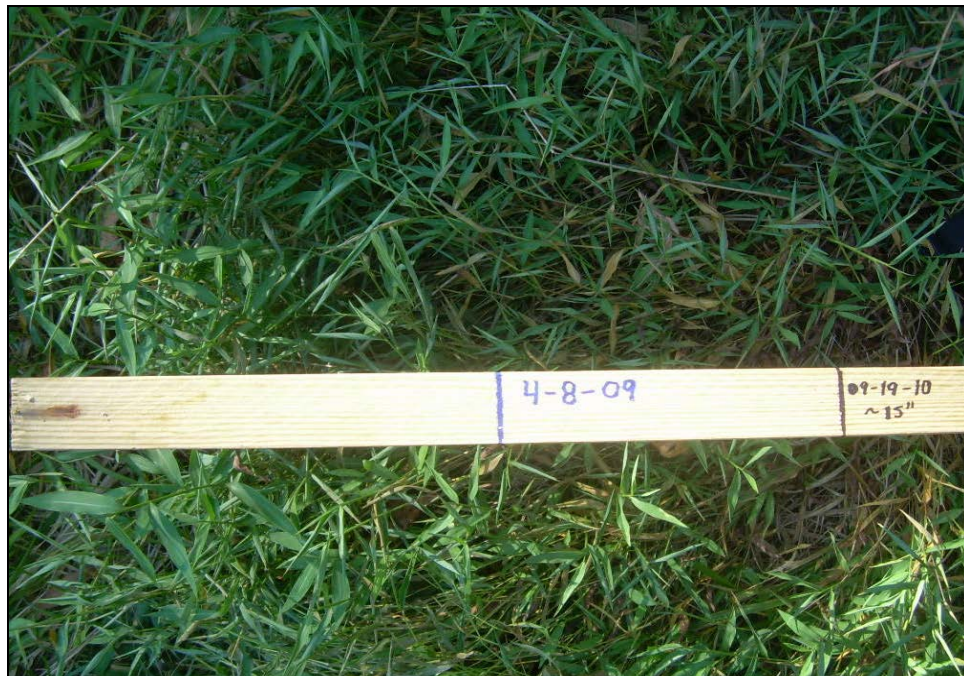
BF 6
Crest gage at 3+80 on Beaverdam Creek Mainstem and 22+75 on UT1, at the confluence of
the two reaches (Year 2).
(EMH&T, 9/19/10)

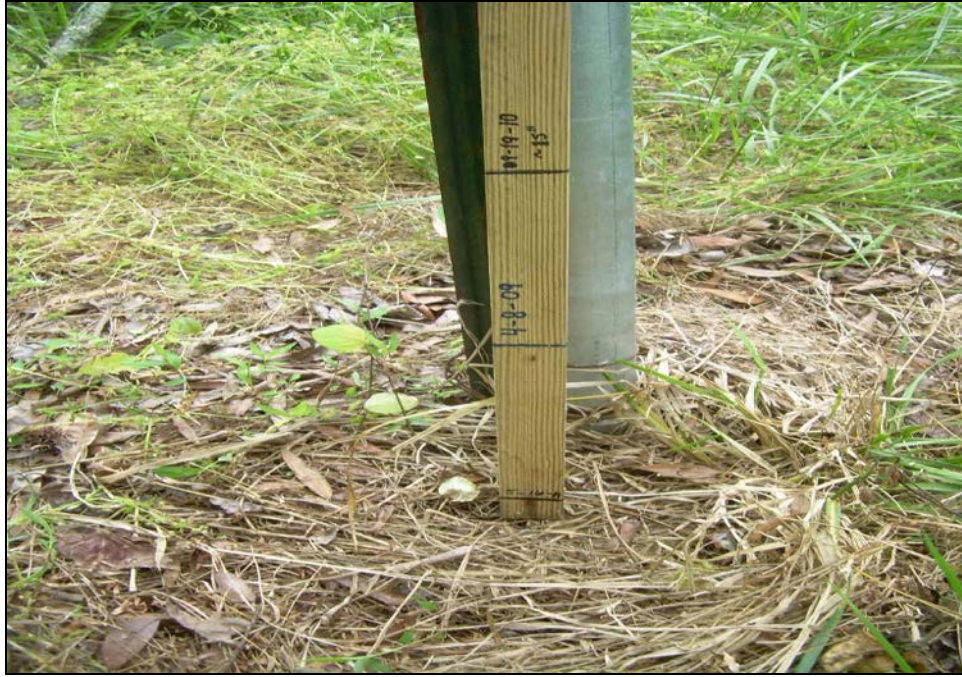
BF 7

Crest gage at 3+80 on Beaverdam Creek Mainstem and 22+75 on UT1, at the confluence of the two reaches (Year 3).
