# ANNUAL REPORT FOR 2004

**Benson Grove Mitigation Site**  
**Johnston County**  
**Project No. 8.1402211**  
**TIP No. R-2547WM**

Prepared By:  
Office of Natural Environment & Roadside Environmental Unit  
North Carolina Department of Transportation  
December 2004

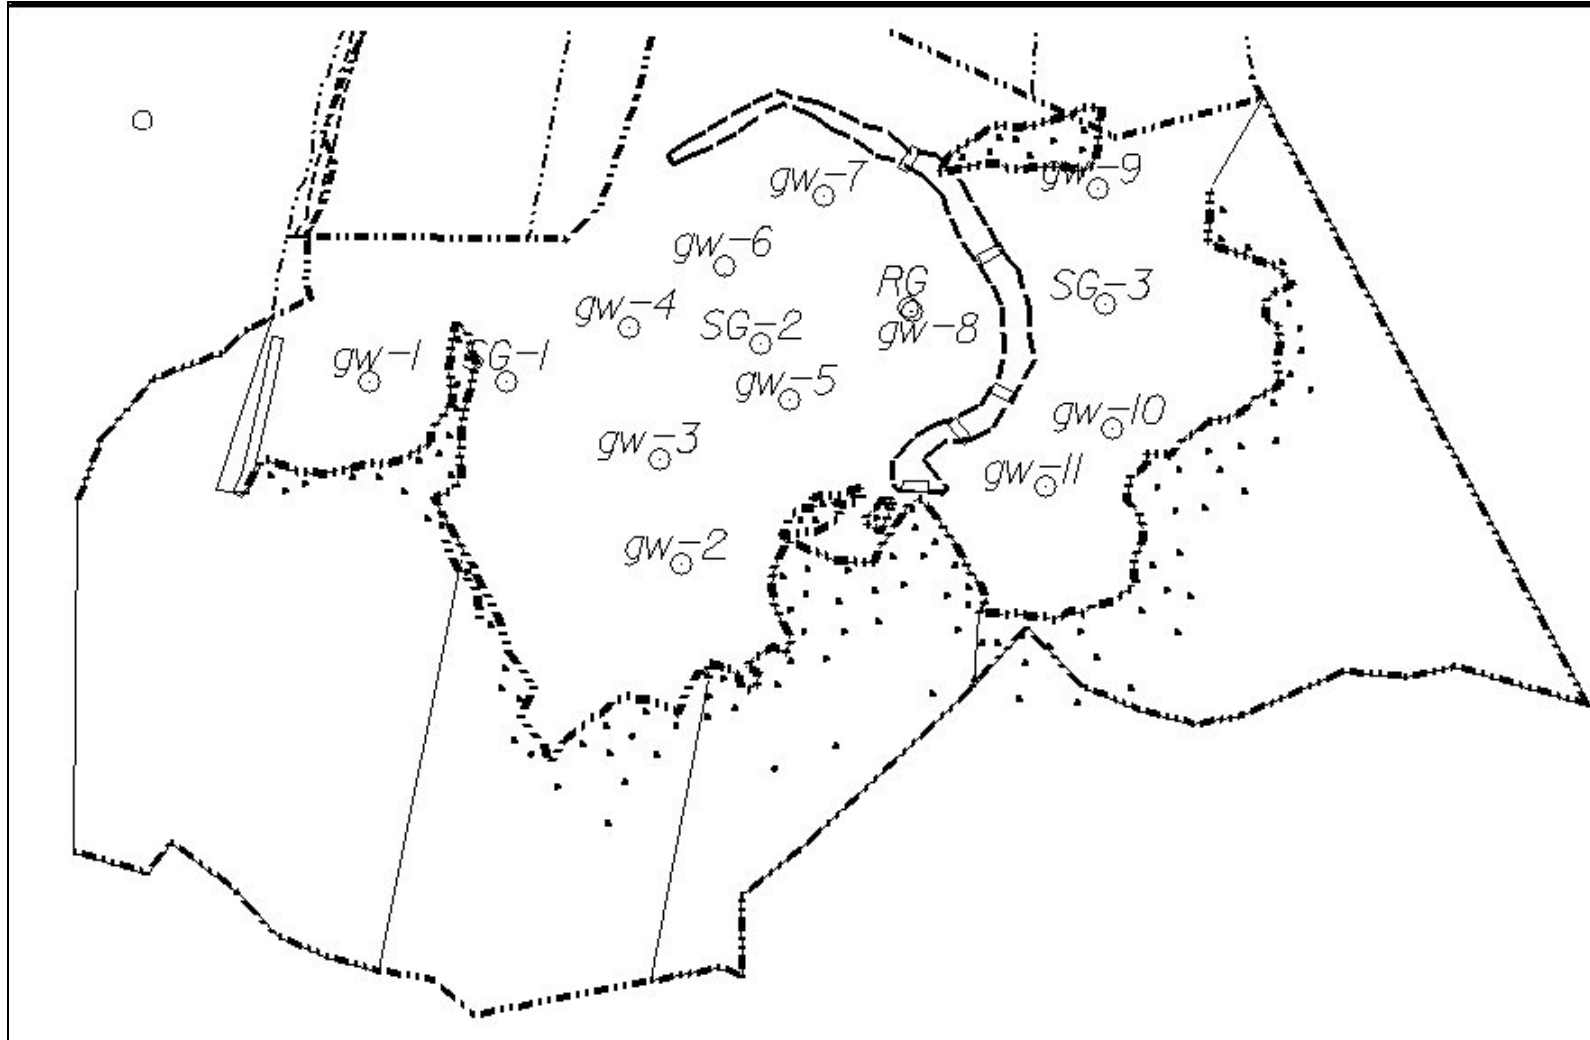
Figure 2. Monitoring Gauge Location Map

In March 2002, eleven groundwater gauges, three surface water gauges, and one onsite rain gauge were installed throughout the site (Figure 2). The automatic monitoring gauges record daily readings of groundwater depth. This represents the third full growing season that the monitoring gauges have been in place.

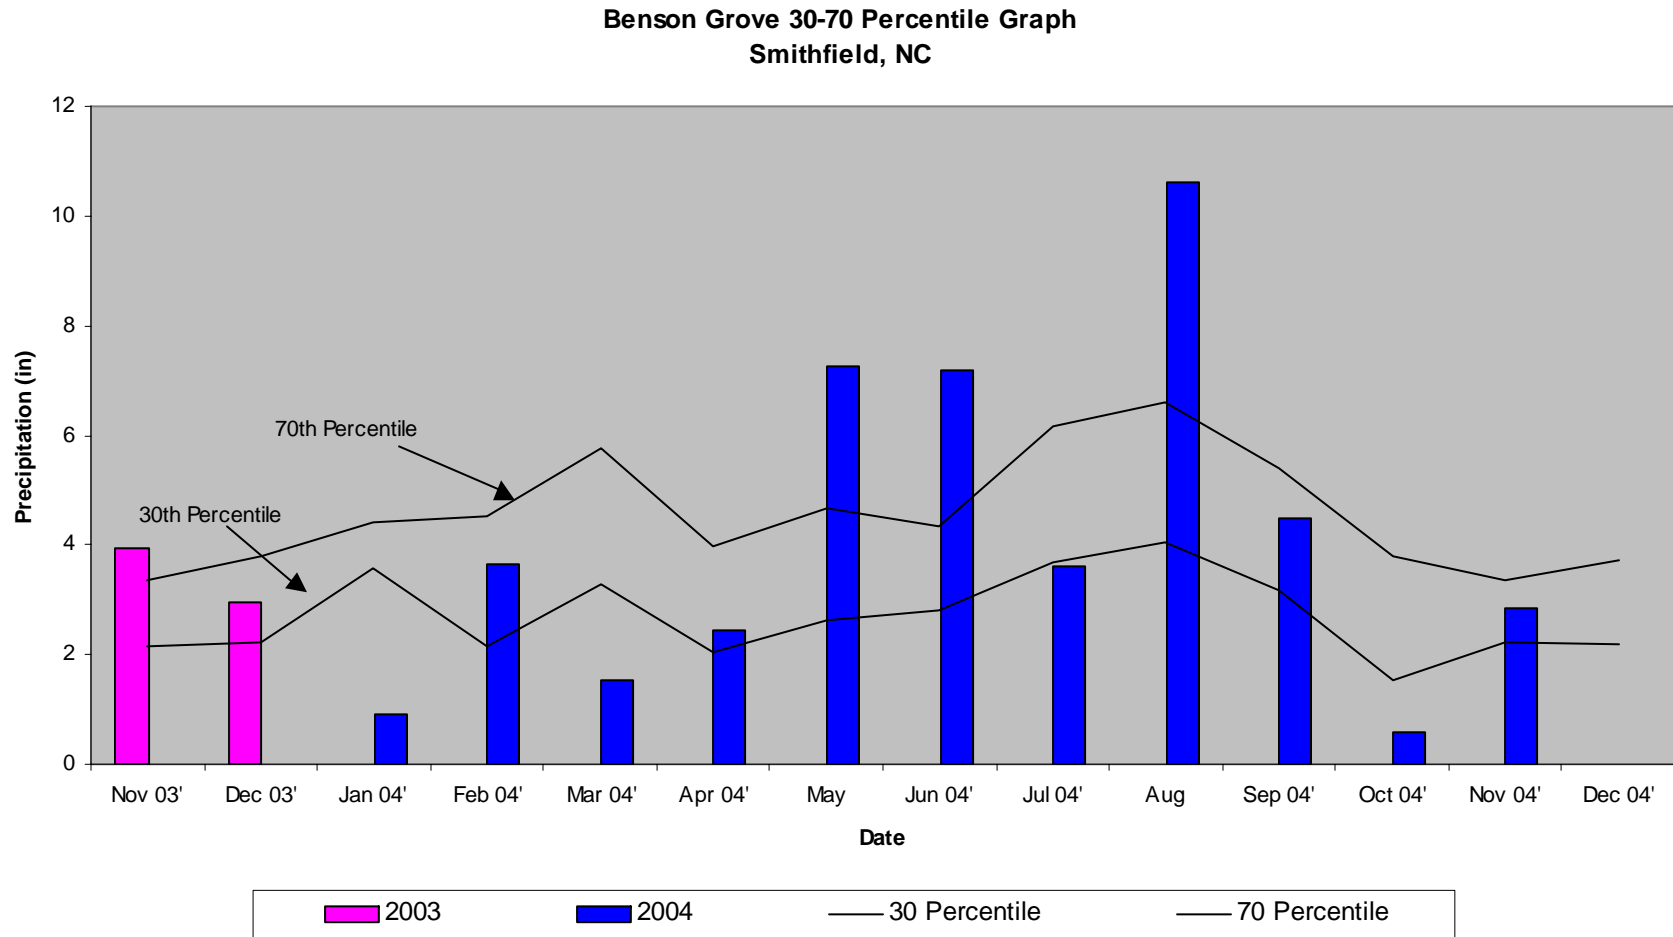
Figure 4: 30-70 Percentile Graph

Figure 4 provides an evaluation of the local climate in comparison with historical data in order to determine whether 2004 was “average” in terms of rainfall. The two lines represent the 30<sup>th</sup> and 70<sup>th</sup> percentiles of monthly precipitation for Smithfield. The bars are the monthly rainfall totals for the 2003 and 2004 hydrologic year. The historical data and monthly rainfall was collected by the National Climatic Data Center.
