**BEST STREAM AND WETLAND RESTORATION PROJECT
MONITORING REPORT
MONITORING YEAR 1**

DUPLIN COUNTY, NORTH CAROLINA
CONTRACT NO. 004631 - PROJECT NO. 95353

March 2016

**Best
Duplin County, North Carolina
DMS Project ID 95353**

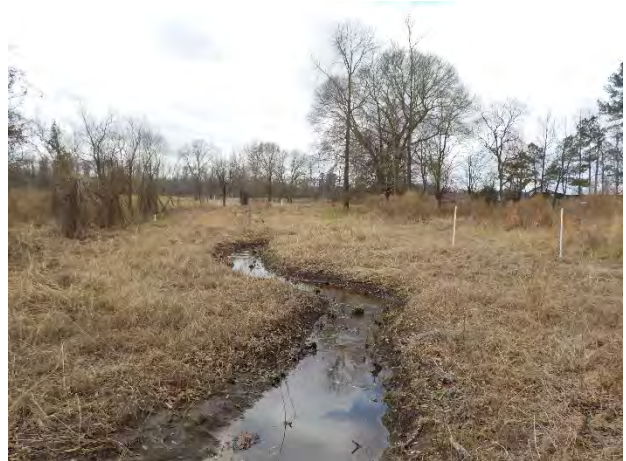
UT1 STA 2+00 Looking Downstream (2/9/2016)

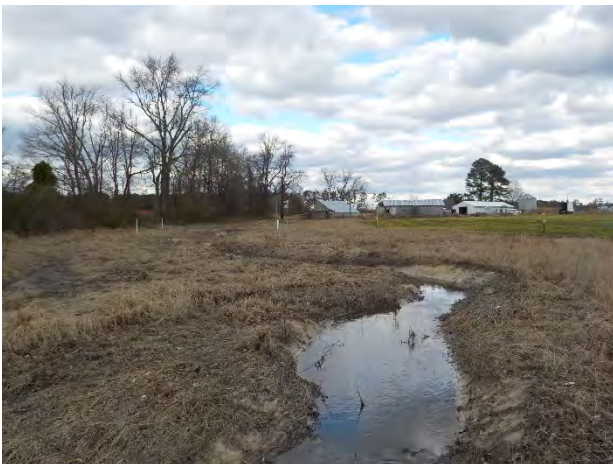
UT2 STA 8+00 Looking Upstream (2/9/2016)

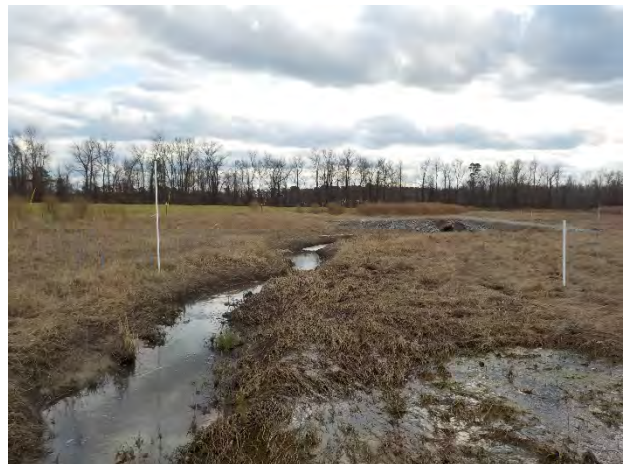
UT2 STA 18+00 Looking Downstream (2/9/2016)

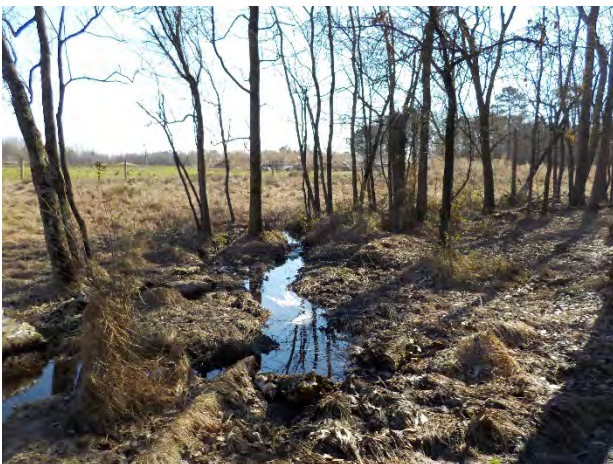
UT3 STA 5+50 at Looking Upstream (2/9/2016)

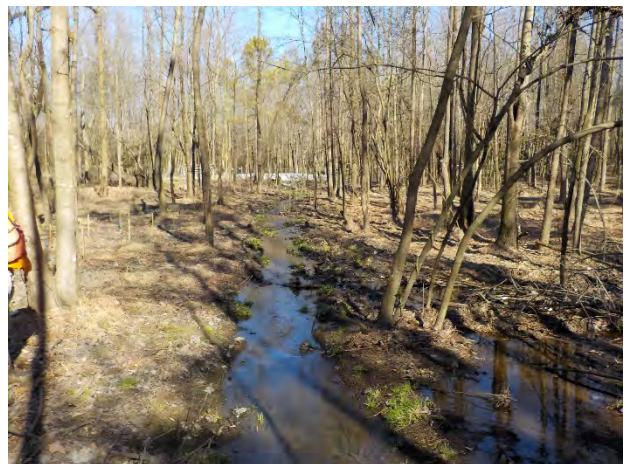
UT4 STA 6+75 Looking Downstream (2/9/2016)

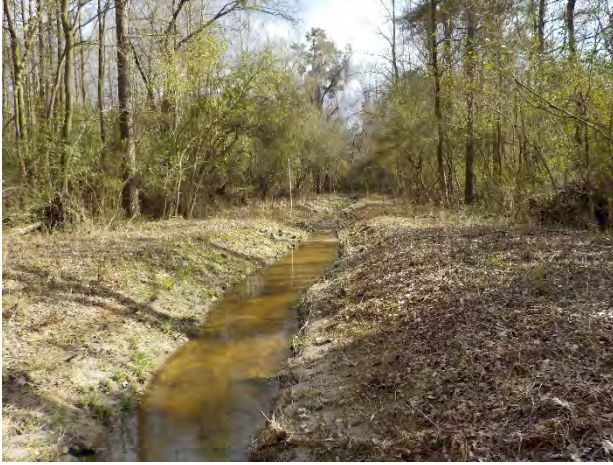
UT6 STA 2+00 Looking Downstream (2/9/2016)

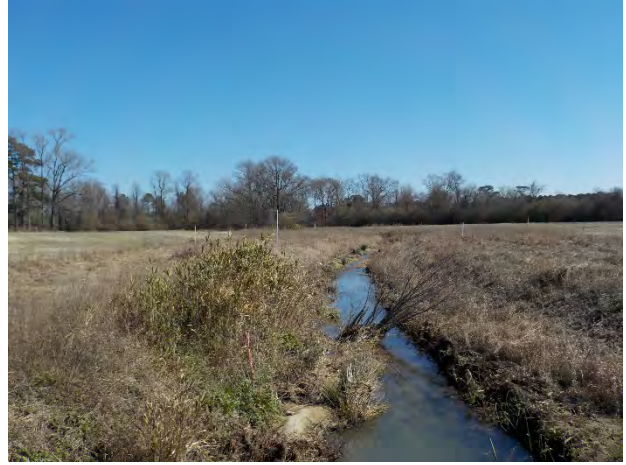
UT8 STA 3+25 Looking Downstream (2/9/2016)

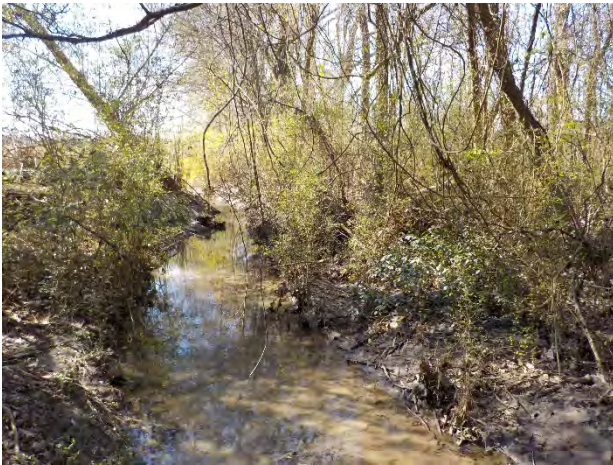
UT8 STA 9+00 Looking Upstream (2/9/2016)

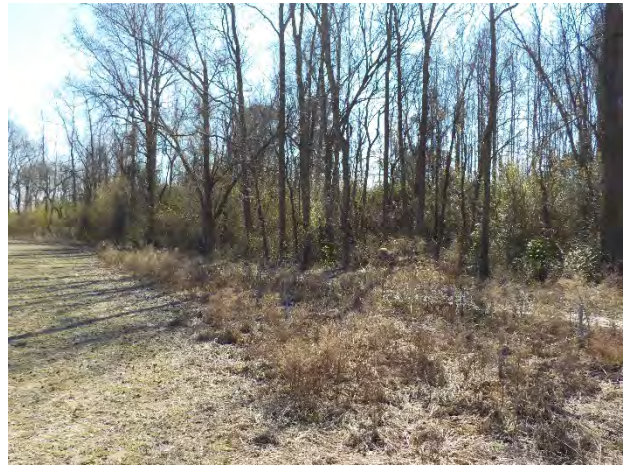
UT9 STA 3+50 Buffer Enhancement Area (2/9/2016)

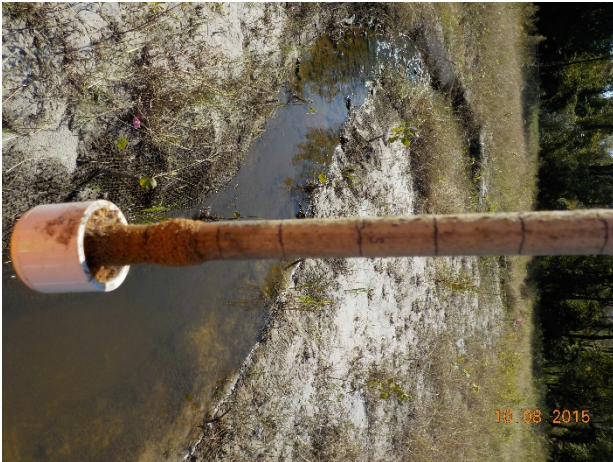
Crest Gauge 1 Reading 0.3' (10/8/2015)

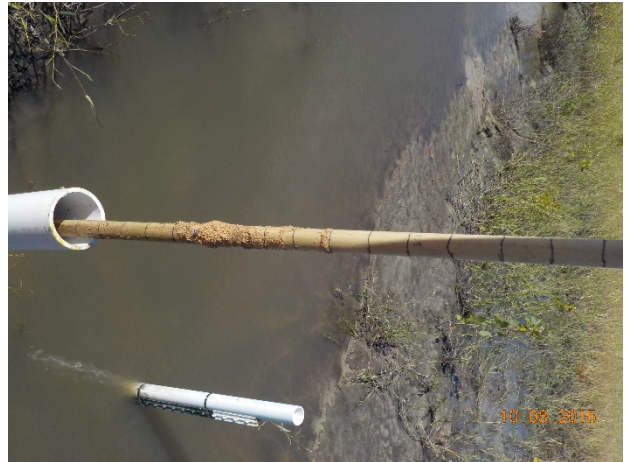
Crest Gauge 2 Reading 1.30' (10/8/2015)

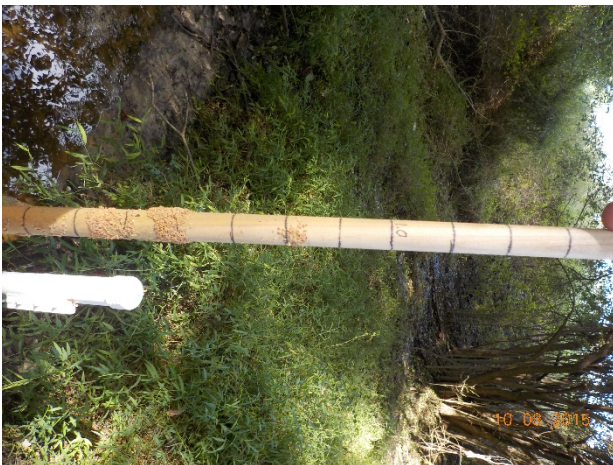
Crest Gauge 3 Reading 0.80' (10/8/2015)

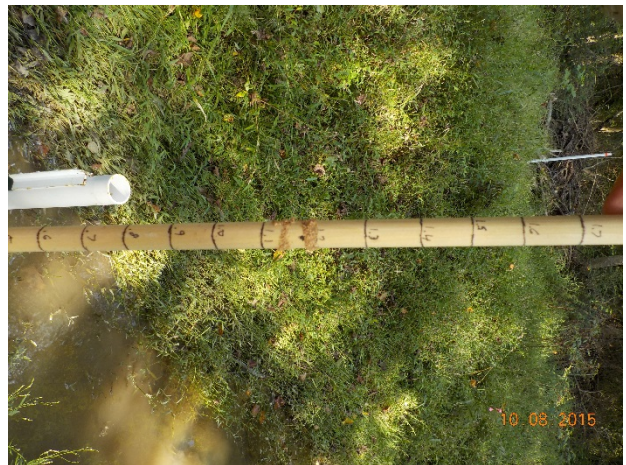
Crest Gauge 5 Reading 1.1' (10/8/2015)

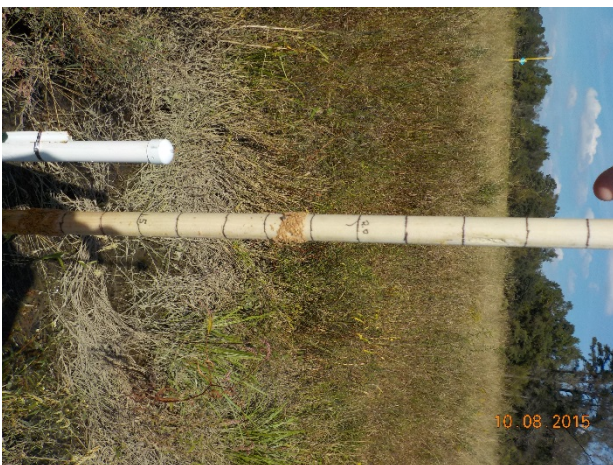
Crest Gauge 6 Reading 1.9' (10/8/2015)
