**BEST STREAM AND WETLAND RESTORATION PROJECT
MONITORING REPORT
MONITORING YEAR 2**

DUPLIN COUNTY, NORTH CAROLINA
CONTRACT NO. 004631 - PROJECT NO. 95353

**Best
Duplin County, North Carolina
DMS Project ID 95353**

**Cape Fear River Basin
HUC 03030007060010**

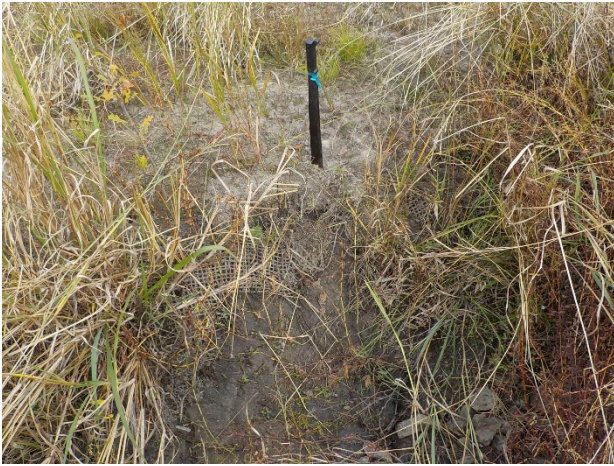
Table 7. Stream Problem Areas			
Best Stream and Wetland Restoration Project - Project # 95353			
Feature Issue	Station # / Range	Suspected Cause; Repair	Photo Number
Minor Bank Erosion	UT1- Sta 12+60	Heavy rain events and sustained high flows; no repair needed currently. Continue to monitor.	SPA1
Bank Erosion/Loose matting on right bank	UT2- Sta. 27+00	Heavy rain events and sustained high flows; no repair needed currently. Continue to monitor.	SPA2
Relic Channel Floodplain Erosion	UT4- Sta. 10+25 to 11+00	Heavy rain events and sustained high flows; , regrade floodplain to disperse concentrated overland flow and add fill material.	SPA3
Multiple locations of fence damage	UT3 and UT4	Falling trees across cattle fencing; all locations have already been repaired.	SPA4

SPA1- Minor Bank Erosion- UT1 @ Sta. 12+60

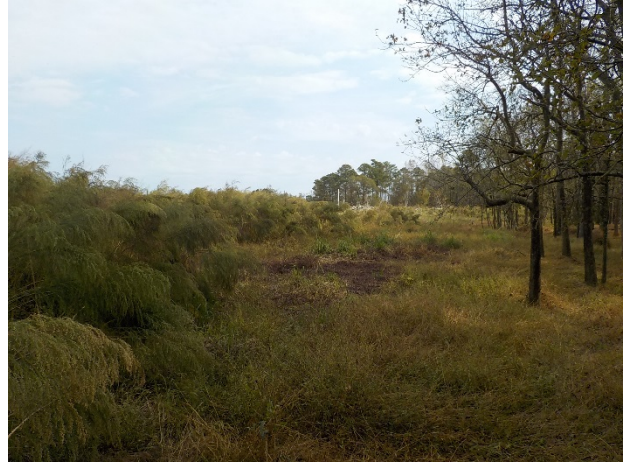
Table 8. Vegetation Problem Areas			
Best Stream and Wetland Restoration Project - Project # 95353			
Feature Category	Station Numbers	Suspected Cause; Repair	Photo Number
Low Stem Density	UT1- Sta. 3+00 to 8+50 (0.47 ac.)	Low Soil Fertility and compaction; Re-plant area with gallon containerized trees.	VPA1
Low Stem Density	UT3- Sta 6+50 to 8+42	Low Soil Fertility and compaction; Re-plant area with gallon containerized trees.	VPA2

VPA2- Low Stem Density- UT3 @ Sta 6+50 to 8+42 (0.97 Ac.)
