**BEST STREAM AND WETLAND RESTORATION PROJECT  
MONITORING REPORT  
MONITORING YEAR 3  
FINAL**

DUPLIN COUNTY, NORTH CAROLINA  
CONTRACT No. 004631 - PROJECT No. 95353  
USACE Action ID No. 2012-01384 -NCDWR Project No. 13-0865

RE: Best Stream and Wetland Restoration Site: MY3 Monitoring Report (NCDMS ID 95353)

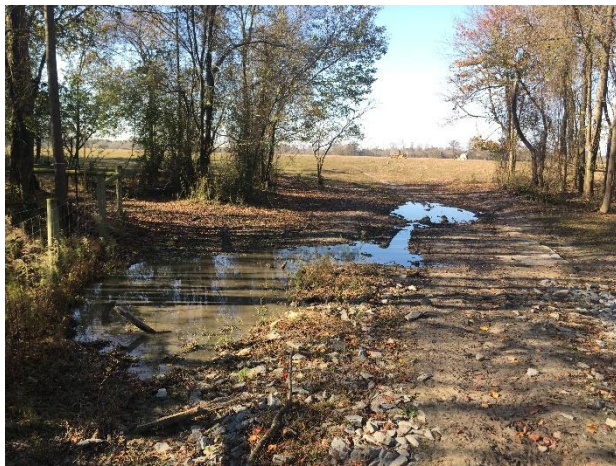
SPA3 – Ponding on Road UT 4 @ Sta. 8+47 to 8+67

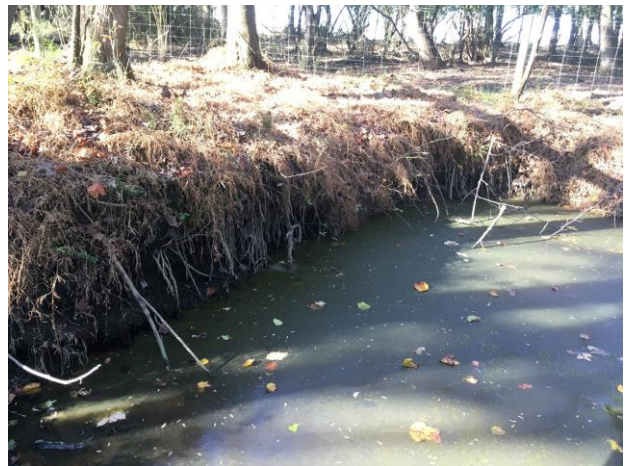
SPA4 – Relic Channel Floodplain Plug Subsidence UT4 @ Sta. 8+75 to 11+03

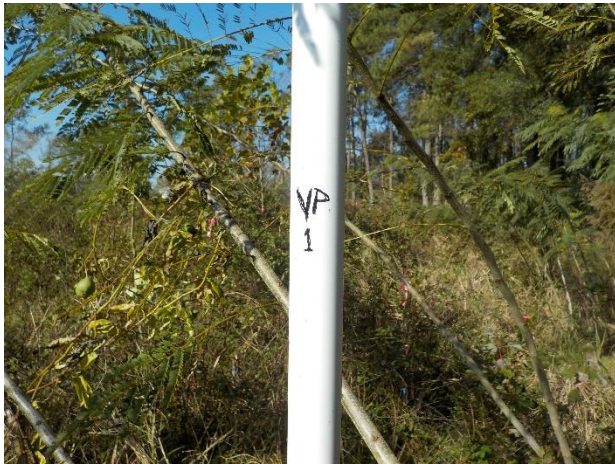
VPA 2 – Invasives Present UT1 @ Sta. 0+00  
(0.13ac)

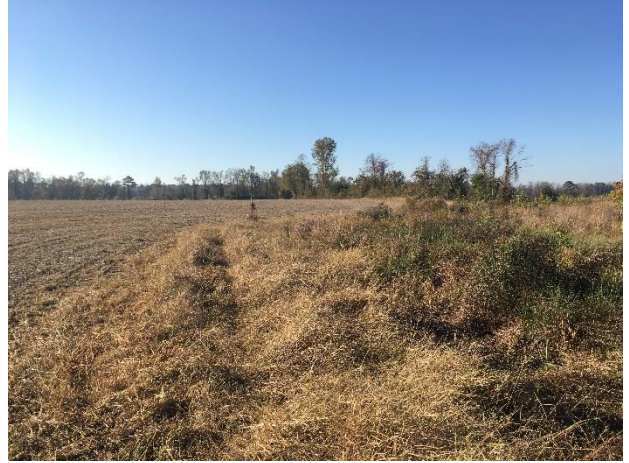
<b>Table 8. Vegetation Problem Areas</b>			
<b>Best Stream and Wetland Restoration Project - Project # 95353</b>			
<b>Feature Category</b>	<b>Station Numbers</b>	<b>Suspected Cause; Repair</b>	<b>Photo Number</b>
<b>Low Stem Density</b>	UT1- Sta. 3+00 to 8+50 (0.47 ac)	Low Soil Fertility and compaction; Re-plant area with gallon containerized trees.	VPA 1
<b>Invasives present</b>	UT1 - Sta. 0+00 (0.13 ac)	Invasives present in easement due to offsite seed source; remove invasive by cutting down and herbiciding	VPA 2
<b>Low Stem Density</b>	UT1 - Sta. 4+00 to 6+00 (0.49 ac)	Low Soil Fertility, compaction, and competition with native weeds; Re-plant area with gallon containerized trees.	VPA 3
<b>Poor Growth/Vigor</b>	UT1 - Sta. 11+00 to 13+00 (0.21 ac)	Low Soil Fertility and compaction; continue to monitor	VPA 4
<b>Encroachment</b>	UT2 - Sta. 25+00 to 26+50 (0.04 ac)	Oversprary from farming operation; continue to monitor	VPA 5

VPA 6 – Poor Growth/Vigor - UT2 @ Sta. 4+50 & 12+00 (0.10 ac)

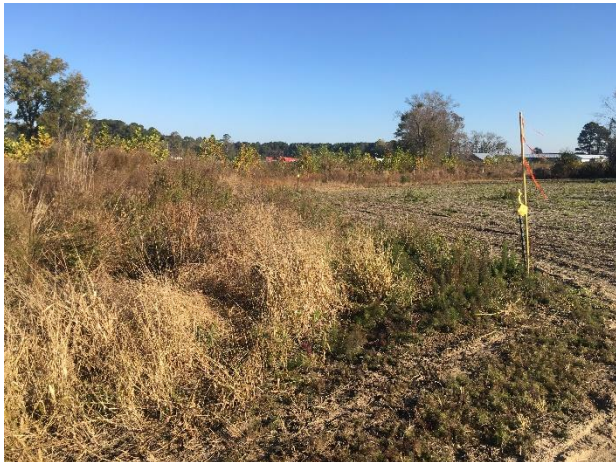
VPA 7- Encroachment UT2 @ Sta. 4+50 & 12+00 (0.10 ac)
