**BEST STREAM AND WETLAND RESTORATION PROJECT
MONITORING REPORT
MONITORING YEAR 4
FINAL**

DUPLIN COUNTY, NORTH CAROLINA
CONTRACT No. 004631 - PROJECT No. 95353
USACE Action ID No. 2012-01384 -NCDWR Project No. 13-0865

**Best
Duplin County, North Carolina
DMS Project ID 95353**

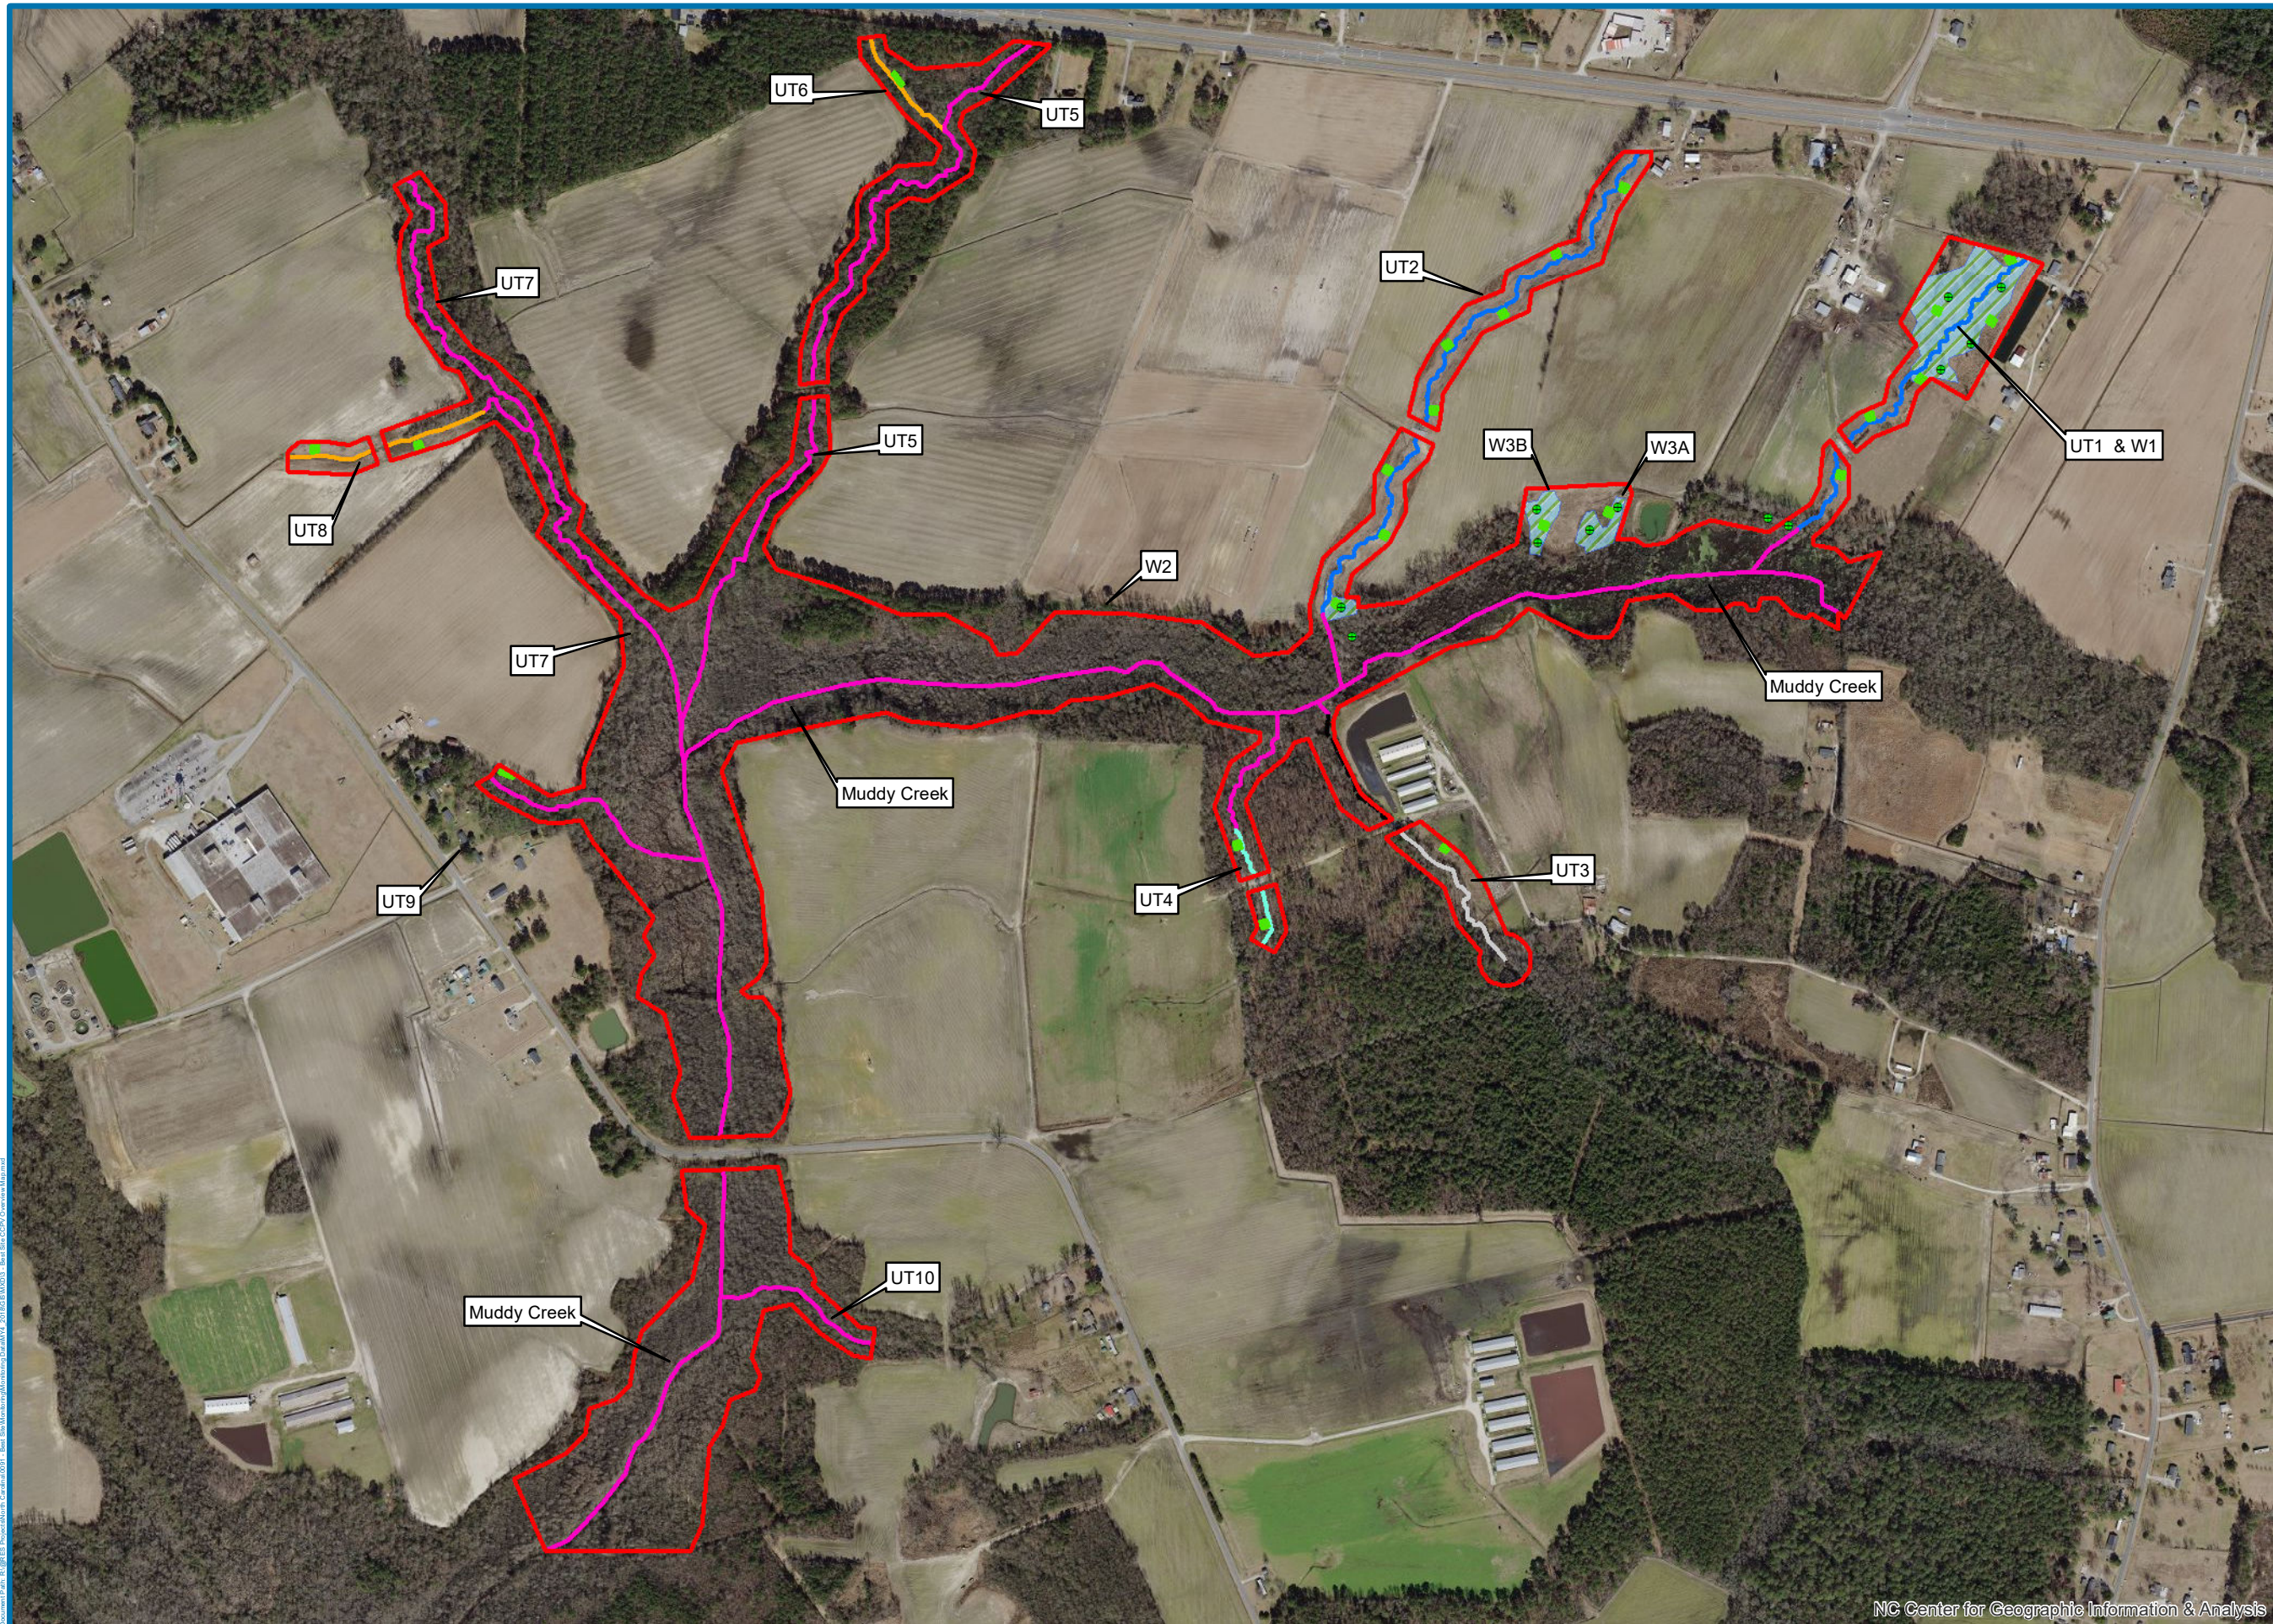
Figure 3a
Best Stream and Wetland Restoration Project
Current Conditions
Plan View
MY4 2018

Three stream problems were identified during the Year 4 monitoring period and have been mapped on the Current Conditions Plan View (CCPV) (**Figure 3**). The fence problem area reported in MY3 was repaired in January 2018. Stream problem area 1 (SPA1) consists of minor bank erosion on UT4 at station 10+20. This area appears stable and RES plans to continue to monitor these areas to see if they worsen. If conditions continue to worsen, livestock and additional bank matting will be installed along the banks. Stream problem area 2 (SPA2) is located on UT4 from station 8+47 to 8+67. This area consists of ponding on the road, due to downstream issue at SPA3. The area involves adding fill material to eliminate the ponding on the road. SPA3 is located on UT4 from station 8+75 to 11+03 and is attributed to the subsidence of the plug that had been installed at construction. This problem is associated with the relic stream channel. Fill material needs to be added to raise the plug elevation in the relic channel. All stream problem areas are localized and the overall condition of the project streams on site are stable. Remedial action repair work was completed in December 2018.

Two vegetation problems were identified during the Year 4 monitoring period. These vegetation problem areas are documented and mapped on the CCPV (**Figure 3**) as part of the annual monitoring report. The poor growth and low stem density areas reported in MY3 along UT1 and UT3 were replanted in January 2018. Vegetation problem area 1 (VPA1) is an area where the invasive species mimosa (*Albizia julibrissin*) and Chinese privet (*Ligustrum sinense*) are present along UT1 and Wetland 1. This area is approximately a tenth of an acre in size, and is well vegetated with native trees and native herbaceous cover. RES plans to continue treat the invasive species in this area. Vegetation problem area 2 (VPA2) is a low stem density area at the top of UT8. This area was replanted in December 2018.
