**BEST STREAM AND WETLAND RESTORATION PROJECT
MONITORING REPORT
MONITORING YEAR 5
FINAL**

DUPLIN COUNTY, NORTH CAROLINA
CONTRACT No. 004631 - PROJECT No. 95353
USACE Action ID No. 2012-01384 -NCDWR Project No. 13-0865

February 2020

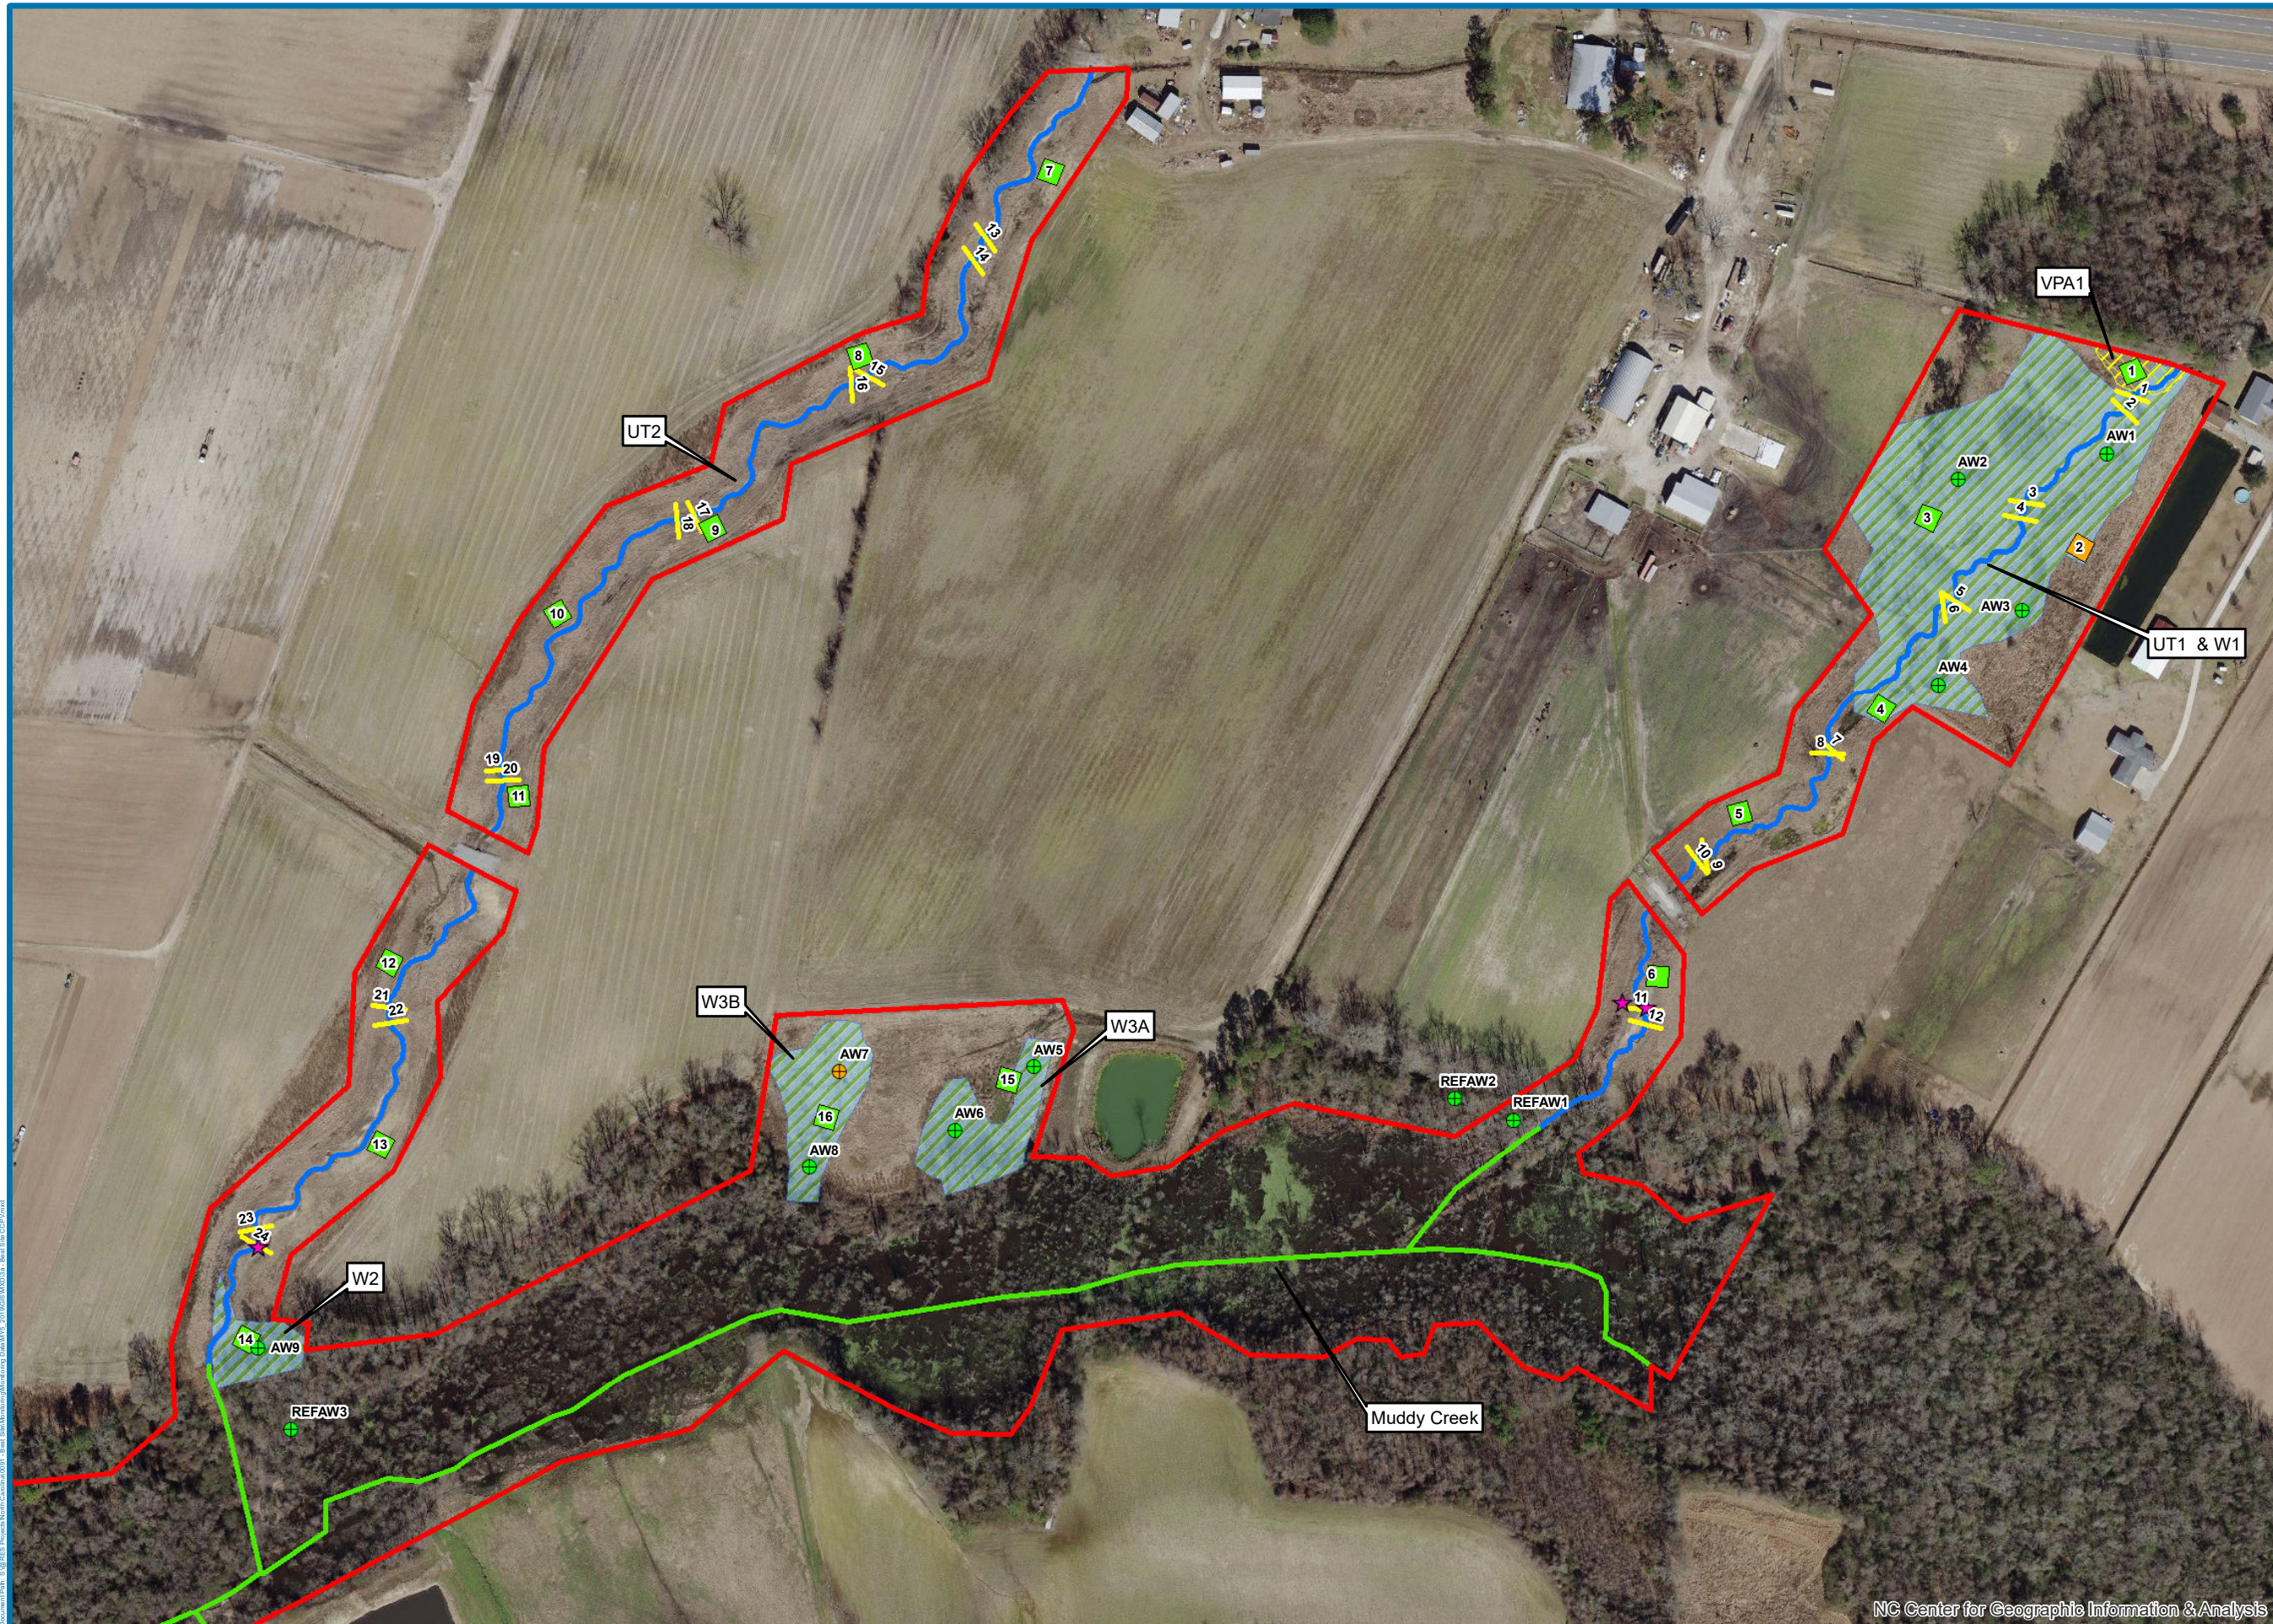
Figure 3a
Best Stream and Wetland Restoration Project
Current Conditions
Plan View
MY5 2019

One vegetation problem was identified during the Year 5 monitoring period. This vegetation problem area is documented (**Table 6** and **Table 8**) and mapped on the CCPV (**Figure 3a**) as part of the annual monitoring report. Vegetation problem area 1 (VPA1) is an area where the invasive species mimosa (*Albizia julibrissin*) and Chinese privet (*Ligustrum sinense*) are present along UT1 and Wetland 1. This area is approximately a tenth of an acre in size, and is well vegetated with native trees and native herbaceous cover (VP1 still has 440 planted stems per acre). RES plans to continue treat the invasive species in this area with mechanical and chemical applications. The poor growth and low stem density areas reported in MY4 along UT1 and UT3 were replanted in January 2018.

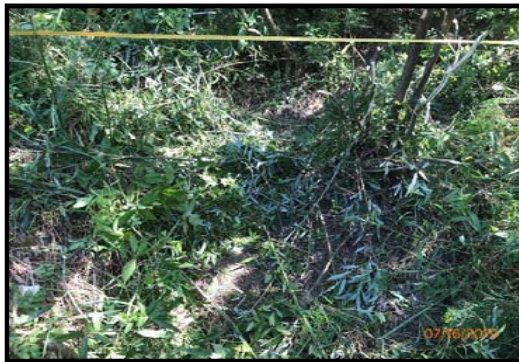
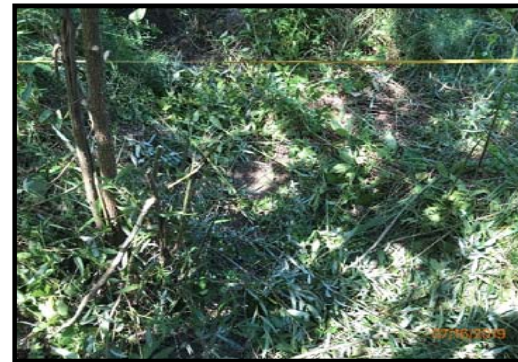
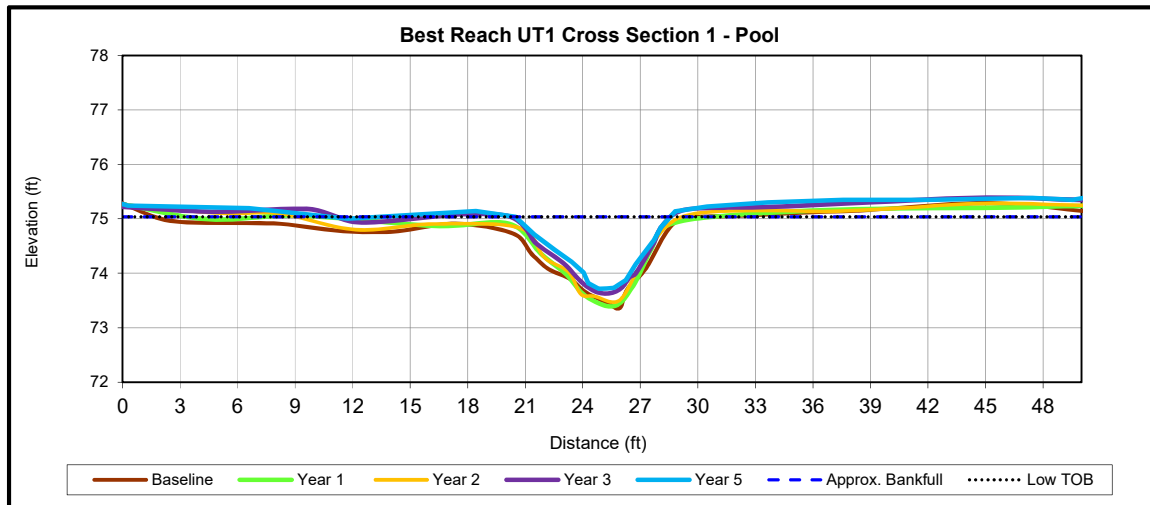
Dimension	Cross Section 1 (Pool)						
	Base	MY1	MY2	MY3	MY5	MY7	MY+
Bankfull Elevation (ft) - Based on AB-XSA ¹	74.7	74.7	74.7	74.7	75.0		
Bankfull Width (ft) ¹	8.0	6.7	7.7	8.9	8.1		
Floodprone Width (ft) ¹	50.0	50.0	50.0	50.0	50.2		
Bankfull Mean Depth (ft)	0.8	0.7	0.8	0.8	-		
Bankfull Max Depth (ft) ²	1.4	1.2	1.3	1.4	1.3		
Low Bank Elevation (ft)	-	-	-	-	75.0		
Bankfull Cross Sectional Area (ft ²) ²	6.0	4.5	5.9	7.0	5.9		
Bankfull Width/Depth Ratio	10.5	10.0	9.9	11.4	-		
Bankfull Entrenchment Ratio ¹	>2.2	>2.2	>2.2	N/A	N/A		
Bankfull Bank Height Ratio ¹	1.0	1.0	1.0	N/A	N/A

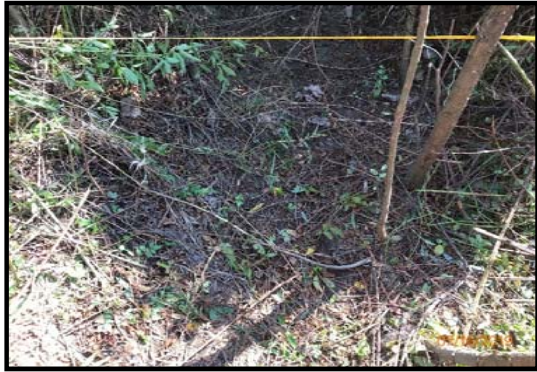
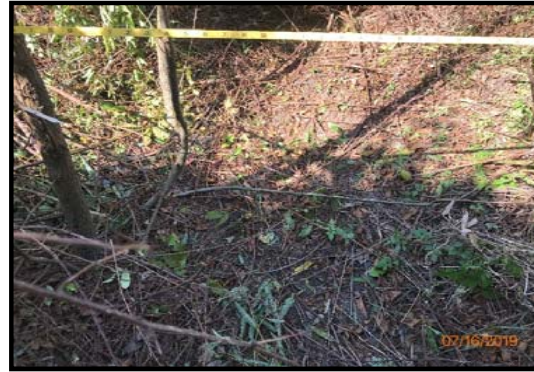
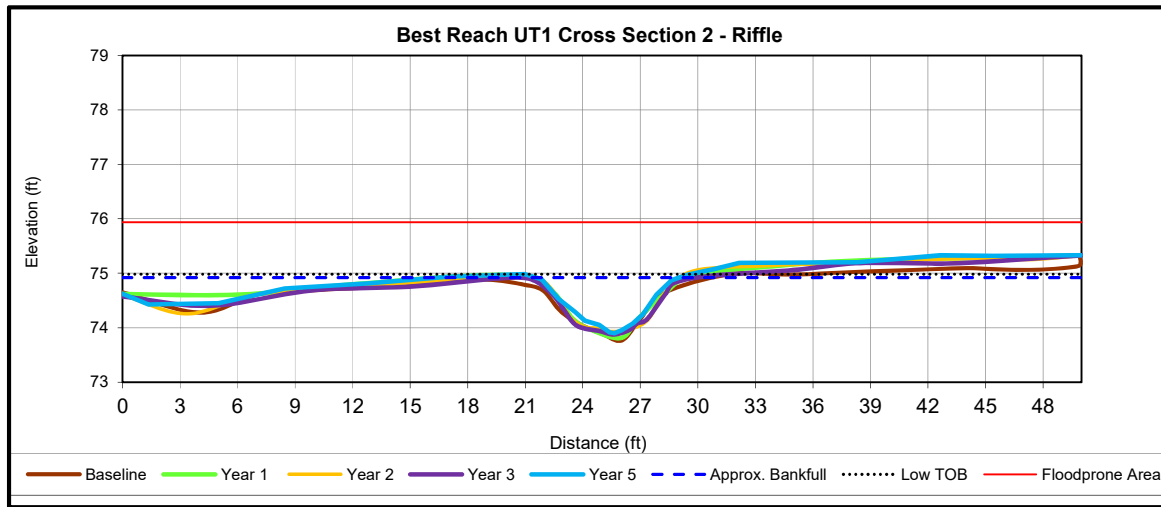
Dimension	Cross Section 2 (Riffle)						
	Base	MY1	MY2	MY3	MY5	MY7	MY+
Bankfull Elevation (ft) - Based on AB-XSA ¹	74.8	74.8	74.8	74.8	74.9		
Bankfull Width (ft) ¹	8.2	7.2	7.8	7.4	7.5		
Floodprone Width (ft) ¹	50.0	50.0	50.0	50.0	50.0		
Bankfull Mean Depth (ft)	0.5	0.5	0.6	0.6	-		
Bankfull Max Depth (ft) ²	1.0	1.0	1.0	0.9	1.1		
Low Bank Elevation (ft)	-	-	-	-	75.0		
Bankfull Cross Sectional Area (ft ²) ²	4.2	3.9	4.8	4.3	4.7		
Bankfull Width/Depth Ratio	15.9	13.5	12.7	12.8	-		
Bankfull Entrenchment Ratio ¹	>2.2	>2.2	>2.2	>2.2	>6.7		
Bankfull Bank Height Ratio ¹	1.0	1.0	1.0	1.0	1.1

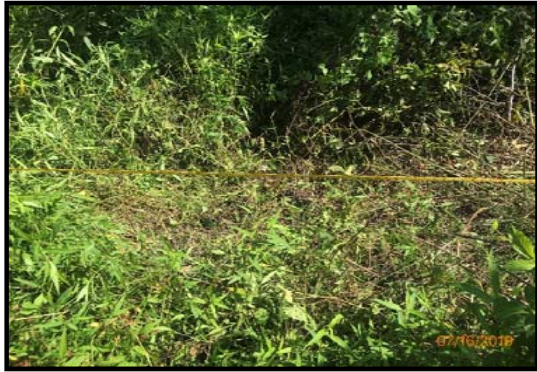
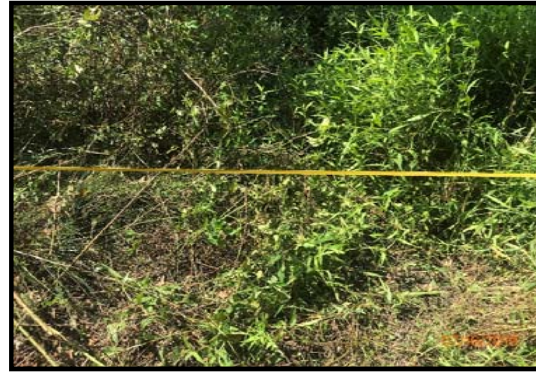
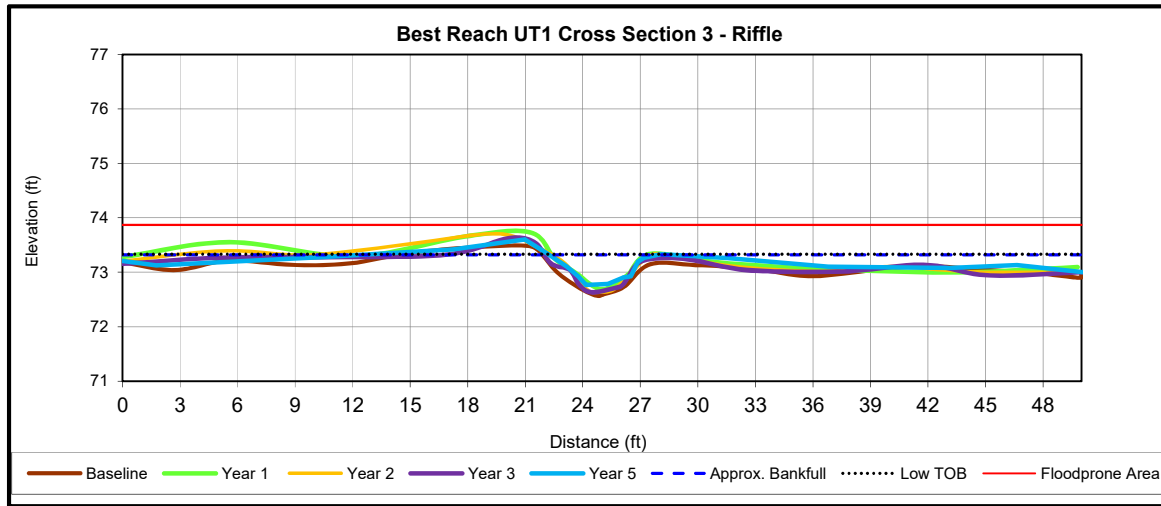
Dimension	Cross Section 3 (Riffle)						
	Base	MY1	MY2	MY3	MY5	MY7	MY+
Bankfull Elevation (ft) - Based on AB-XSA ¹	73.1	73.1	73.1	73.1	73.3		
Bankfull Width (ft) ¹	5.2	3.9	5.6	5.6	5.7		
Floodprone Width (ft) ¹	50.0	50.0	50.0	50.0	50.1		
Bankfull Mean Depth (ft)	0.3	0.2	0.4	0.3	-		
Bankfull Max Depth (ft) ²	0.6	0.5	0.7	0.6	0.6		
Low Bank Elevation (ft)	-	-	-	-	73.3		
Bankfull Cross Sectional Area (ft ²) ²	1.8	0.9	2.1	1.8	1.8		
Bankfull Width/Depth Ratio	15.1	16.2	14.7	16.9	-		
Bankfull Entrenchment Ratio ¹	>2.2	>2.2	>2.2	>2.2	>8.9		
Bankfull Bank Height Ratio ¹	1.0	1.0	1.0	1.0	1.0
