**BEST STREAM AND WETLAND RESTORATION PROJECT
MONITORING REPORT
MONITORING YEAR 6
FINAL**

DUPLIN COUNTY, NORTH CAROLINA
CONTRACT No. 004631 - PROJECT No. 95353
USACE Action ID No. 2012-01384 -NCDWR Project No. 13-0865

January 2021

RE: Best Stream and Wetland Restoration Site: MY6 Monitoring Report (NCDMS ID 95353)

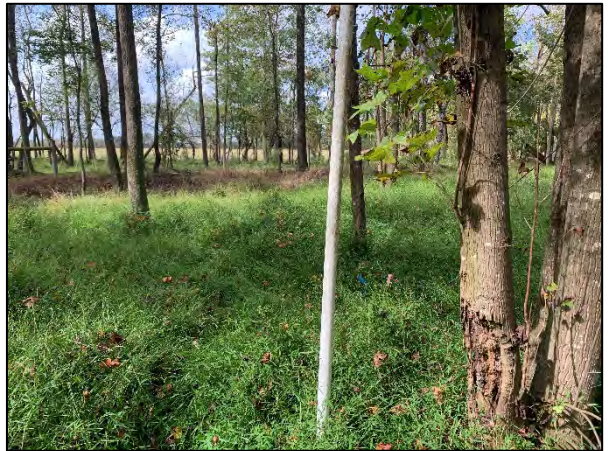
Vegetation Plot 18

Feature Category	Station Numbers	Suspected Cause; Repair	Photo Number
Low Stem Density	UT4 (0.28 acres)	Located in full canopy; replant with shade tolerant container trees	VP 18
