Big Cedar Creek Stream Restoration Final Year 1 Monitoring Report (2009) Stanly County, North Carolina

EEP Project Number D06054-D

Final Year 1 Monitoring Report (2009)

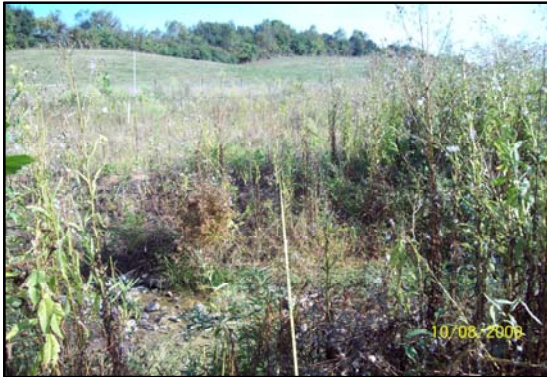
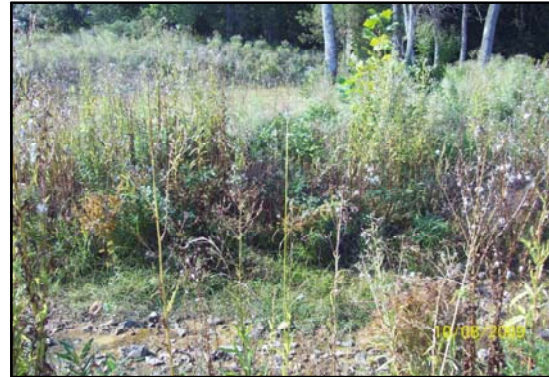
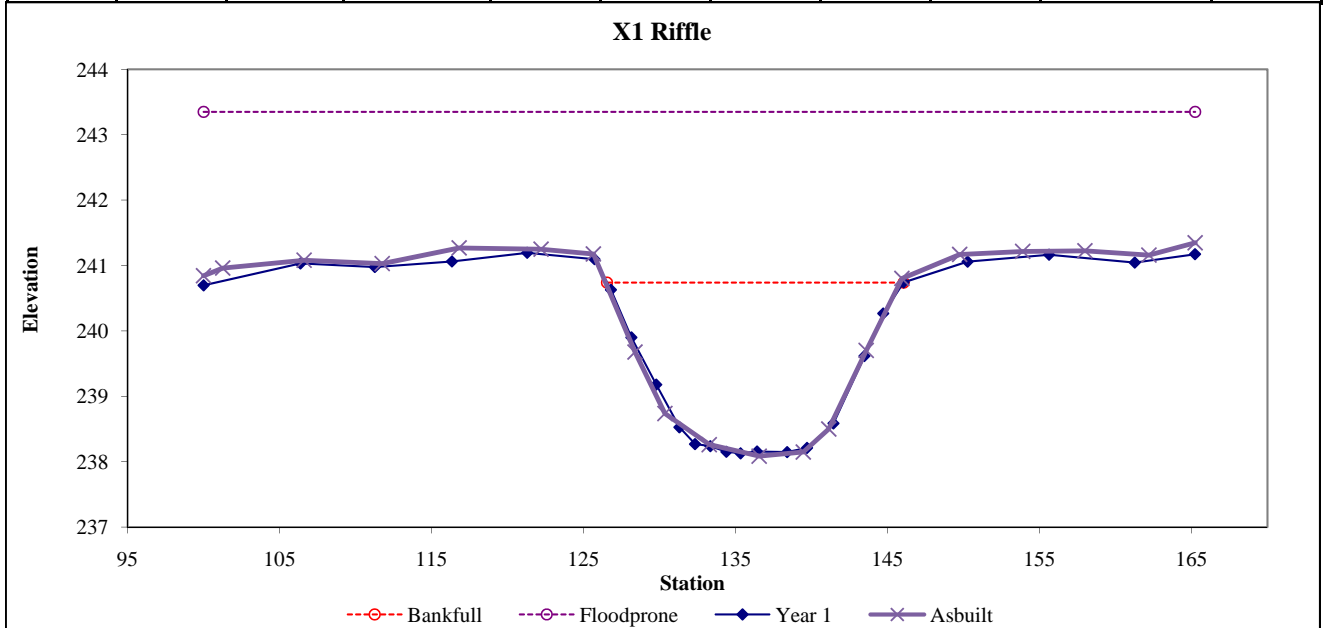
Permanent Cross Section X1
 (Year 1 Monitoring Data - collected October 2009)

Feature	Stream Type	BKF Area	BKF Width	BKF Depth	Max BKF Depth	W/D	BH Ratio	ER	BKF Elev	TOB Elev
Riffle	E	35.6	19.52	1.82	2.61	10.71	1	3.3	240.74	240.74

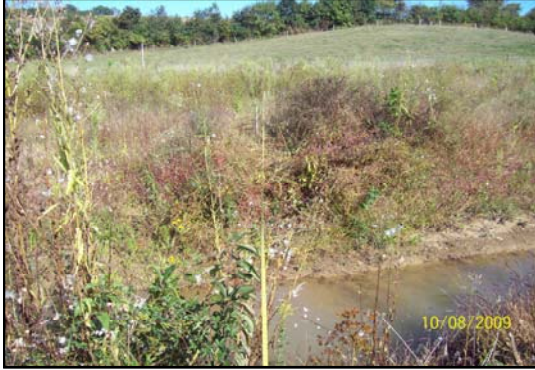
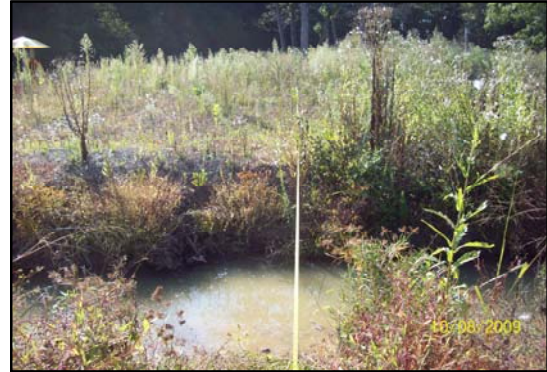
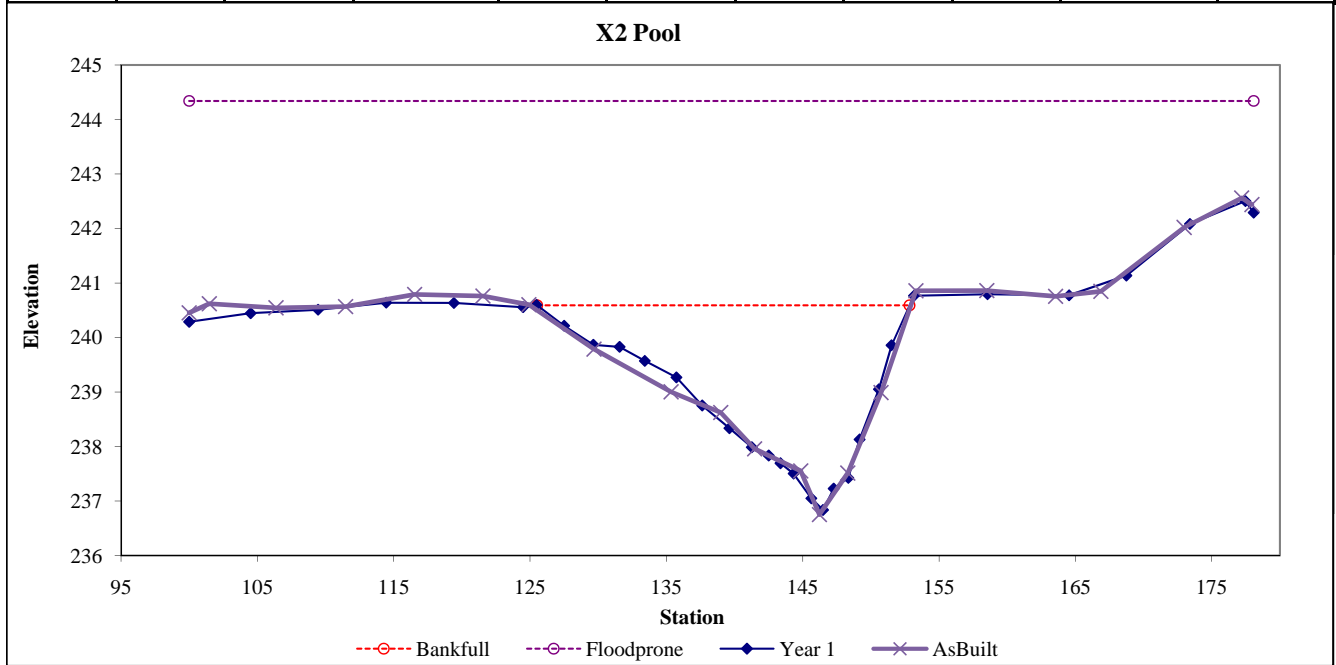
Permanent Cross Section X2
(Year 1 Monitoring Data - collected October 2009)

Feature	Stream Type	BKF Area	BKF Width	BKF Depth	Max BKF Depth	W/D	BH Ratio	ER	BKF Elev	TOB Elev
Pool		47.5	27.32	1.74	3.75	15.73	1		240.59	240.6

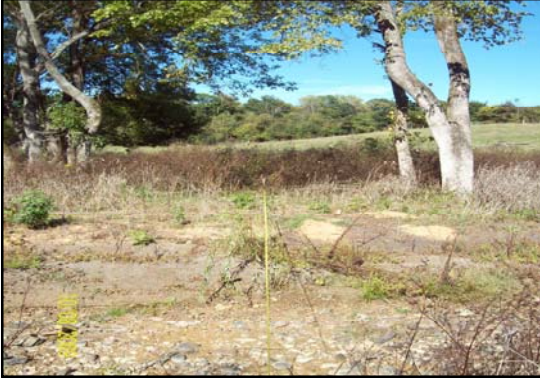
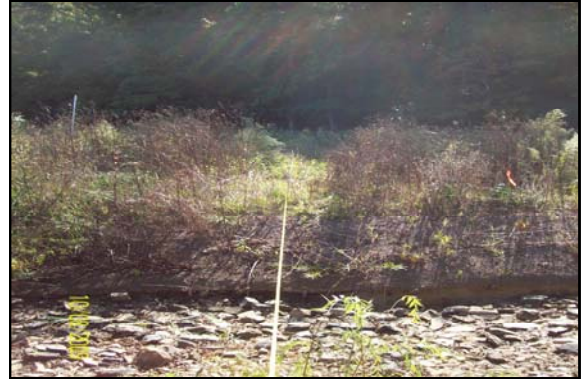
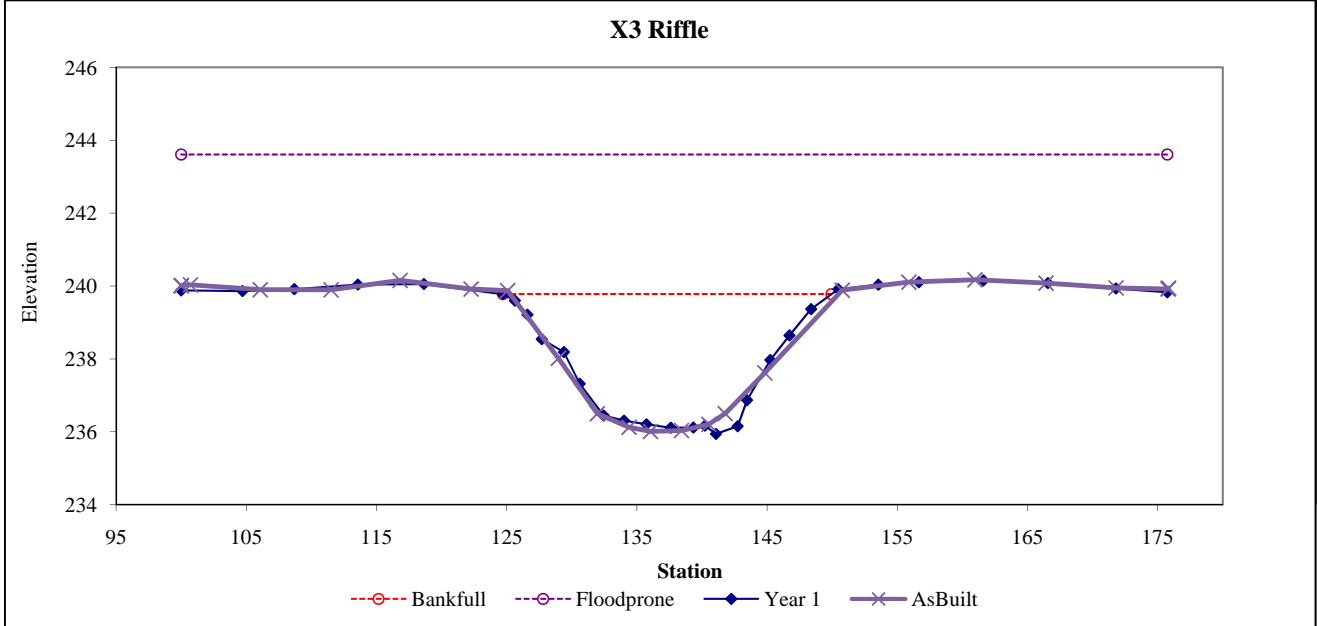
Permanent Cross Section X3
 (Year 1 Monitoring Data - collected October 2009)

Feature	Stream Type	BKF Area	BKF Width	BKF Depth	Max BKF Depth	W/D	BH Ratio	ER	BKF Elev	TOB Elev
Riffle	E	59	25.24	2.34	3.83	10.8	1	3	239.78	239.78

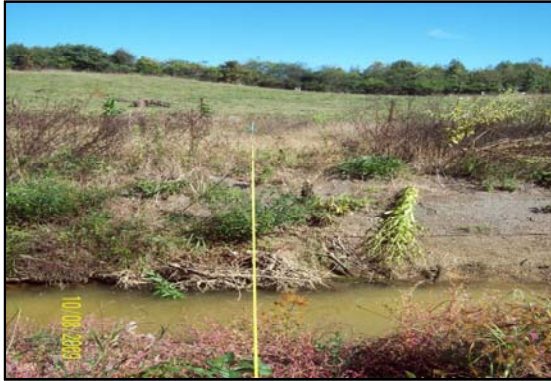
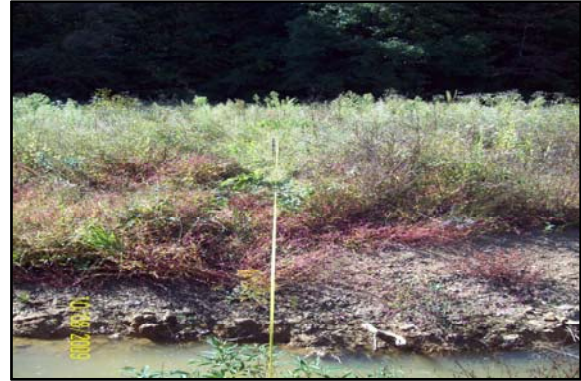
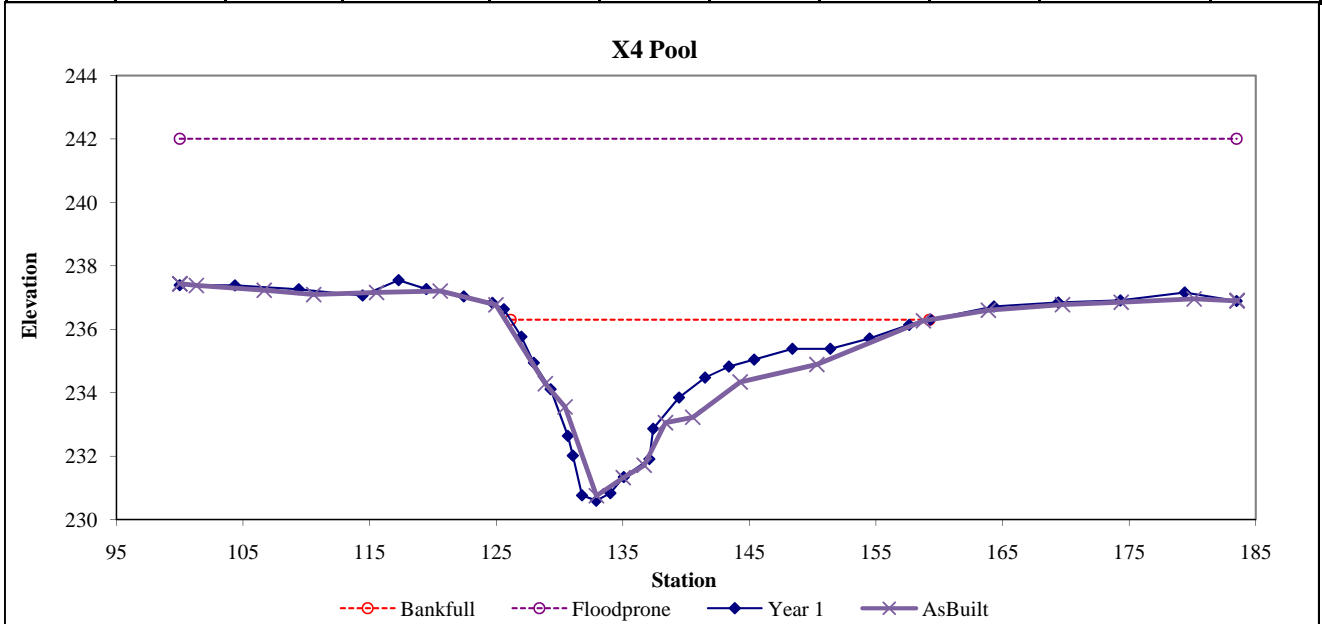
Permanent Cross Section X4
(Year 1 Monitoring Data - collected October 2009)

Feature	Stream Type	BKF Area	BKF Width	BKF Depth	Max BKF Depth	W/D	BH Ratio	ER	BKF Elev	TOB Elev
Pool		67.2	33.08	2.03	5.71	16.28	1		236.3	236.31

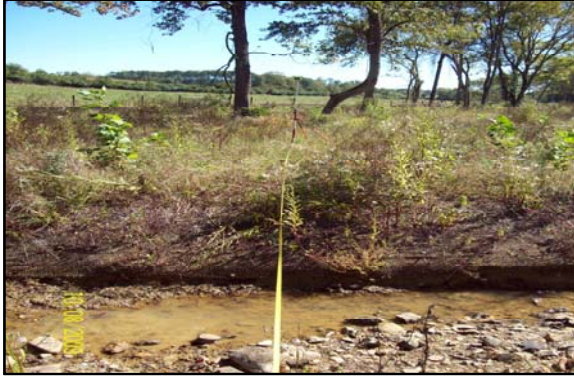
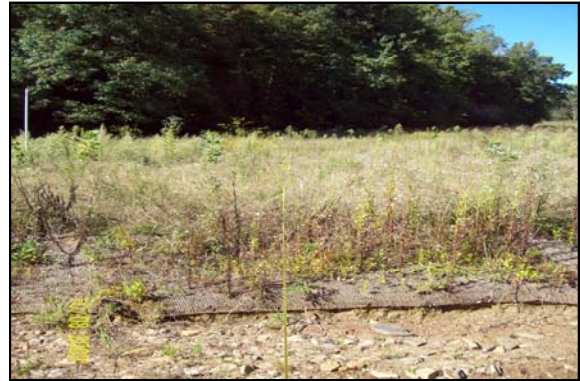
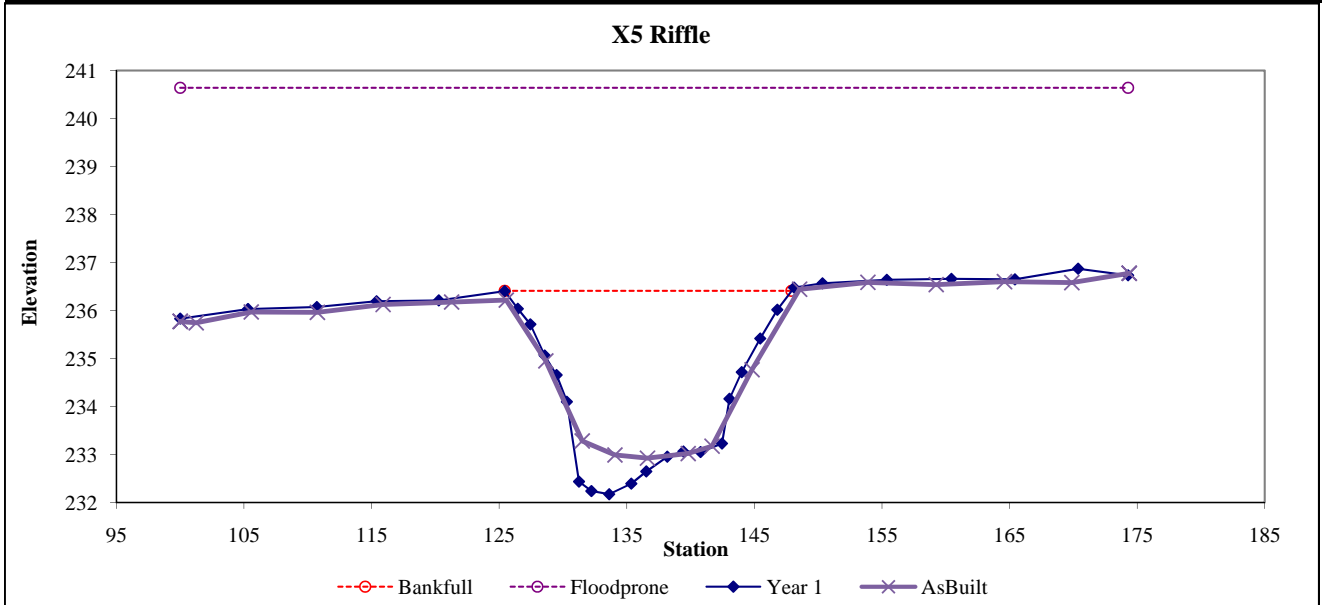
Permanent Cross Section X5
 (Year 1 Monitoring Data - collected October 2009)

Riffle Cross-sections 5, 13, 30, and 32 experienced some bed degradation. The bed scour at cross-sections 5, 13, and 32 is located along the side of channel that receives the flow vectors from upstream outer meander bends. The outside of meander bends experience an increase in shear stress during large storm events that can cause scour. This increase in shear stress isn't being dissipated as flow leaves the pool feature immediately upstream of these riffles. Cross-section 30 experienced bed scour across the entire channel. The amount of scour may reflect an inadequate pool size immediately upstream. Pool construction was difficult in areas due to the presence of bedrock. The riffle has downcut to bedrock where it has stabilized. These changes in channel geometry will be monitored but it is anticipated that these changes represent localized bed adjustments and not systemic problems that will get worse with time.

Feature	Stream Type	BKF Area	BKF Width	BKF Depth	Max BKF Depth	W/D	BH Ratio	ER	BKF Elev	TOB Elev
Riffle	E	56.2	22.47	2.5	4.23	8.99	1	3.3	236.41	236.41

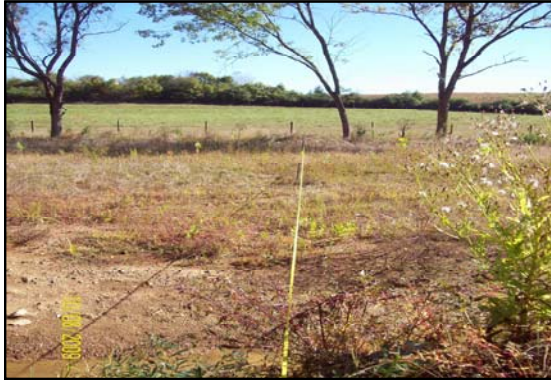
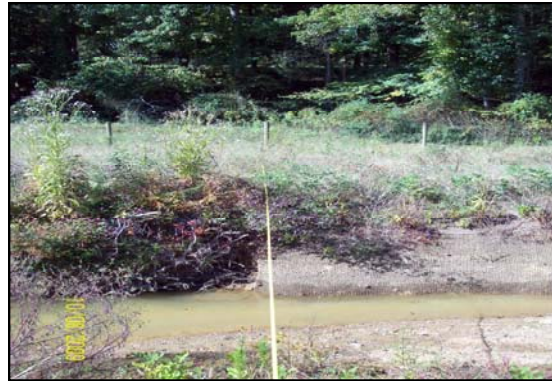
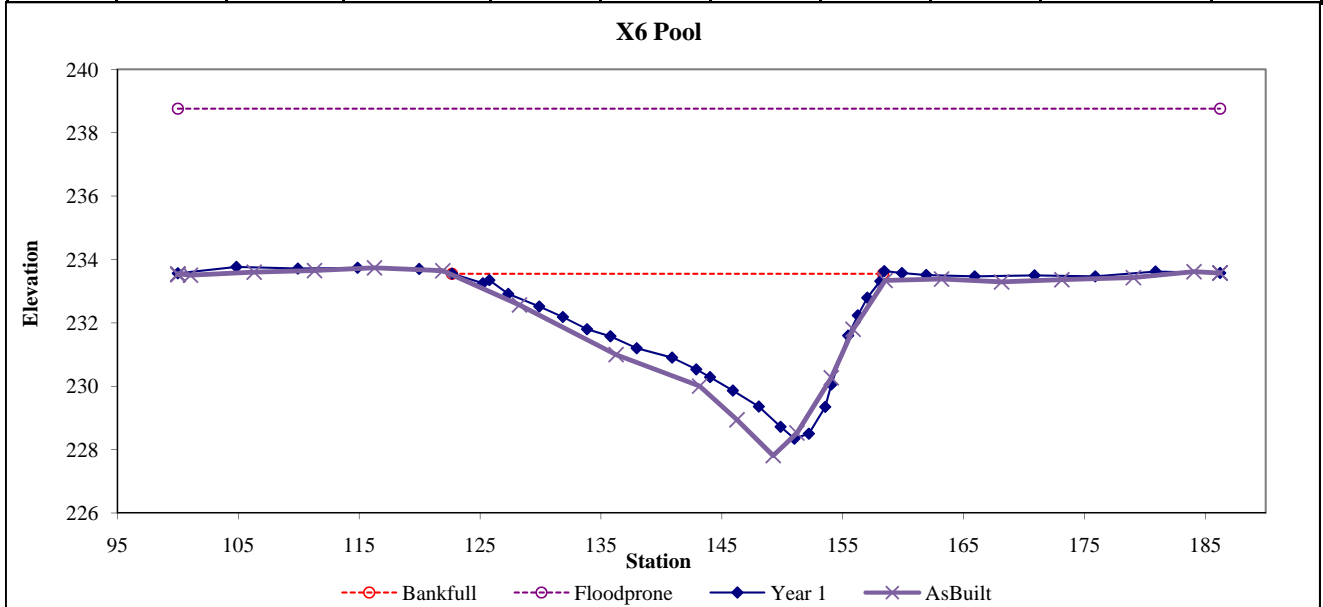
Permanent Cross Section X6
 (Year 1 Monitoring Data - collected October 2009)

Feature	Stream Type	BKF Area	BKF Width	BKF Depth	Max BKF Depth	W/D	BH Ratio	ER	BKF Elev	TOB Elev
Pool		83.4	35.67	2.34	5.21	15.25	1		233.55	233.55

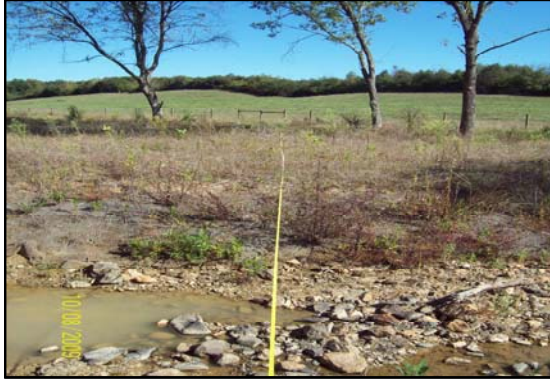
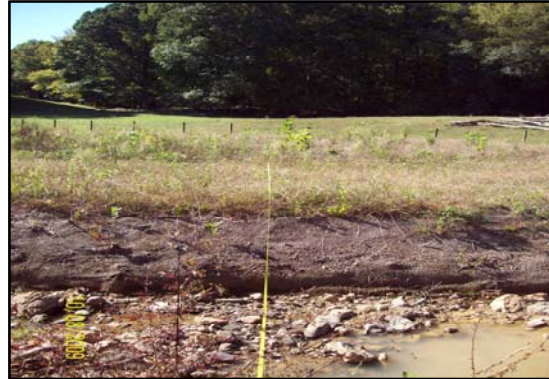
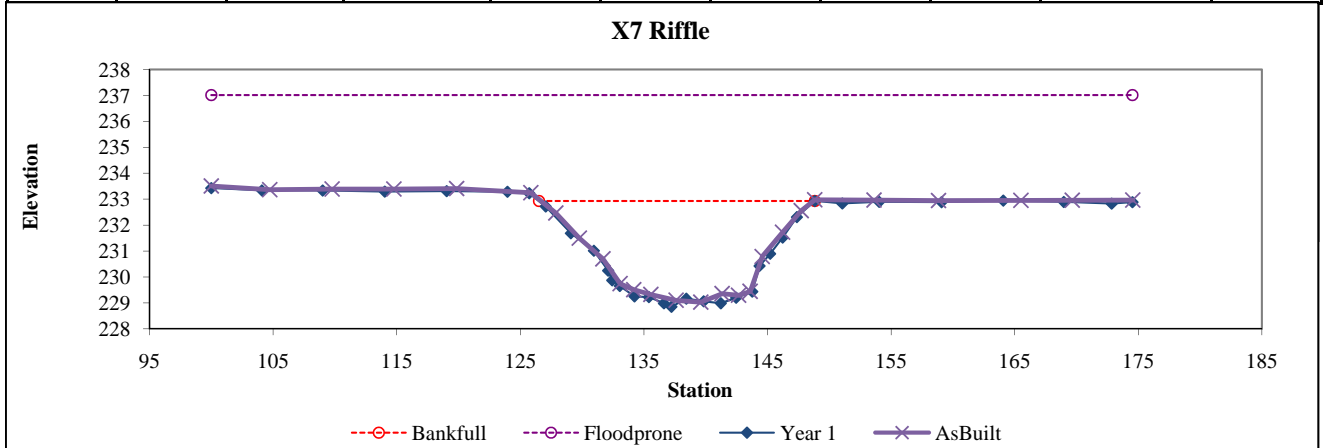
Permanent Cross Section X7
(Year 1 Monitoring Data - collected October 2009)

Feature	Stream Type	BKF Area	BKF Width	BKF Depth	Max BKF Depth	W/D	BH Ratio	ER	BKF Elev	TOB Elev
Riffle	E	57.6	22.32	2.58	4.08	8.65	1	3.3	232.93	232.93

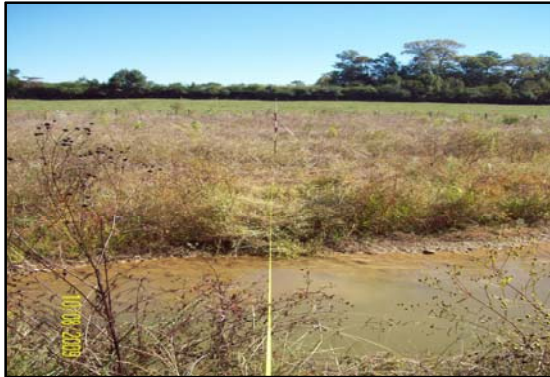
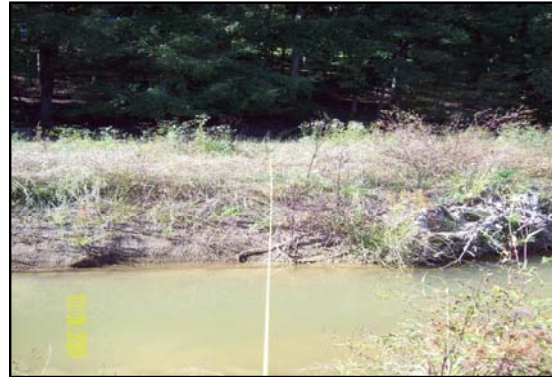
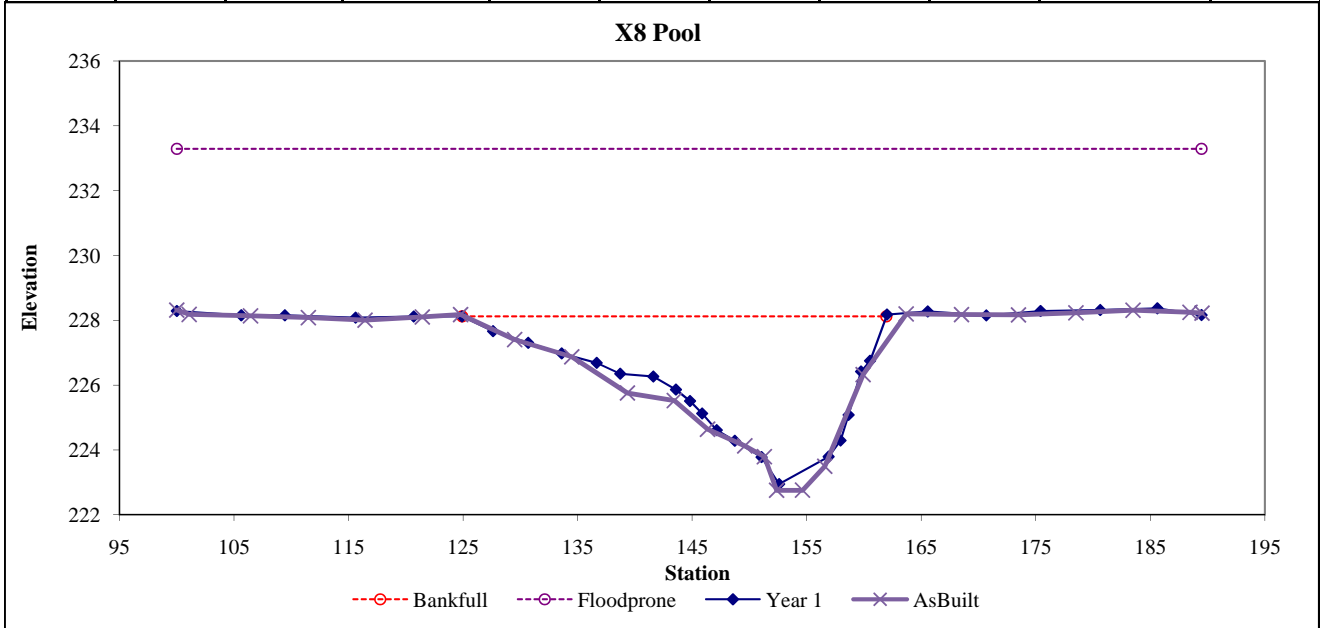
Permanent Cross Section X8
 (Year 1 Monitoring Data - collected October 2009)

Feature	Stream Type	BKF Area	BKF Width	BKF Depth	Max BKF Depth	W/D	BH Ratio	ER	BKF Elev	TOB Elev
Pool		86.6	37.03	2.34	5.17	15.84	1		228.12	228.12

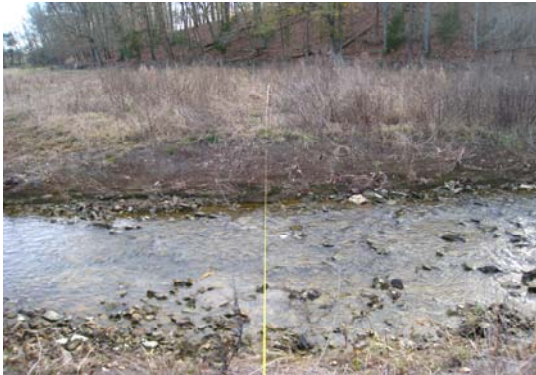
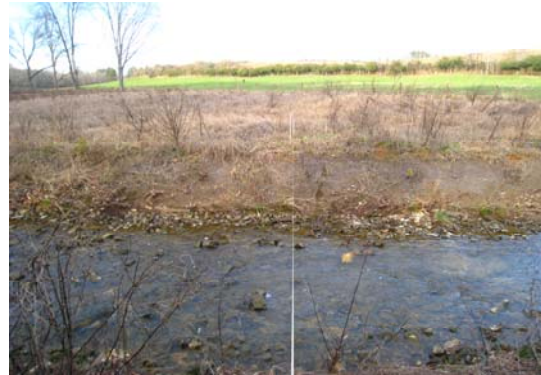
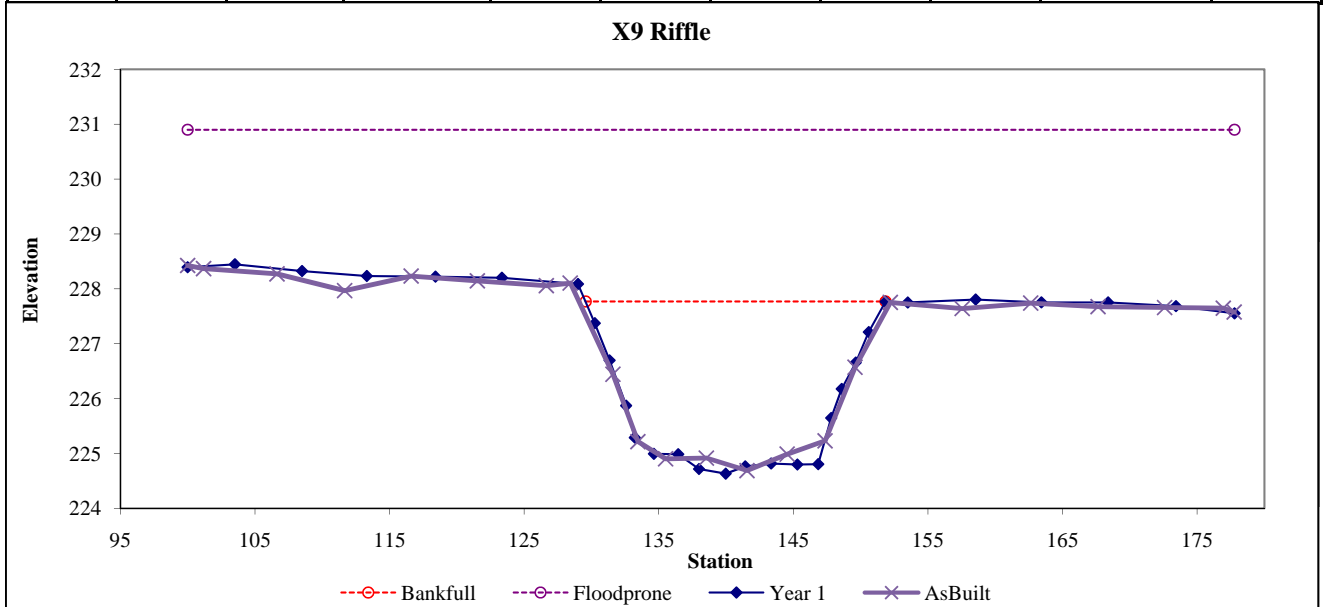
Permanent Cross Section X9
 (Year 1 Monitoring Data - collected October 2009)

Feature	Stream Type	BKF Area	BKF Width	BKF Depth	Max BKF Depth	W/D	BH Ratio	ER	BKF Elev	TOB Elev
Riffle	E	50.5	22.29	2.27	3.13	9.83	1	3.5	227.77	227.77

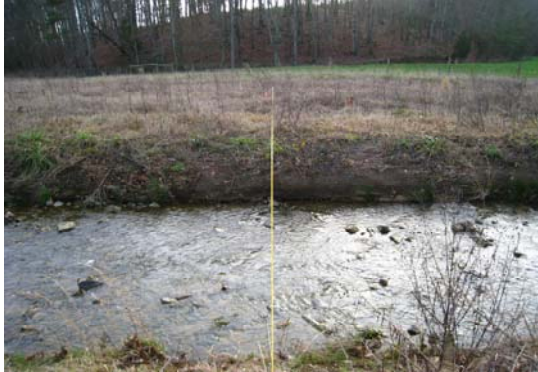
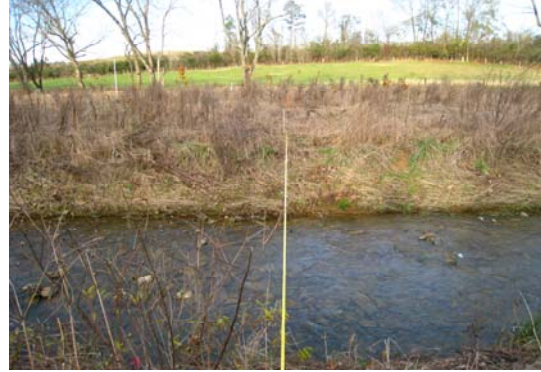
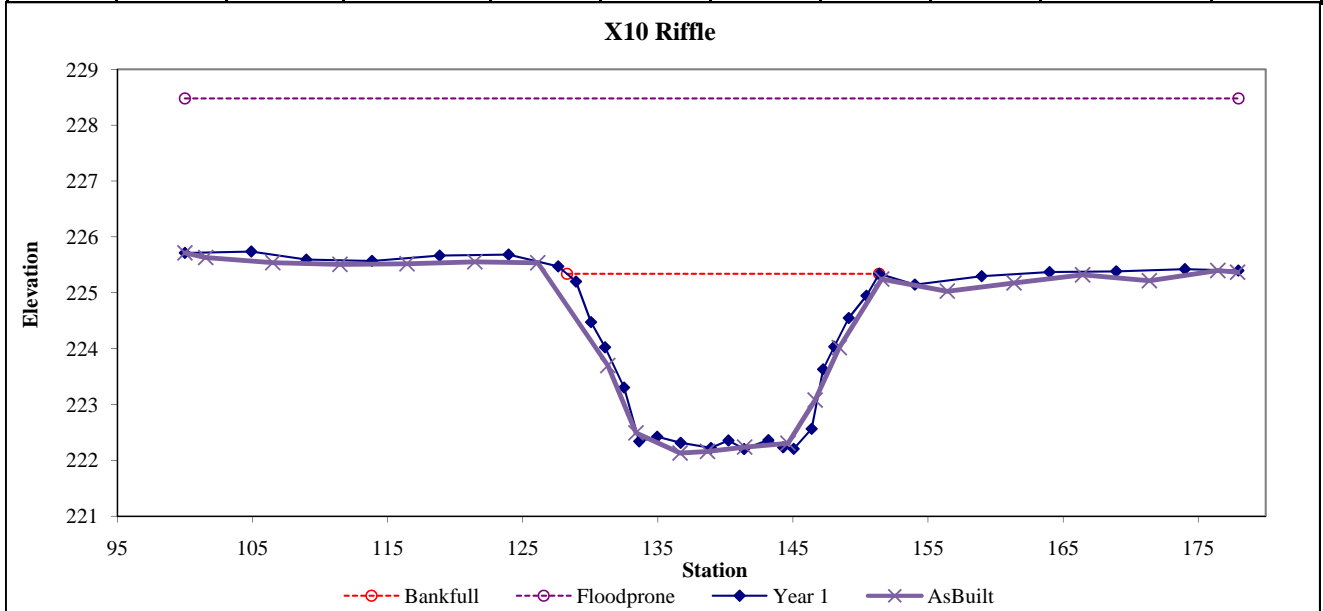
Permanent Cross Section X10
(Year 1 Monitoring Data - collected October 2009)

Feature	Stream Type	BKF Area	BKF Width	BKF Depth	Max BKF Depth	W/D	BH Ratio	ER	BKF Elev	TOB Elev
Riffle	E	50.8	23.12	2.2	3.14	10.51	1	3.4	225.34	225.34

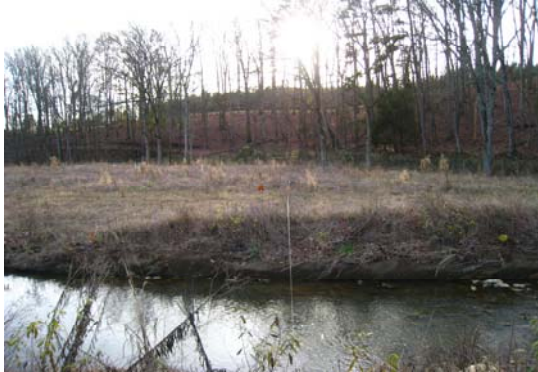
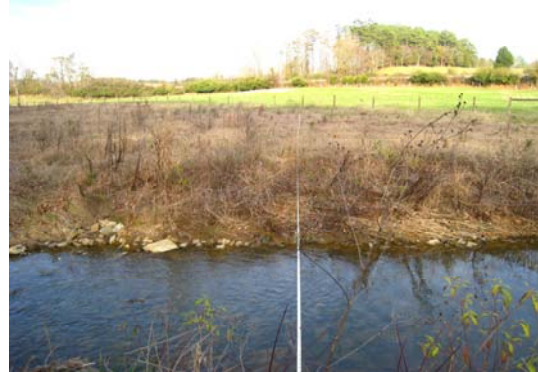
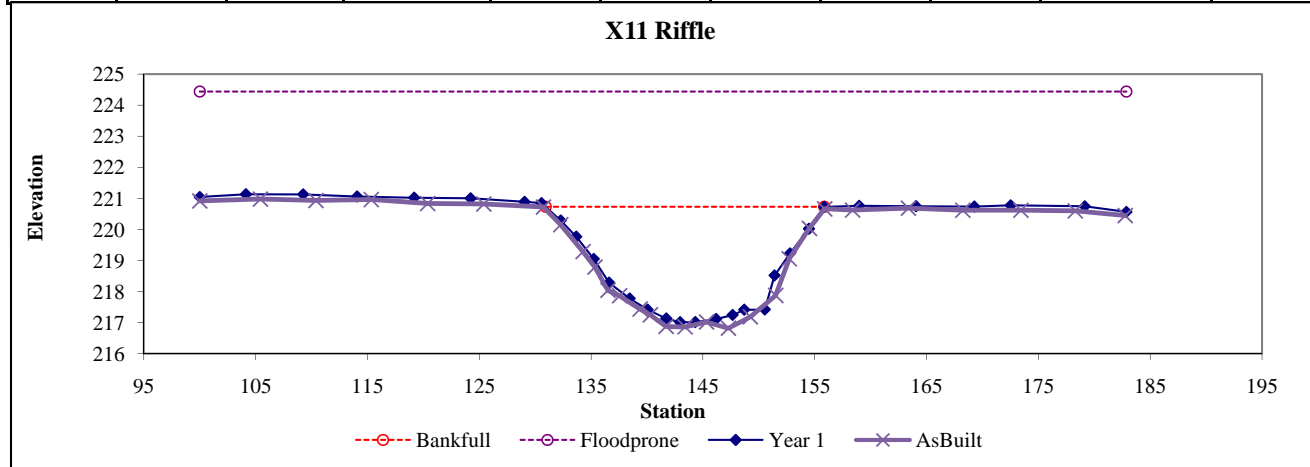
Permanent Cross Section X11
(Year 1 Monitoring Data - collected October 2009)

Feature	Stream Type	BKF Area	BKF Width	BKF Depth	Max BKF Depth	W/D	BH Ratio	ER	BKF Elev	TOB Elev
Riffle	E	60.4	24.92	2.43	3.71	10.27	1	3.3	220.73	220.73

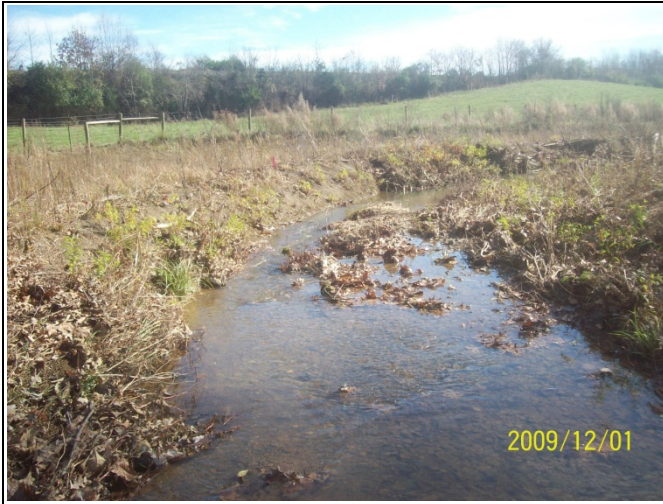
BCC Reach 1			
Feature Issue	Station No.	Suspected Cause	Photo Number
Aggradation / Bar Formation	11+60	Offsite sediment	SP1
Bank Scour / Raw Bank			
Bed Scour/Degradation			
Engineered Structures - back or arm scour			
BCC Reach 2			
Feature Issue	Station No.	Suspected Cause	Photo Number
Aggradation / Bar Formation	33+20	Thalweg shifted	SP2
Bank Scour / Raw Bank	32+40	Unknown	SP3
Bed Scour/Degradation	25+00	Upstream pool is small	SP4
	30+00	Upstream pool is small	
	37+25	Upstream pool is small	
Engineered Structures - back or arm scour	31+80	Unknown	SP5
Engineered Structures - improper elevations	30+50	Structure set too high	SP6
	31+80	Structure set too high	
BCC Reach 3			
Feature Issue	Station No.	Suspected Cause	Photo Number
Aggradation / Bar Formation			
Bank Scour / Raw Bank	48+50	Matting pulled up	SP7
	51+50	Thalweg shifted towards bank	
Bed Scour/Degradation			
Engineered Structures - back or arm scour	54+80	Unknown	SP8

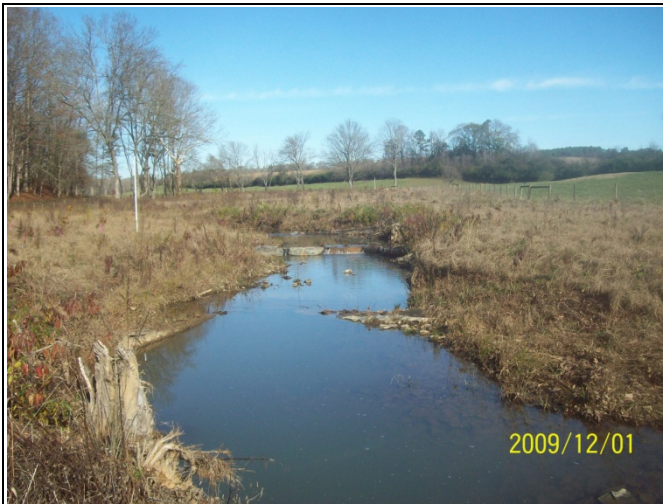
Engineered Structures - improper elevations	54+25	Structure set too low (submerged)	SP9
BCC Reach 4			
Feature Issue	Station No.	Suspected Cause	Photo Number
Aggradation / Bar Formation			
Bank Scour / Raw Bank	57+90	Overland flow during storm event	SP10
	59+50	Thalweg shifted towards bank	
Bed Scour/Degradation			
Engineered Structures - back or arm scour

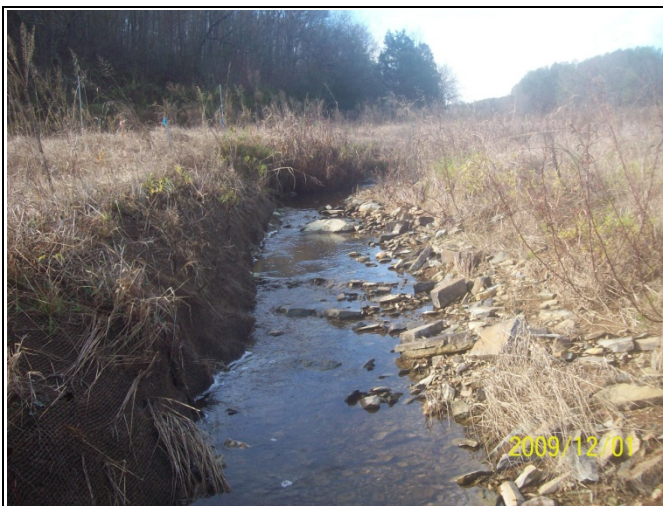
UT1 Reach 3			
Feature Issue	Station No.	Suspected Cause	Photo Number
Aggradation / Bar Formation			
Bank Scour / Raw Bank	39+50	Thalweg shifted towards bank	SP11
	40+15	Matting pulled up	
Bed Scour/Degradation			
Engineered Structures - back or arm scour			
UT1 Reach 4			
Feature Issue	Station No.	Suspected Cause	Photo Number
Aggradation / Bar Formation			
Bank Scour / Raw Bank	54+80	Thalweg shifted towards bank	SP12
	55+95	Matting pulled up	
	56+25	Matting pulled up	
	56+70	Overland flow during storm event	
	57+80	Rocky soils not allowing veg. to establish	
Bed Scour/Degradation	55+50	Upstream pool is small	SP13
	56+90	No bed armor	
	58+00	Upstream pool is small	
Engineered Structures - back or arm scour

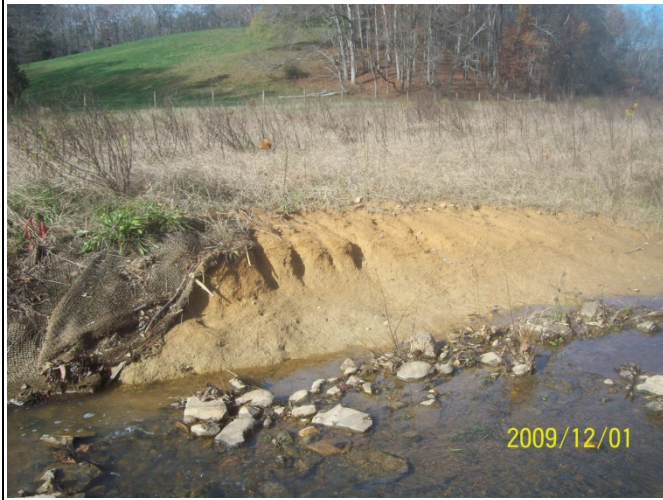
VPA 1 – Bare bank

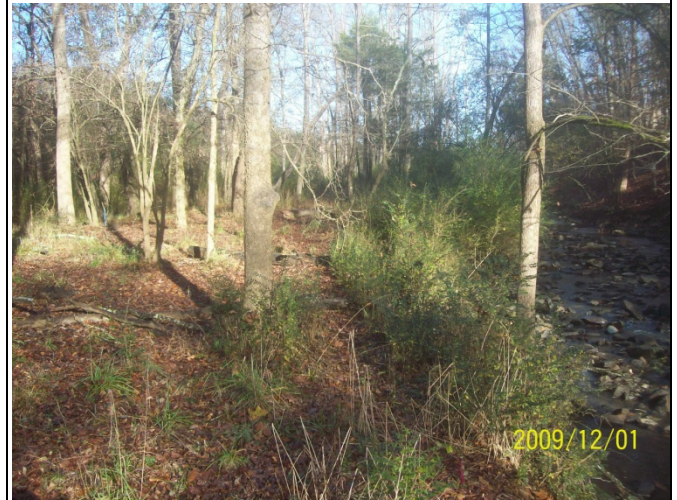
VPA 2 – Invasive vegetation

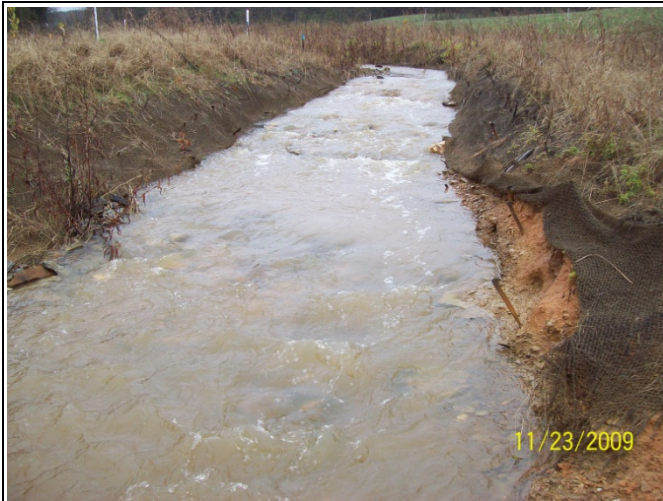
VPA 3 – Bare bank on UT1

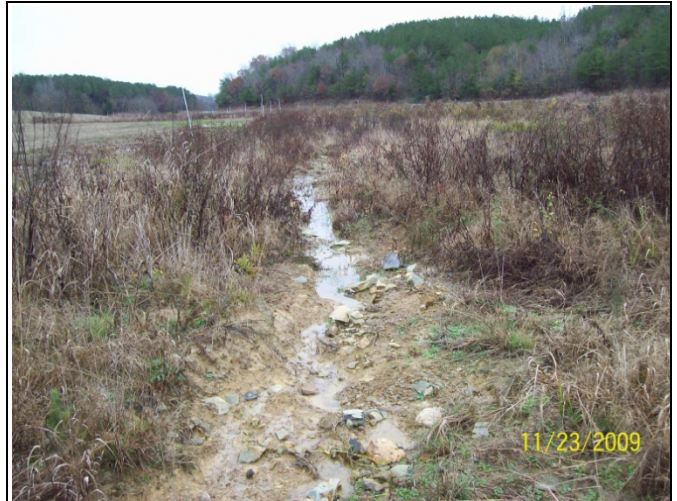
VPA 4 – Bare floodplain on UT1

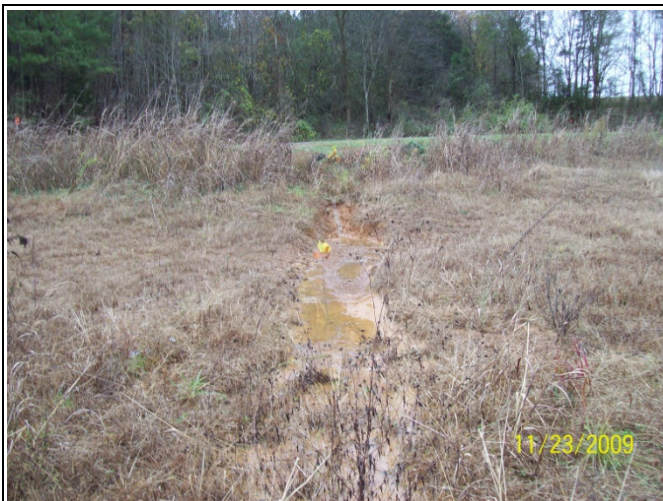
VPA 5 – Bare spot from offsite storm pipe.

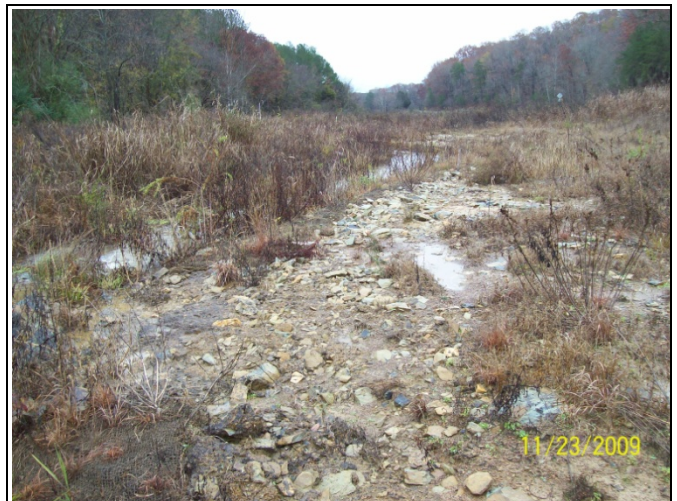
VPA 6 – Bare floodplain

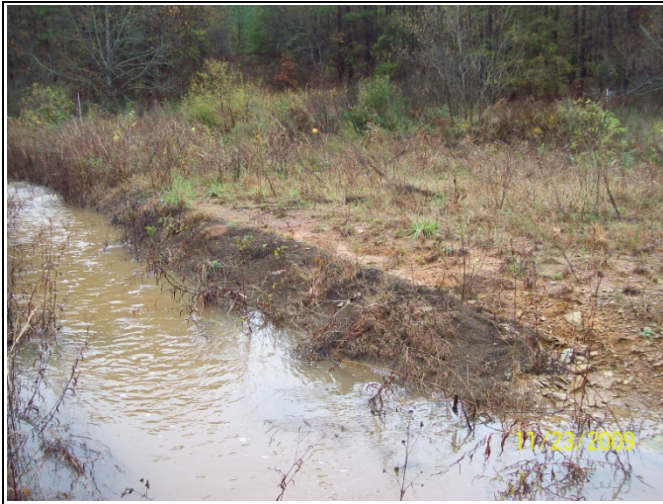
VPA 7 – Bare floodplain

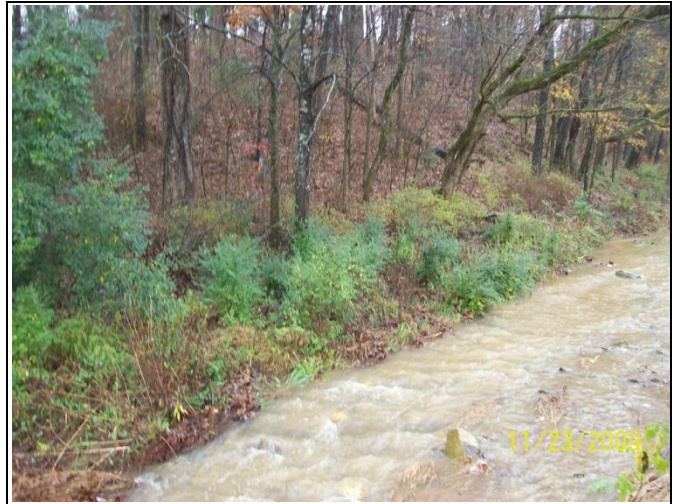
VPA 8 – Invasive vegetation

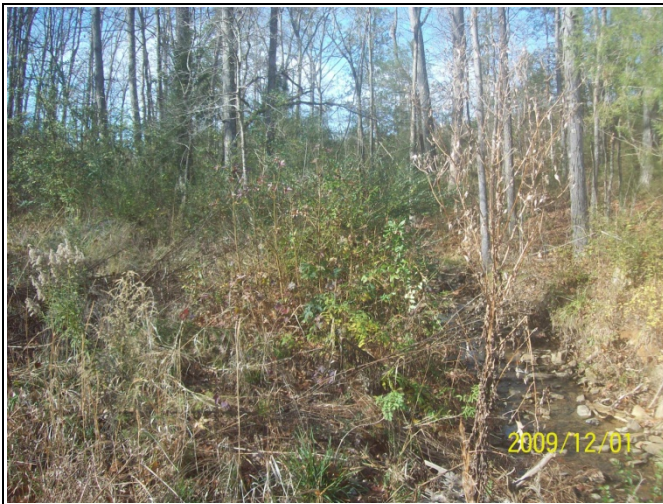
VPA 9 – Invasive vegetation on UT2
