Big Cedar Creek Stream Restoration Final Year 2 Monitoring Report (2010) Stanly County, North Carolina

EEP Project Number D06054-D

Data Collection Period: November 2010

Submission Date: December 2010

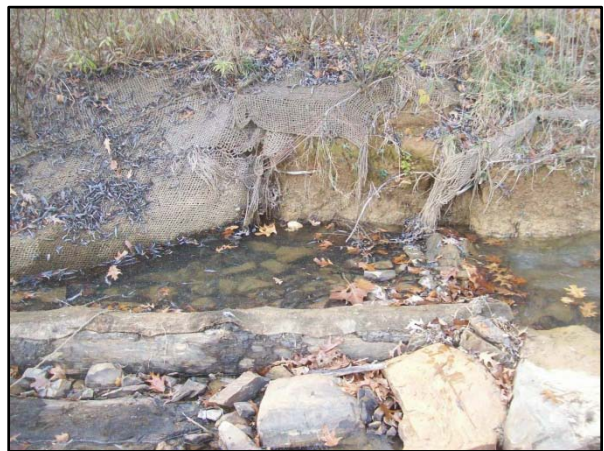
SPA 4 – Erosion/Scour behind log sill

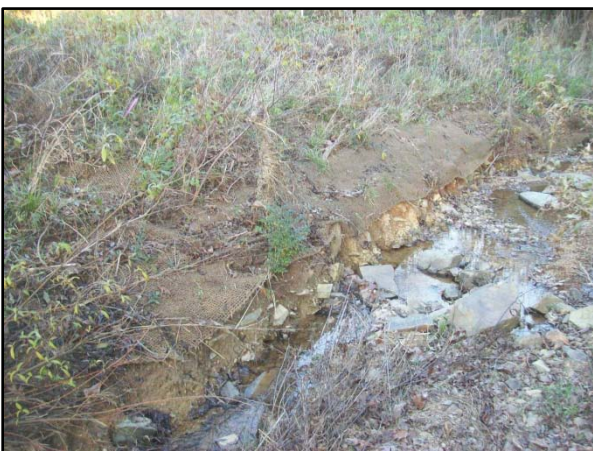
SPA 5 – BCC Toe Erosion from thalweg shift

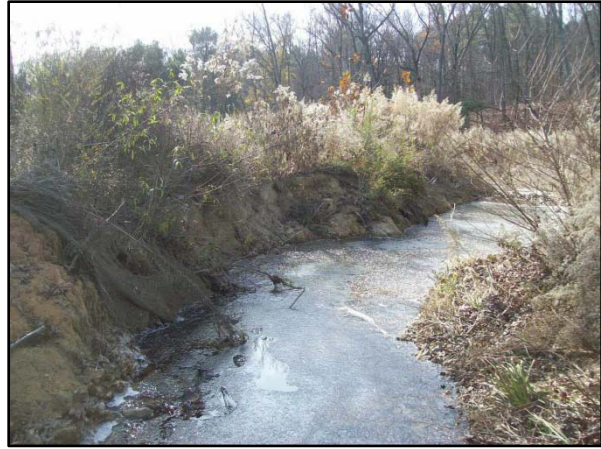
SPA 8 – BCC Erosion from loss of matting

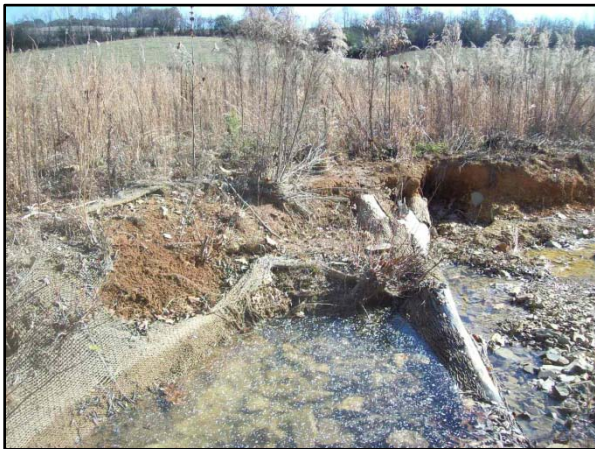
SPA 9 – Log sill set too low

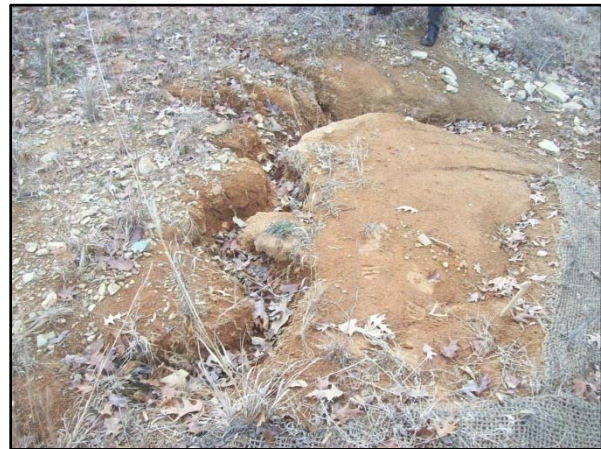
SPA 10 – Bank scour from overland stormwater flow

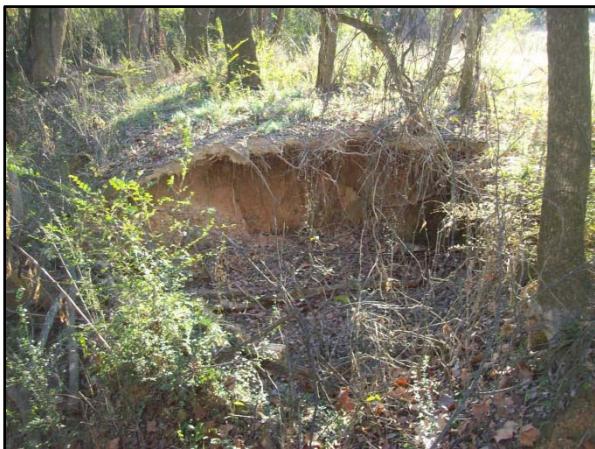
SPA 11 – Bank Sinkhole from up-rooted tree

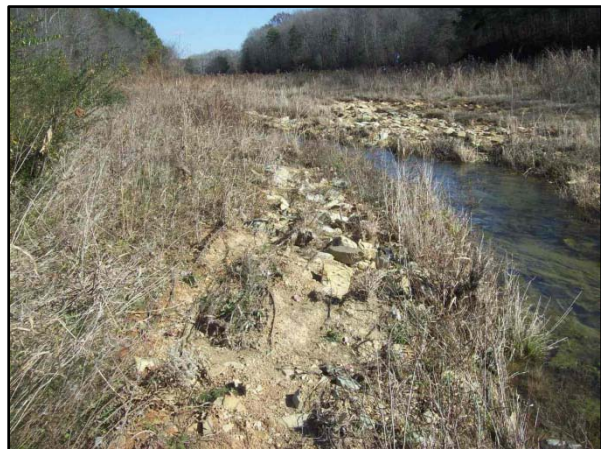
SPA 12 – UT1 Bank scour

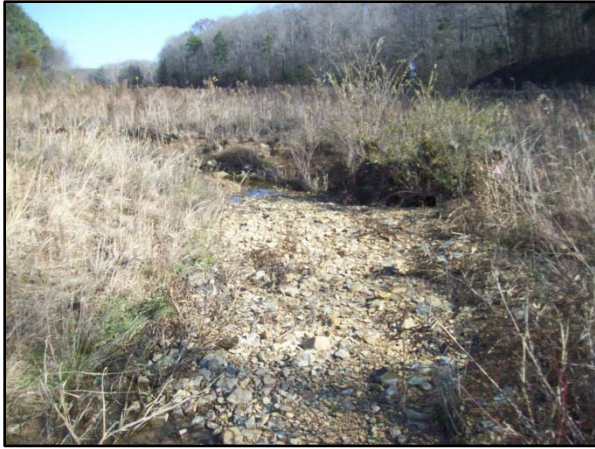
SPA 13 – UT1 Pool Filling from floodplain sediment erosion

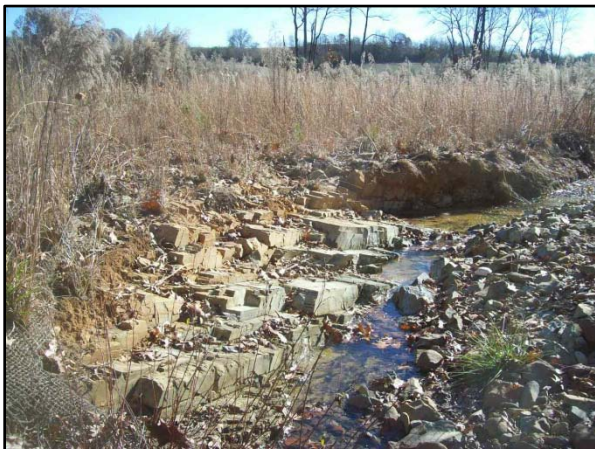
SPA 17 – UT2 Bank scour from lack of vegetation due to poor soils

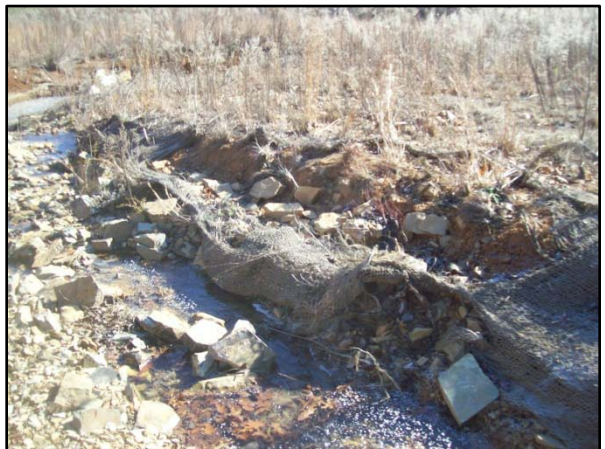
SPA 18 – UT2 Bank Slump

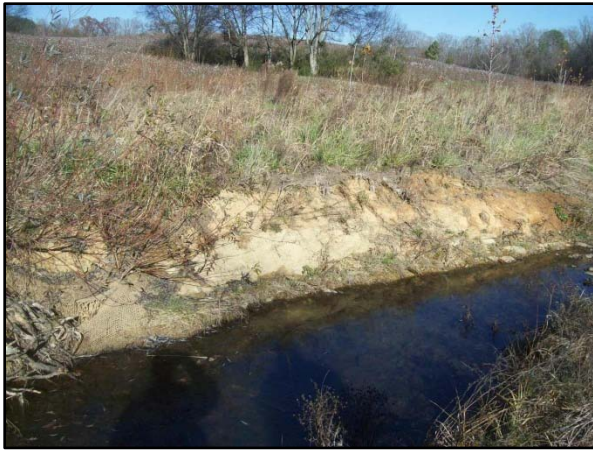
VPA 7 – UT1 Bare Bank loss of matting

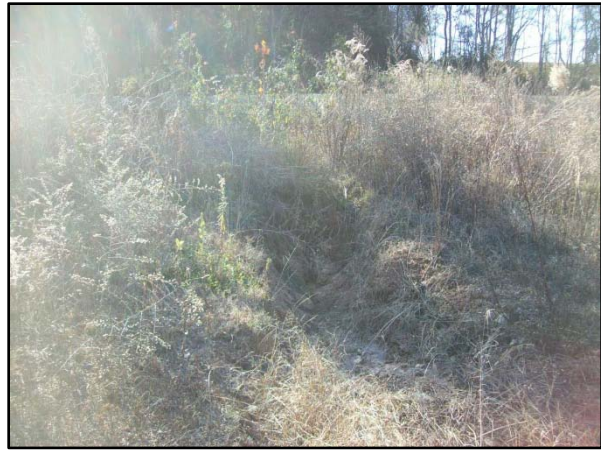
VPA 8 – UT1 Existing & stabilizing wash area

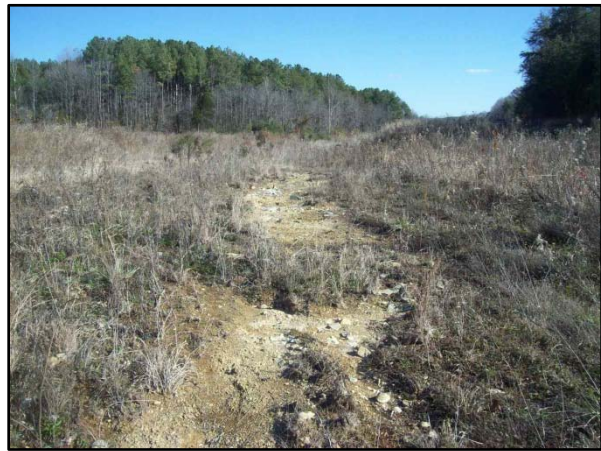
VPA 10 – UT1 Bare Floodplain from stormwater flows

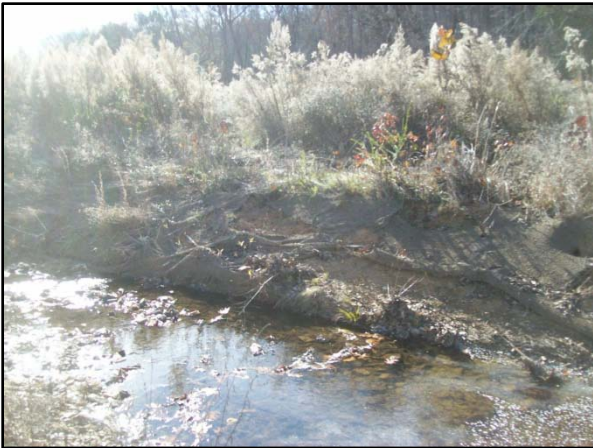
VPA 11 – UT2 Bare Bank with loss of matting
