Big Cedar Creek Stream Restoration Final Year 3 Monitoring Report (2011) Stanly County, North Carolina

EEP Project Number D06054-D

Data Collection Period: November 2011 – February 2012

Submission Date: March 2012

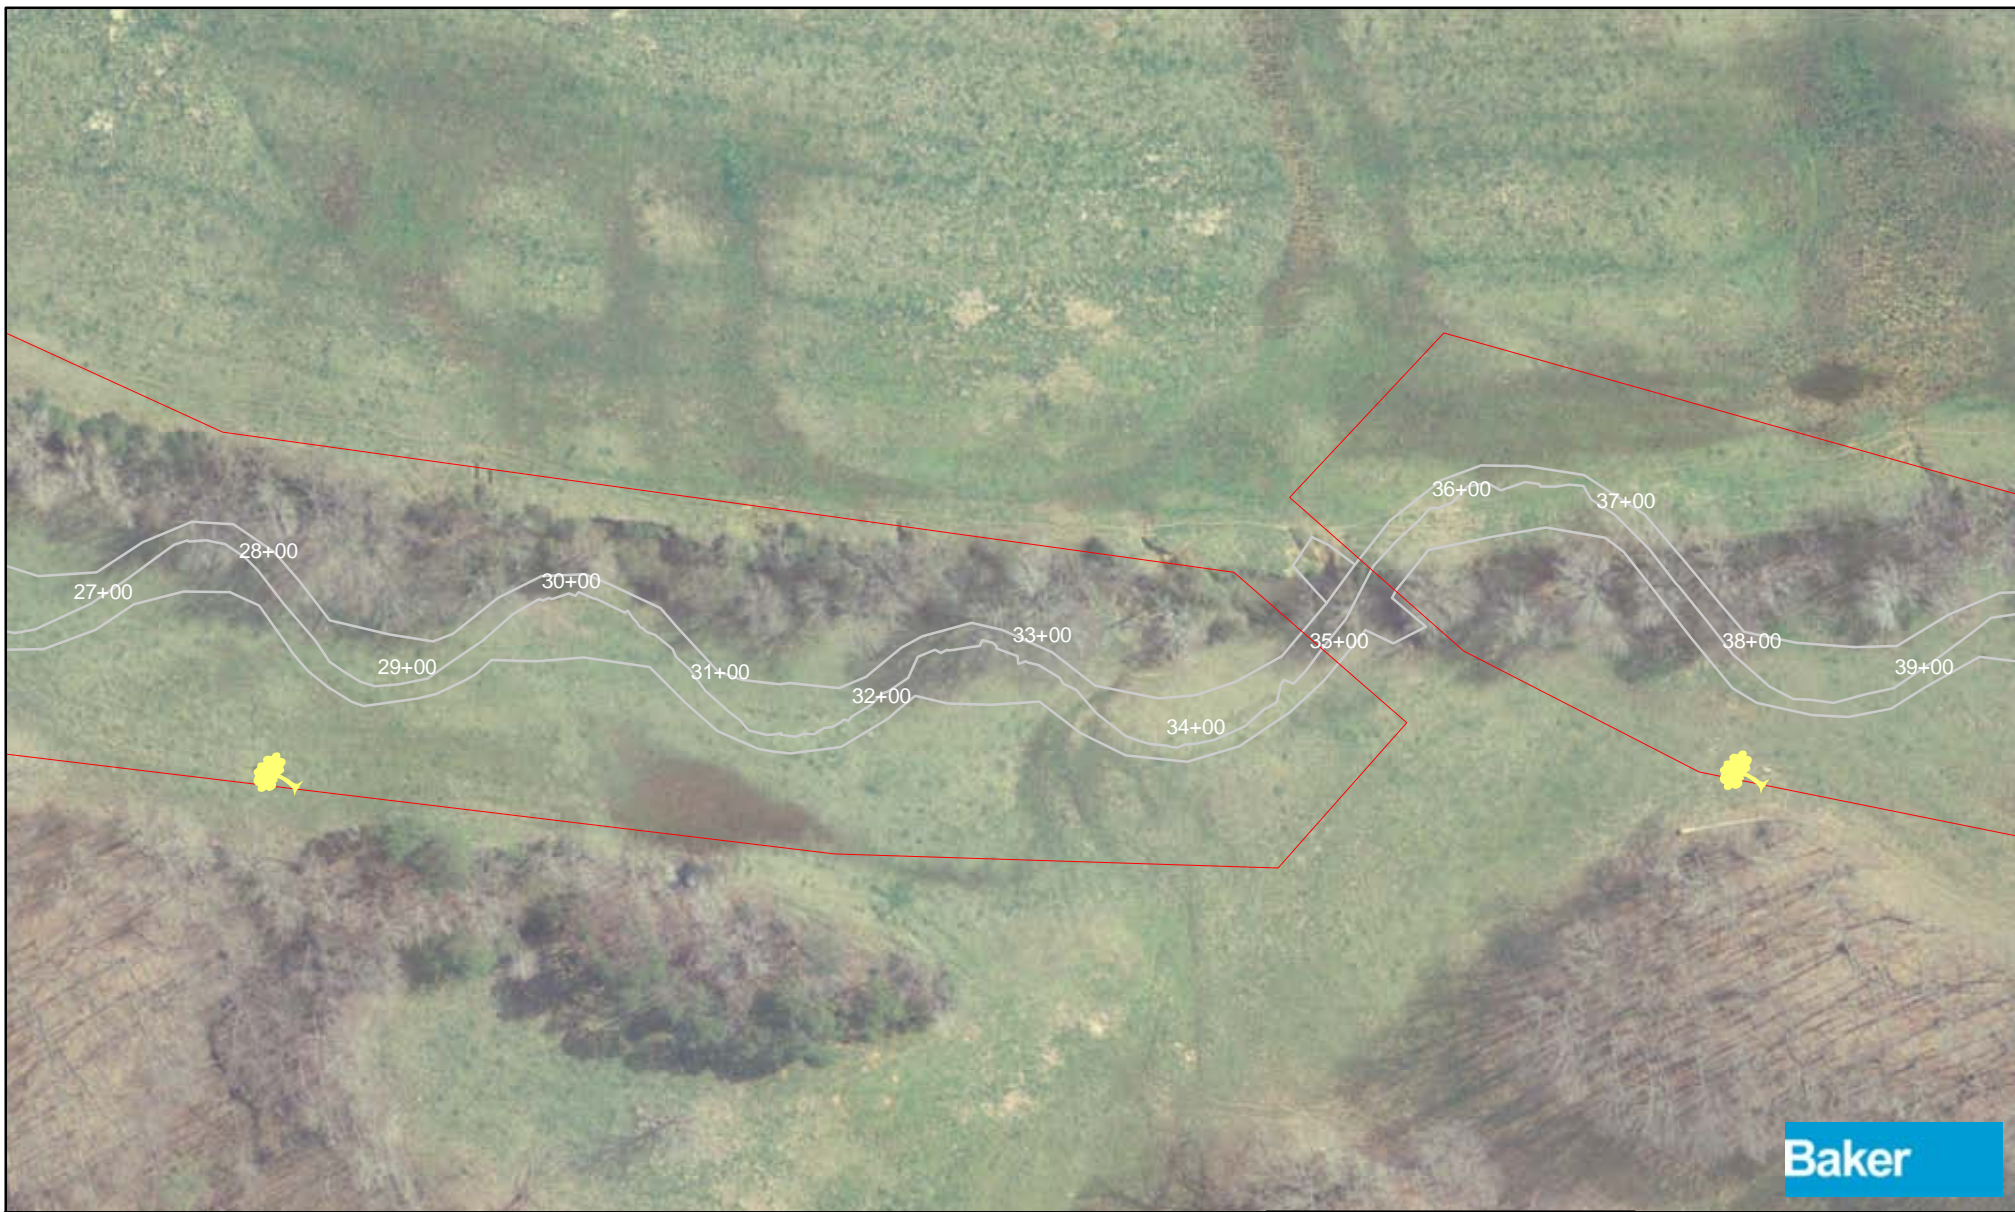
**Figure B1: Stream Problem Areas
BCC (Station 27+00 to 39+00)**

BCC Reach 2			
Feature Issue	Station No.	Suspected Cause	Photo Number
Other	28+50, Right Floodplain	Conservation easement fence damage caused by fallen tree	SPA 1
Other	38+25, Right Floodplain	Conservation easement fence damage caused by fallen tree	SPA 2
BCC Reach 3			
Feature Issue	Station No.	Suspected Cause	Photo Number
Bed Scour/Degradation	46+60, Right Bank	Location of old beaver lodge	SPA 3
Other	46+90	Abandoned beaver dam	SPA 4
BCC Reach 6			
Feature Issue	Station No.	Suspected Cause	Photo Number
Other	77+10, Right Bank	Right bank of stream altered by fallen/uprooted tree	SPA 5
UT1 Reach 3			
Feature Issue	Station No.	Suspected Cause	Photo Number
Engineered Structures - back or arm scour	39+75	Scour behind boulder sill due to loss of seal	SPA 6

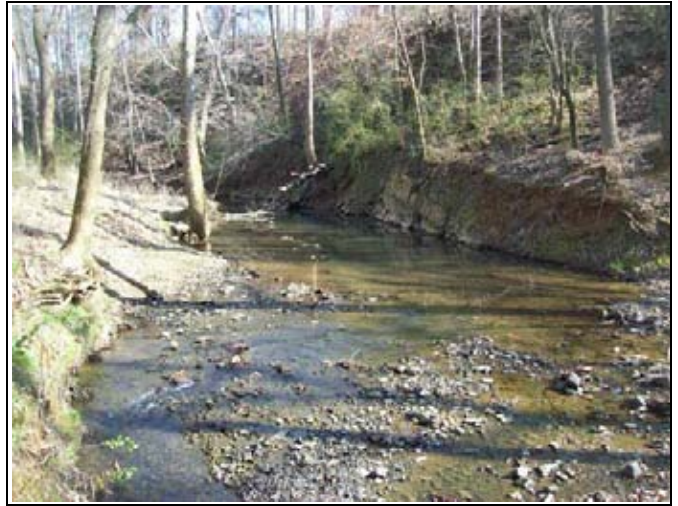
BCC PID 2 – Re-graded Riffle, BCC Reach 6

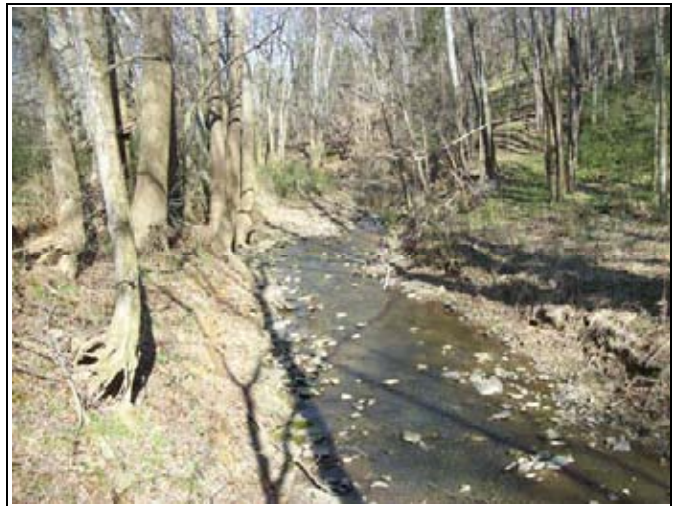
BCC PID 4 – Re-graded Riffle, BCC Reach 6

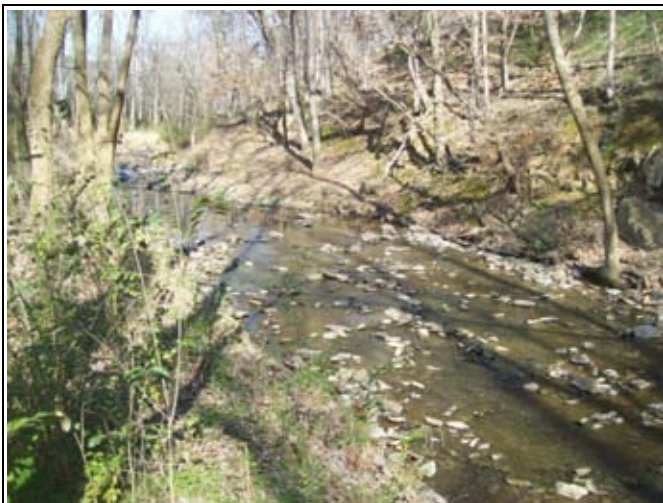
BCC PID 5 – Re-graded Riffle, BCC Reach 6
