# Big Cedar Creek Stream Restoration Final Year 4 Monitoring Report (2012) Stanly County, North Carolina

EEP Project ID #92532/EEP Contract #D06054-D

Data Collection Period: November 2012

Submission Date: March 2013

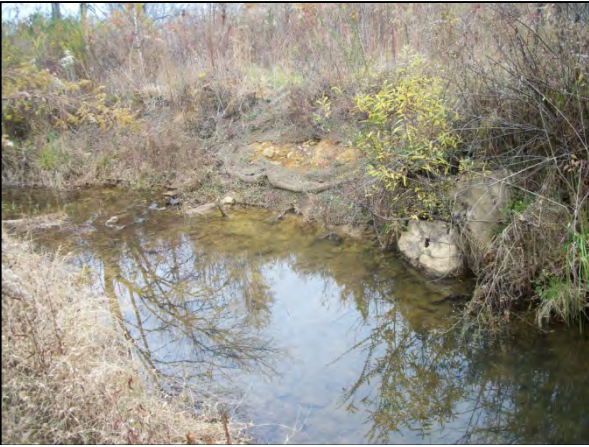
<b>BCC Reach 2</b>			
<b>Feature Issue</b>	<b>Station No.</b>	<b>Suspected Cause</b>	<b>Photo Number</b>
Minor bank erosion	24+00, Left Bank	Loose matting/sparse vegetation	SPA 1
Minor bank erosion	30+50 - 32+75, Left Bank	Loose matting/sparse vegetation	SPA 2
Vegetation in channel	Station 37+00	Sedimentation from ford crossing	SPA 3
<b>BCC Reach 3</b>			
<b>Feature Issue</b>	<b>Station No.</b>	<b>Suspected Cause</b>	<b>Photo Number</b>
Other	46+90	Abandoned beaver dam	SPA 4
Vegetation in channel	Station 49+00	Sediment from tributary	SPA 5
<b>UT1 Reach 3</b>			
<b>Feature Issue</b>	<b>Station No.</b>	<b>Suspected Cause</b>	<b>Photo Number</b>
Filled Channel/Shift Thalweg	44+25 - 44+75	Sediment from roadway outfall.	SPA 6
<b>UT2</b>			
<b>Feature Issue</b>	<b>Station No.</b>	<b>Suspected Cause</b>	<b>Photo Number</b>
Minor bank erosion	11+30, Right Bank	Loose matting/sparse vegetation	SPA 7
Minor bank erosion	12+30, Left Bank	Loose matting/sparse vegetation/rocky substrate	SPA 8

SPA 1 – Minor bank erosion along BCC at Station 24+00, left bank

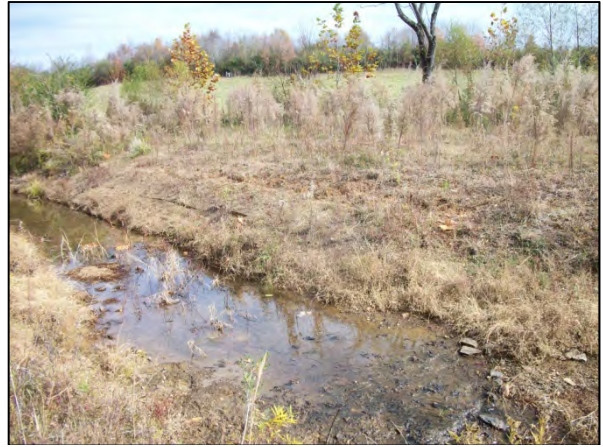
SPA 2 – Minor bank erosion along BCC at Station 30+50 to 32+75, left bank

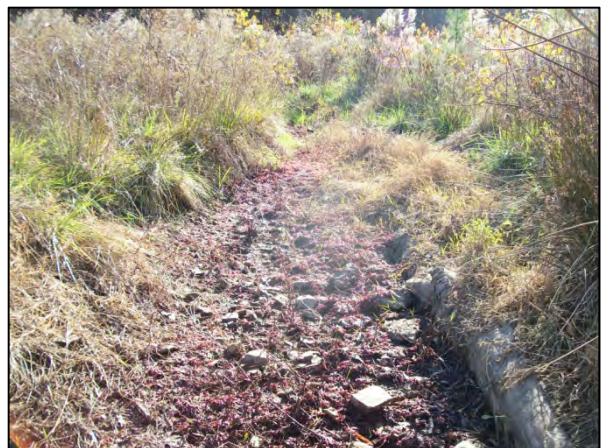
SPA 6 – Shifted thalweg along UT1 Station 44+25-44+75

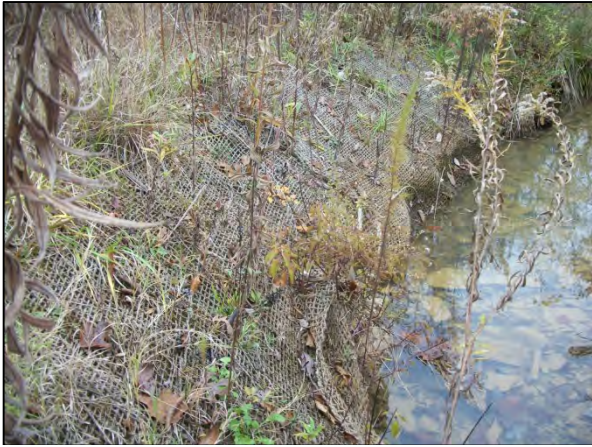
SPA 7 – Minor bank erosion along UT2 at Station 11+30, right bank

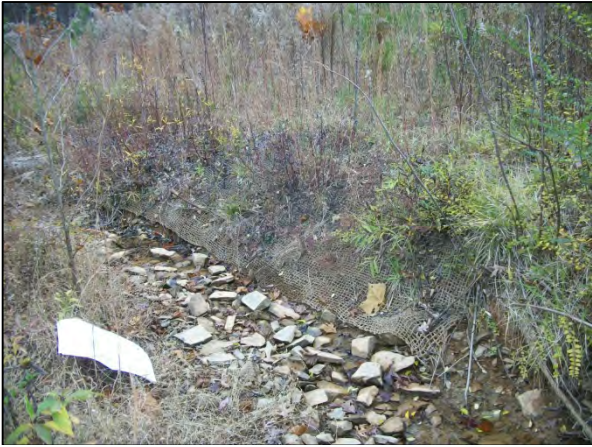
SPA 8 – Minor bank erosion along UT2 at Station 12+30, left bank

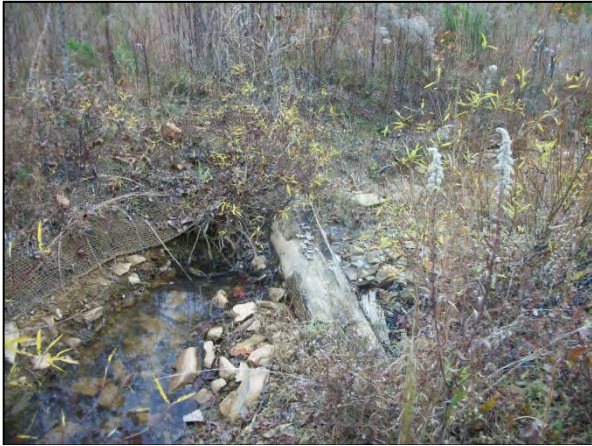
SPA 9 – Minor bank erosion along UT2 at Station 13+75 to 14+30, left bank

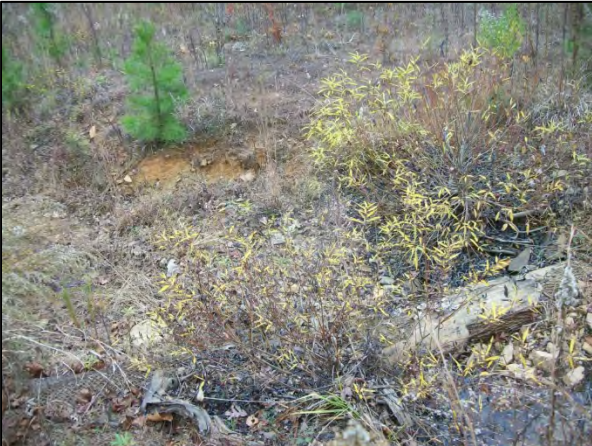
SPA 10 – Bank scour at Station 14+00 on right bank, UT2

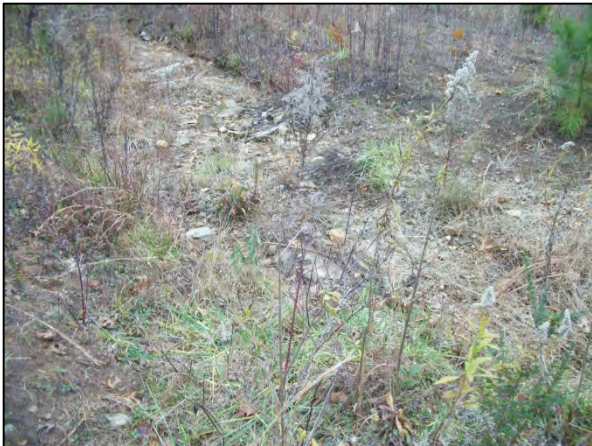
SPA 11 – Filled channel near Station 14+25, UT2

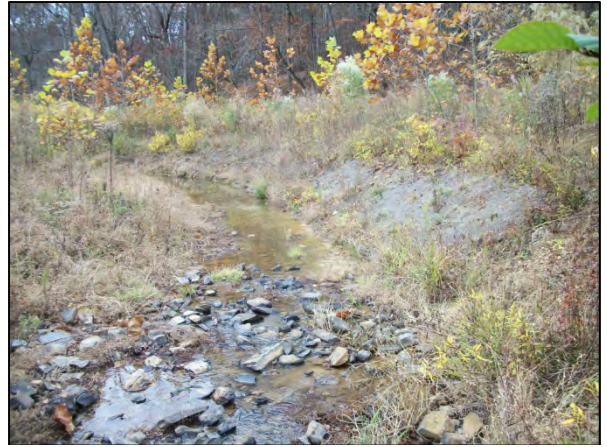
VPA 2 – Bare bank along BCC at Station 26+00 to 26+60, right bank

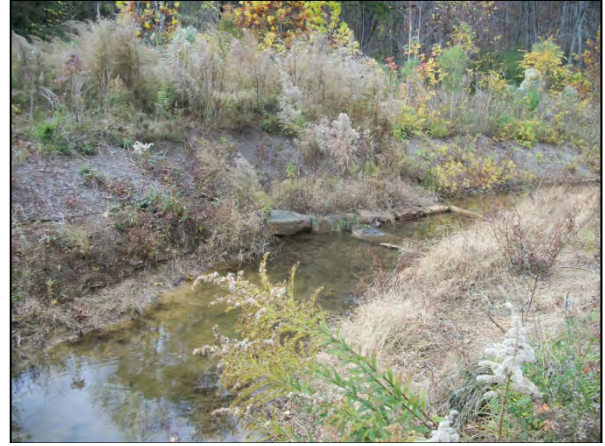
VPA 4 – Bare bank along BCC at Station 29+00 to 29+75, right bank

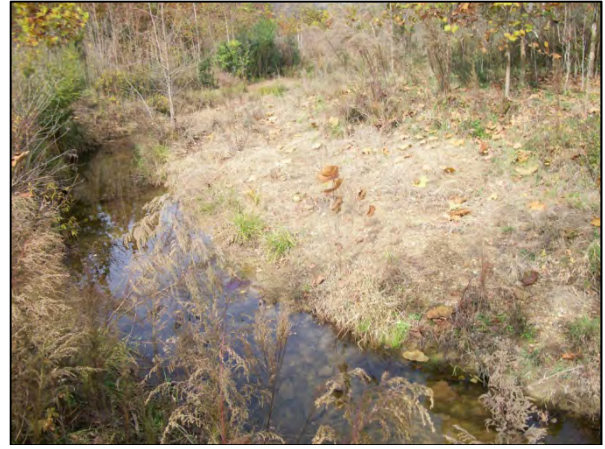
VPA 6 – Bare bank along BCC at Station 33+50 to 34+25, left bank

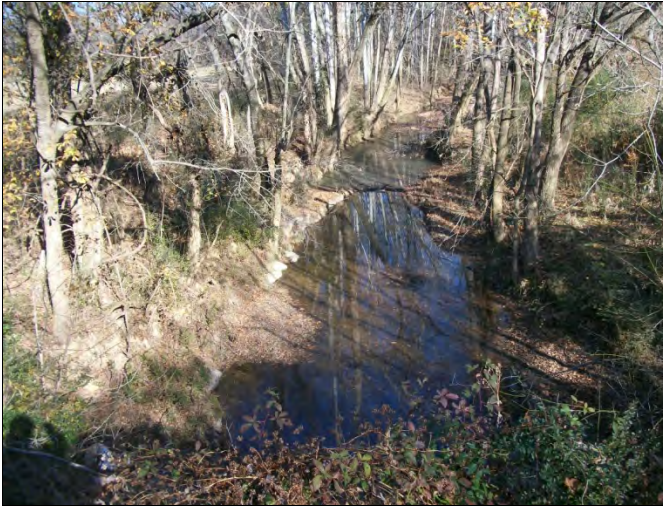
BCC PID 1– Cross Vane, BCC Reach 6 End

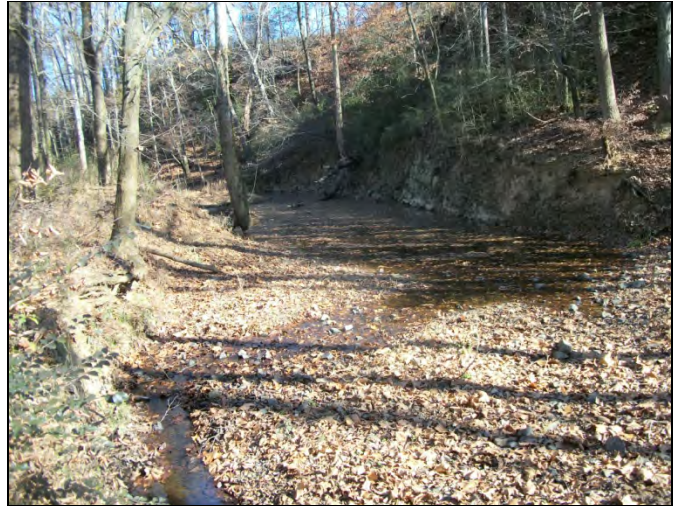
BCC PID 2 – Re-graded Riffle, BCC Reach 6

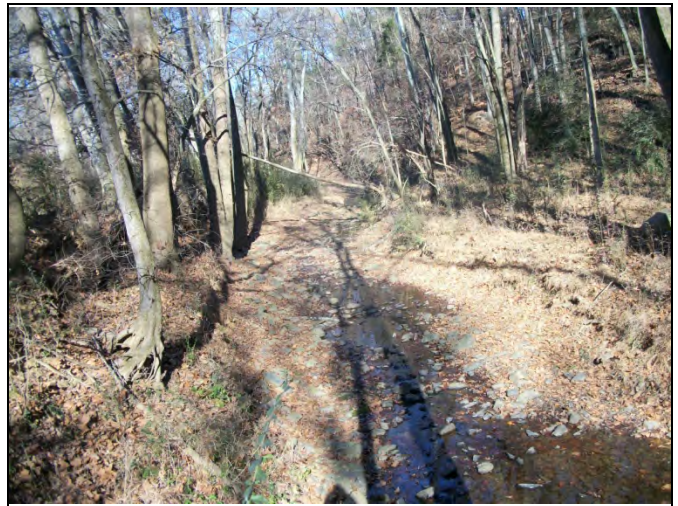
BCC PID 4 – Re-graded Riffle, BCC Reach 6

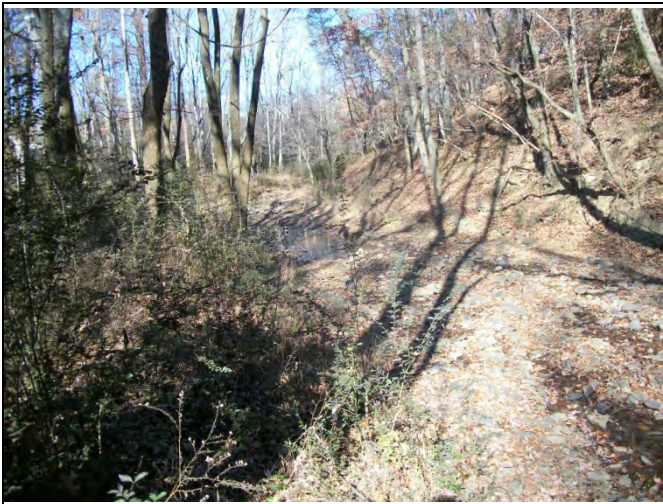
BCC PID 5 – Re-graded Riffle, BCC Reach 6

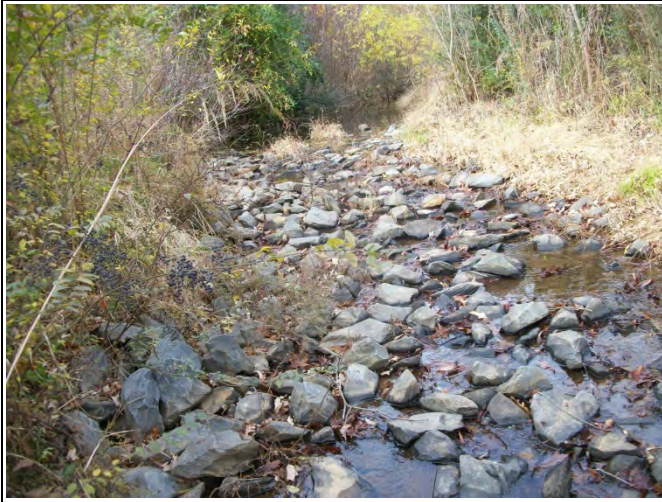
BCC PID 7 – Constructed Riffle, BCC Reach 4 End

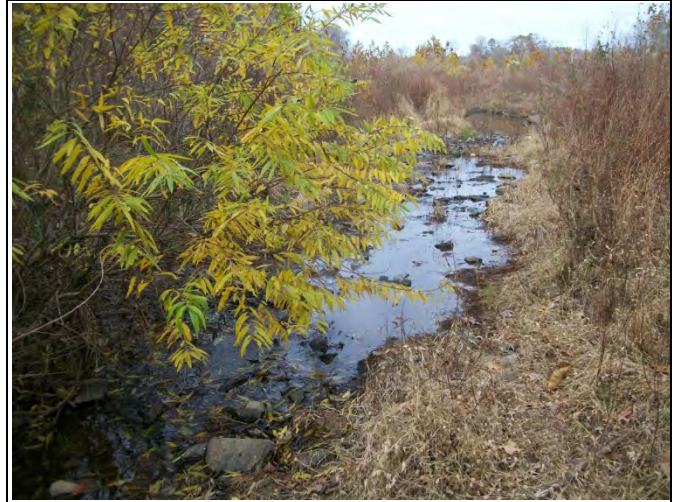
BCC PID 8 – Constructed Riffle, BCC Reach 4

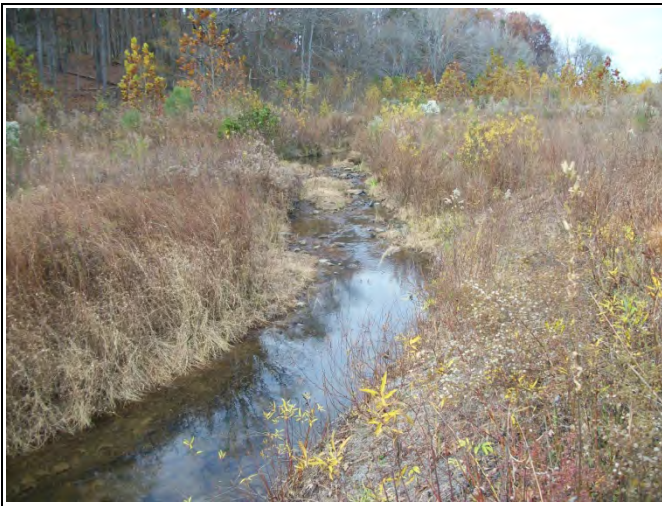
BCC PID 9 – Constructed Riffle, BCC Reach 4

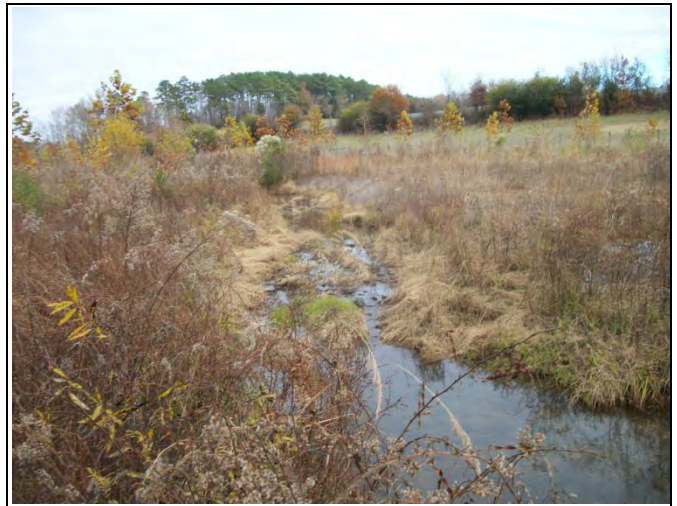
BCC PID 10 – Constructed Riffle, BCC Reach 4 Start

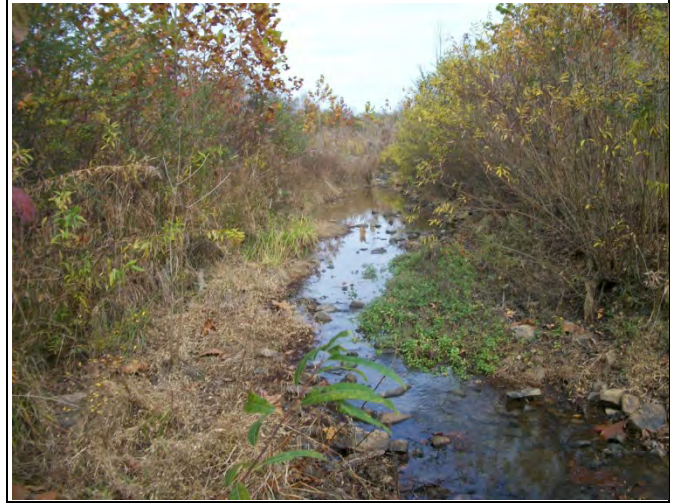
**BCC PID 14 – Constructed Riffle, BCC Reach 3**

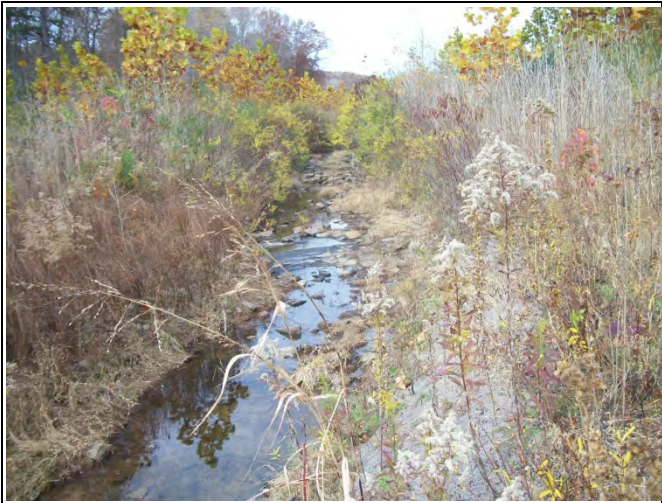
**BCC PID 15 – Constructed Riffle, BCC Reach 3**

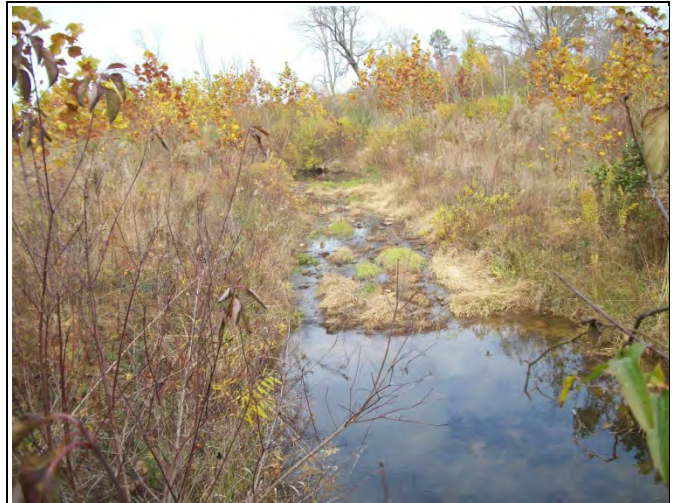
**BCC PID 16 – Constructed Riffle, BCC Reach 3**

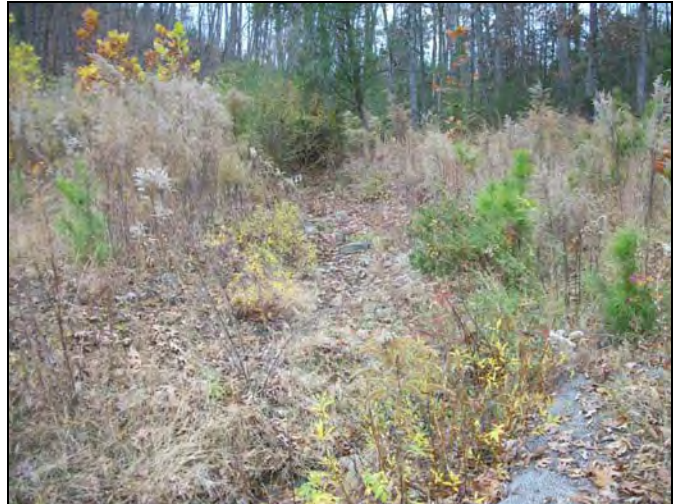
UT2 PID 8 – Constructed Riffle, UT2 Start
