Big Cedar Creek Stream Restoration FINAL Year 5 Monitoring Report (2013) Stanly County, North Carolina

EEP Project ID #92532/EEP Contract #D06054-D

Data Collection Period: October - December 2013

Submission Date: May 2014

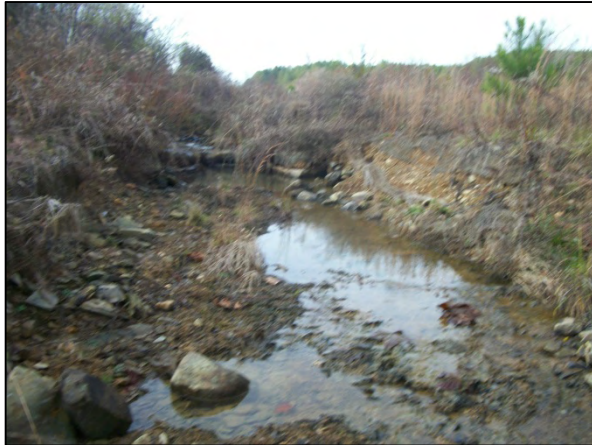
UT1 Reach 4			
Feature Issue	Station No.	Suspected Cause	Photo Number
Minor bank erosion	56+60, Left Bank	Loose matting/sparse vegetation	SPA 1
Mid-channel bar	43+25 - 43+75	Large willow & vegetation in channel backing up sediment	SPA 2
BCC Reach 4			
Feature Issue	Station No.	Suspected Cause	Photo Number
Minor bank erosion	59+60 - 60+00, Left Bank	Sparse woody vegetation	SPA 3
BCC Reach 3			
Feature Issue	Station No.	Suspected Cause	Photo Number
Minor bank erosion	46+90 - 47+30, Left Bank	Loose matting/sparse vegetation	SPA 4
Riffle degradation	51+60 - 52+02	Unknown (Degradation not apparent during field walk. Noted from profile survey.)	N/A
BCC Reach 2			
Feature Issue	Station No.	Suspected Cause	Photo Number
Debris across channel	21+25; 33+00	Remnant Beaver Dam	SPA 5

SPA 1 – Minor bank erosion on UT1 at Station 56+60, left bank

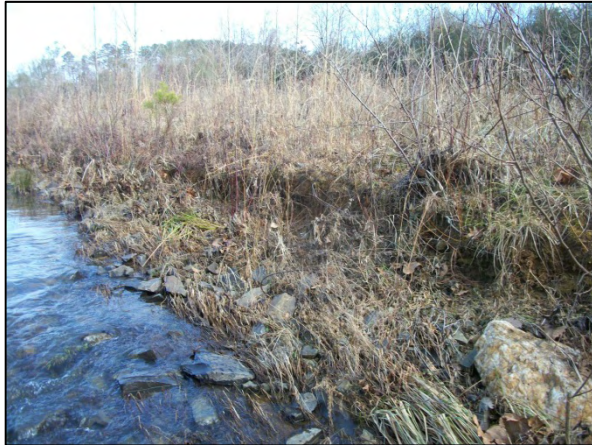
SPA 3 – Minor bank erosion on left bank of BCC from Station 60+00 to 59+60

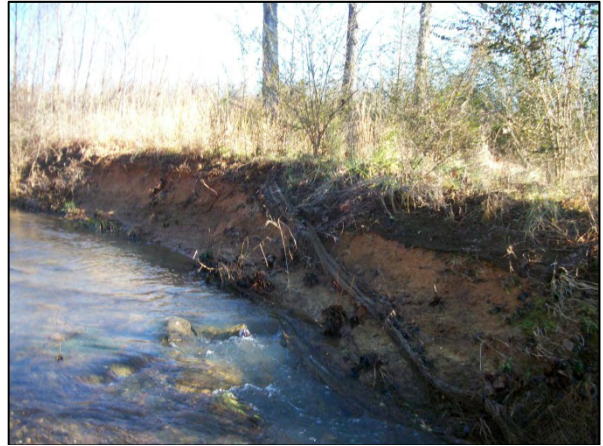
SPA 4 – Bank erosion on left of BCC from Station 46+90 to 47+30

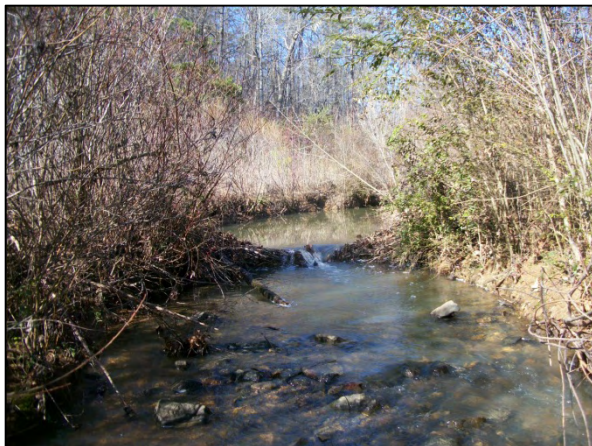
SPA 5 – Remnant beaver dam on BCC at Station 21+25 and Station 33+00

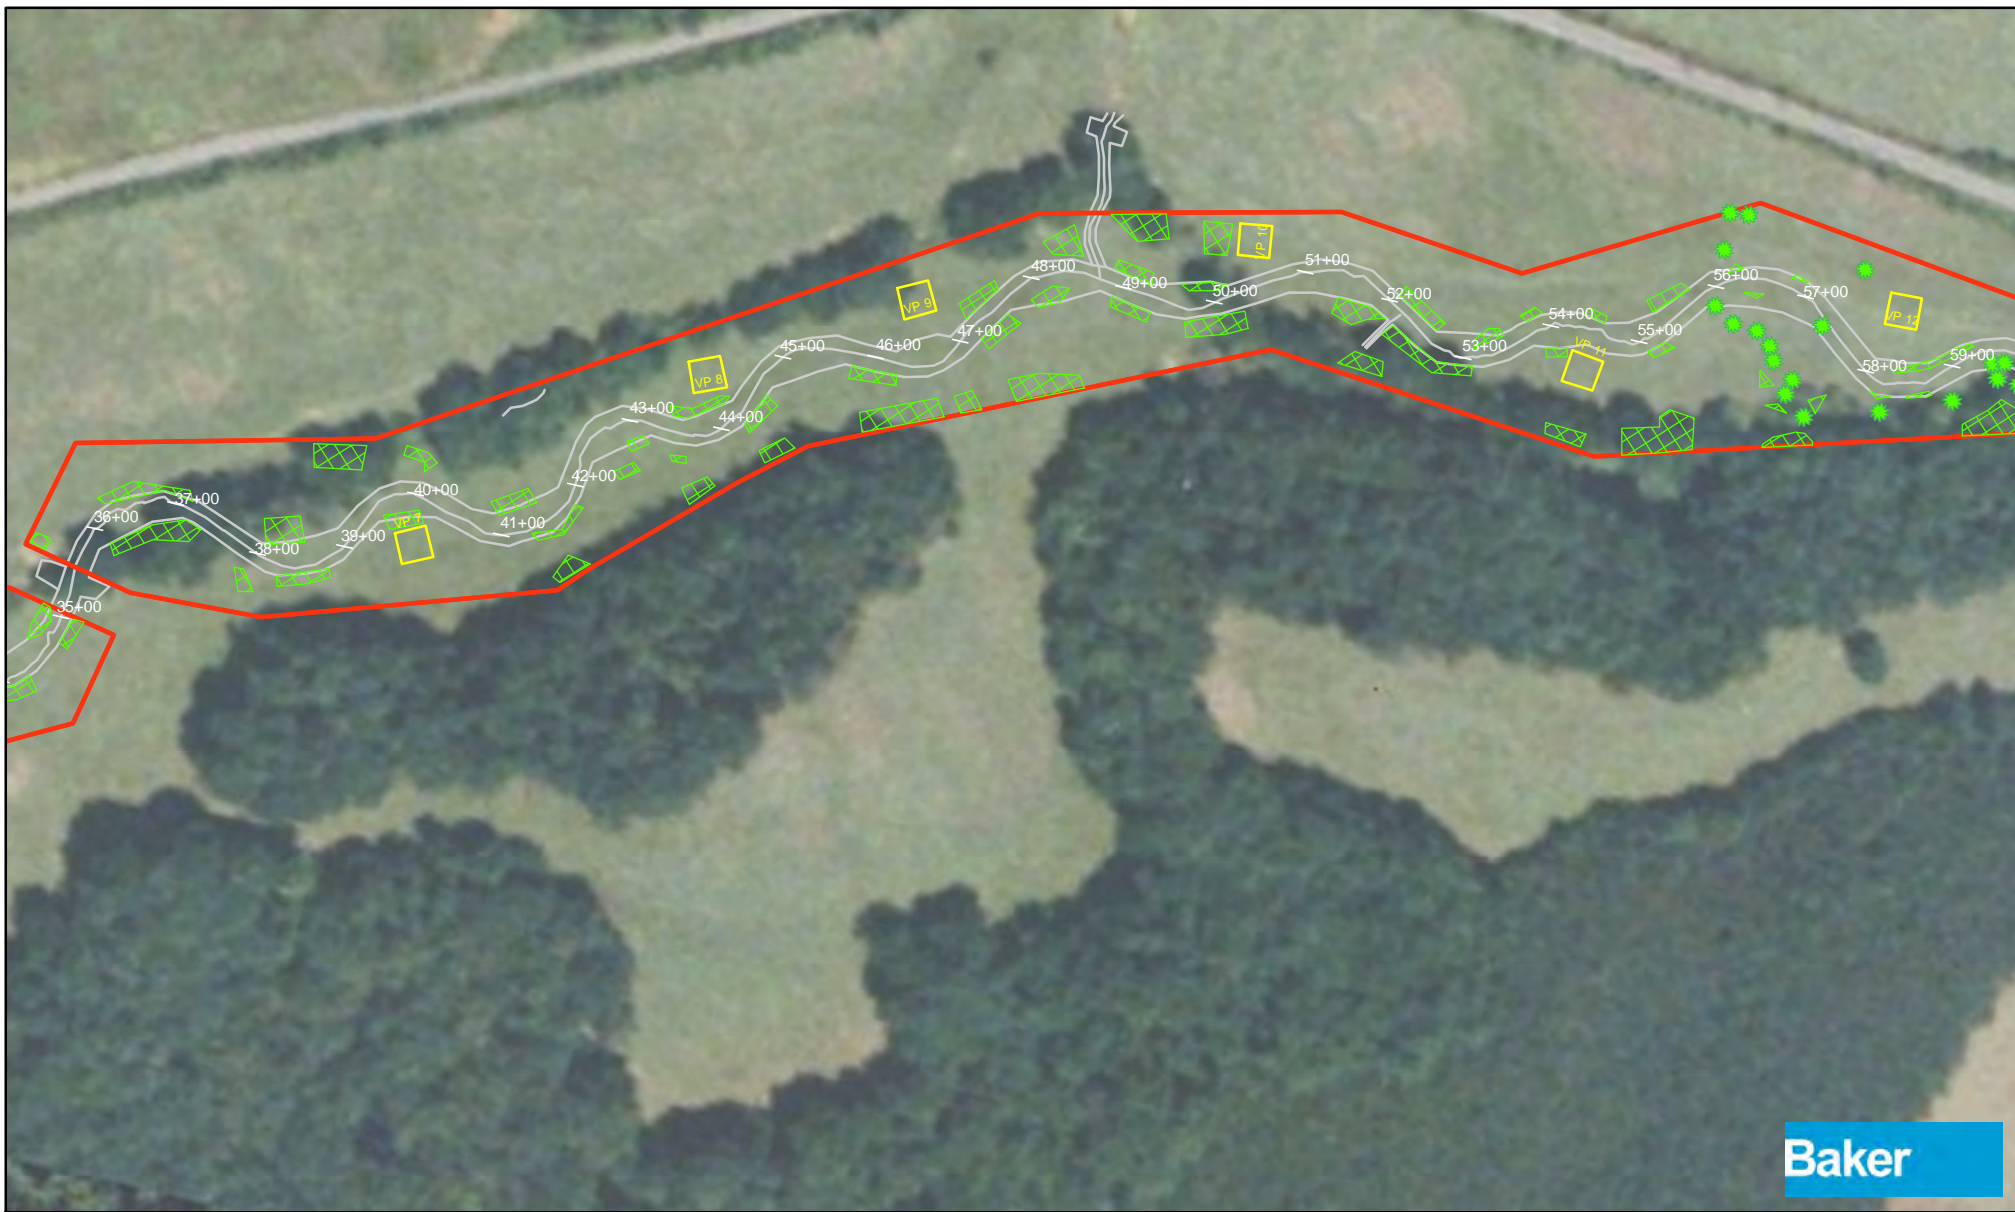
**Figure C2: Vegetation Problem Areas
BCC (Station 37+00 to 59+00)**

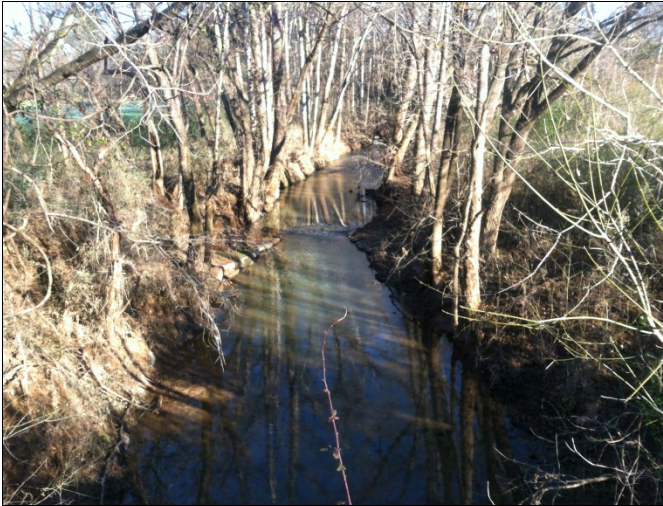
BCC PID 1– Cross Vane, BCC Reach 6 End

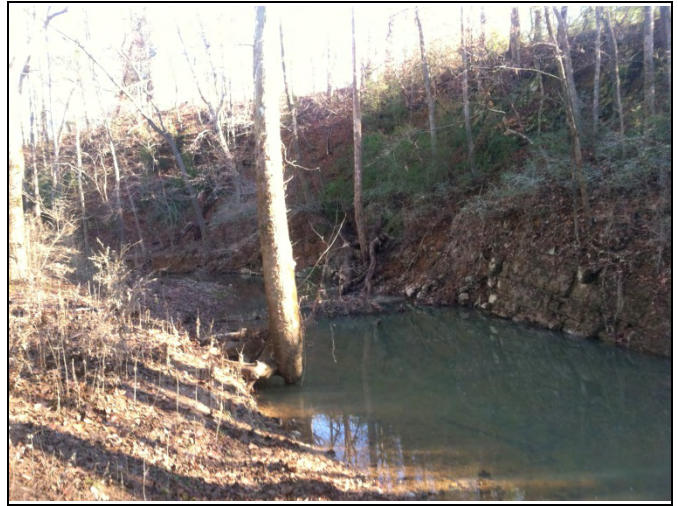
BCC PID 2 – Re-graded Riffle, BCC Reach 6

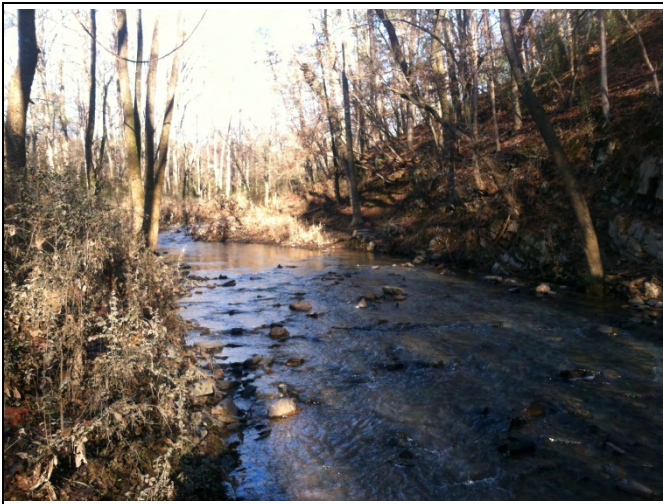
BCC PID 5 – Re-graded Riffle, BCC Reach 6

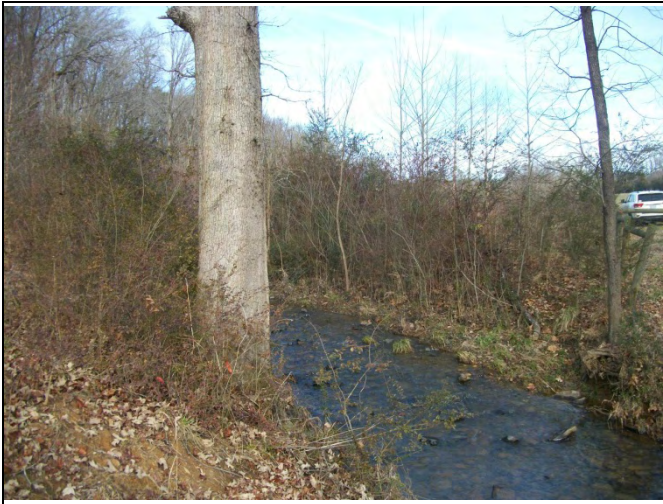
BCC PID 7 – Constructed Riffle, BCC Reach 4 End

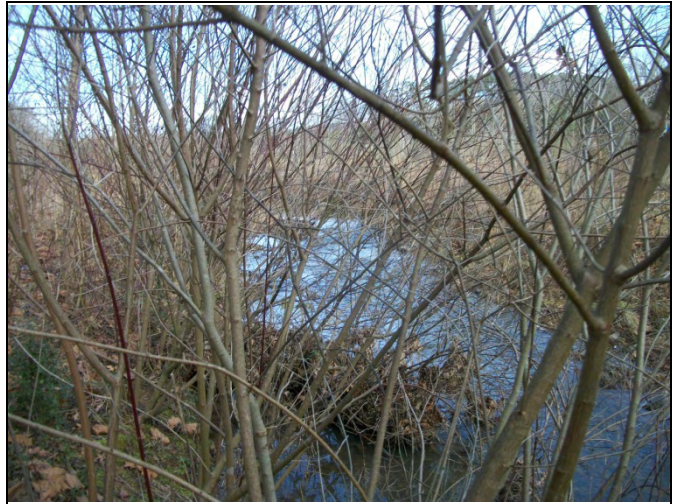
BCC PID 8 – Constructed Riffle, BCC Reach 4

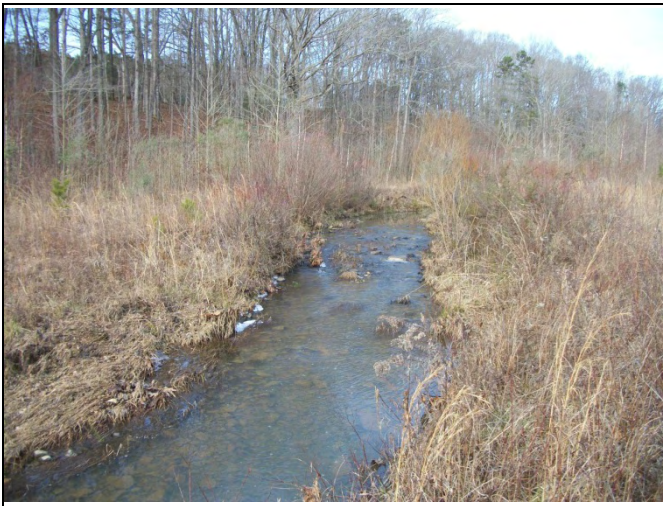
BCC PID 9 – Constructed Riffle, BCC Reach 4

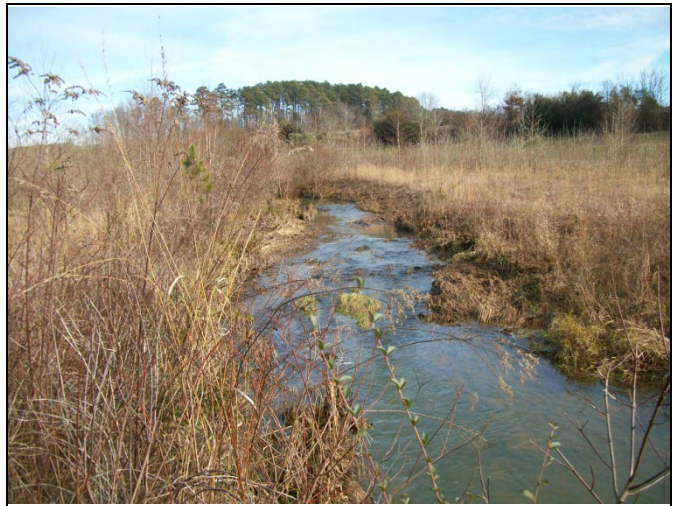
BCC PID 10 – Constructed Riffle, BCC Reach 4 Start

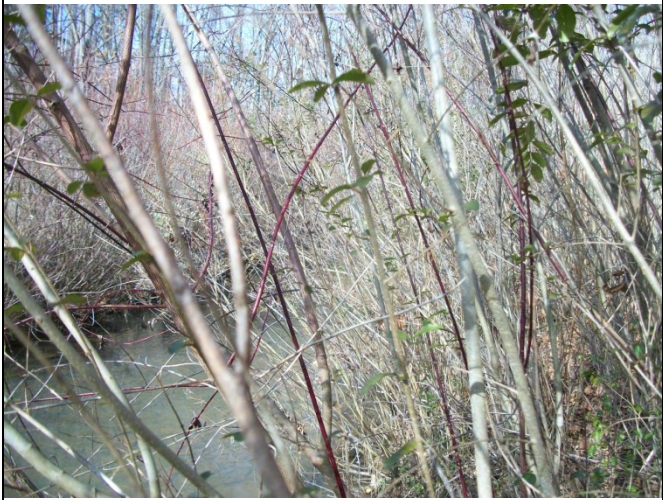
BCC PID 13 – Log J-Hook & Constructed Riffle, BCC Reach 3

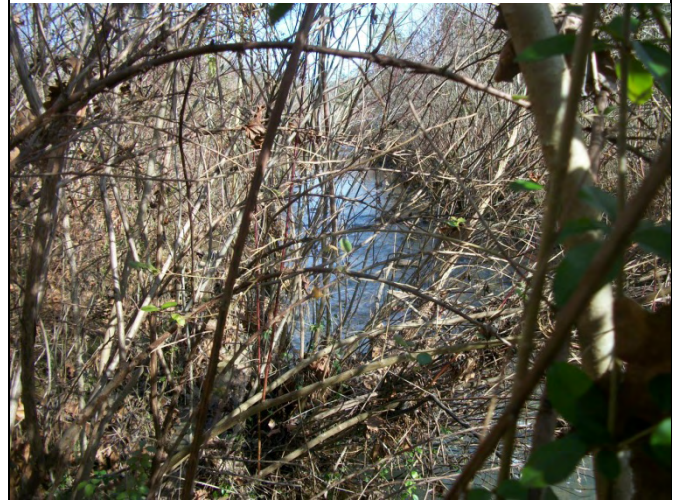
BCC PID 14 – Constructed Riffle, BCC Reach 3

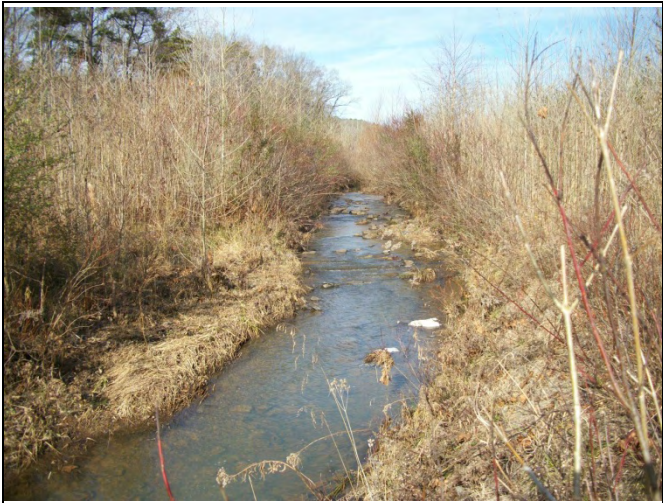
BCC PID 15 – Constructed Riffle, BCC Reach 3

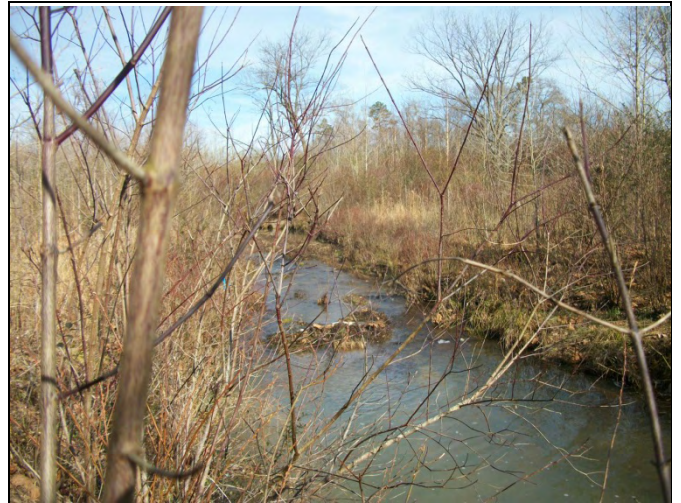
BCC PID 16 – Constructed Riffle, BCC Reach 3

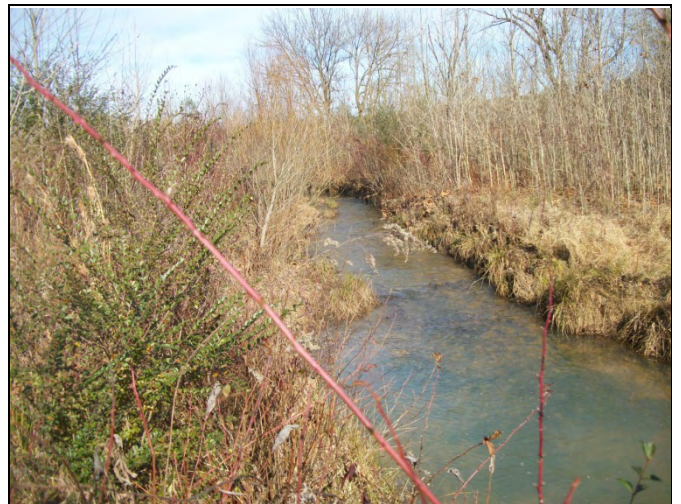
BCC PID 18 – Constructed Riffle, BCC Reach 3

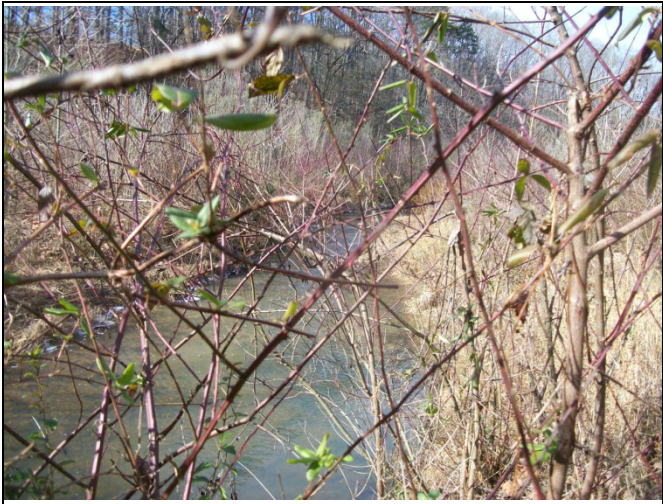
BCC PID 19 – Constructed Riffle, BCC Reach 3

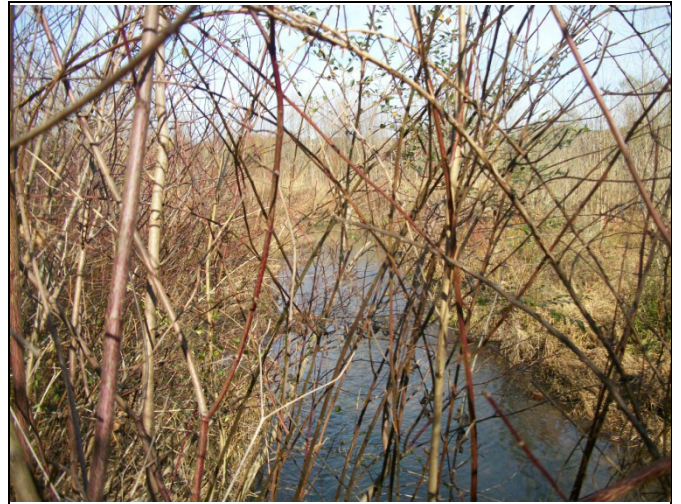
BCC PID 20 – Constructed Riffle, BCC Reach 3

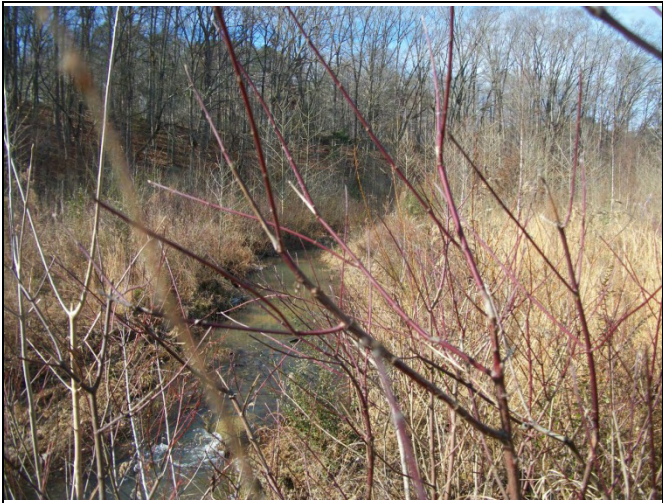
BCC PID 21 – Constructed Riffle, BCC Reach 3

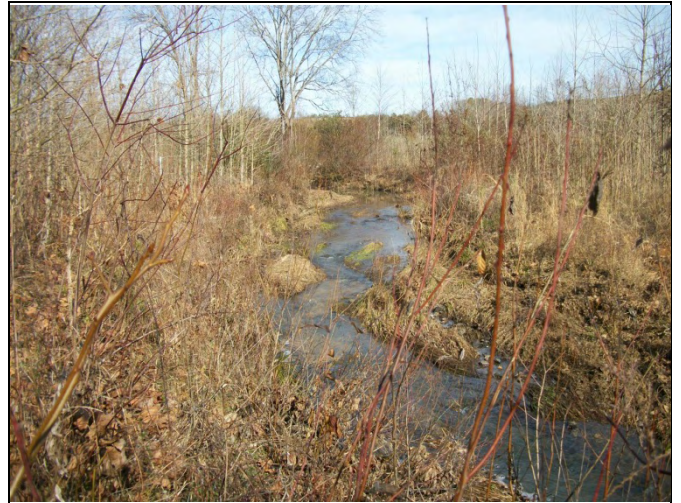
BCC PID 22 – Constructed Riffle, BCC Reach 3

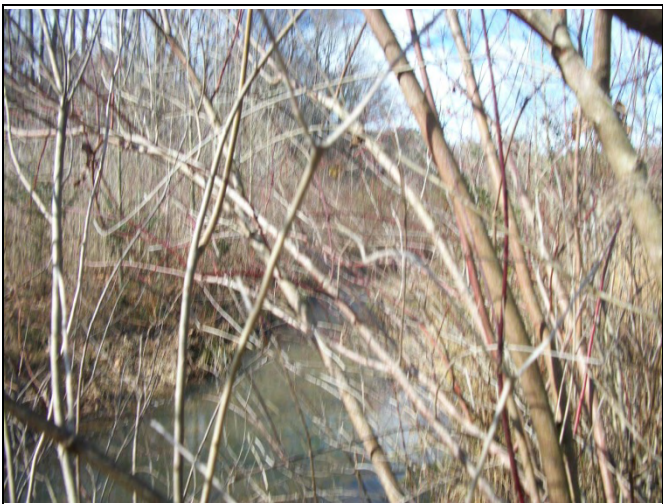
BCC PID 23 – Constructed Riffle, BCC Reach 3 Start

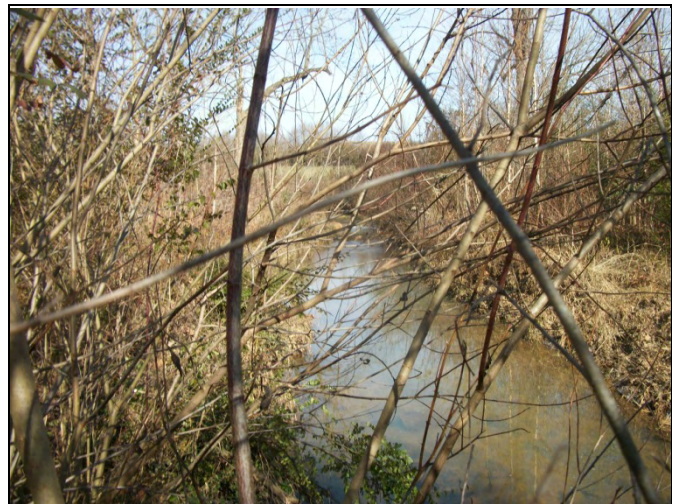
BCC PID 24 – Constructed Riffle, BCC Reach 2 End

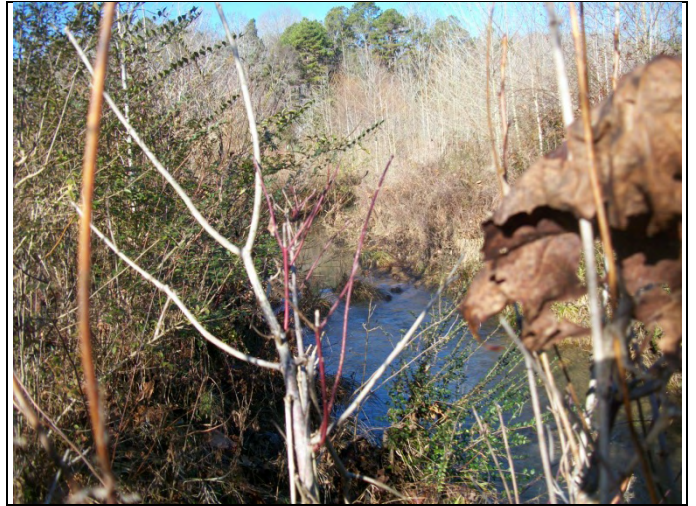
BCC PID 26 – Constructed Riffle, BCC Reach 2

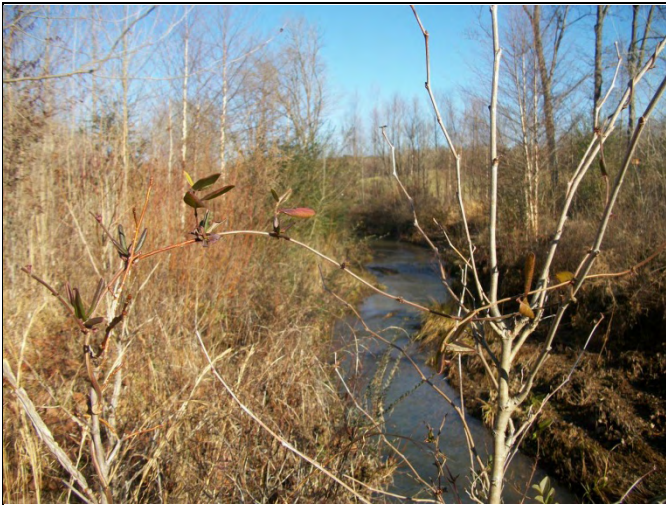
BCC PID 27 – Constructed Riffle, BCC Reach 2

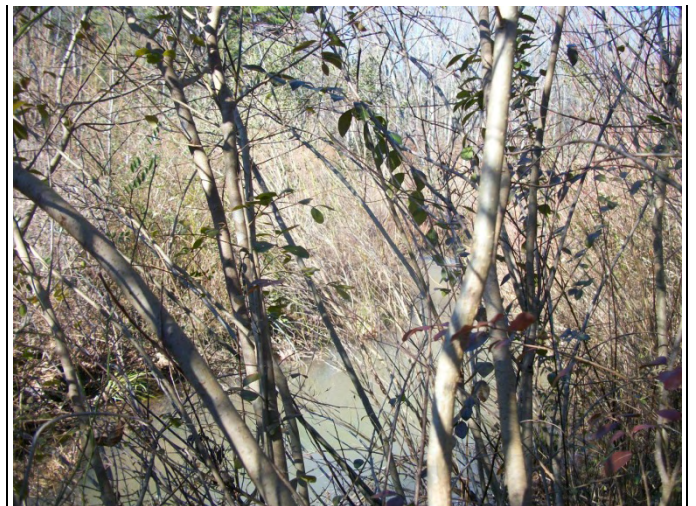
BCC PID 30 – Constructed Riffle, BCC Reach 2

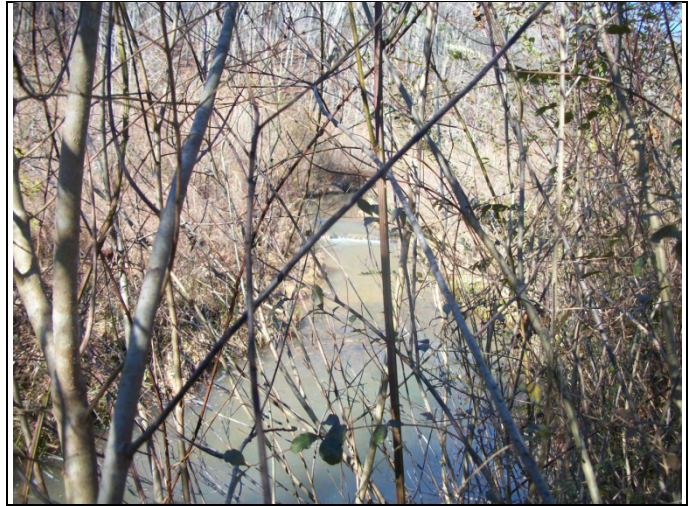
BCC PID 31 – Constructed Riffle, BCC Reach 2

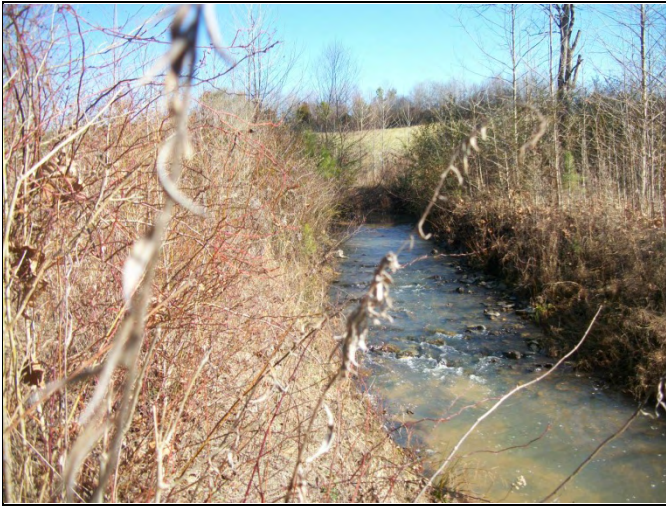
BCC PID 32 – Constructed Riffle, BCC Reach 2

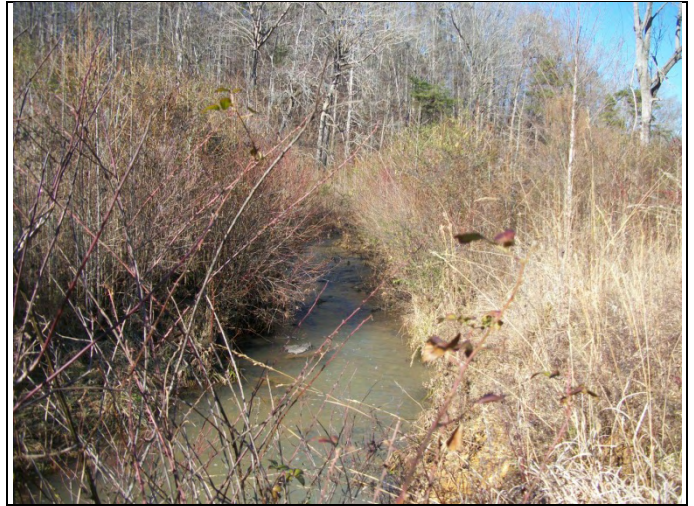
BCC PID 33 – Constructed Riffle, BCC Reach 2

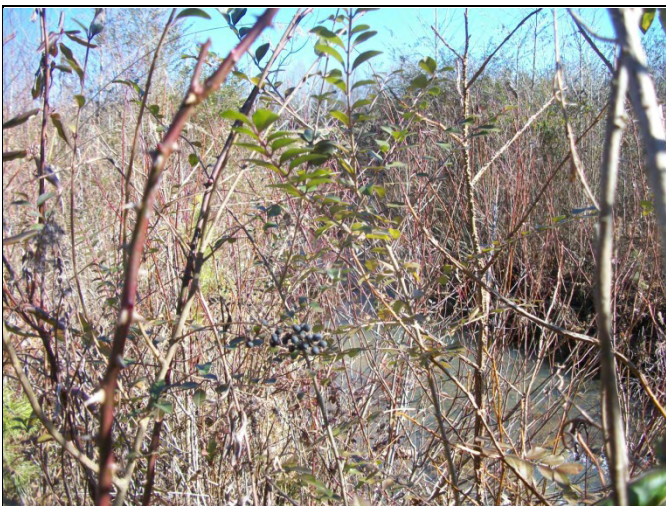
BCC PID 34 – Constructed Riffle, BCC Reach 2

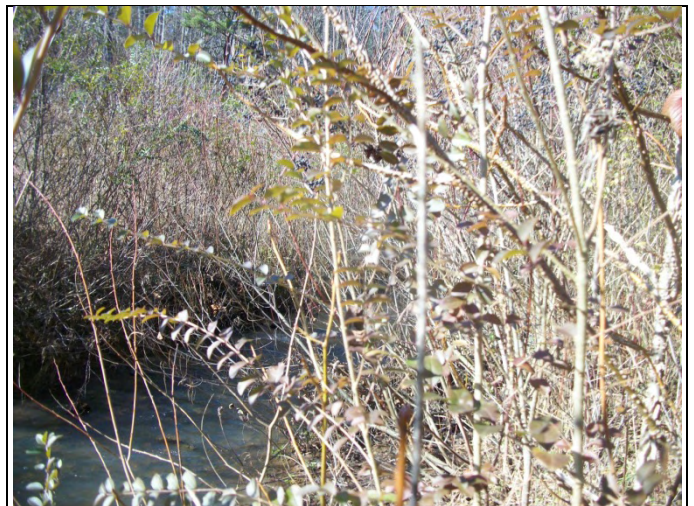
BCC PID 35 – Constructed Riffle, BCC Reach 2

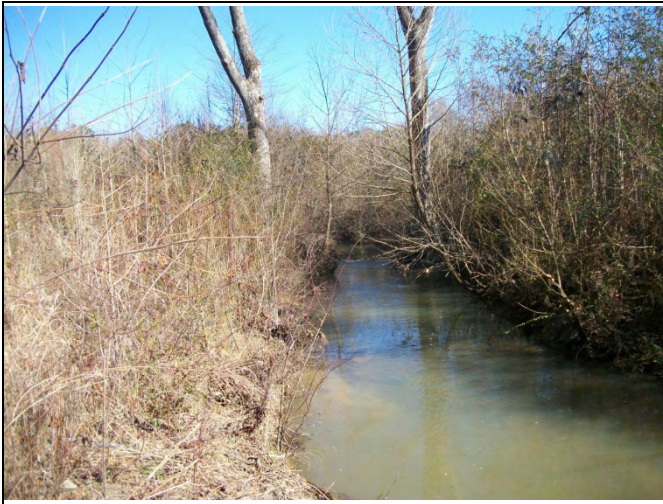
BCC PID 36 – Constructed Riffle, BCC Reach 2

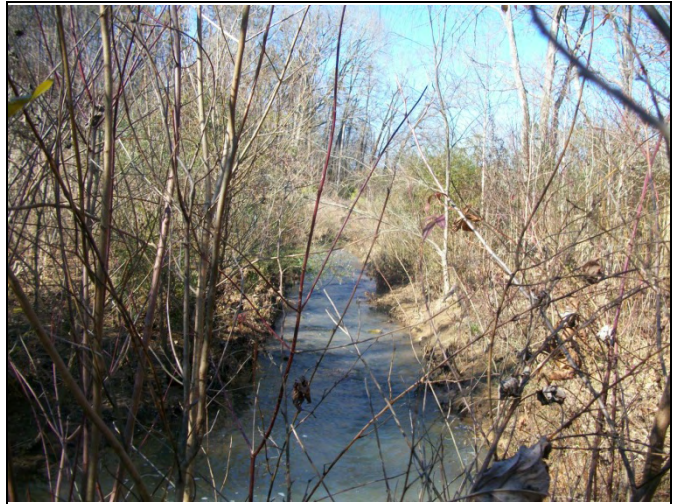
BCC PID 37 – Constructed Riffle, BCC Reach 2

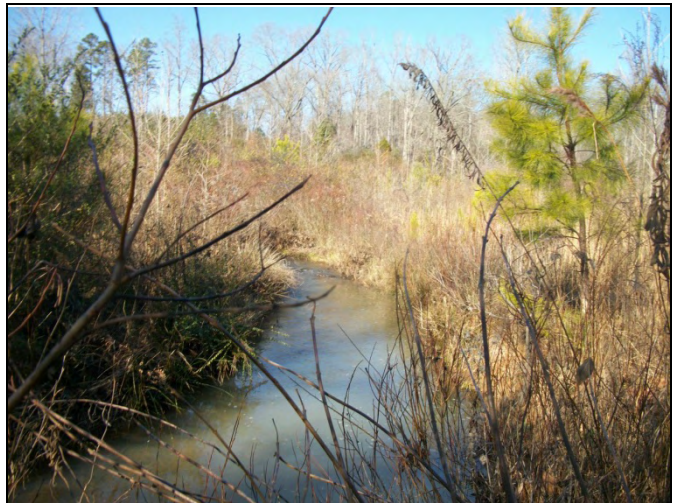
BCC PID 39 – Constructed Riffle, BCC Reach 2 Start

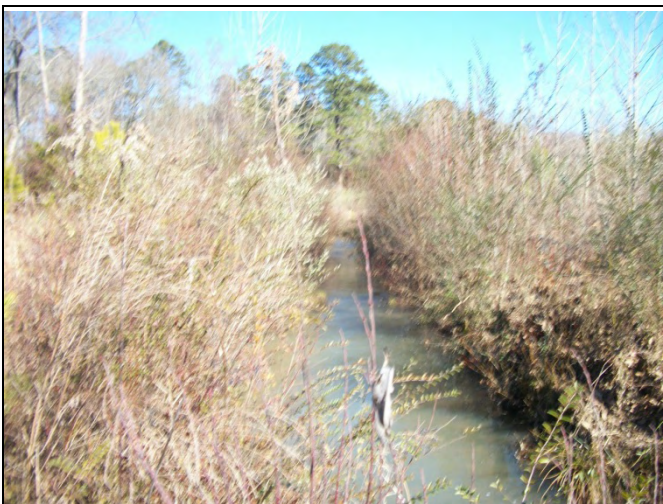
BCC PID 40 – Constructed Riffle, BCC Reach 1 End

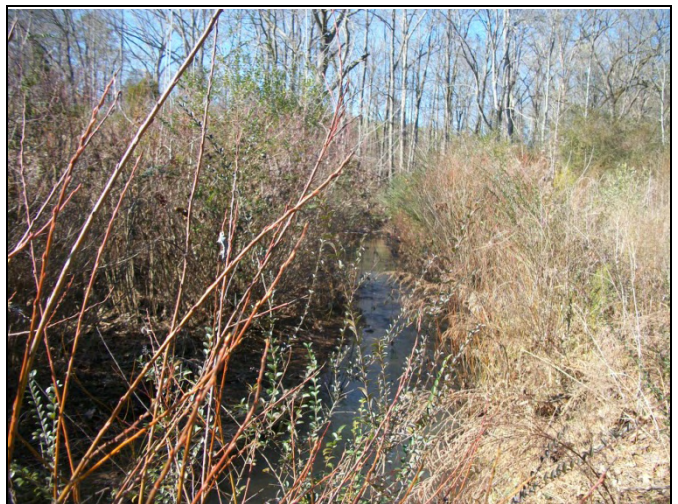
BCC PID 41 – Constructed Riffle, BCC Reach 1

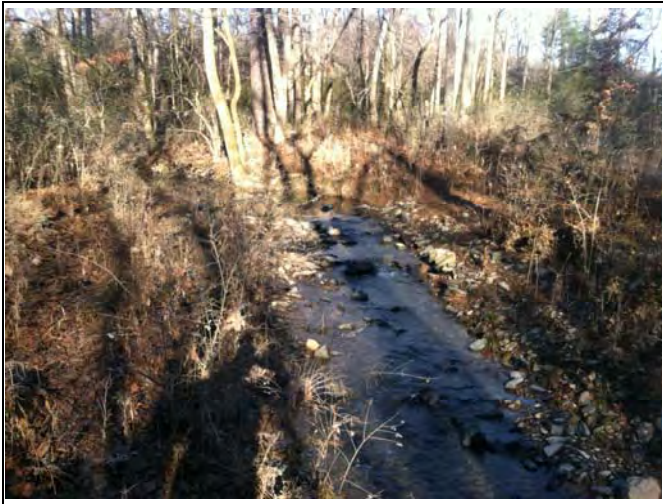
BCC PID 42 – Constructed Riffle, BCC Reach 1 Start

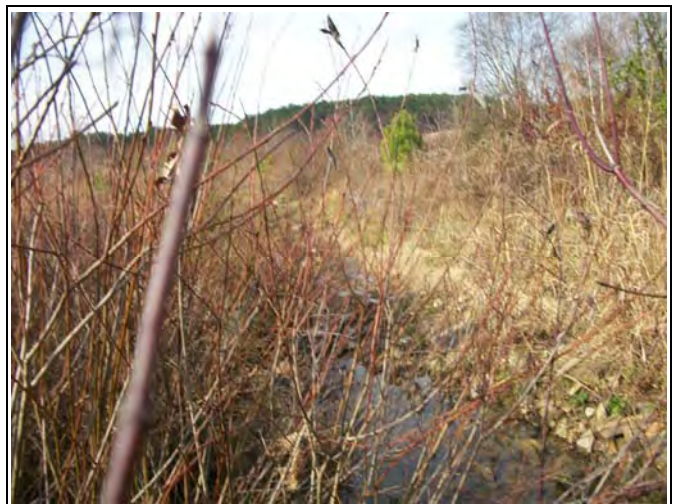
UT1 PID 5 – Riffle Crossing, UT1 Reach 4

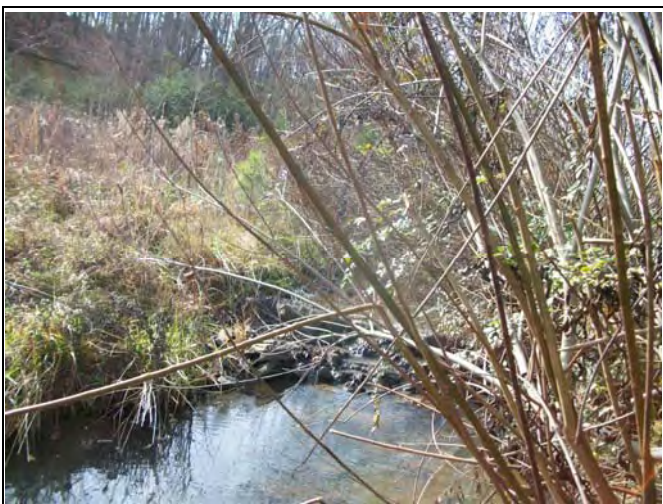
UT1 PID 10 – Constructed Riffle, UT1 Reach 4

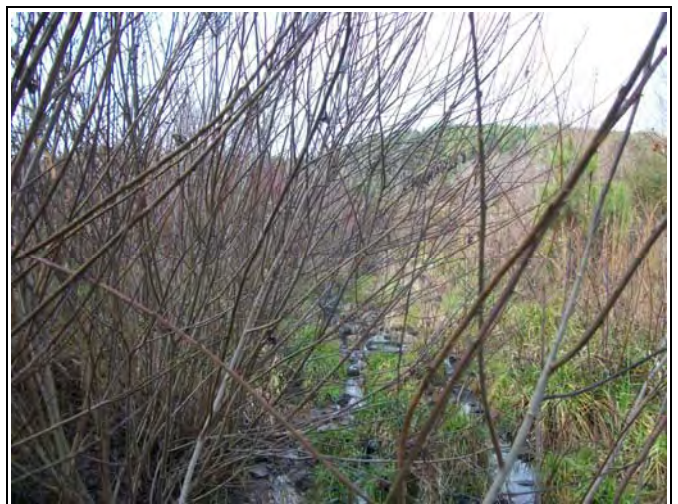
UT1 PID 11 – Constructed Riffle, UT1
Reach 4 Start

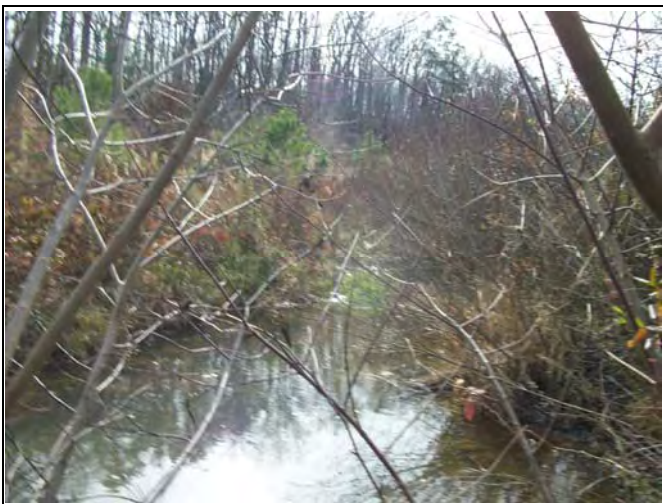
UT1 PID 16 – Constructed Riffle, UT1 Reach 3

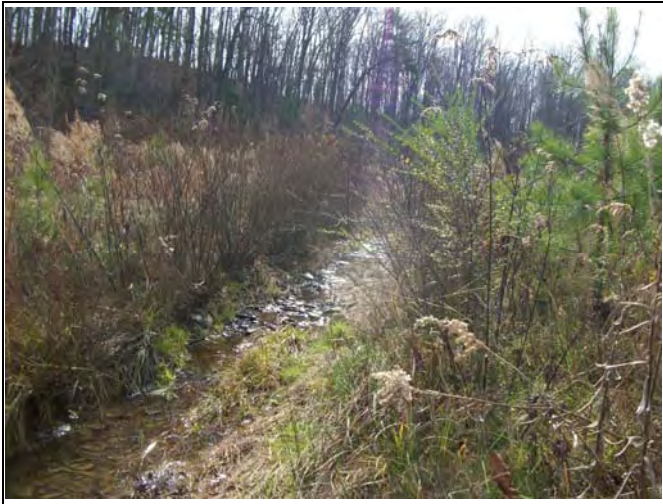
UT1 PID 18 – Constructed Riffle, UT1 Reach 3

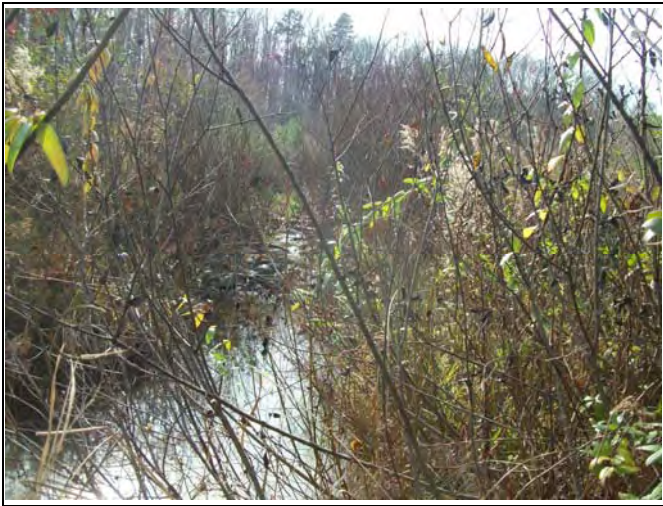
UT1 PID 20 – Constructed Riffle, UT1 Reach 3

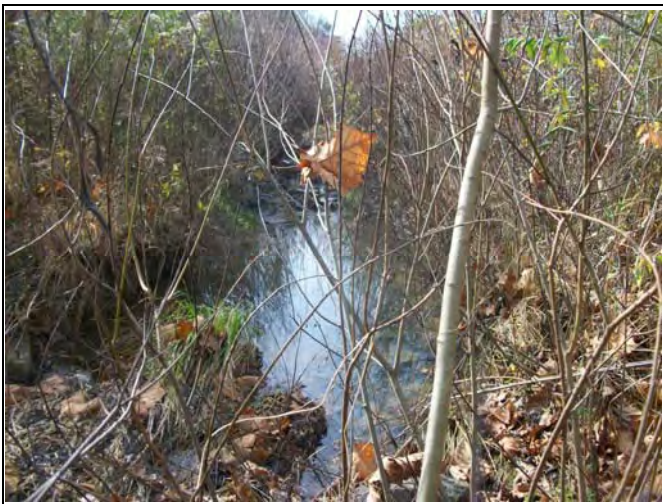
UT1 PID 22 – Constructed Riffle, UT1 Reach 3

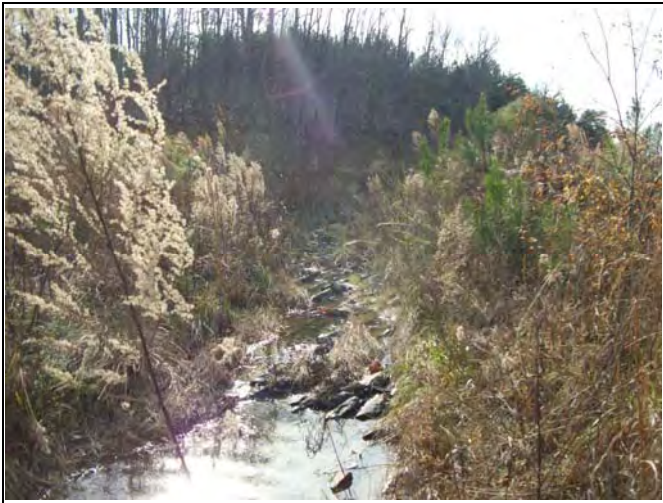
UT1 PID 26 – Constructed Riffle, UT1 Reach 3

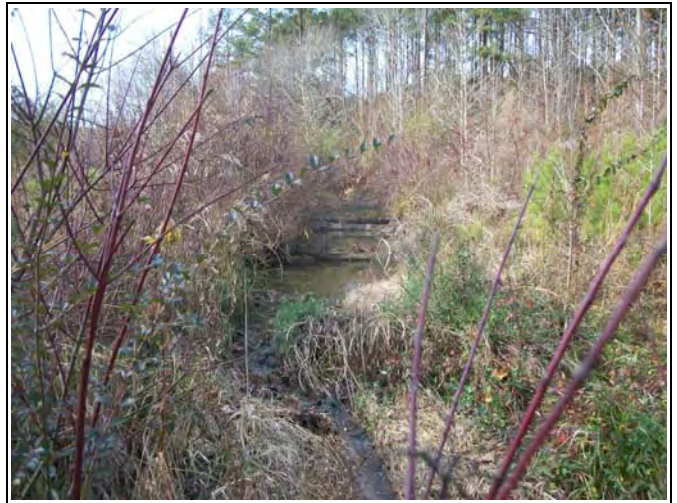
UT1 PID 27 – Constructed Riffle, UT1 Reach 3

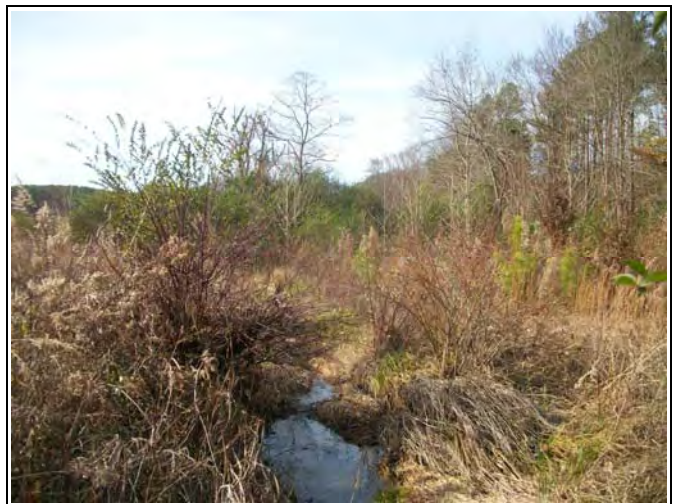
UT1 PID 30– Constructed Riffle, UT1 Reach 3 Start

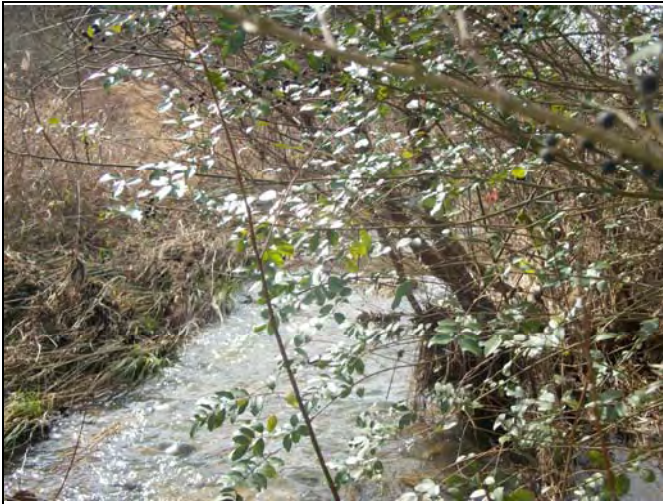
UT1 PID 31 – Constructed Riffle, UT1 Reach 2 End

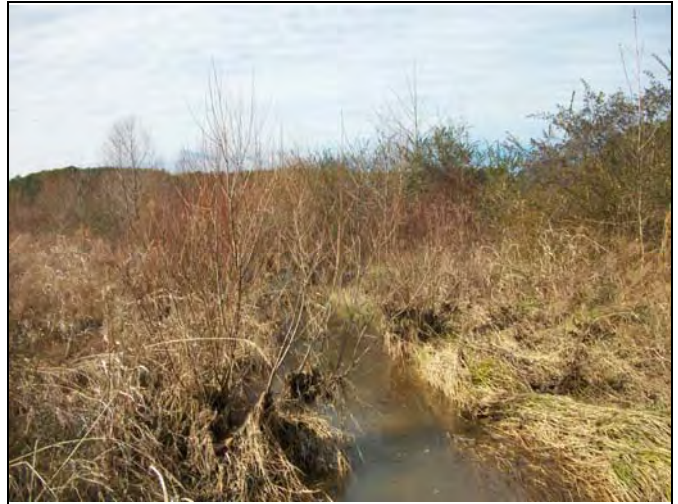
UT1 PID 32 – Constructed Riffle, UT1 Reach 2

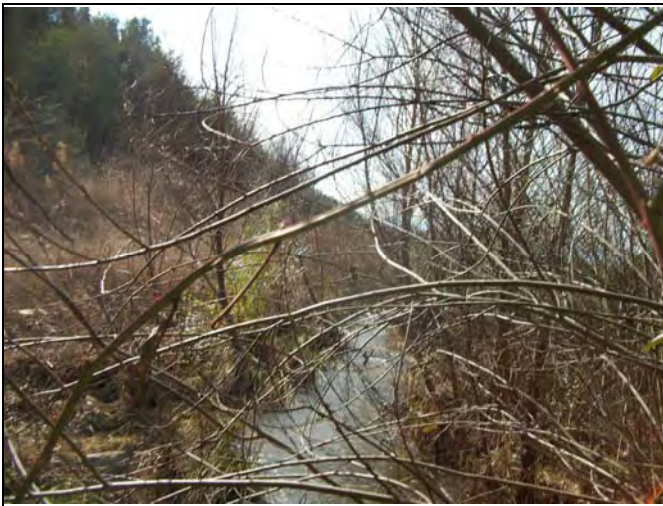
UT1 PID 33 – Constructed Riffle, UT1 Reach 2

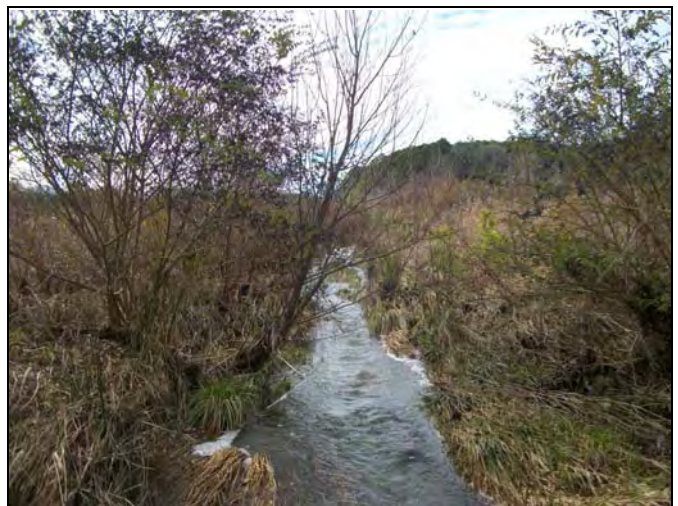
UT1 PID 36 – Constructed Riffle, UT1 Reach 2

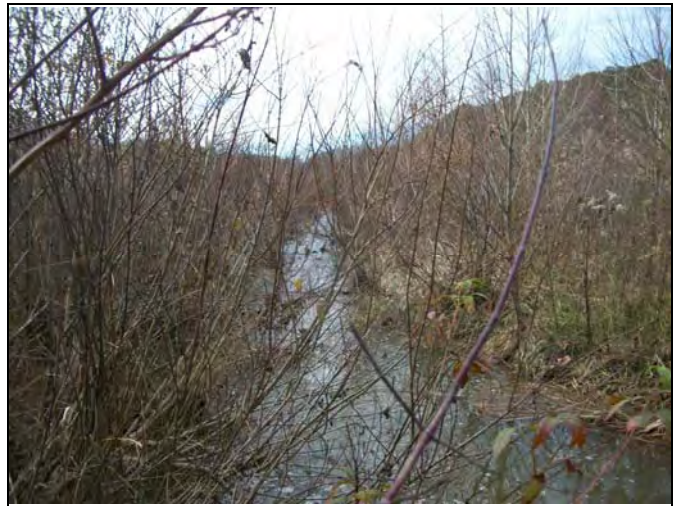
UT1 PID 40 – Constructed Riffle, UT1 Reach 2

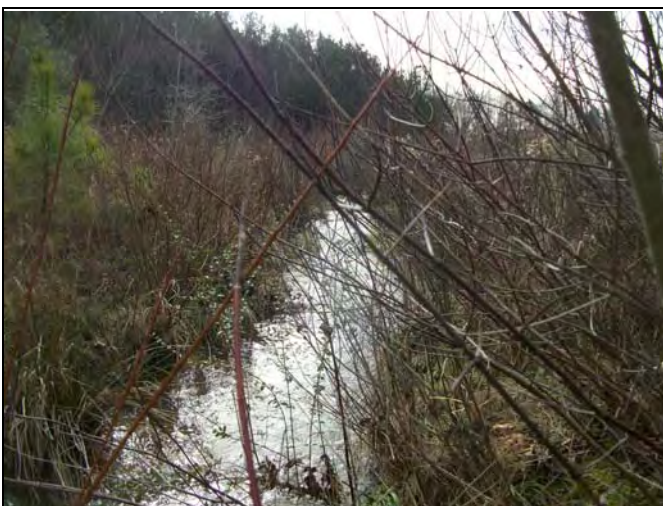
UT1 PID 41 – Riffle crossing, UT1 Reach 2 Start

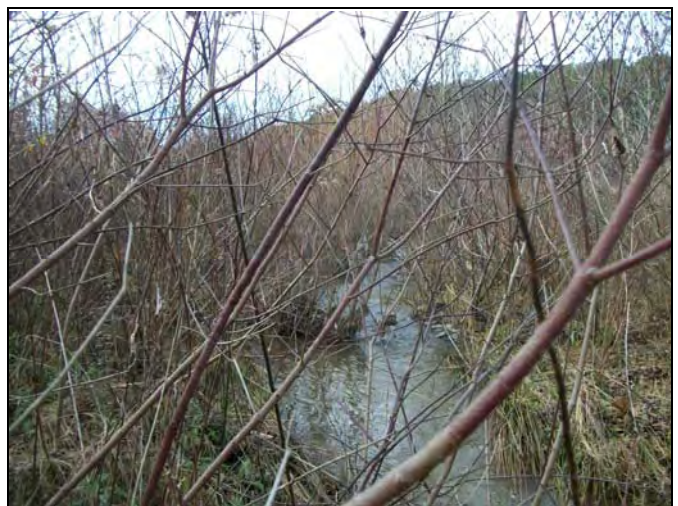
UT1 PID 42 – Constructed Riffle, UT1 Reach 1 End

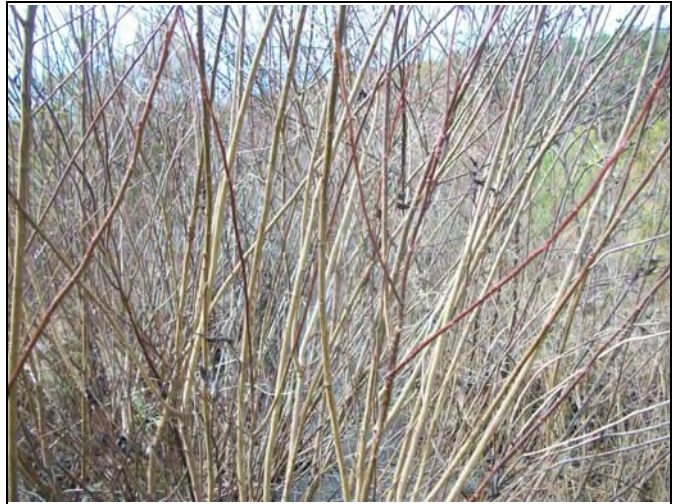
UT1 PID 44 – Constructed Riffle, UT1 Reach 1

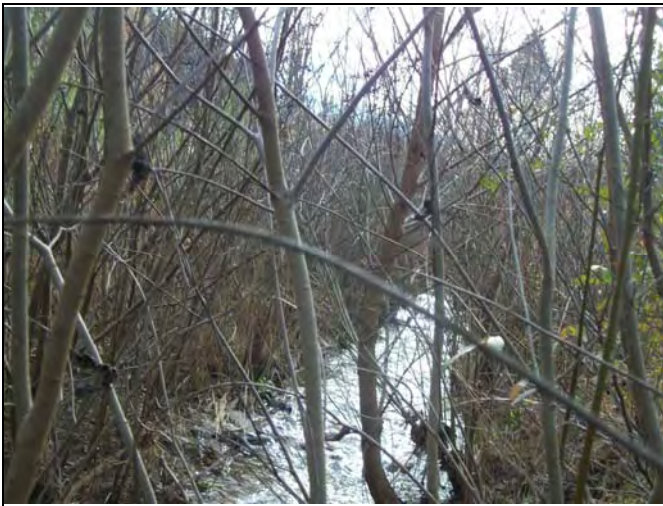
UT1 PID 45 – Constructed Riffle, UT1 Reach 1

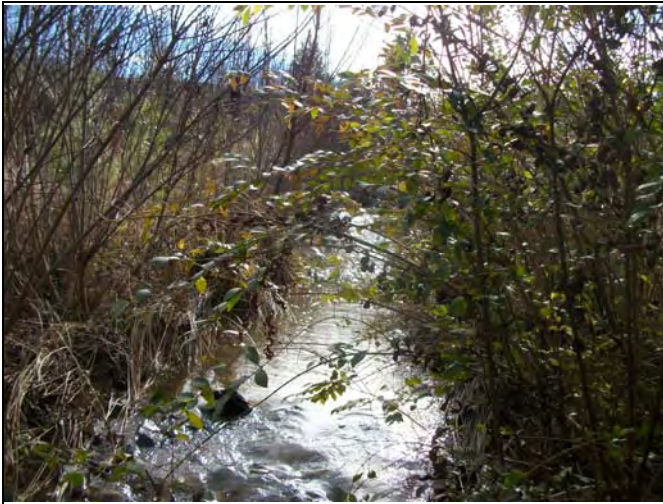
UT1 PID 49 – Constructed Riffle, UT1 Reach 1

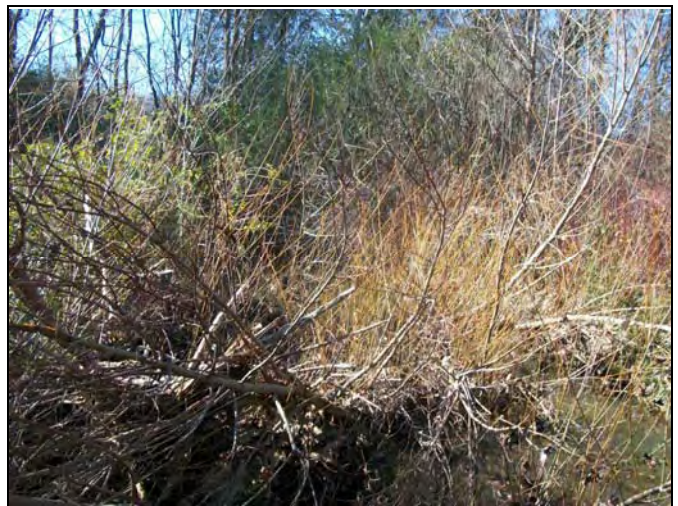
UT1 PID 54 – Constructed Riffle, UT1
Reach 1 Start

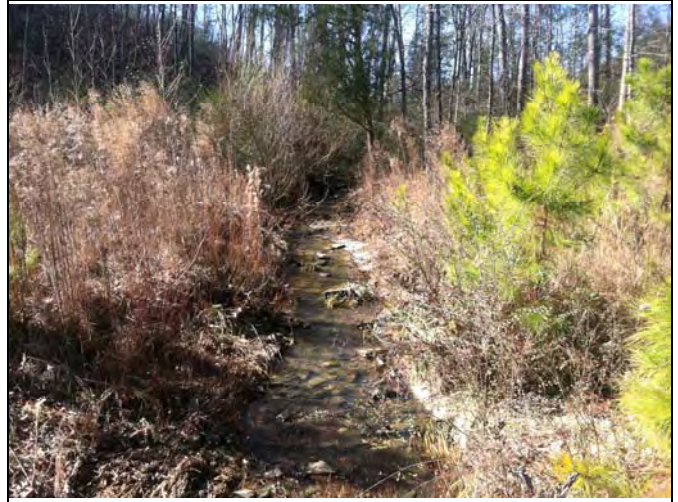
UT2 PID 8 – Constructed Riffle, UT2 Start
